NOBLIN & ASSOCIATES L.C.
Consulting Engineers

**BUILDING ENVELOPE CONDITION SURVEY
CHILMARK SCHOOL
CHILMARK, MASSACHUSETTS**

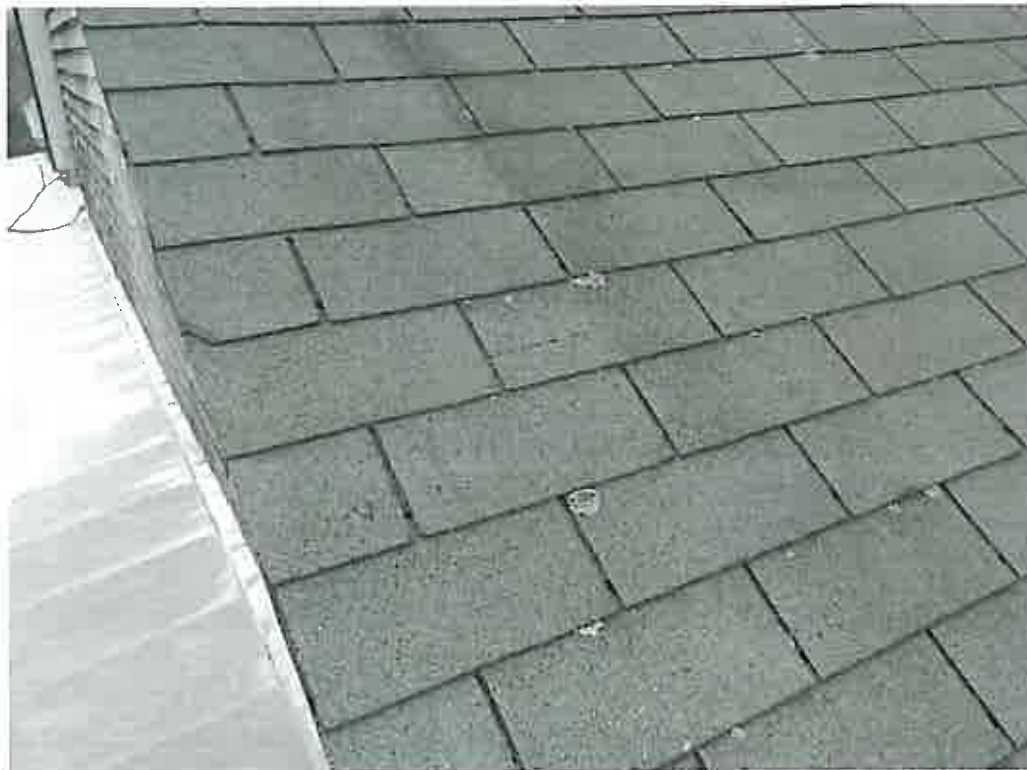
BLACK STAINING AND LICHEN GROWTH ON THE THREE TAB SHINGLES AT THE CHILMARK SCHOOL

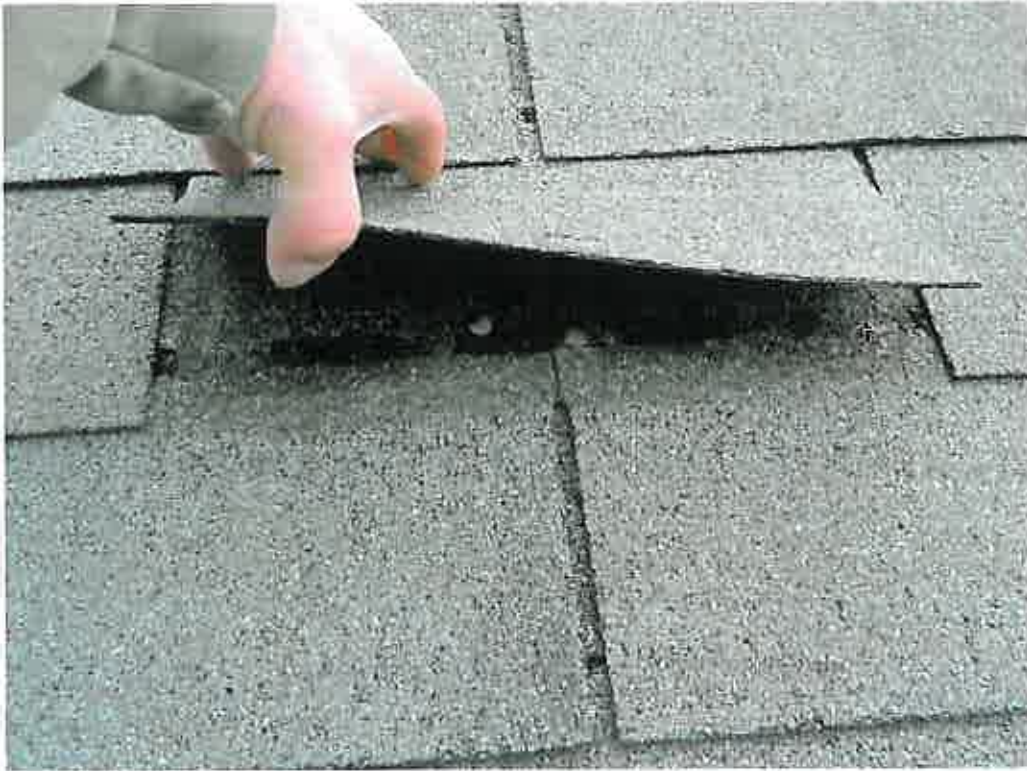
TYPICAL HIGH NAILING OF THE ASPHALT SHINGLES

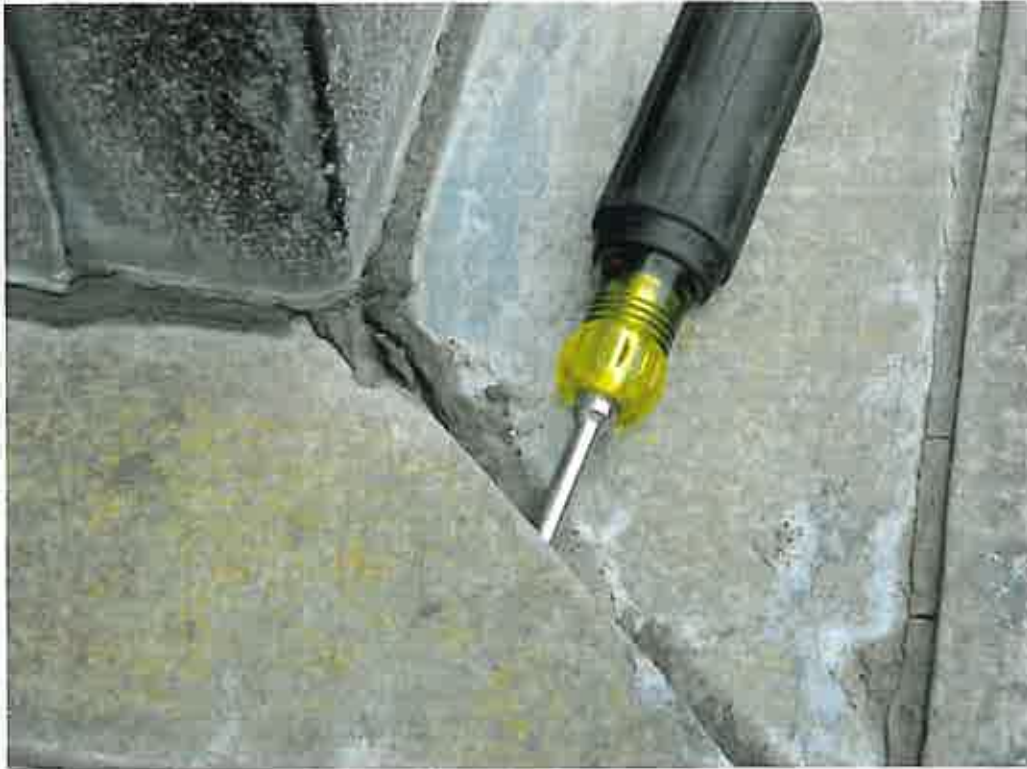
FAILED SEALANT AT THE LCC LOW-SLOPED ROOF

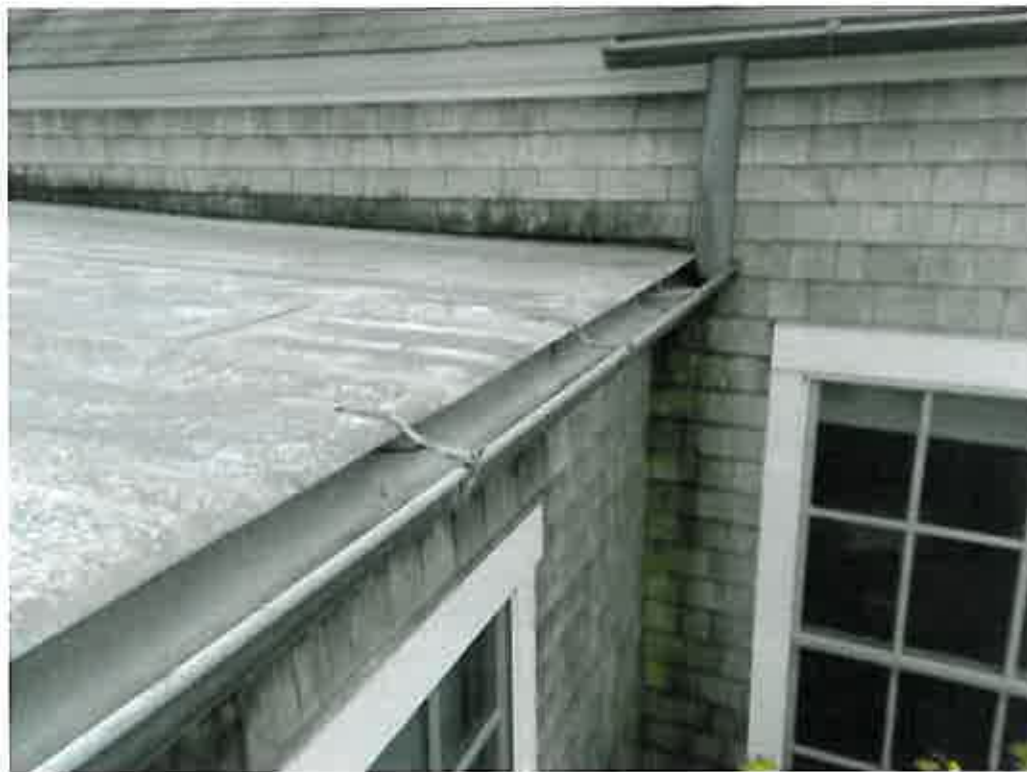
OVERVIEW OF A TYPICAL GUTTER CONFIGURATION AT THE CHILMARK SCHOOL, NOTE- DOWNSPOUTS BEING DIRECTED INTO A LOWER GUTTER OF INSUFFICIENT SIZE TO CARY THE RUNOFF

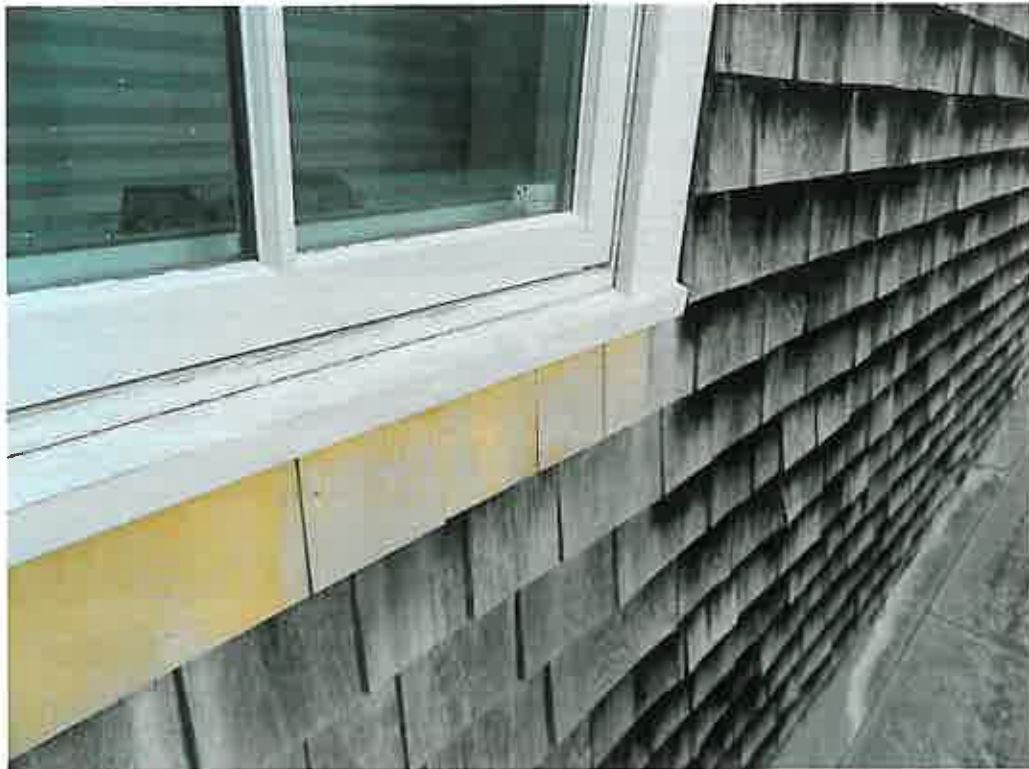
STAINLESS STEEL FACE NAILS ON RECENTLY REPLACED SHINGLES

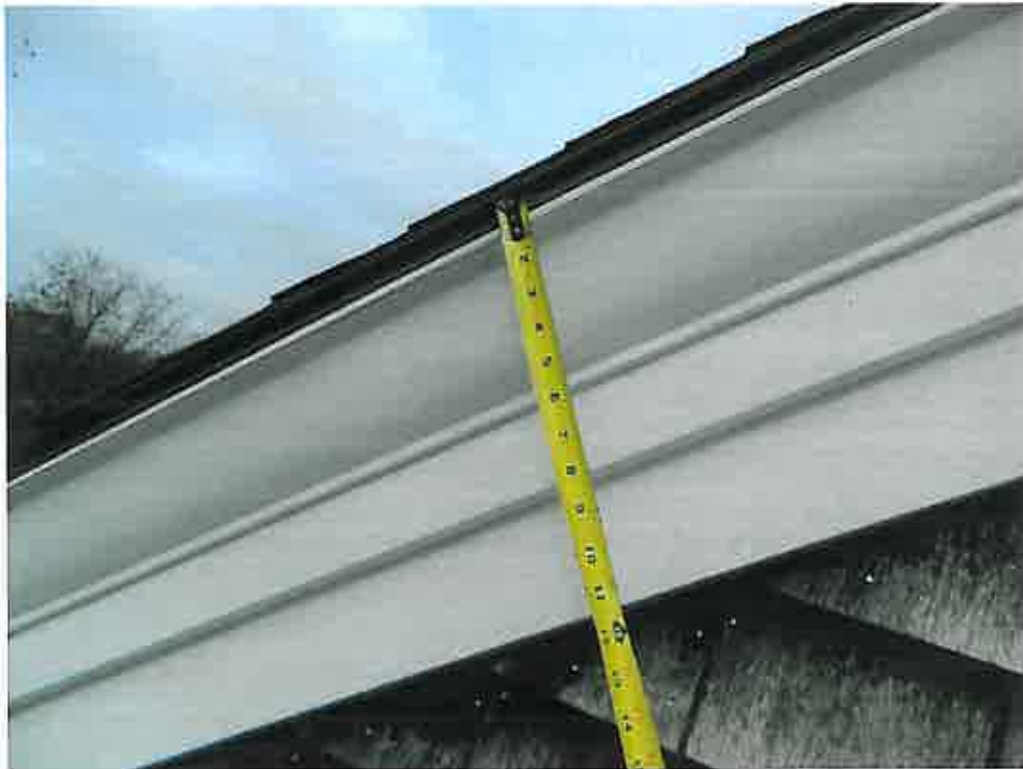
CEDAR RAKE TRIM IN VERY GOOD CONDITION

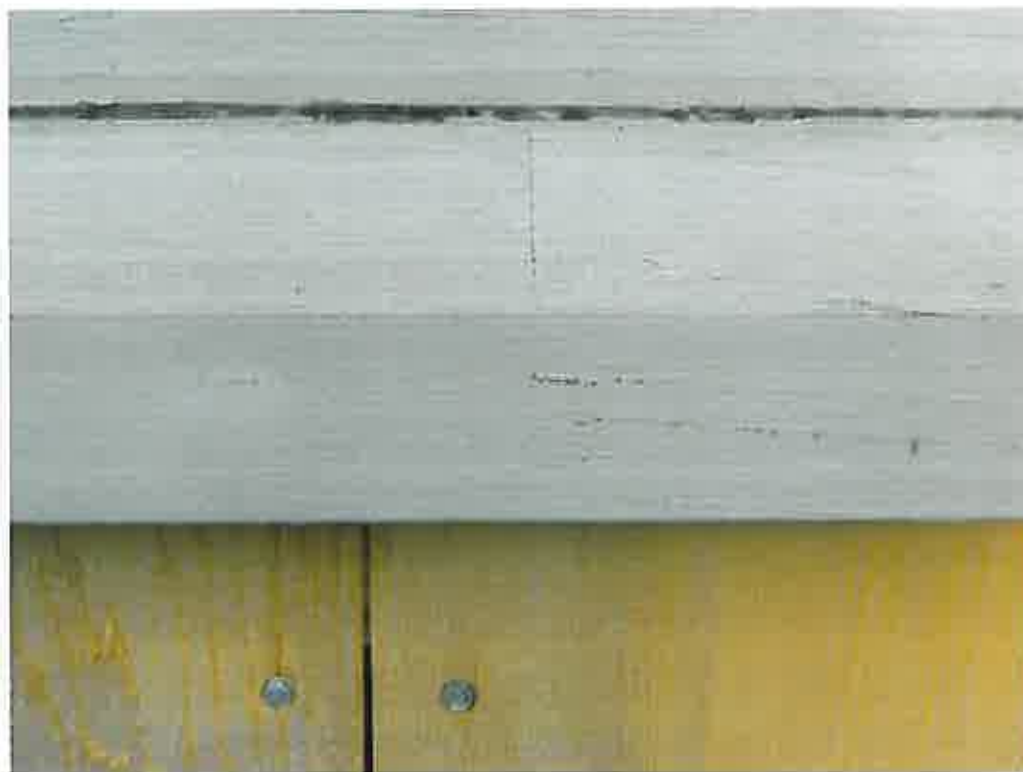
FINGER JOINTED PINE WINDOW SILL AND SASH SHOWING SIGNS OF THE EARLY STAGES OF FAILURE

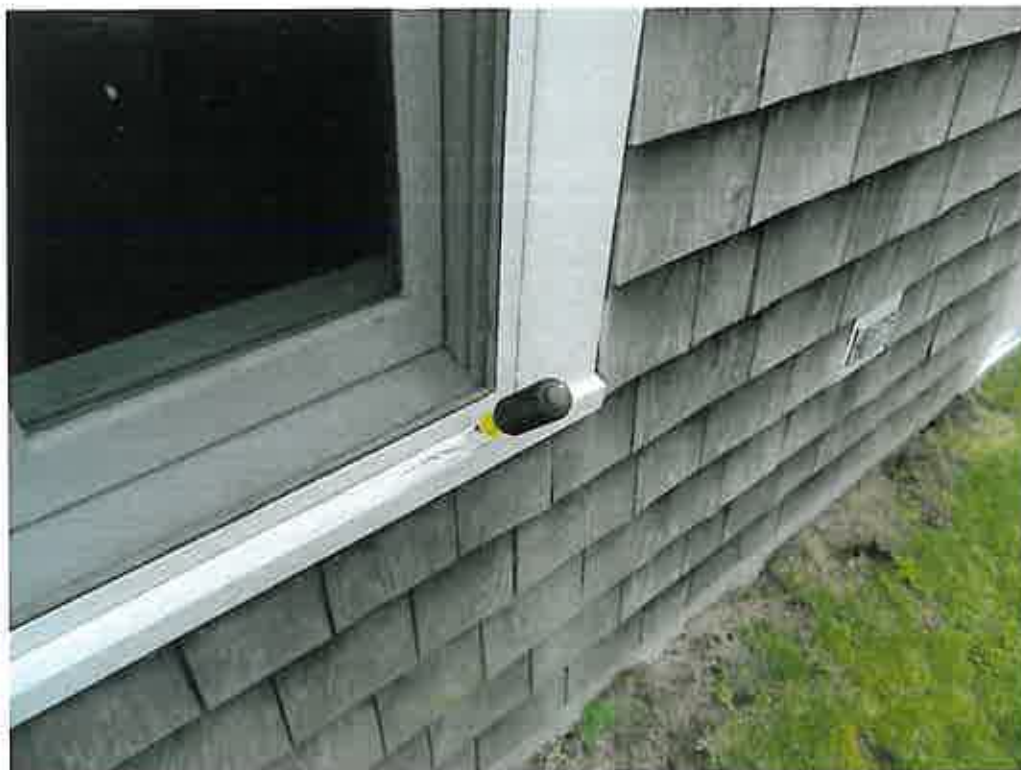
SEVERELY DETERIORATED WINDOW SILL LIKELY AFFECTING THE BUILDING ENVELOPE

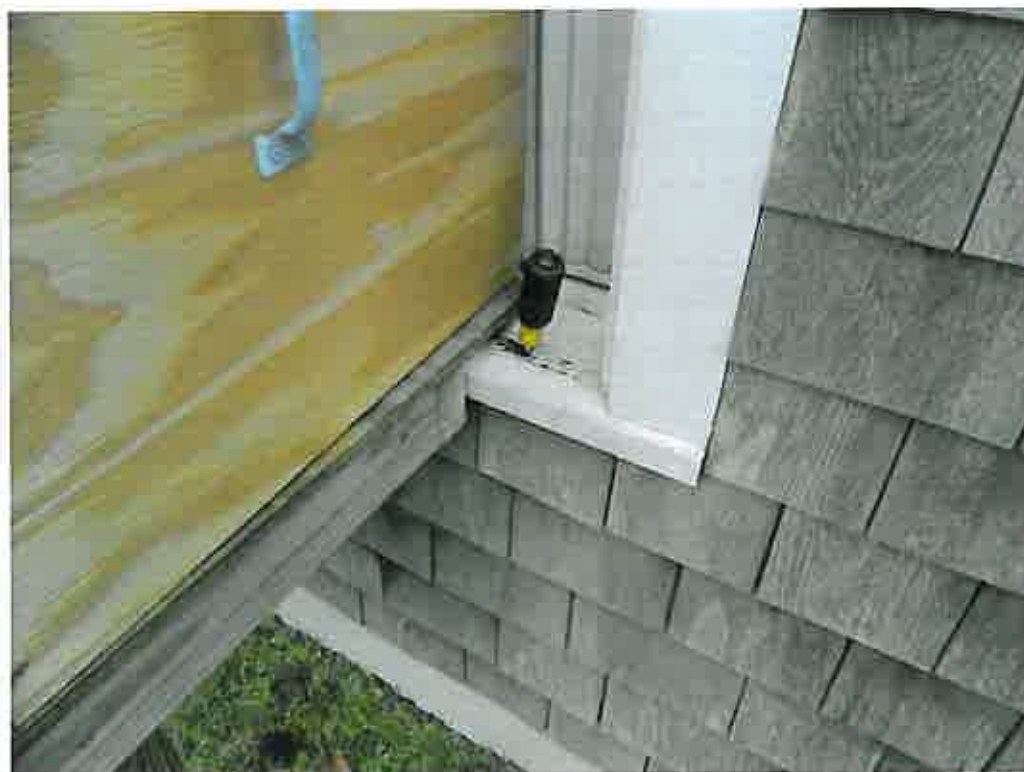
ANOTHER SEVERELY DETERIORATED WINDOW SILL

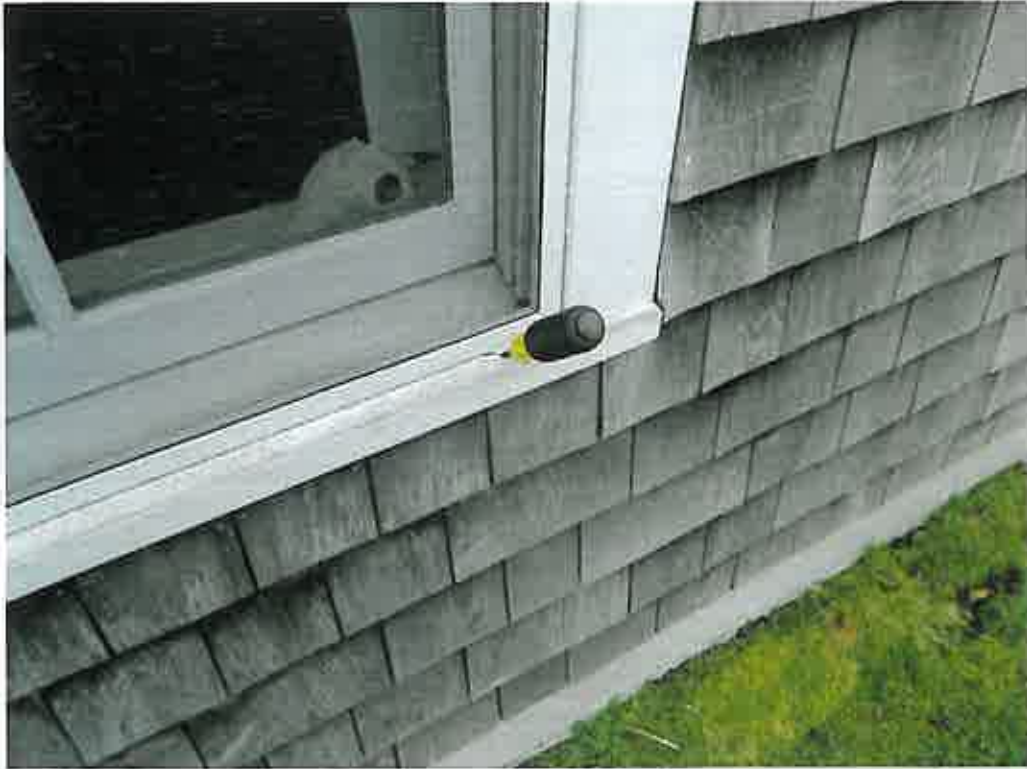
ANOTHER SEVERELY DETERIORATED WINDOW SILL

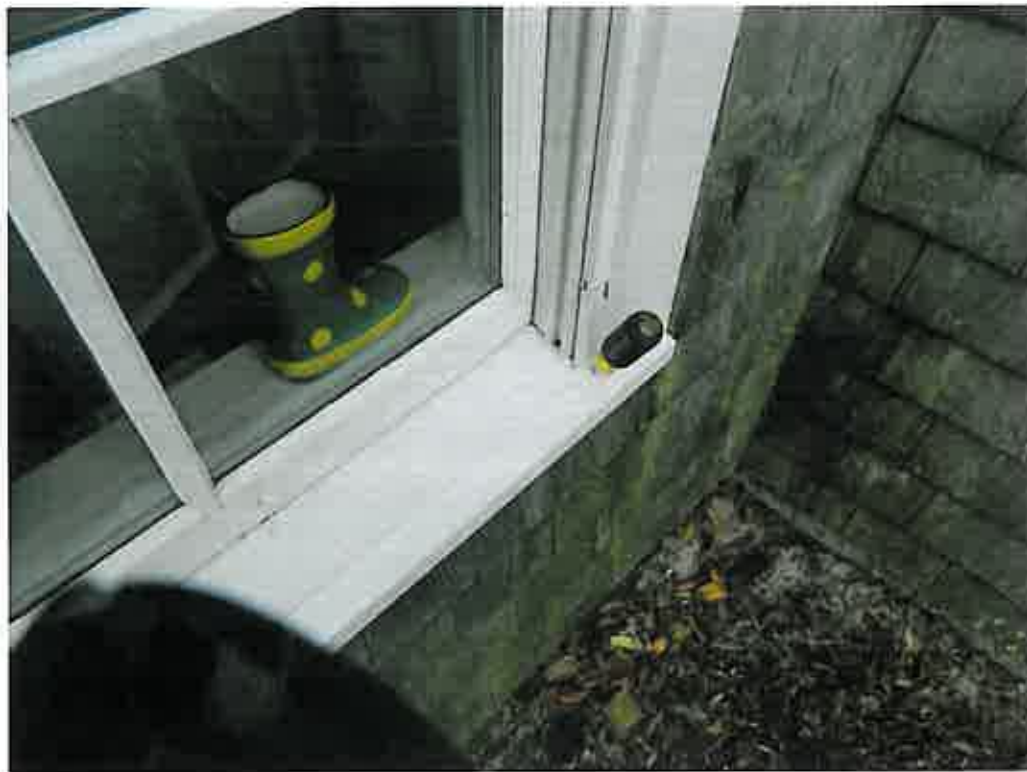
ANOTHER SEVERELY DETERIORATED WINDOW SILL

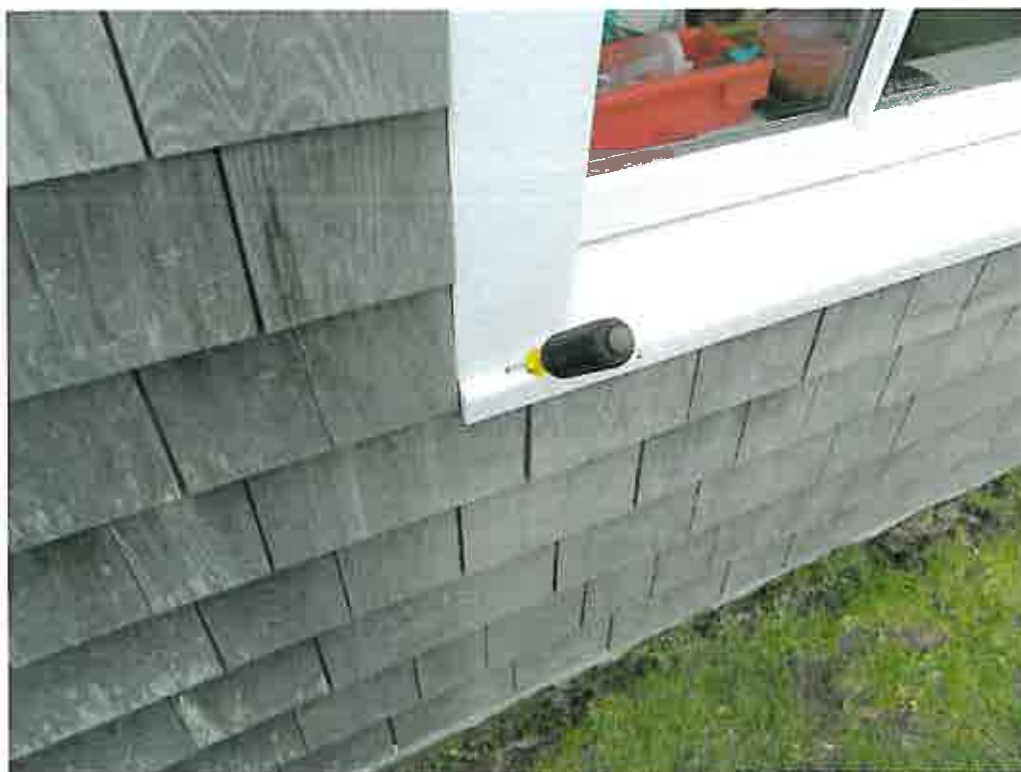
ANOTHER SEVERELY DETERIORATED WINDOW SILL

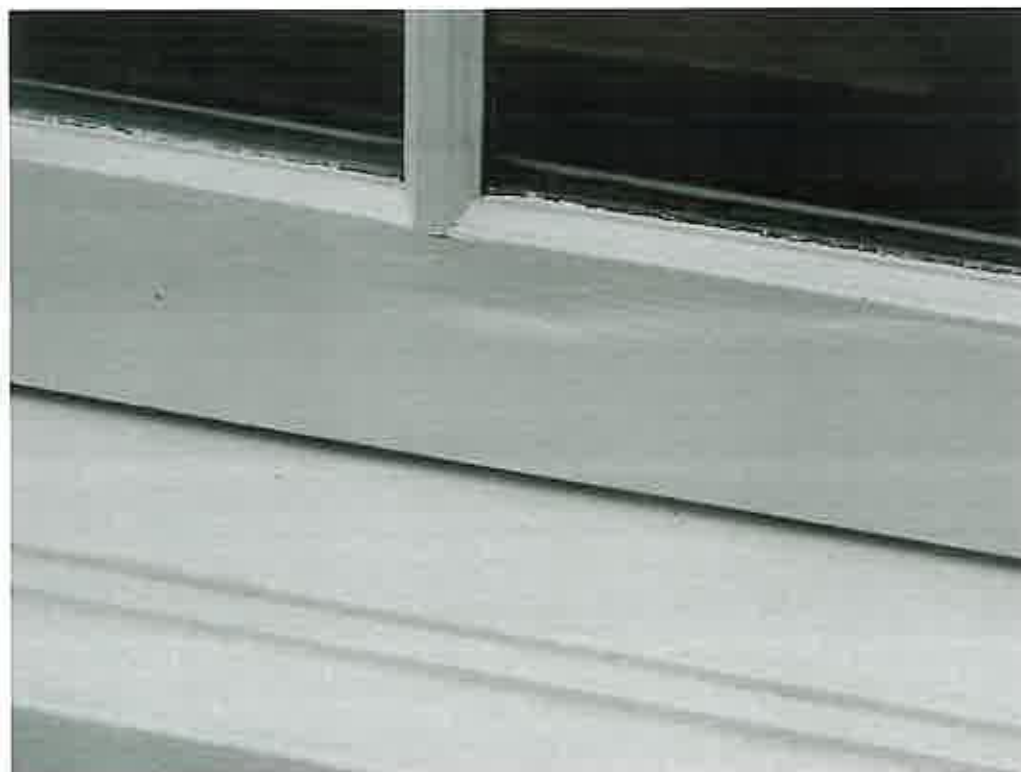
SEVERELY DETERIORATED WINDOW SASH

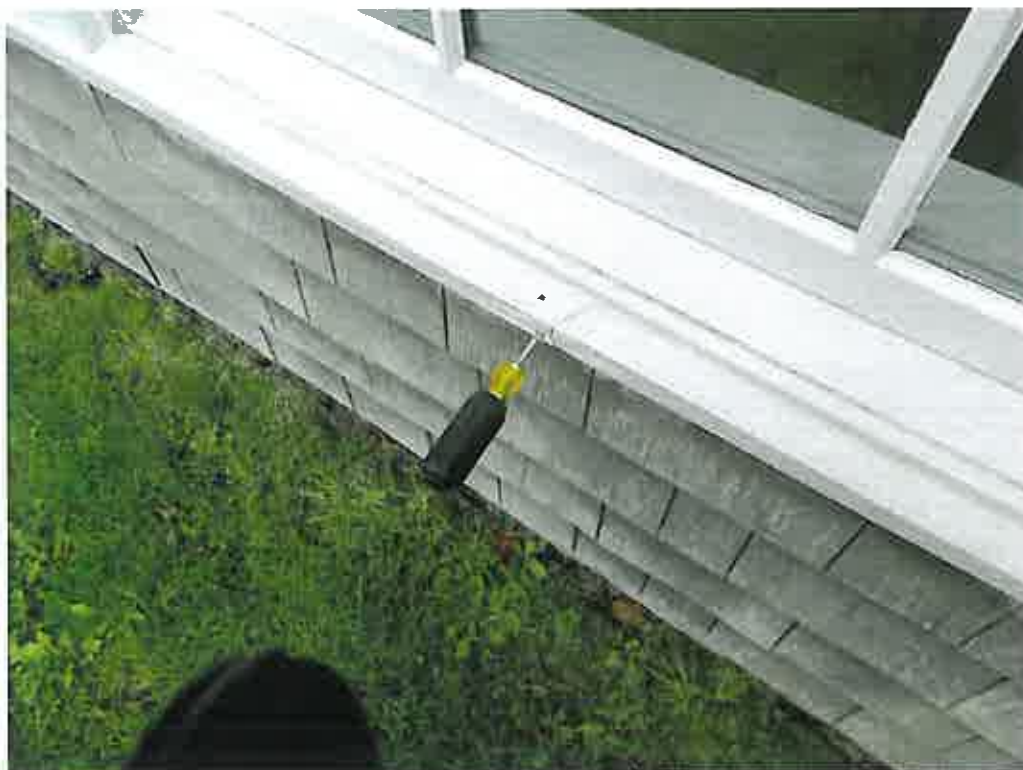
SEVERELY DETERIORATED WINDOW SILL AT COURTYARD LOCATION

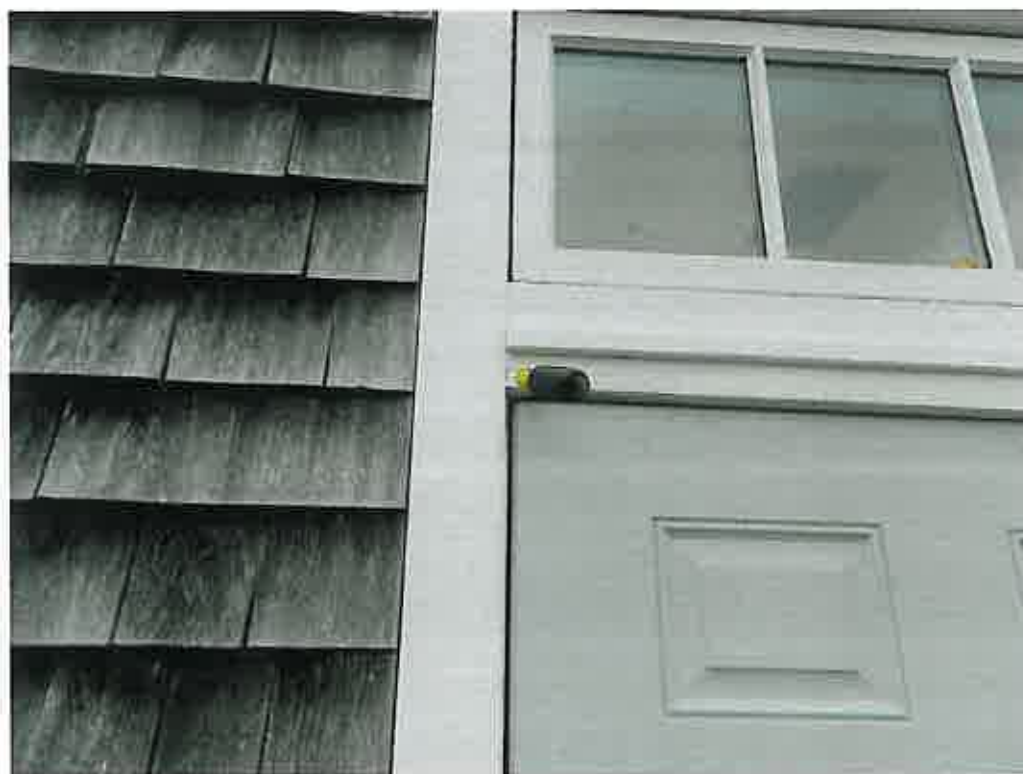
SEVERELY DETERIORATED DOOR FRAME

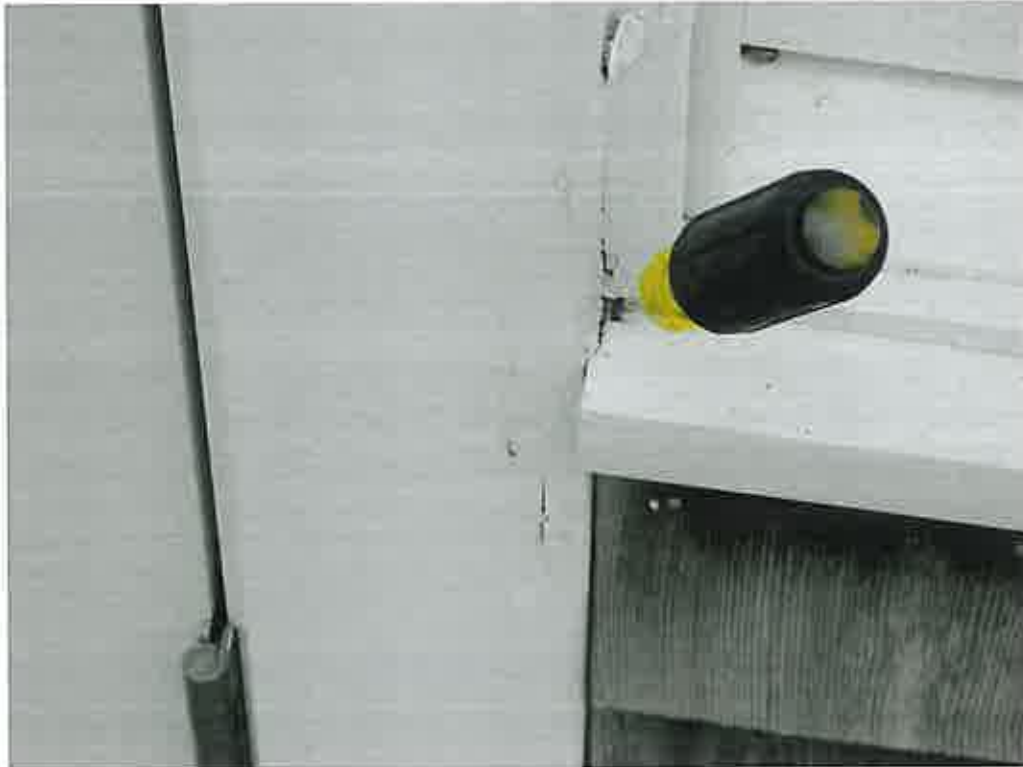
SEVERELY DETERIORATED WINDOW-TO-DOOR FRAME TRANSITION

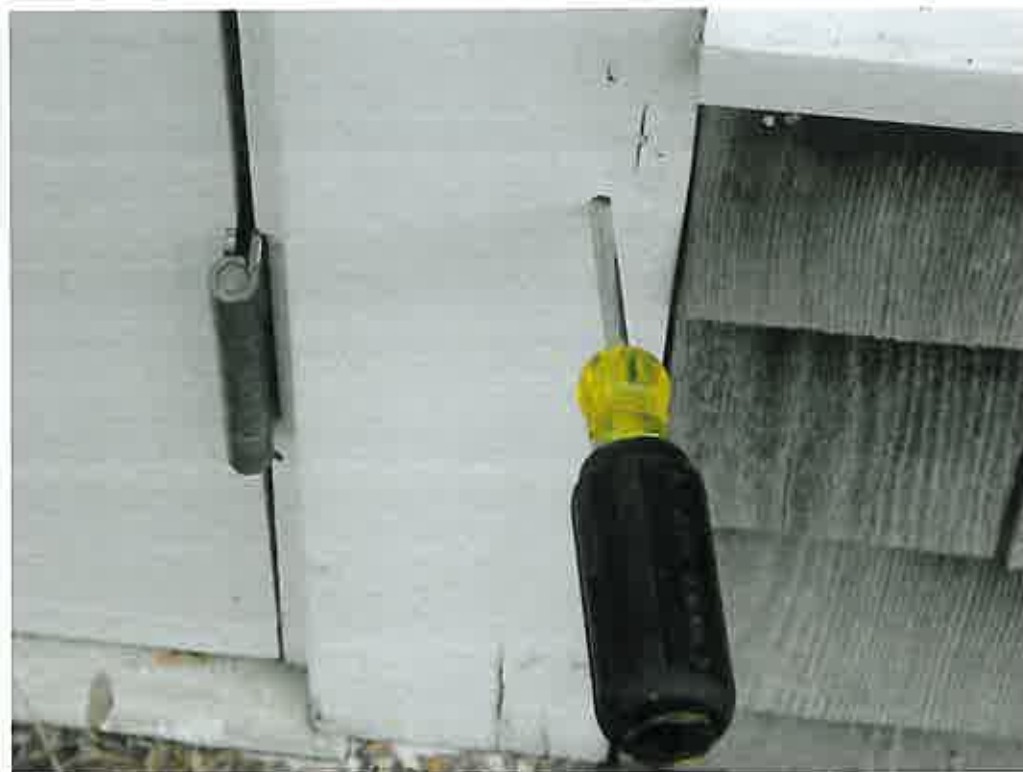
SEVERELY DETERIORATED DOOR TRIM

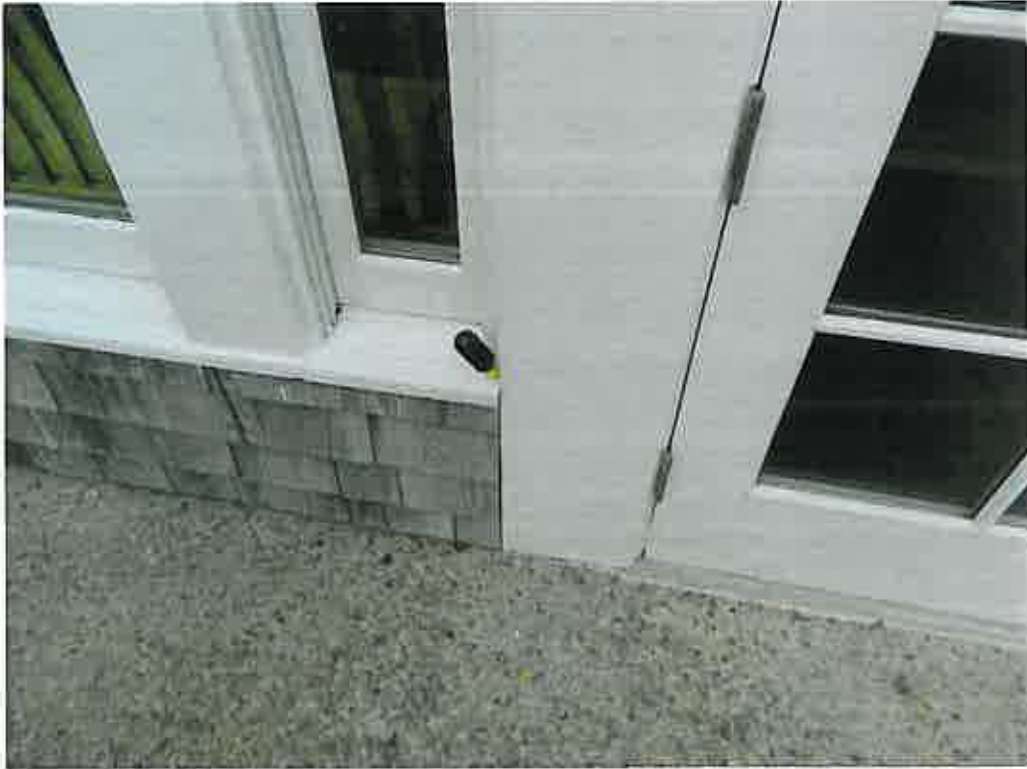
ANOTHER DETERIORATED WINDOW-TO-DOOR TRANSITION WITH LIKELY FRAMING DETERIORATION

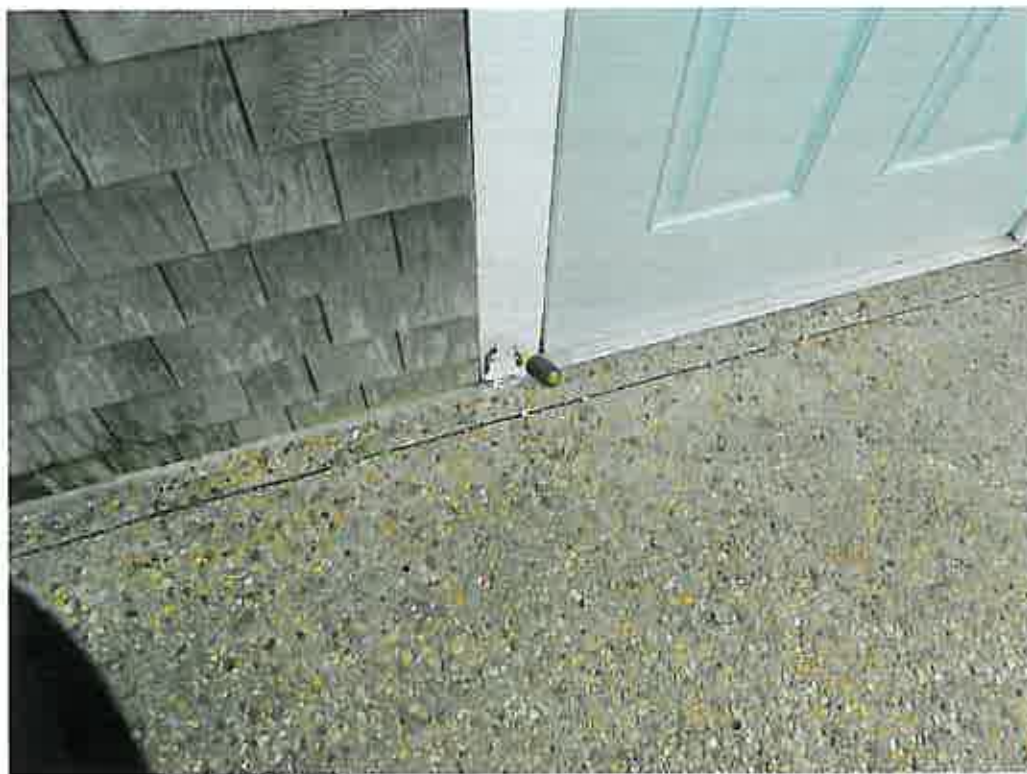
MORE DETERIORATED DOOR TRIM AND LIKELY DOOR FRAME DETERIORATION

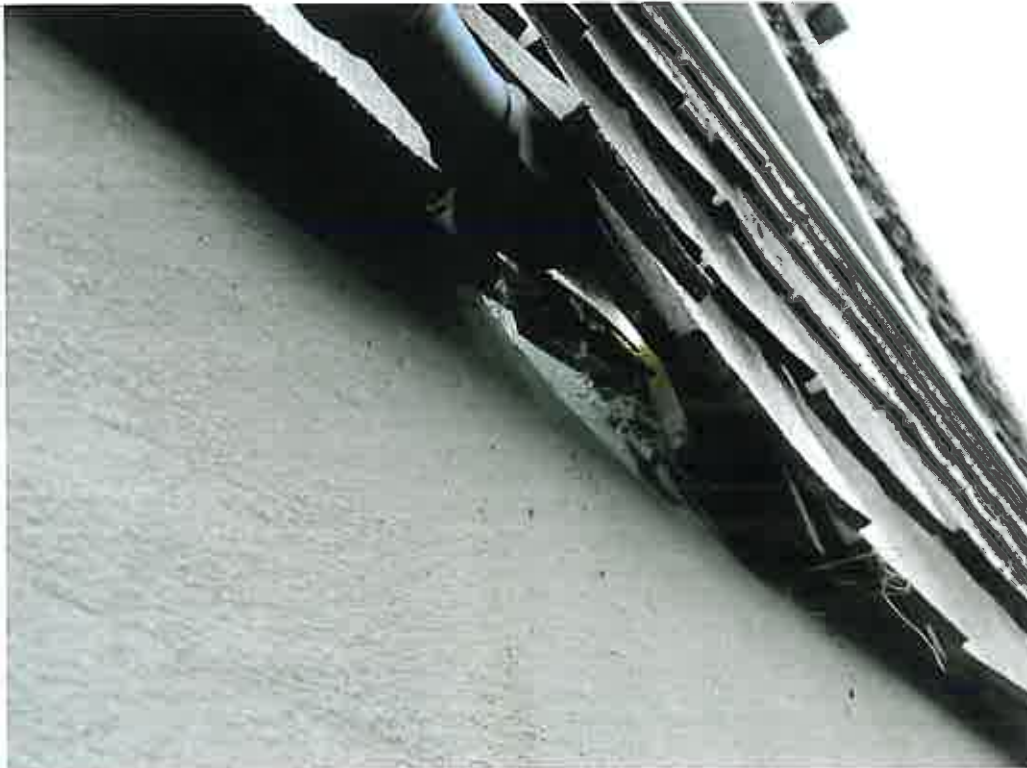
DETERIORATED OSB SHEATHING DIRECTLY BELOW A WINDOW (DIFFICULT TO MAKE OUT)

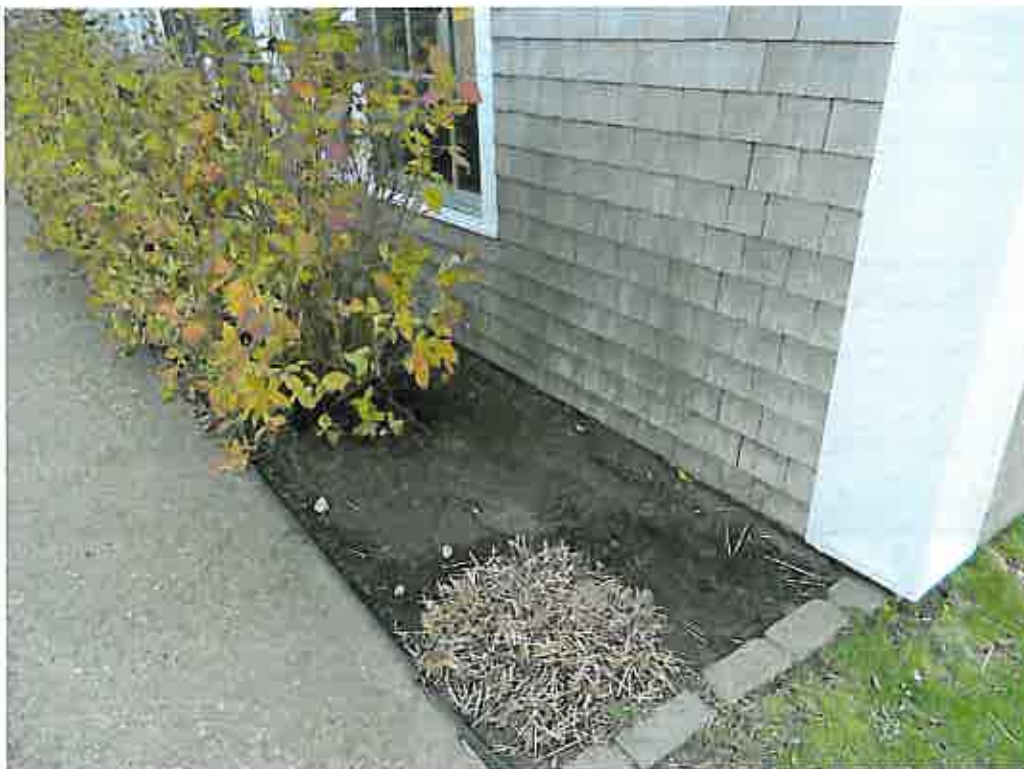
SIDING NEARLY IN CONTACT WITH GRADE, NOT CODE COMPLIANT

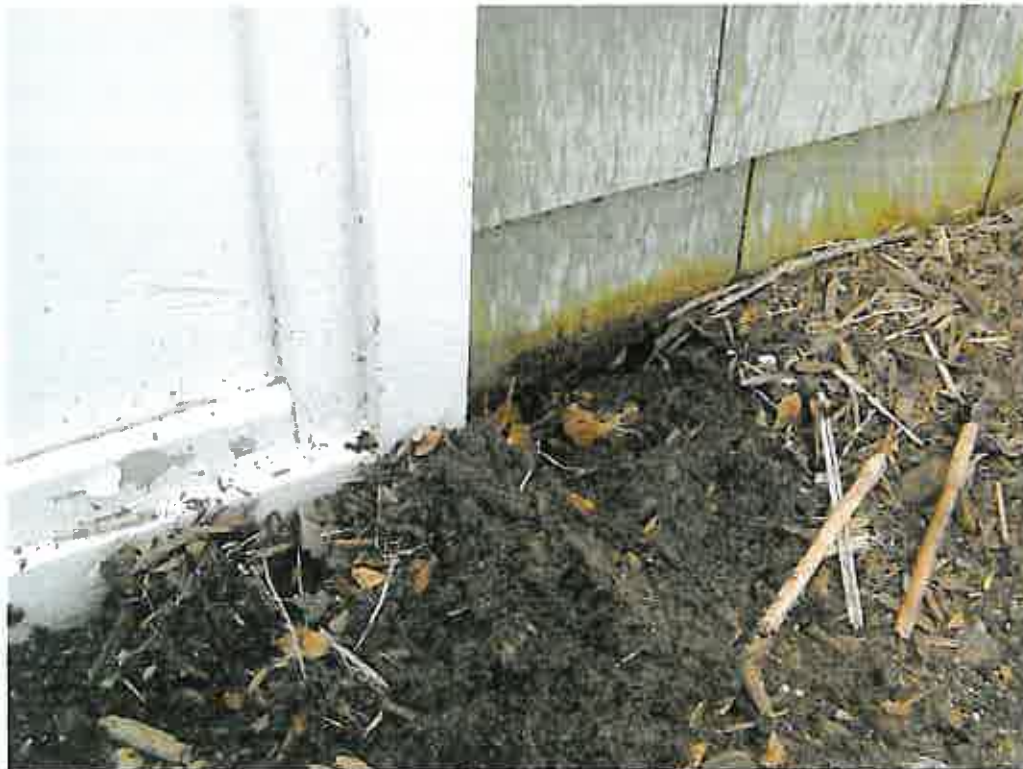
DETERIORATED SIDING IN CONTACT WITH GRADE

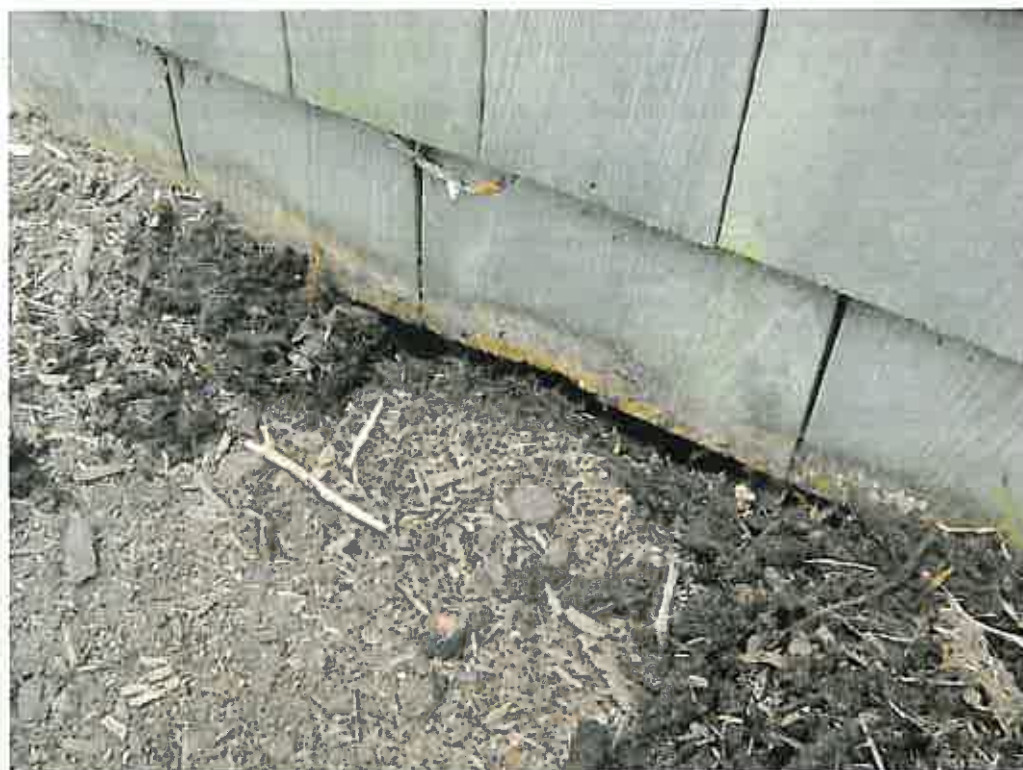
MORE DETERIORATED SIDING IN CONTACT WITH GRADE

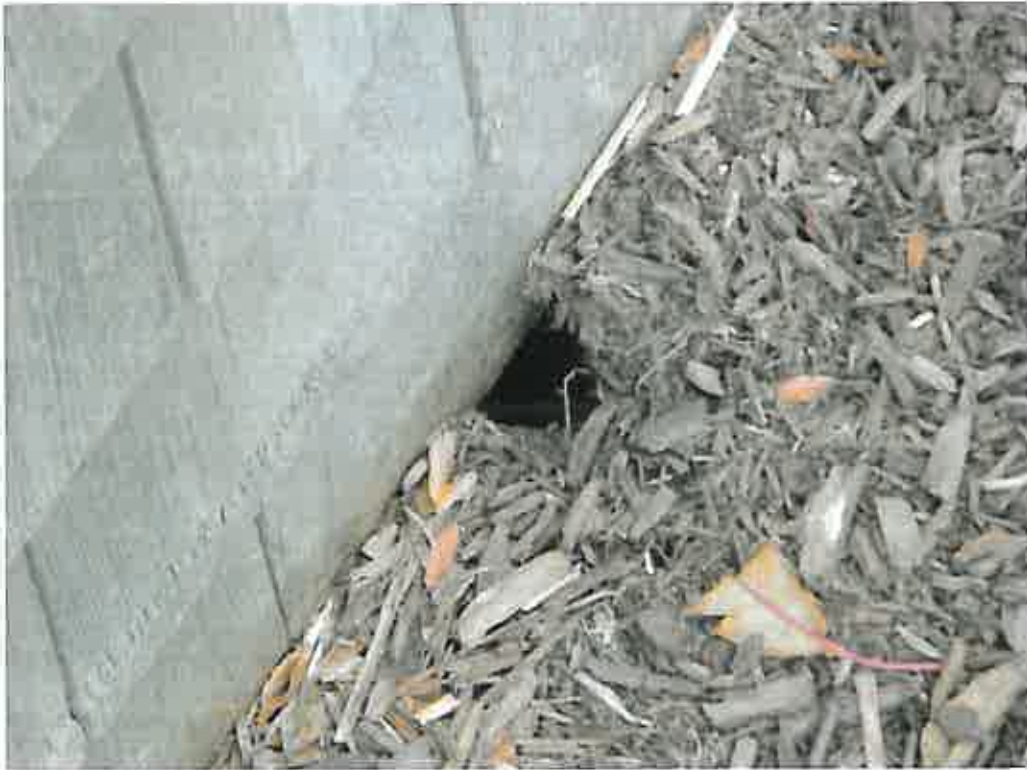
RODENT HOLE AT LOCATION OF SIDING IN CONTACT WITH GRADE

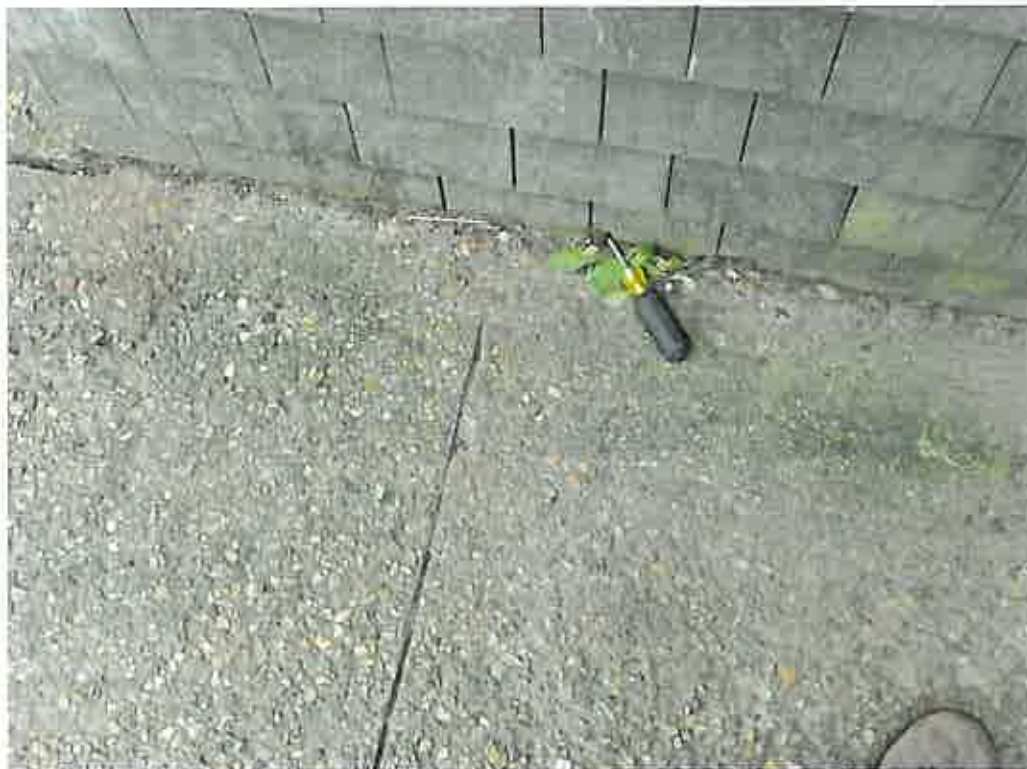
DETERIORATED SIDING IN CONTACT WITH A CONCRETE WALKWAY

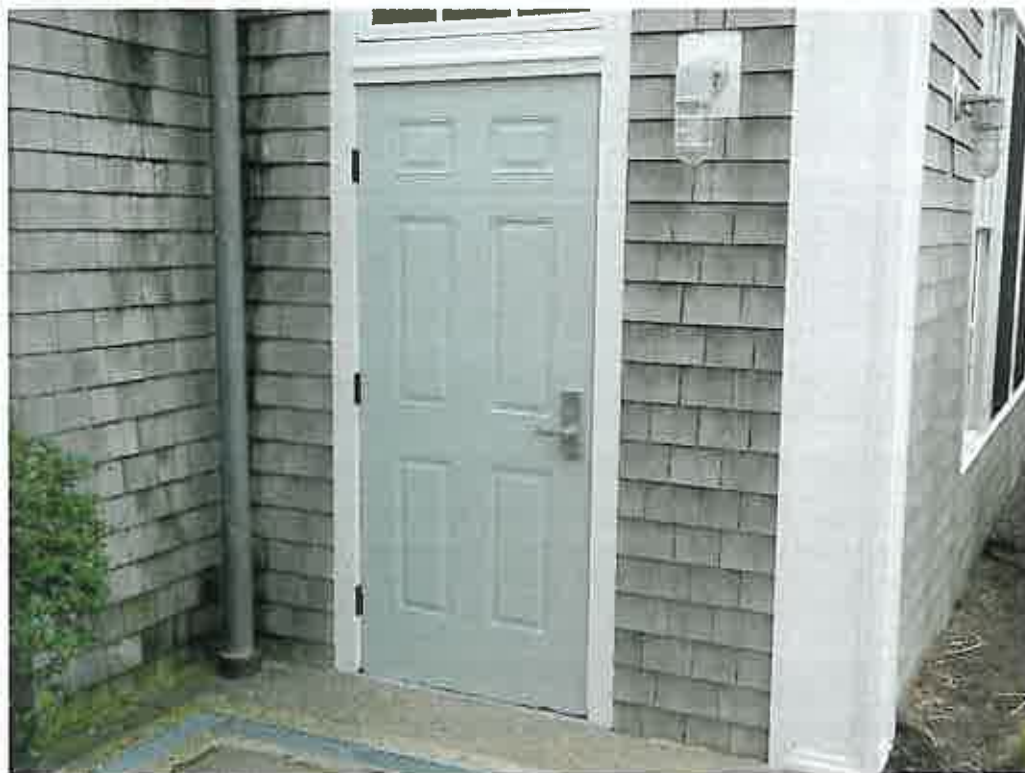
SIDING IN CONTACT WITH WALKWAY/GRADE

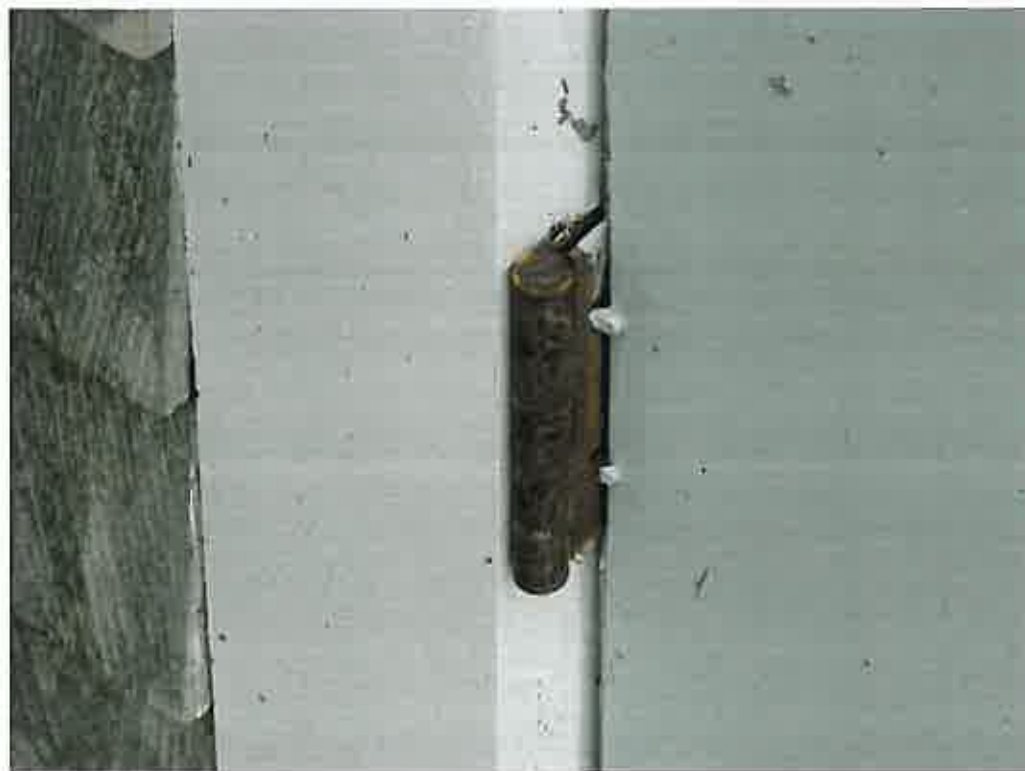
RUSTING DOOR HINGE, IMPROPER HARDWARE FOR THIS ENVIRONMENT
