TO:	Pete Clark, Town of Falmouth	DATE:	June 10, 2008
FROM:	Paul Birkel, W-P	PROJECT NO.:	10876C
SUBJECT:	Falmouth on The Green - Sewer Study

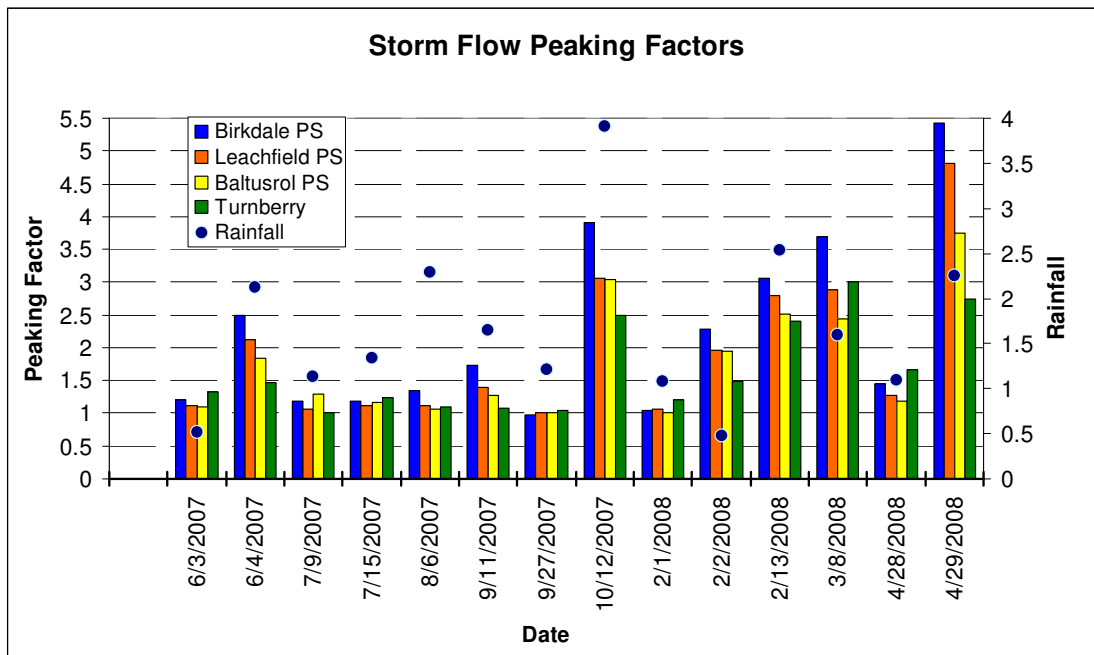
The following graph outlines a comparison of peaking factors for the pump stations and Turnberry Lane over the storms monitored in the above tables.

The following observations can be made from a review of the data in general. First, there appears to be a strong correlation between the peaking factor at Turnberry Lane and at the remainder of the pump stations included for the assessment. While there are instances where there is separation between the peaking factors such as with the April 29th storm (Turnberry peaking factor lower than the rest) this may be explained by both other minor sources of flow entering the system that otherwise is not available to enter the Turnberry system, such as infiltration through manhole defects, service connections or gravity sewers and the fact that Turnberry Lane is sited at a higher elevation than downstream sections of Birkdale Road and has a free draining topography. Lower portions of Birkdale are low lying, located adjacent to a nearby brook and exhibited saturated soils even in August 2007 when the smoke testing was conducted by Wright-Pierce. This may further explain why the Birkdale pump station exhibits a higher peaking factor than the other pump stations as well.

In summary, we feel the data supports the theory that the septic tanks are the largest contributor of infiltration in the system and that their subsequent removal will greatly reduce storm-related high flows.
