Smoke Testing Report  
September 2007

**FROM:** Paul Birkel, Kattie Collins - W-P      **PROJECT No.:** 10876C

**SUBJECT:** Falmouth on the Green - Smoke Testing Results

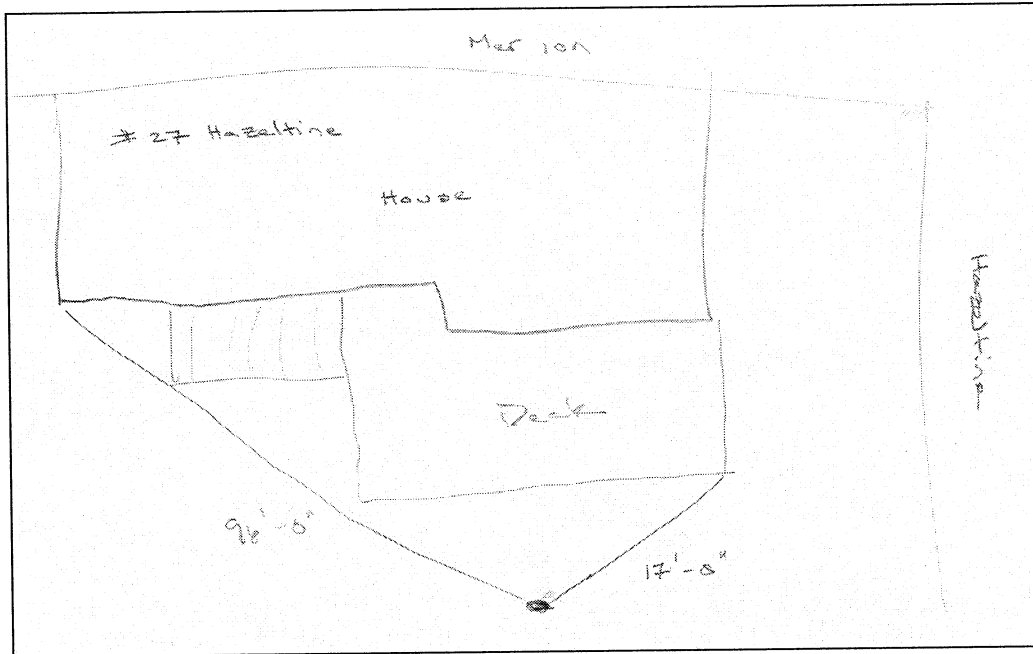
**Smoke Testing Log**  
**Setup No. 2 - 27 Hazeltine Drive**

<b>Location</b>	<b>Remarks</b>
Hazeltine Drive, SMH 4 to SMH 5	Noted a lot of clear water coming from upstream of SMH 5 but very minimal water coming from upstream of SMH 4. Further investigation is recommended.
27 Hazeltine Drive	Smoke coming from ground behind house, likely septic tank. Roof drains were piped into ground, could be day-lighted.
22 Hazeltine Drive	Roof drains were piped into ground, termination unknown.
13 Hazeltine Drive	Roof drains were piped into ground, termination unknown.
7 Merion Way	Toilet in downstairs bathroom gurgling, noted sewer smell.
3 Hoylake Circle	Toilets were gurgling, downstairs toilet backed up with solids, noted sewer smell.
1 Prestwick Circle	Smoke coming from ground in front of house, smoke from the downstairs bathroom which was under construction.
3 Prestwick Circle	Smoke coming from buried septic tank in front of house.
4 Prestwick Circle	Smoke coming from buried septic tank in front of house.

House No.	Smoke Venting?	Other Issues
5	Y/N	
7	Y/N	Town said septic tank was bypassed, toilet gurgling - plumber verified that there were no internal plumbing issues
8	Y/N (1/2)	
22	Y/N	Roof leader piped into ground
31	Y/N	
28	Y/N	
*27	Y/N	Roof leader piped into ground (site topography could allow daylighting). Smoke rising from garden behind house, ground very saturated. No Bros sketch. See sketch and photos.
	Y/N	
	Y/N	
Catch Basins:		None
Other Issues:		Dew on ground, damp soil
		*No. 27 Hazeltine Dr. from Blow Bros. map is No. 4 Merion Way.

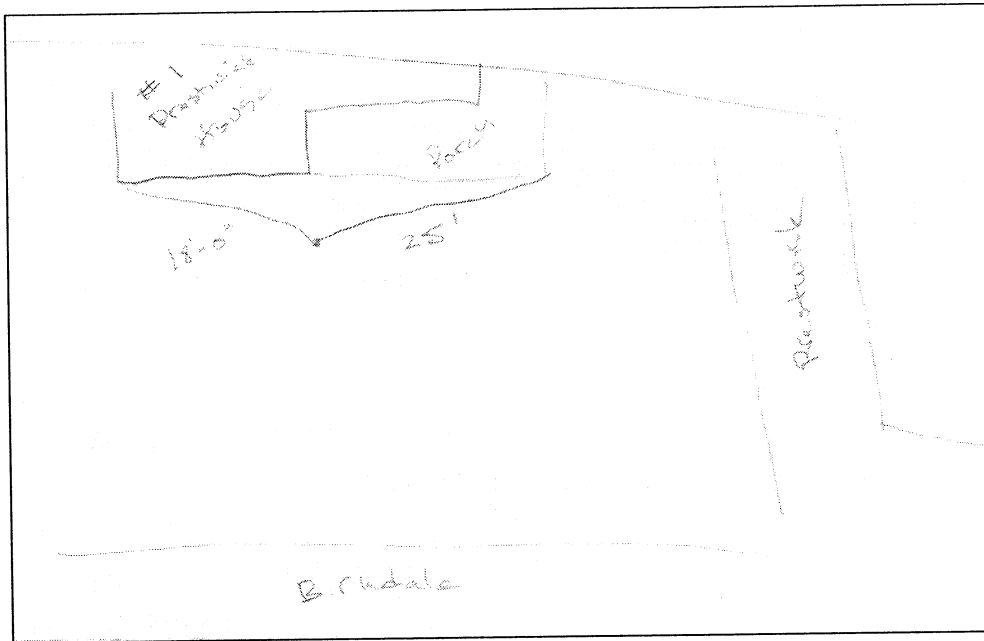
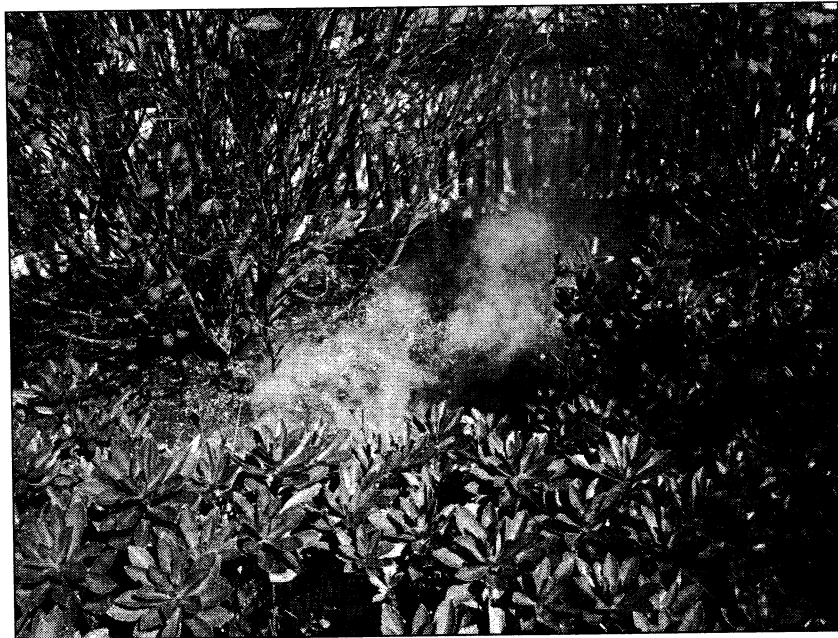
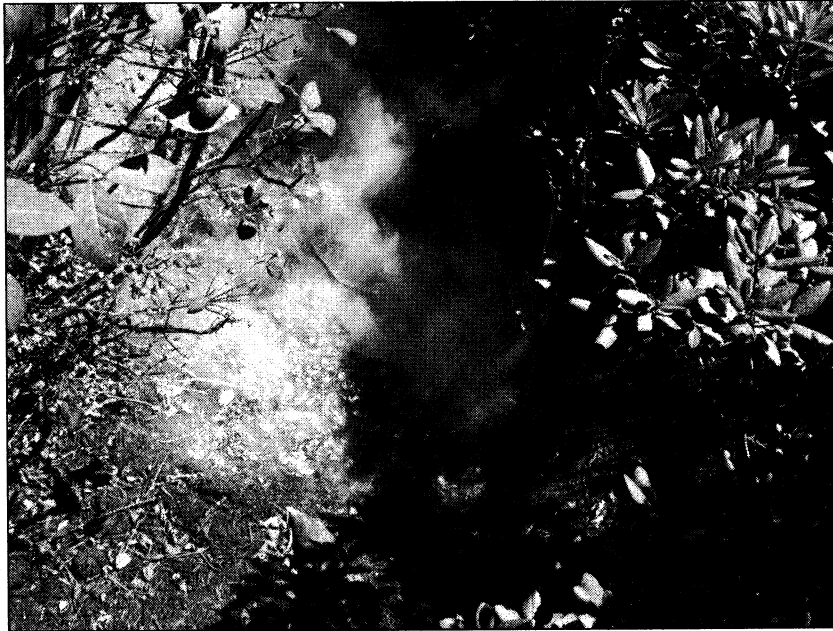
*Smoke Testing Log*  
*Setup No. 3 - 1 Prestwick Circle*

House No.	Smoke Venting?	Other Issues
1 Hoylake	Y / (N)	
3	Y / (N)	Ben & Judy Bertrans/878-6466, solids backed up into 1st floor bathroom toilet, upstairs gurgling as well. See photos.
4	Y / (N)	
17 Birkdale	(Y) / N	
19	(Y) / N	
21	(Y) / N	
20	(Y) / N	
18	(Y) / N 1/2	
1 Prestwick	(Y) / N	Smoke from depression in ground on roadside, toilet under construction and smoking. See sketch and photos.
2	(Y) / N	
3*	Y / (N)	Smoke rising from front of house. See sketch and photos.
4*	(Y) / N 2/3	Smoke rising from ground in front of house, very saturated. See sketch and photos.
Catch Basins:		
	None	
Other Issues:		
	SMH 58 was checked to verify that smoke was reaching the end as none of the vents were going. Smoke was reaching the end.	
	*These houses are located in very marshy areas. See photos. These houses also do not have Bros. sketches.

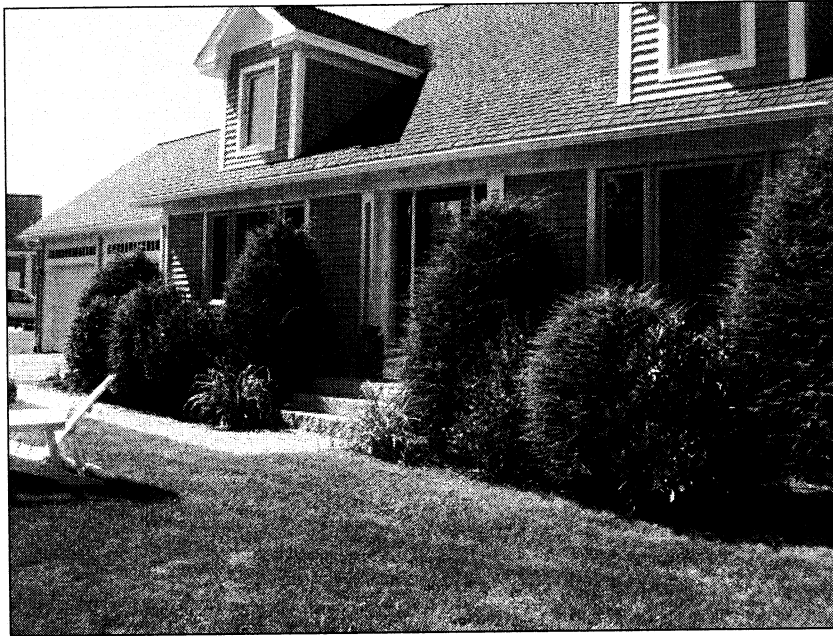
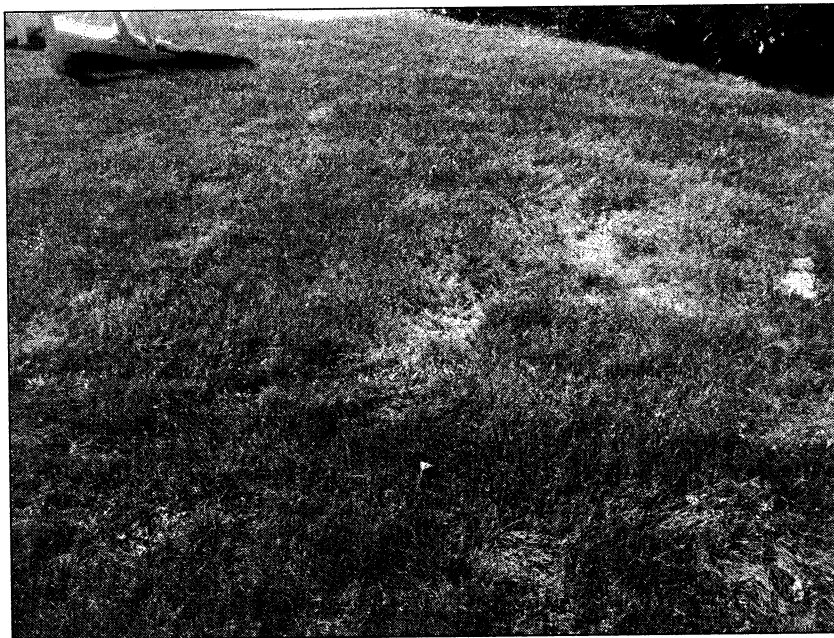
*Smoke Testing Log*  
*Setup No. 4 - 8 Birkdale Road*

8 Birkdale Road	Smoke coming from buried septic tank in front of house.
9 Birkdale Road	Smoke coming from buried septic tank in front of house.
16 Birkdale Road	Smoke coming from buried septic tank in front of house.
1 Muirfield Road	Sewer smell noted in laundry room, owner reported being able to smell and taste smoke in the laundry room and in the downstairs bathroom.
3 Muirfield Road	Smoke coming from buried septic tank in front of house.
6 Baltusrol Circle	Smoke coming from exposed septic tank cover beside house.
8 Baltusrol Circle	Smoke coming from buried septic tank in front of house.
4 Medinah Circle	Smoke coming from buried septic tank in woods in front of house.
6 Medinah Circle	Owner noted toilet gurgling in bathroom and sewer smell.

House No.	Smoke Venting?	Other Issues
15	Ⓢ/N	
13	Ⓢ/N	Town indicated they were piped through tank
11	Ⓢ/N	
9	Ⓢ/N	Smoke rising from ground. See sketch and photos.
16	Ⓢ/N	Smoke from ground in front of house. See photos.
14	Ⓢ/N	
12	Y/Ⓢ	
10	Ⓢ/N (1/2)	
7	Y/Ⓢ	
6	Y/Ⓢ	
8	Y/Ⓢ	Smoke rising from ground in front of house. See photos
5	Ⓢ/N	
4	Ⓢ/N (1/2)	
3	Y/Ⓢ	
2	Y/Ⓢ	Town thinks they're on a pump
1	Ⓢ/N (3/4)	Piped through tank per Town
Catch Basins: <u>None</u>		
Other Issues:

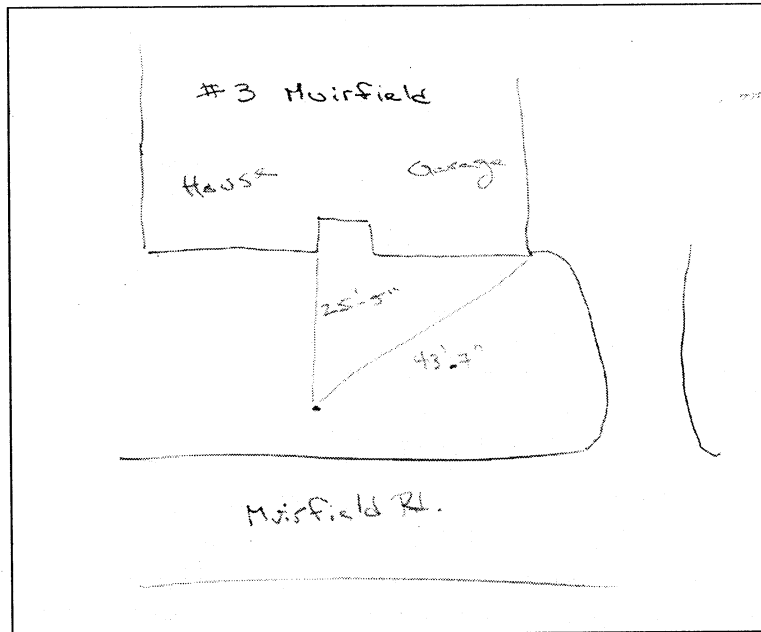
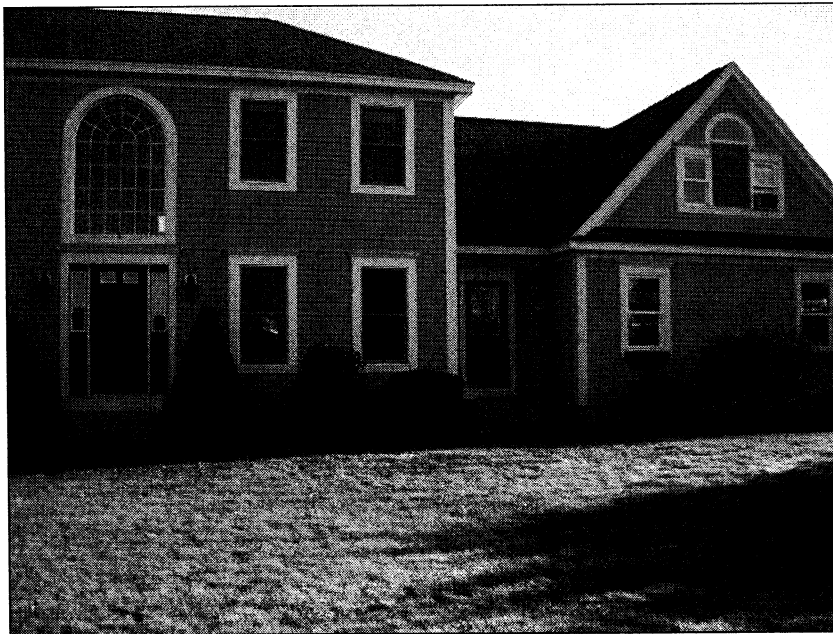
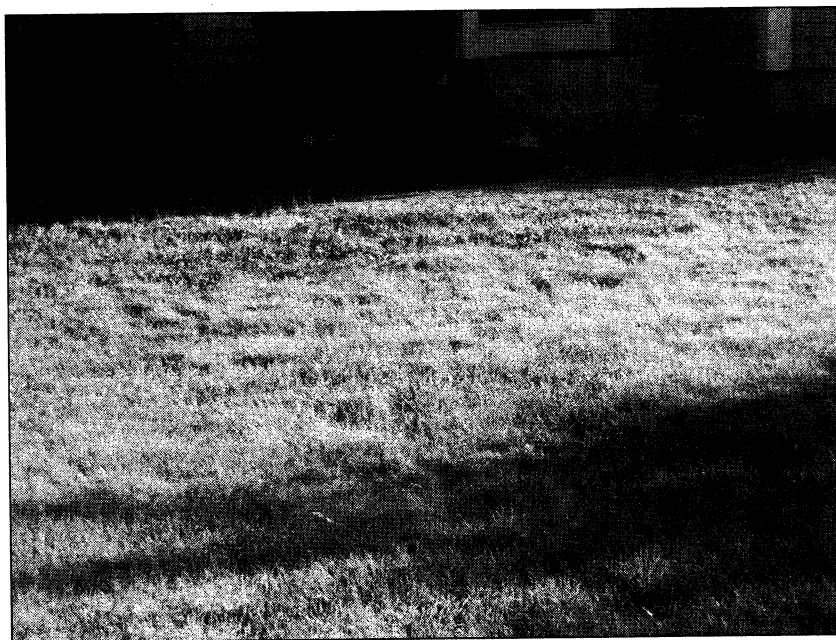
*Smoke Testing Log*  
*Setup No. 6 - 3 Muirfield Road*

House No.	Smoke Venting?	Other Issues
5	Ⓢ/ N	
3	Ⓢ/ N (1/2)	Smoke rising from ground in front of house. See sketch and photos.
1	Ⓢ/ N (3/4)	Laundry room smelled like sewer*
10	Y /Ⓢ	
2	Y /Ⓢ	Likely on Carnoustia low pressure force main
12	Y /N	No house on lot
10	Y /Ⓢ	
8	Ⓢ/ N	
6	Ⓢ/ N (2/3)	
4	Ⓢ/ N (3/4)	
2	Y /Ⓢ	
	Y / N	
	Y / N	
Catch Basins:	None	
Other Issues:	Noted smoke coming from flow meter box at end of Turnberry. Smoke venting through conduit from manhole.	
	*The owner said that this had only happened once 2-3 yrs. earlier and that they had to have the tank pumped. They haven't had the tank pumped since then and may need to have the tank pumped again. The owner said they saw and smelled smoke as well, but I wasn't able to detect anything.

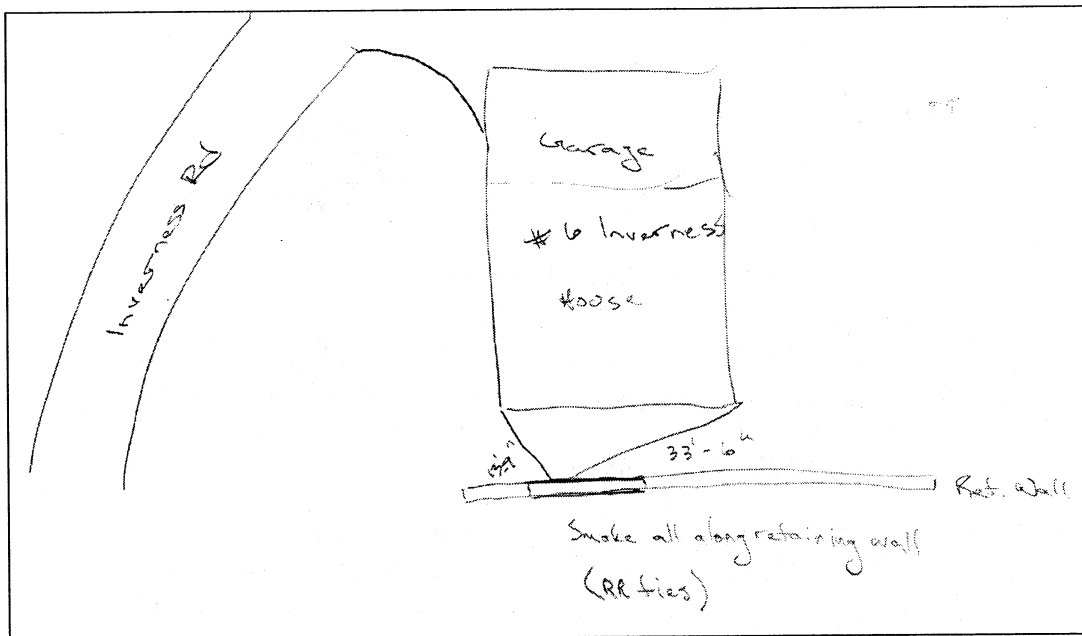
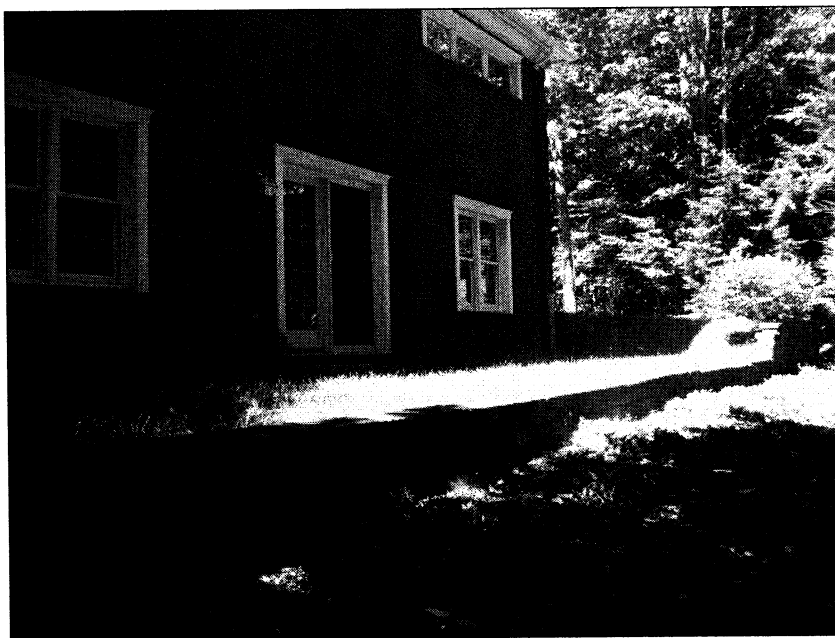
*Smoke Testing Log*  
*Setup No. 10 - 6 Inverness Road*

7 Medinah Circle	Roof drains were piped into ground, termination unknown.
4 Inverness Road	Roof drains were piped into ground, termination unknown.
6 Inverness Road	Smoke coming from ground near risers at the side of the house, likely the septic tank.
SMH 67, Inverness Road	Riser and joints leak, noted a "running" leak in the manhole invert.

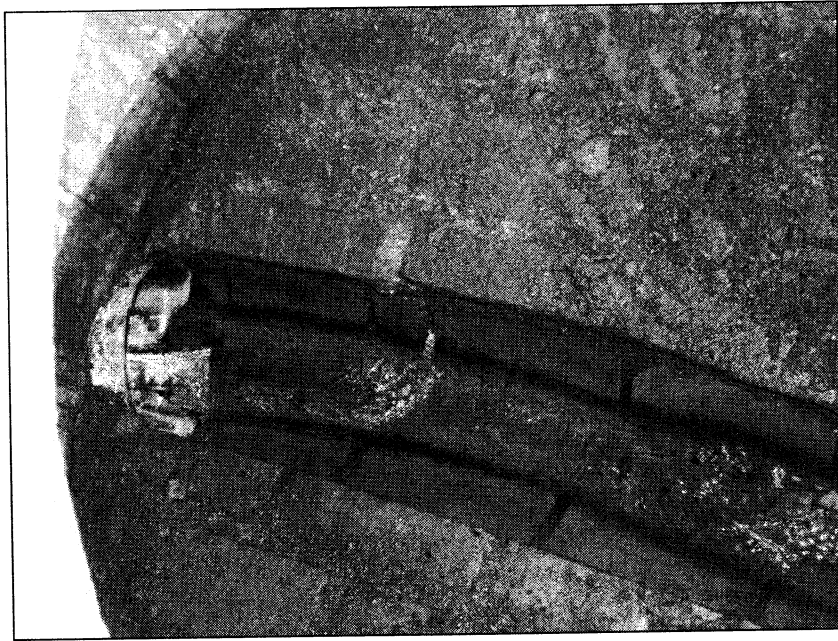
*Smoke Testing Log*  
*Setup No. 11 - SMH 67, Inverness Road*

The line between SMH 4 and SMH 5 noted on Hazeltine Drive is a prime area for infiltration of clear water. The source of this high quantity of clear water could be defects in the pipe such as cracks or leaking joints as well as defects in a service connection or septic tank. SMH 67 in Inverness Road is also a prime source of clean water as there was a seeming continuous leak in the invert and evidence of additional leaking from the riser and joints. These items were identified from the manholes that were opened during smoke testing. As not all of the manholes in the system were opened and as there may be other similar defects within the collection system that are contributing to the high inflow and infiltration rate, manhole inspections are slated for the spring during high groundwater conditions. It should be noted that the pavement in all of the areas tested is in good condition with very few cracks. This is important because if there were any cracks in the pipe, the smoke would most likely be suppressed beneath the pavement.
