Appendix D

Manhole Inspection Logs  
May 2008

**Falmouth on the Green  
Manhole Numbering Reference Table**

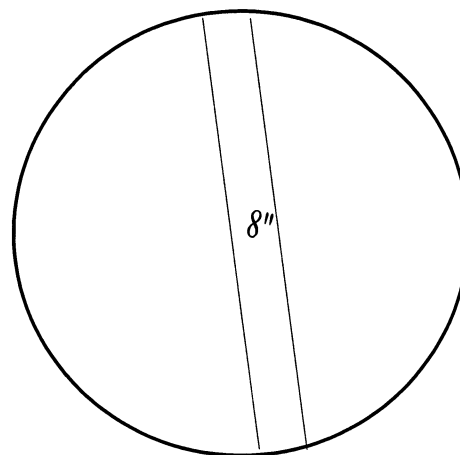
**WRIGHT-PIERCE**  
**MANHOLE INSPECTION REPORT**MH No. FCC-24PROJECT LOCATION: Falmouth on the Green Falmouth, Maine PROJECT NO.: 10876BDATE: 5/19/08 WEATHER: Cloudy TIME: 1:17 INSPECTOR: Tim ParksLOCATION DATA:STREET: BirkdaleBURIED: Yes/No PAVED AREA: Yes/NoMANHOLE DATA:COVER CONDITION: EX GD PRCOVER DIAMETER: 18" 24" 26" 30"NO. OF COVER HOLES: 0SIZE OF COVER HOLES: -CONDITION OF RIM: EX GD PRCONDITION OF FRAME: EX GD PRRISER CONDITION: EX GD PRRISERS ARE: BRICK BLOCK PRECASTMANHOLE DIAMETER 2FT 3FT 4FT OTHER:                     MANHOLE IS: BRICK BLOCK PRECAST OTHER:                     DEPTH OF MANHOLE: 10.5 FTCONDITION OF WALLS: EX GD ⇔ PR Exp. RebarCONDITION OF STEPS: EX GD PRNUMBER OF SECTIONS: 1 2 3 4 6CONDITION OF INVERTS: EX GD PRCONDITION OF TABLE: EX GD PRLEAKAGE POINTS:COVER: Y/N JOINTS: Y/NFRAME: Y/N INVERTS: Y/NWALLS: Y/N TABLES: Y/NESTIMATED I/I (GPM):                     CORROSION PROBLEMS? Y/NCOMMENTS: Experienced rebar on wall.

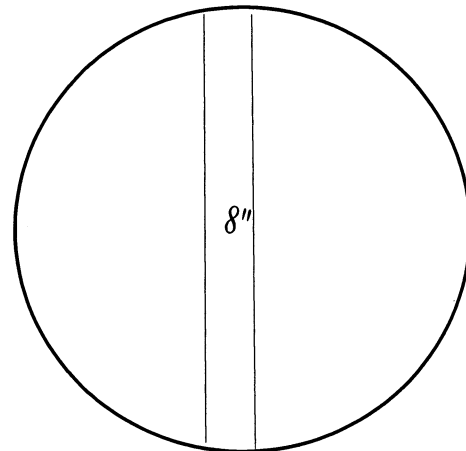
ESTIMATED I/I (GPM):                     CORROSION PROBLEMS? Y/NCOMMENTS: Number of Sections: 1 missing. SECTION

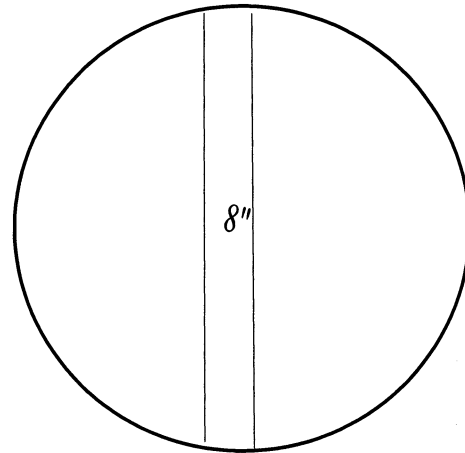
**WRIGHT-PIERCE**  
**MANHOLE INSPECTION REPORT**MH No. FCC-26PROJECT LOCATION: Falmouth on the Green Falmouth, Maine PROJECT NO.: 10876BDATE: 5/19/08 WEATHER: Cloudy TIME: 3:30 INSPECTOR: Tim ParksLOCATION DATA:STREET: BirkdaleBURIED: Yes/No PAVED AREA: Yes/NoMANHOLE DATA:COVER CONDITION: EX GD PRCOVER DIAMETER: 18" 24" 26" 30"NO. OF COVER HOLES: 0SIZE OF COVER HOLES: -CONDITION OF RIM: EX GD PRCONDITION OF FRAME: EX GD PRRISER CONDITION: EX GD PRRISERS ARE: BRICK BLOCK PRECASTMANHOLE DIAMETER 2FT 3FT 4FT OTHER:                     MANHOLE IS: BRICK BLOCK PRECAST OTHER:                     DEPTH OF MANHOLE: 11.42 FTCONDITION OF WALLS: EX GD PRCONDITION OF STEPS: EX GD PRNUMBER OF SECTIONS: 1 2 3 4 7 missing

(Need rotation)

CONDITION OF INVERTS: EX GD PRCONDITION OF TABLE: EX GD PRLEAKAGE POINTS:COVER: Y/N JOINTS: Y/NFRAME: Y/N INVERTS: Y/NWALLS: Y/N TABLES: Y/NESTIMATED I/I (GPM):                     CORROSION PROBLEMS? Y/NCOMMENTS: Number of Sections: 7 - need rotation as noted. SECTION

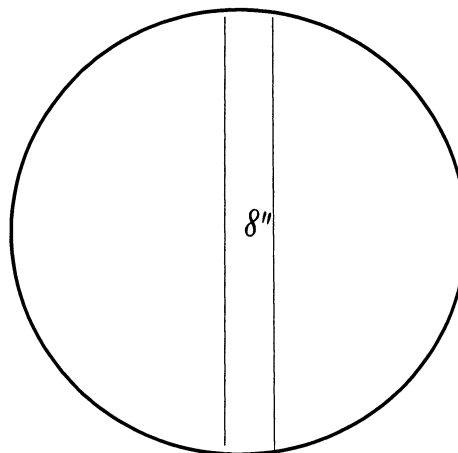
**WRIGHT-PIERCE**  
**MANHOLE INSPECTION REPORT**MH No. FCC-27PROJECT LOCATION: Falmouth on the Green Falmouth, Maine PROJECT NO.: 10876BDATE: 5/19/08 WEATHER: Cloudy TIME: 4:03 INSPECTOR: Tim ParksLOCATION DATA:STREET: BirkdaleBURIED: Yes/No PAVED AREA: Yes/NoMANHOLE DATA:COVER CONDITION: EX GD PRCOVER DIAMETER: 18" 24" 26" 30"NO. OF COVER HOLES: 0SIZE OF COVER HOLES: -CONDITION OF RIM: EX GD PRCONDITION OF FRAME: EX GD PRRISER CONDITION: EX GD PRRISERS ARE: BRICK BLOCK PRECASTMANHOLE DIAMETER 2FT 3FT 4FT OTHER:                     MANHOLE IS: BRICK BLOCK PRECAST OTHER:                     DEPTH OF MANHOLE: 9.42 FTCONDITION OF WALLS: EX GD ↔ PRCONDITION OF STEPS: EX GD PRNUMBER OF SECTIONS: 1 2 3 4 5CONDITION OF INVERTS: EX GD PRCONDITION OF TABLE: EX GD PRLEAKAGE POINTS:COVER: Y/N JOINTS: Y/N smallFRAME: Y/N INVERTS: Y/NWALLS: Y/N small TABLES: Y/NESTIMATED I/I (GPM):                     CORROSION PROBLEMS? Y/NCOMMENTS: Small leakage points in joints and walls.SECTION

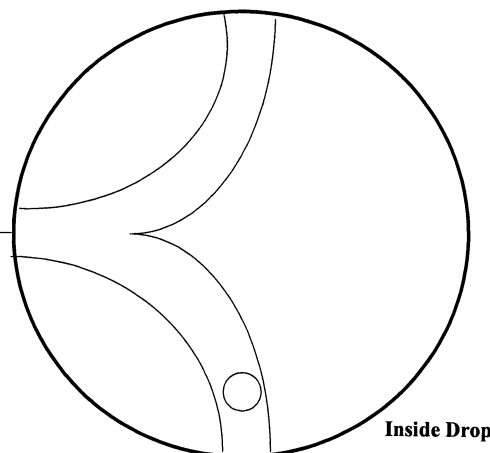
**WRIGHT-PIERCE**  
**MANHOLE INSPECTION REPORT**MH No. FCC-28PROJECT LOCATION: Falmouth on the Green Falmouth, Maine PROJECT NO.: 10876BDATE: 5/19/08 WEATHER: Cloudy TIME: 4:03 INSPECTOR: Tim ParksLOCATION DATA:STREET: BirkdaleBURIED: Yes/No PAVED AREA: Yes/NoMANHOLE DATA:COVER CONDITION: EX GD PRCOVER DIAMETER: 18" 24" 26" 30" P.S. ←NO. OF COVER HOLES: 0SIZE OF COVER HOLES: -CONDITION OF RIM: EX GD PRCONDITION OF FRAME: EX GD PRRISER CONDITION: EX GD PRRISERS ARE: BRICK BLOCK PRECASTMANHOLE DIAMETER 2FT 3FT 4FT OTHER:                     MANHOLE IS: BRICK BLOCK PRECAST OTHER:                     DEPTH OF MANHOLE: 11.42 FTCONDITION OF WALLS: EX GD PRCONDITION OF STEPS: EX GD PRNUMBER OF SECTIONS: 1 2 3 4 8CONDITION OF INVERTS: EX GD PRCONDITION OF TABLE: EX GD PR DIRTYLEAKAGE POINTS:COVER: Y/N JOINTS: Y/N smallFRAME: Y/N INVERTS: Y/NWALLS: Y/N small TABLES: Y/NESTIMATED I/I (GPM):                     CORROSION PROBLEMS? Y/NCOMMENTS: Table was dirty.SECTION

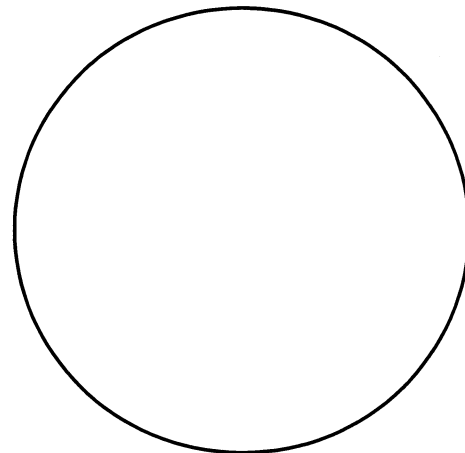
**WRIGHT-PIERCE**  
**MANHOLE INSPECTION REPORT**MH No. FCC-37PROJECT LOCATION: Falmouth on the Green Falmouth, Maine PROJECT NO.: 10876BDATE: 5/20/08 WEATHER: Sunny TIME: 7:53 INSPECTOR: Tim ParksLOCATION DATA:STREET: BirkdaleBURIED: Yes/No PAVED AREA: Yes/NoMANHOLE DATA:COVER CONDITION: EX GD PRCOVER DIAMETER: 18" 24" 26" 30"NO. OF COVER HOLES: 0SIZE OF COVER HOLES: -CONDITION OF RIM: EX GD PRCONDITION OF FRAME: EX GD PRRISER CONDITION: EX GD PRRISERS ARE: BRICK BLOCK PRECASTMANHOLE DIAMETER 2FT 3FT 4FT OTHER:                     MANHOLE IS: BRICK BLOCK PRECAST OTHER:                     DEPTH OF MANHOLE: 8 FTCONDITION OF WALLS: EX GD PRCONDITION OF STEPS: EX GD PRNUMBER OF SECTIONS: 2 3 4 5CONDITION OF INVERTS: EX GD PR **DIRTY**CONDITION OF TABLE: EX GD PRLEAKAGE POINTS:COVER: Y/N JOINTS: Y/NFRAME: Y/N INVERTS: Y/NWALLS: Y/N TABLES: Y/NESTIMATED I/I (GPM):                     CORROSION PROBLEMS? Y/NCOMMENTS: Inverts are dirty.SECTION

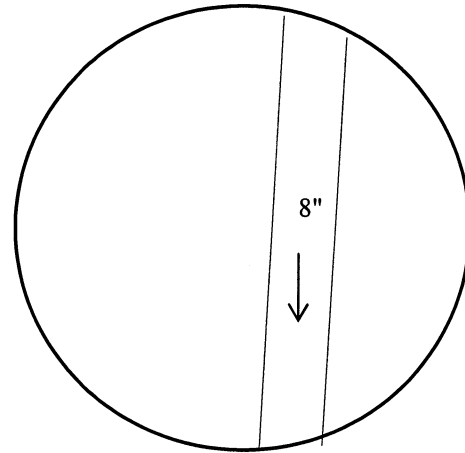
CORROSION PROBLEMS? Y/NCOMMENTS: Table was dirty.SECTION

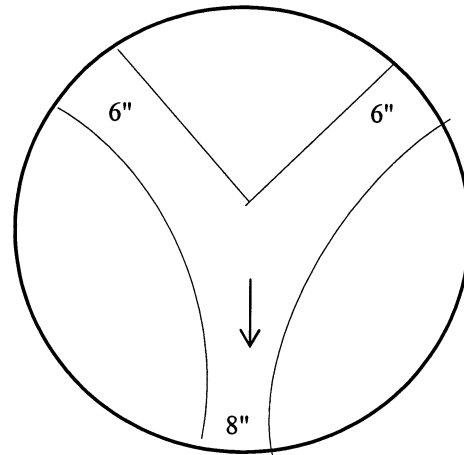
**WRIGHT-PIERCE**  
**MANHOLE INSPECTION REPORT**MH No. FCC-41PROJECT LOCATION: Falmouth on the Green Falmouth, Maine PROJECT NO.: 10876BDATE: 5/20/08 WEATHER: Sunny TIME: 12:39 INSPECTOR: Tim ParksLOCATION DATA:STREET: MedinahBURIED: Yes/No PAVED AREA: Yes/NoMANHOLE DATA:COVER CONDITION: EX GD PRCOVER DIAMETER: 18" 24" 26" 30"NO. OF COVER HOLES: 0SIZE OF COVER HOLES: -CONDITION OF RIM: EX GD PRCONDITION OF FRAME: EX GD PRRISER CONDITION: EX GD PRRISERS ARE: BRICK BLOCK PRECASTMANHOLE DIAMETER 2FT 3FT 4FT OTHER:                     MANHOLE IS: BRICK BLOCK PRECAST OTHER:                     DEPTH OF MANHOLE: 5.92 FTCONDITION OF WALLS: EX GD PRCONDITION OF STEPS: EX GD PR NONENUMBER OF SECTIONS: 2 3 4 -CONDITION OF INVERTS: EX GD PRCONDITION OF TABLE: EX GD PRLEAKAGE POINTS:COVER: Y/N JOINTS: Y/NFRAME: Y/N INVERTS: Y/NWALLS: Y/N TABLES: Y/NESTIMATED I/I (GPM):                     CORROSION PROBLEMS? Y/NCOMMENTS: Table was dirty.SECTION

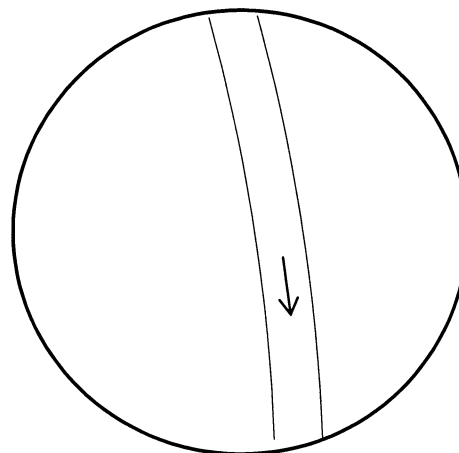
**WRIGHT-PIERCE**  
**MANHOLE INSPECTION REPORT**MH No. FCC-42PROJECT LOCATION: Falmouth on the Green Falmouth, Maine PROJECT NO.: 10876BDATE: 5/20/08 WEATHER: Sunny TIME:            INSPECTOR: Tim ParksLOCATION DATA:STREET: MedinahBURIED: Yes/No PAVED AREA: Yes/NoMANHOLE DATA:COVER CONDITION: EX GD PRCOVER DIAMETER: 18" 24" 26" 30"NO. OF COVER HOLES: 0SIZE OF COVER HOLES: -CONDITION OF RIM: EX GD PRCONDITION OF FRAME: EX GD ↔ PRRISER CONDITION: EX GD PRRISERS ARE: BRICK BLOCK PRECASTMANHOLE DIAMETER 2FT 3FT 4FT OTHER:           MANHOLE IS: BRICK BLOCK PRECAST OTHER:           DEPTH OF MANHOLE: 8.17 FTCONDITION OF WALLS: EX GD ↔ PRCONDITION OF STEPS: EX GD OK PRNUMBER OF SECTIONS: 2 3 4CONDITION OF INVERTS: EX GD PRCONDITION OF TABLE: EX GD PRLEAKAGE POINTS:COVER: Y/N JOINTS: Y/NFRAME: Y/N INVERTS: Y/NWALLS: Y/N TABLES: Y/NESTIMATED I/I (GPM):           CORROSION PROBLEMS? Y/NCOMMENTS: Table was dirty.SECTION

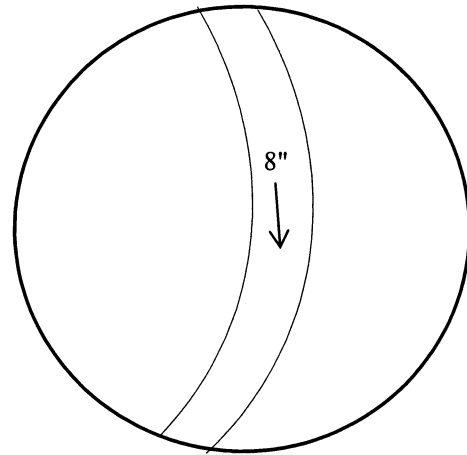
Subsystem No. **WRIGHT-PIERCE**  
**MANHOLE INSPECTION REPORT**MH No. FCC-44PROJECT LOCATION: Falmouth on the Green Falmouth, MainePROJECT NO.: 10876BDATE: 5/20/08WEATHER: SunnyTIME: 1:00INSPECTOR: Tim ParksLOCATION DATA:STREET: MedinahBURIED: Yes/No PAVED AREA: Yes/NoMANHOLE DATA:COVER CONDITION: EX GD PRCOVER DIAMETER: 18" 24" 26" 30"NO. OF COVER HOLES: 0SIZE OF COVER HOLES: -CONDITION OF RIM: EX GD PRCONDITION OF FRAME: EX GD PRRISER CONDITION: EX GD PRRISERS ARE: BRICK BLOCK PRECASTMANHOLE DIAMETER 2FT 3FT 4FT OTHER:                     MANHOLE IS: BRICK BLOCK PRECAST OTHER:                     DEPTH OF MANHOLE: 11 FTCONDITION OF WALLS: EX GD PRCONDITION OF STEPS: EX GD PRNUMBER OF SECTIONS: 2 3 4 7CONDITION OF INVERTS: EX GD PR **DIRTY**CONDITION OF TABLE: EX GD PRLEAKAGE POINTS:COVER: Y/N JOINTS: Y/NFRAME: Y/N INVERTS: Y/NWALLS: Y/N TABLES: Y/NESTIMATED I/I (GPM):                     CORROSION PROBLEMS? Y/NCOMMENTS: Inverter dirty.
