Shoreline Stabilization and Utility Assessment

Town of Falmouth

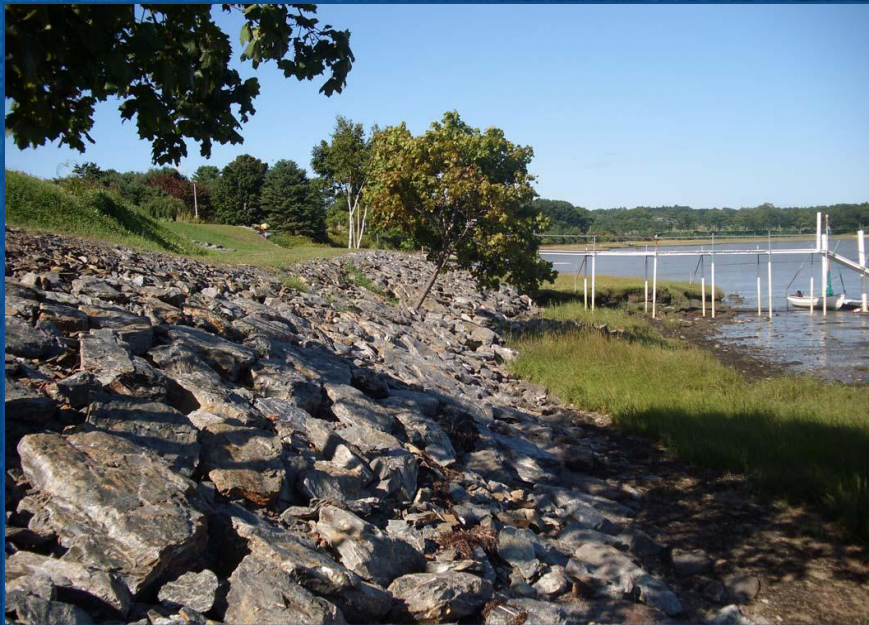
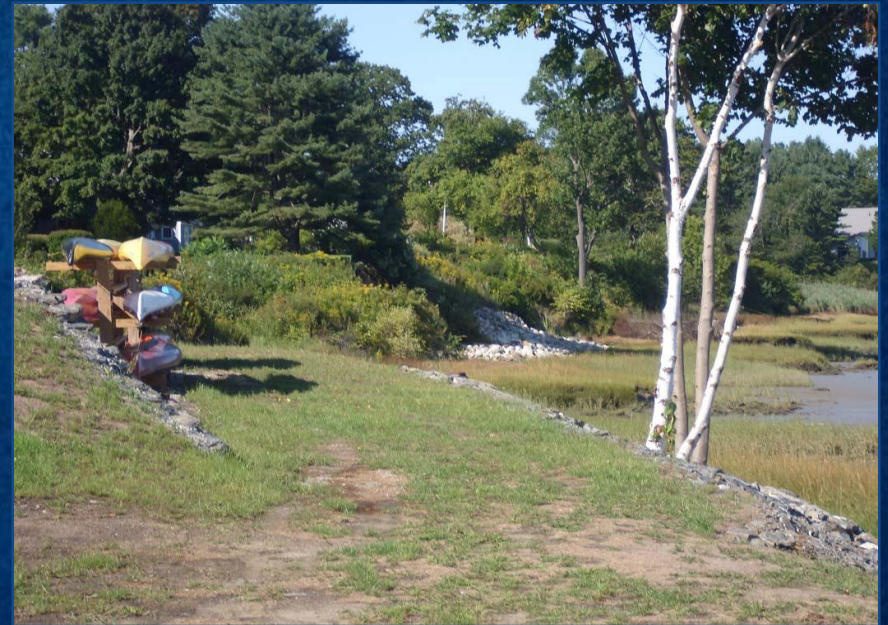
Well-sorted and terraced rip rap stabilization at Hammond.

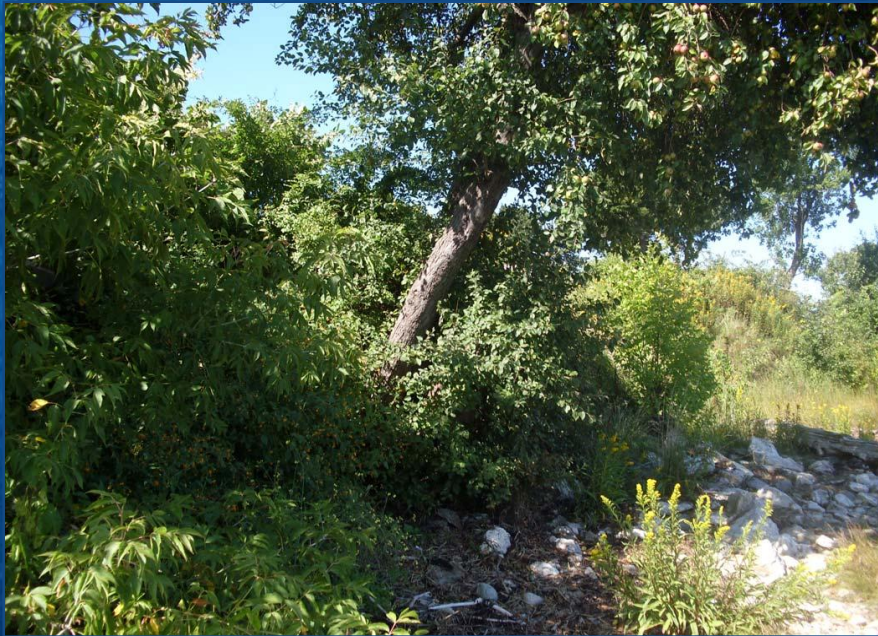
Block failure between Avon and McKinley.

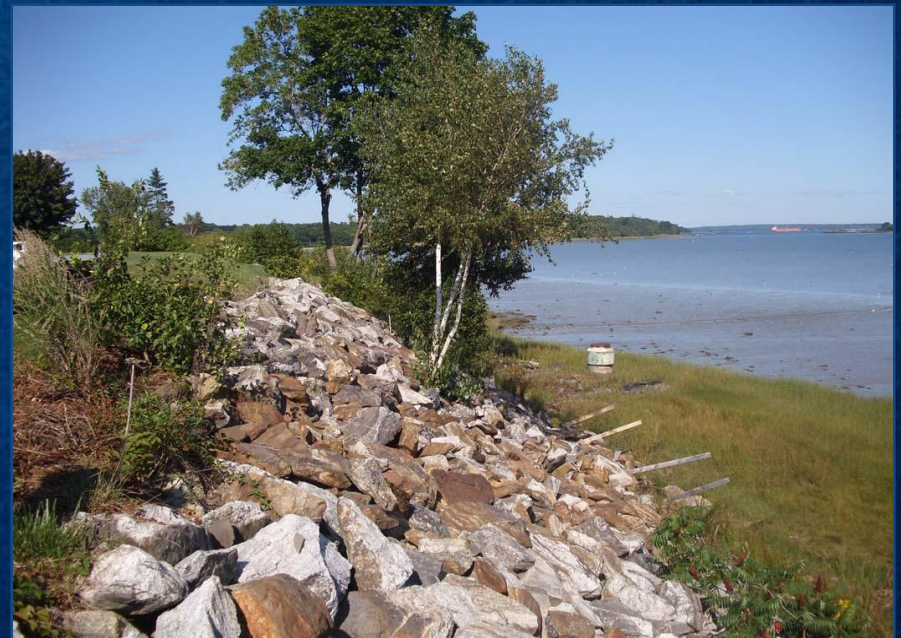
Well-sorted rip-rap stabilization at McKinley.

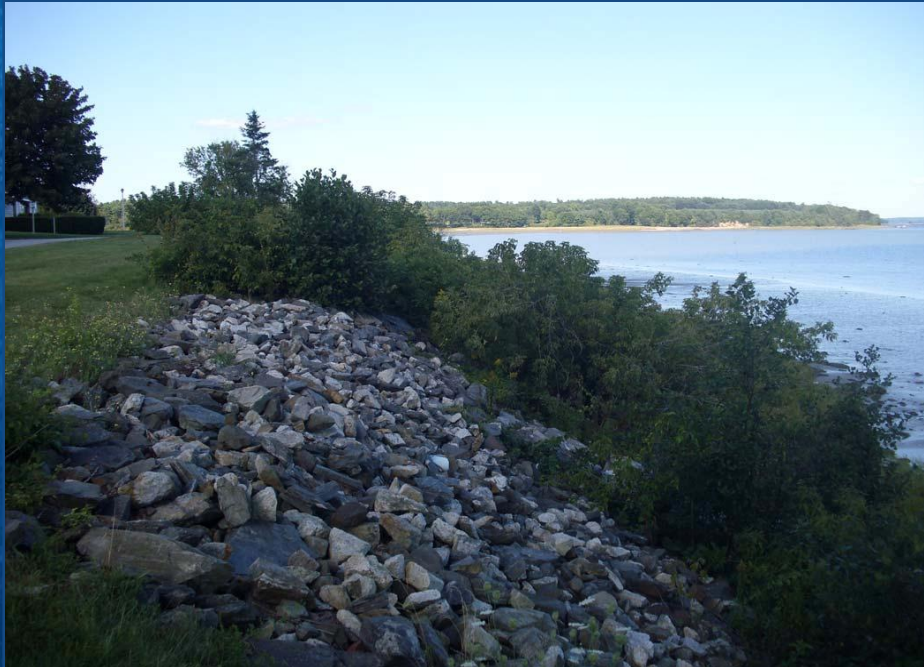
Poorly sorted rip-rap stabilization at McKinley.

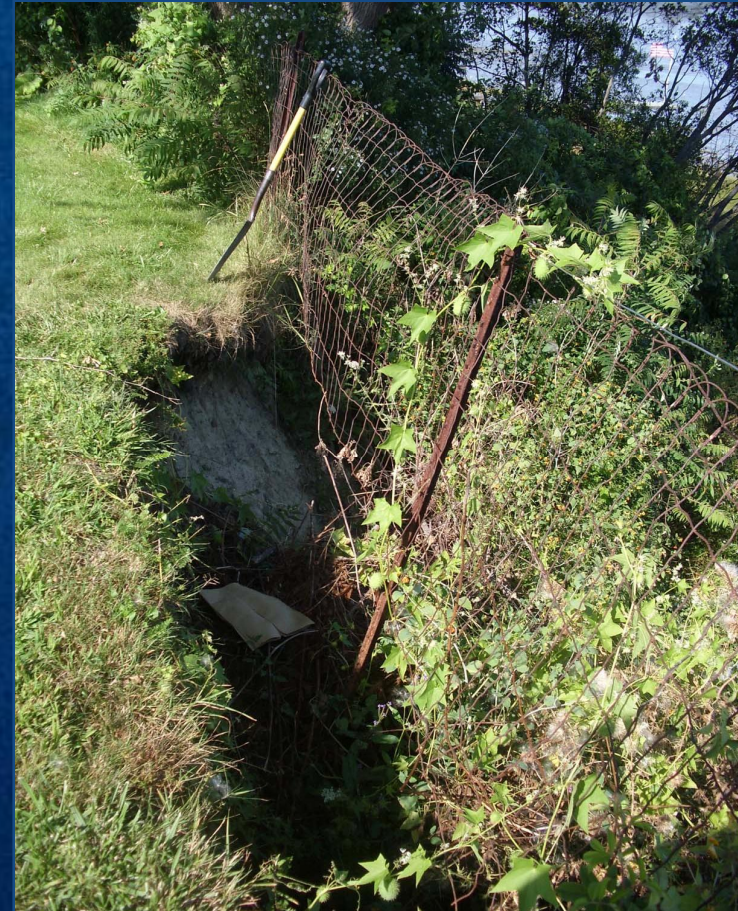
Head of block failure at Payson.
