March 18, 2010

Subject: River Point Bridge Safety Review
Falmouth, Maine

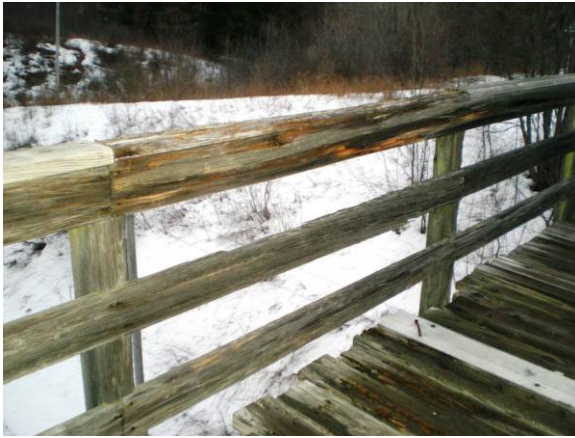
- The bridge railing is in poor condition and does not meet minimum life safety standards for pedestrians or vehicles. Several top rail sections are loose, deteriorated, and sprouting moss and lichen. The height of the rail meets the Building Code requirements for guards but the spacing of the horizontal rails do not. The code states “open guards shall have balusters or ornamental patterns such that a 4-inch diameter sphere can not pass through any opening up to a height of 34 inches”. This provision is to prevent small children from squeezing through railings. A spot check found the rail spacing to be 9”. It is difficult to know if the rail posts are structurally adequate for code pedestrian loads without further site investigation and performing calculations. However, it is clear by inspection that the rail system is not adequate to restrain even a small slow moving vehicle.

Photo 1 – Deteriorated bridge railing. Spacing of horizontal rails exceeds code required 4" maximum.

In summary, the existing rails are inadequate for safe pedestrian and vehicle use. We recommend that the bridge be closed to pedestrians until the railing is upgraded to meet code geometric and load requirements. In addition, we recommend that a greater physical deterrent than the existing steel chain be installed to prevent accidental vehicle use of the bridge. Possible options include removable bollards or jersey barriers. These could be spaced to allow pedestrians to pass but not vehicles. If the rail system is upgraded for vehicle impact and deteriorated deck boards are replaced, it appears that infrequent and controlled vehicle use could be limited to off-road ATV type maintenance/utility vehicles with a total weight limit of 1½ tons. We recommend that the Town continue to monitor the condition of the bridge on a yearly basis.

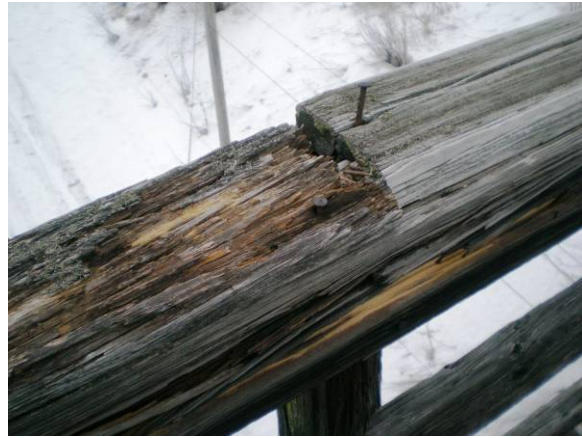
Photo 2 – Top railings are deteriorated and loose at several locations.

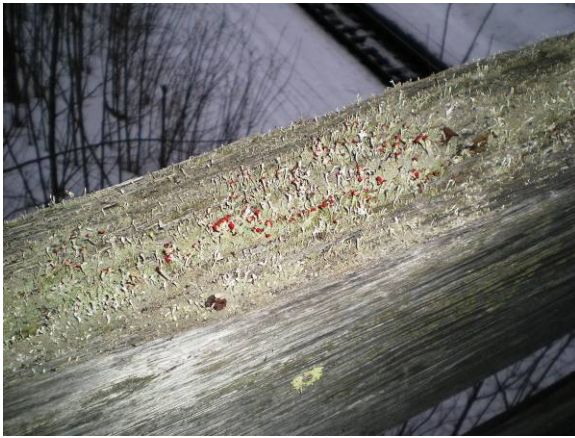
Photo 3 – Lichen and moss growing on top rail.

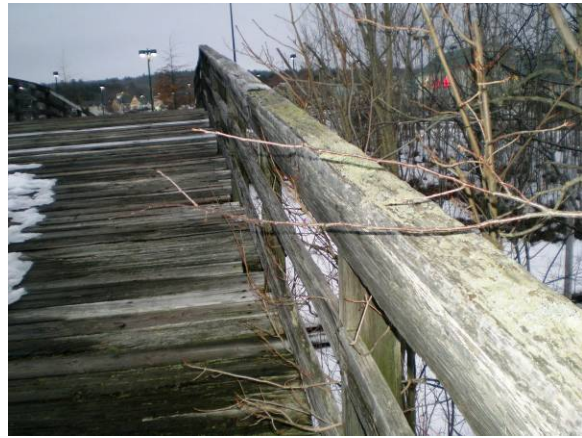
Photo 4 – View of railing looking toward shopping center.

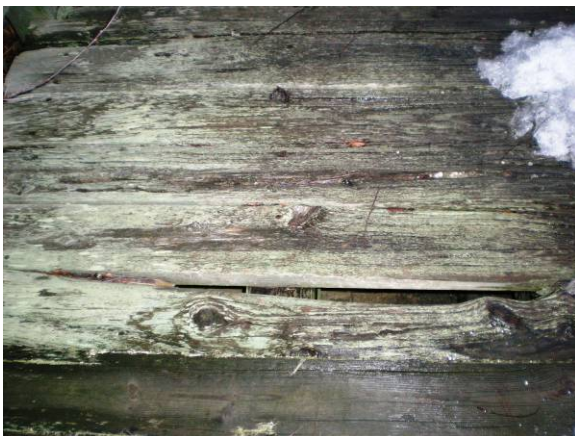
- Although it appears that some deck boards have been recently replaced, approximately one-third of the remaining deck boards have some section loss resulting from deterioration. Moss, mildew, decay and cracking were observed in these boards.

Photo 5 – Moss, mildew, and decay on deck boards.

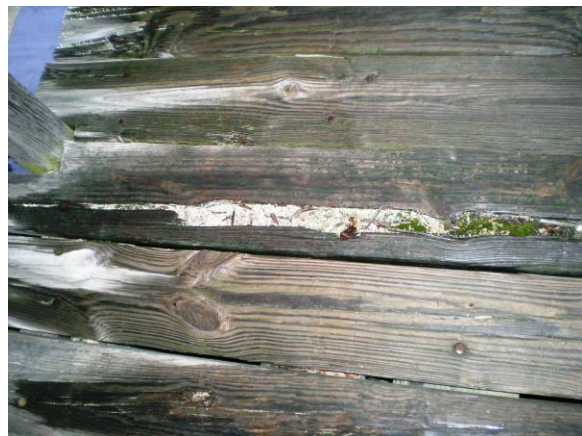
Photo 6 – Cracked deck board with moss growing.

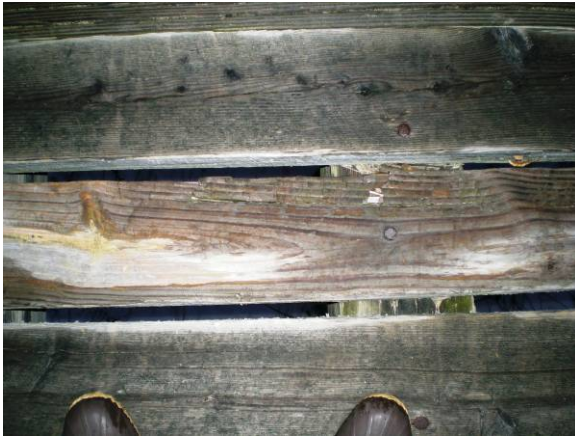
- The current condition of the timber stringers is difficult to assess. We could not review the critical top surface of the stringers, where deterioration tends to occur, without removing deck boards. However, we did observe a green mildew growing on

the tops of the stringers in the gaps between deck boards at many locations. This green mildew was also visible on the sides of the exterior stringers.

Photo 7 – Green mildew growing on top surface of stringer as seen between gaps in deck boards.

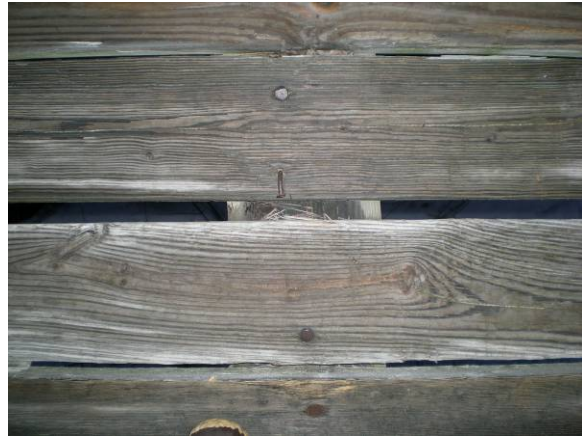
Photo 8 – Moisture tends to collect on top surface of stringers at deck boards.

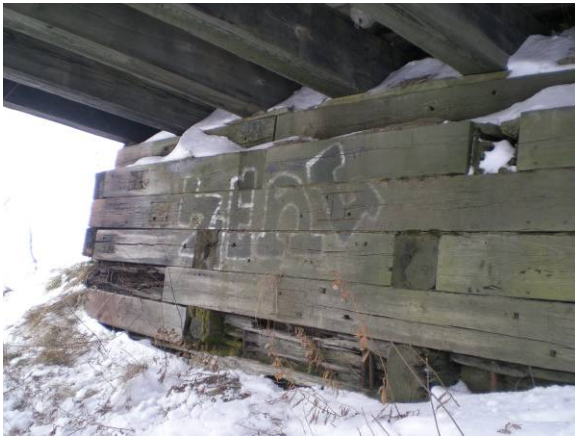
- The timber crib abutments are in poor condition. Several lower timbers are severely deteriorated to the point that sections of wood can be removed by hand.

Photo 9 – Severely deteriorated lower timbers of the abutment closest to the shopping center.

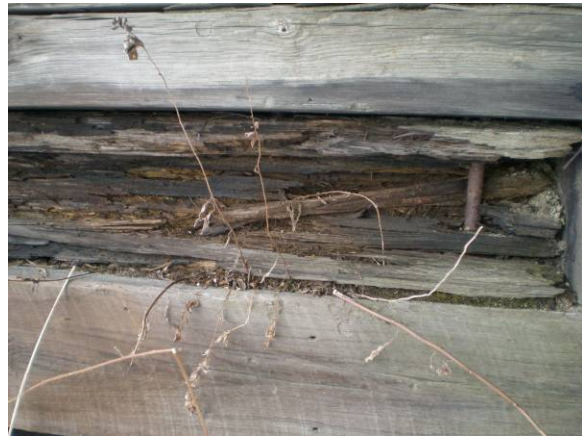
Photo 10 – Deteriorated wood can be removed by hand from abutment timbers.

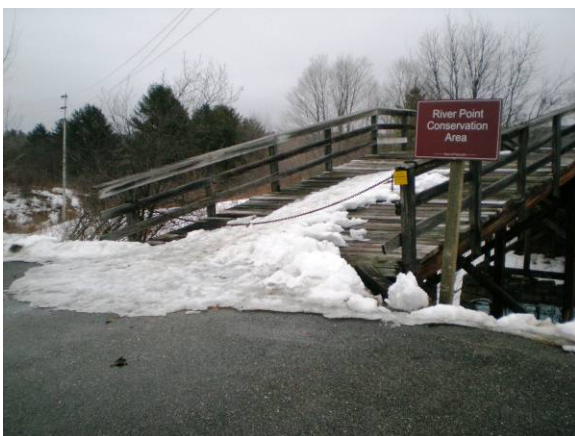
- A small sign mounted on the end rail post on the shopping center side of the bridge states "Motorized Vehicles Prohibited (snowmobiles permitted on marked trails)". To prevent vehicle access, a locked steel chain has been draped across the bridge entrance. The sign does not directly address pedestrian usage or provide a posted load capacity. While the chain may discourage vehicular use, it also may confuse pedestrians trying to determine if the bridge is open or closed.

Photo 11 – Chain draped across bridge entrance to prevent vehicle access. Note small sign on end post.

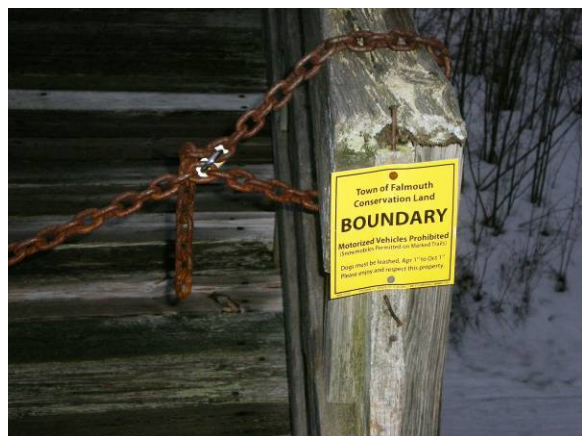
Photo 12 – Small sign on post states “Motorized Vehicles Prohibited” from bridge.
