SUMMARY REPORT

Town Hall and Food Pantry Renovation Falmouth, Maine

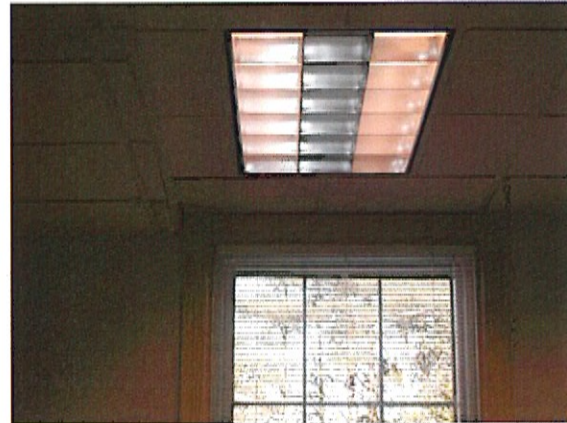
Water damaged ceiling tiles in the original structure level one - northwest wall area

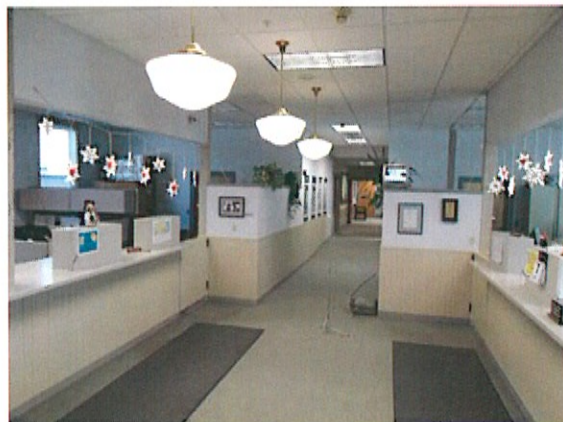
Original Structure, general office area, level one

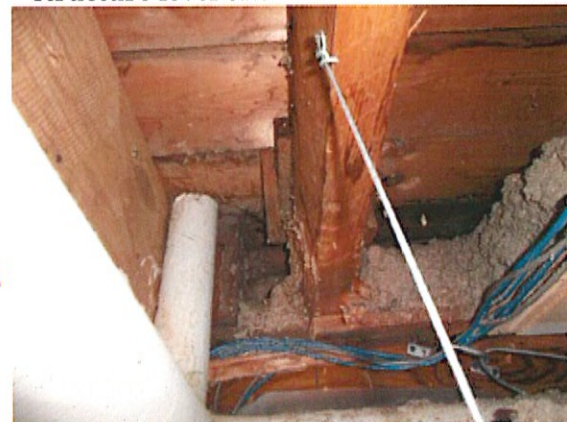
Above damaged ceiling tiles, disturbed cellulose insulations by rodent activity

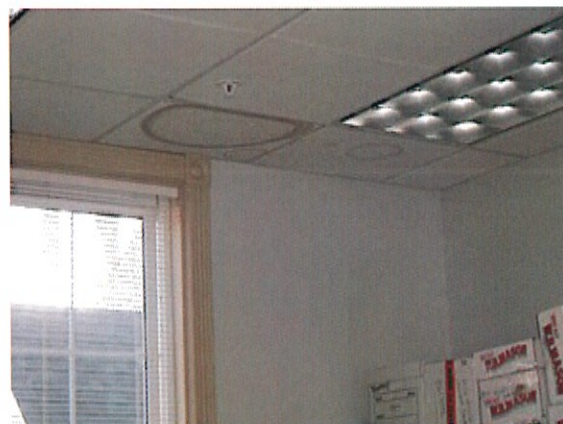
Water damaged ceiling tiles seen in the original structure level one – northeast wall area

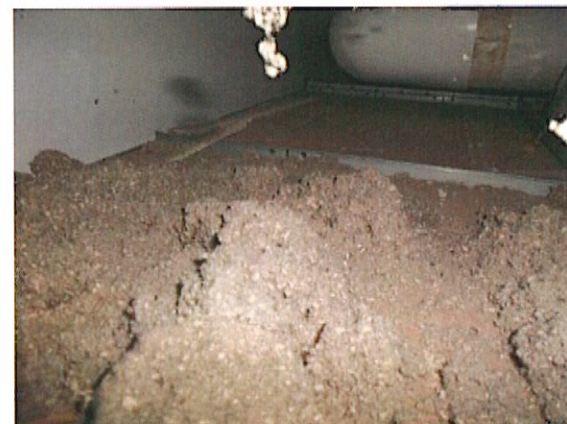
Rodent disturbed insulations on top ceiling of tile, visible signs of rodent urine and pipe condensation

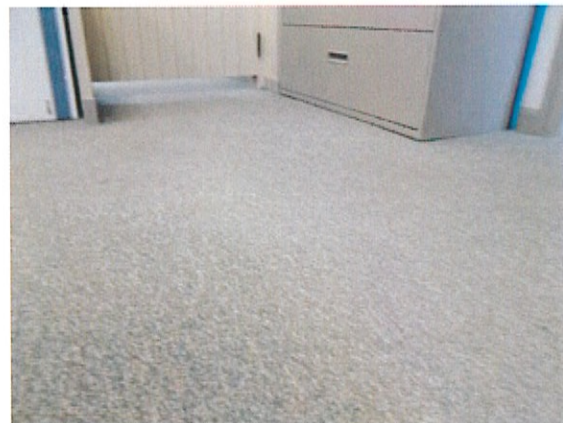
Heavy wear for carpets in walkways, may contribute to elevated particle activity

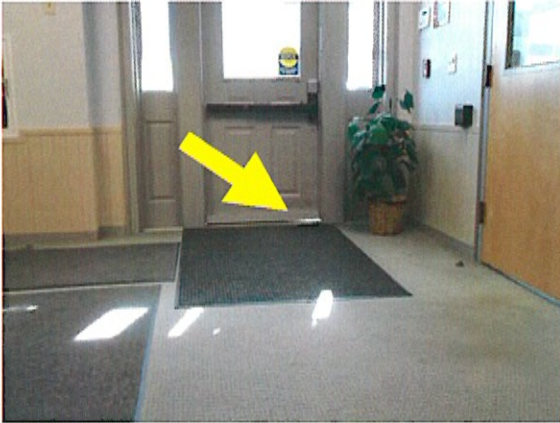
Door sweep gap allows for rodent/insect access and exhaust fume infiltration

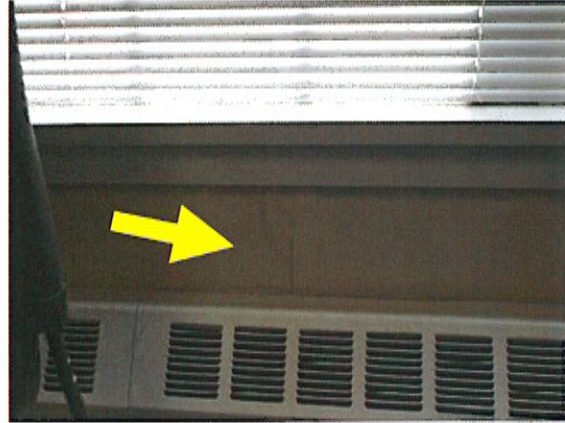
Council Chambers with water damage to paint on the south side of the exterior wall below the window

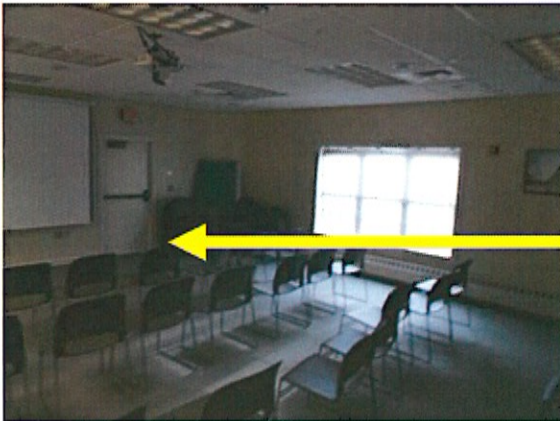
Council Chambers, add-on structure area level one

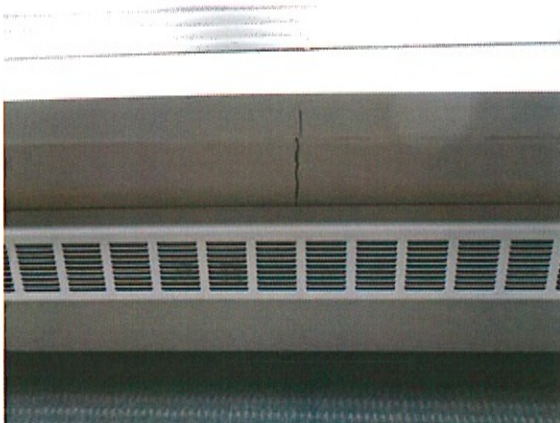
Council Chambers with a crack in south side exterior wall below the window

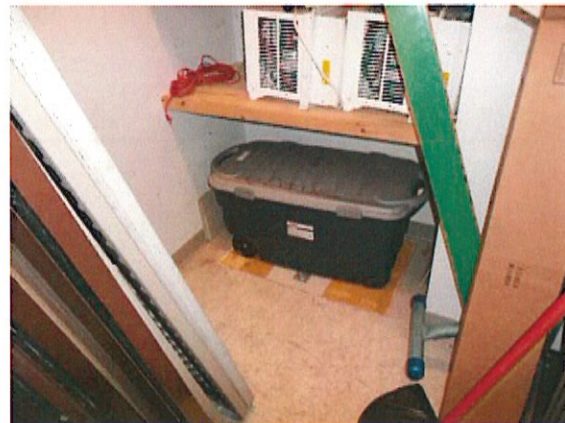
Access to the crawlspace in Council Chambers closet

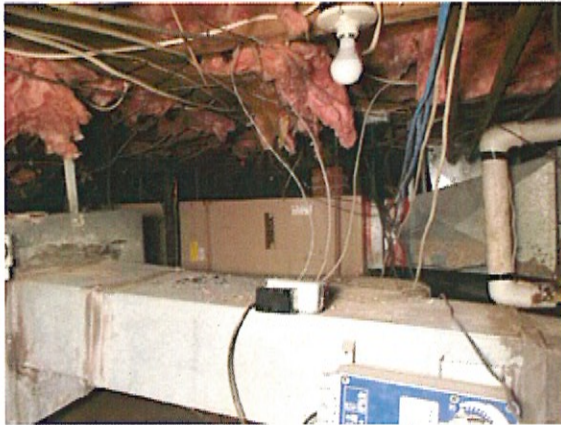
The areas around each AHU have loose fiberglass insulation and damp soils

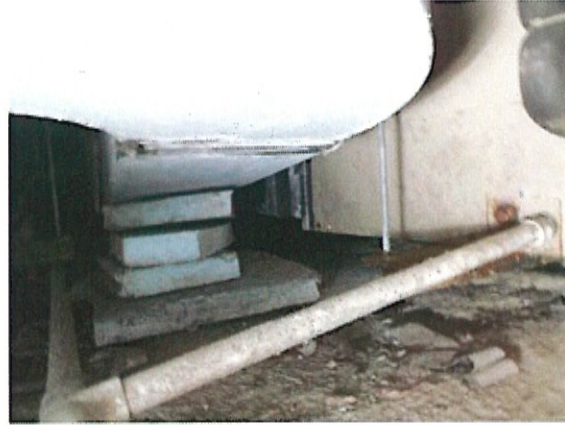
AHU's are in close proximity to damp crawl space soils

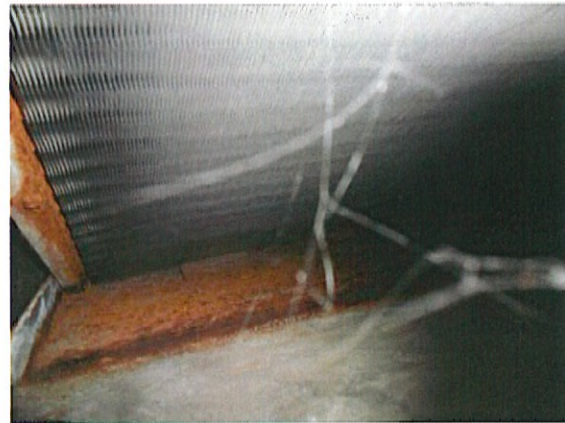
AHU's have significant rust for condensate pans

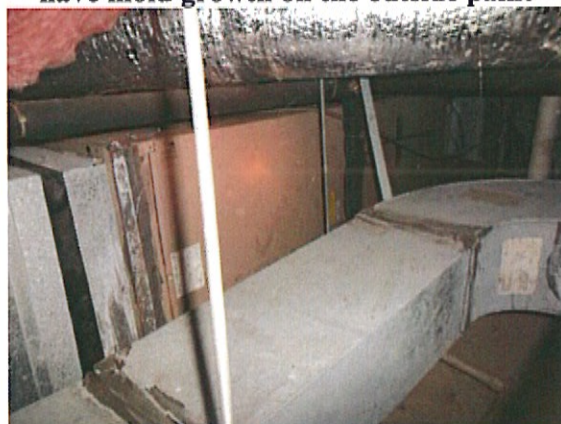
The AHU's are dirty, unmaintained and have mold growth on the outside paint

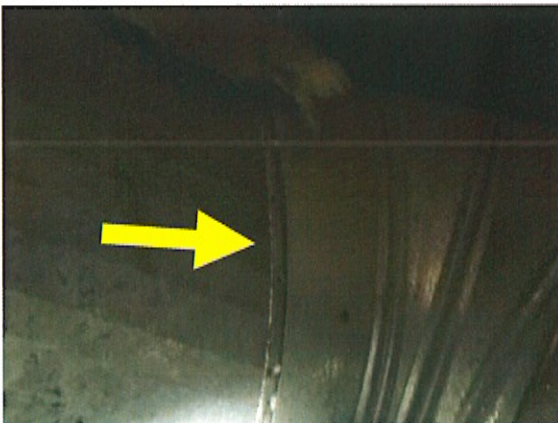
One of several locations where crawlspace air infiltrates the AHU ductwork

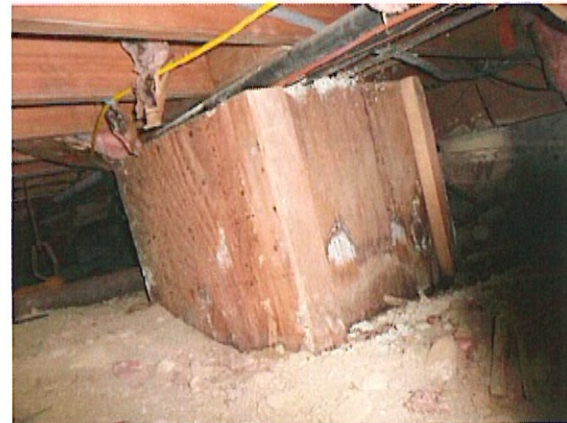
Plywood forms around steel posts have visible heavy mold growth

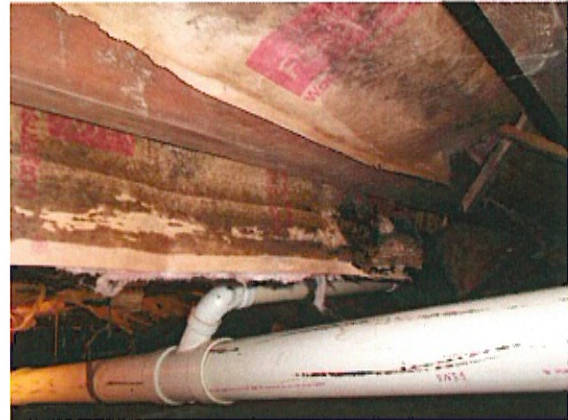
The paper faced insulations are moldy, moisture damaged, and have rodent urine

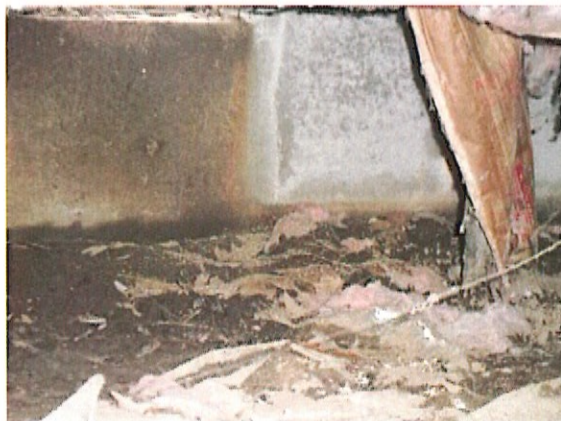
Soils below window above show signs of routine water intrusion

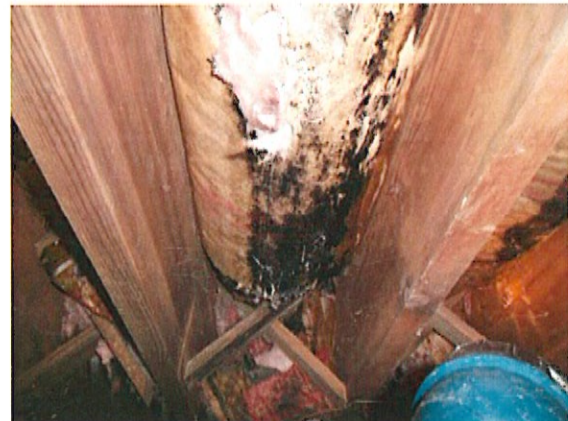
Insulation damage due to crawlspace humidity, mold growth and rodent urine

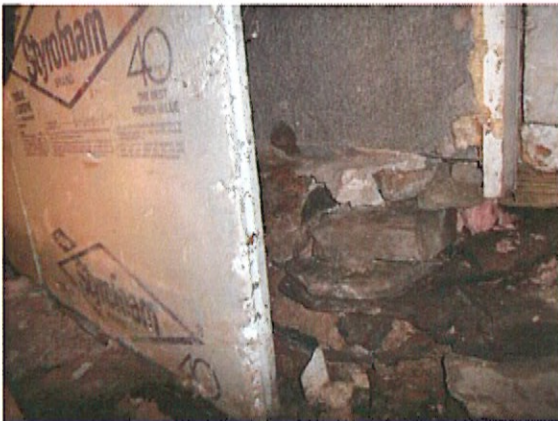
Conditions behind ridged foam board for crawlspace foundation walls

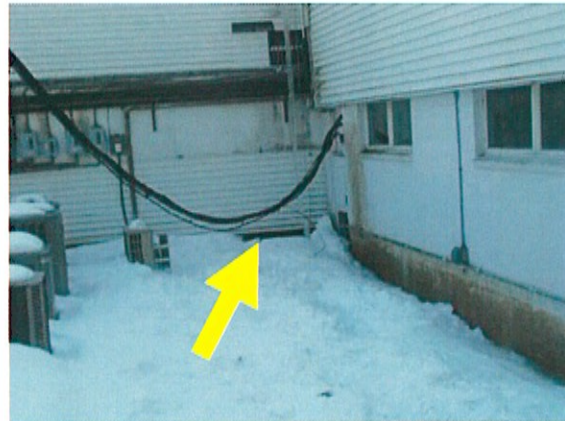
Window appears to be an access point for water and rodent intrusion
