GCG ASSOCIATES, INC.PROFESSIONAL CIVIL ENGINEERS AND LAND SURVEYORS
84 Main Street
Wilmington, Massachusetts 01887Phone: (978) 657-9714
Fax: (978) 657-7915

RE: Sewage Pump Station Evaluation

STATION NAME: Water Street Wastewater Pump Station

DATE: 8/27/2012

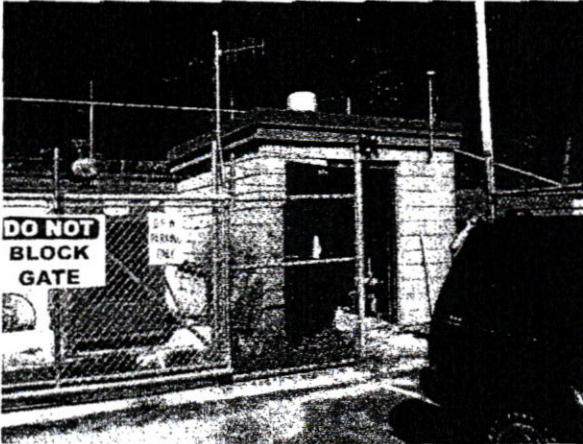
Building

- Exterior: The building consists of textured masonry with aluminum trim in good shape. The rolled rubber roof is in fair shape with some seams lifting requiring patching-no leaks. Downspout disconnected from gutter and should be reattached.

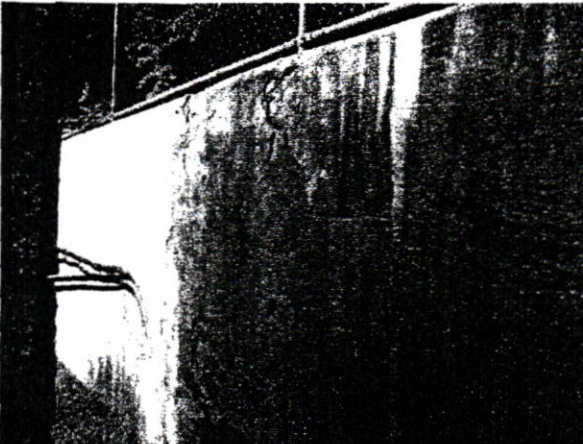
Spalling Concrete Wall

- Concrete slab: Slab over wet well and supporting generator in good shape with minor spalling observed.
- Asphalt: None
- Grounds: Pea Stone perimeter provides adequate surface drainage toward the parking lot, Concrete retaining wall in good shape with one area behind the building spalling and requiring patching.

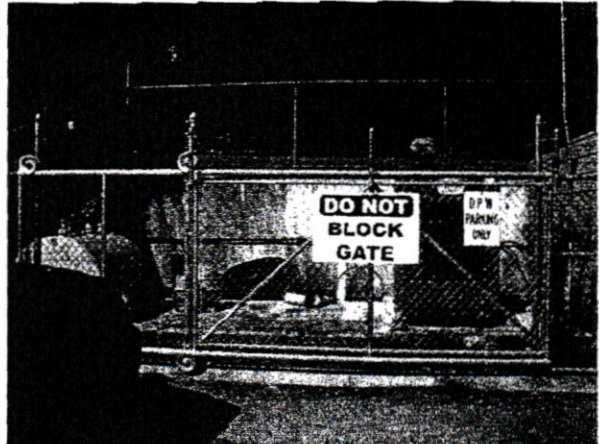
Fence Roller Gate

- Fencing and gate: Fencing in good shape with new roller gate providing access to the wet well for cleaning.

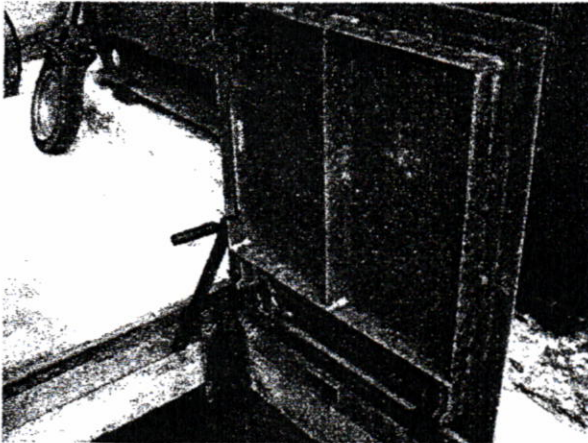
Aluminum Hatch

- Interior piping: Suction lines not visible.
- Aluminum hatch: Hatch in good shape but lift assist system rotted away and should be replaced.
- Level control system: Replaced to accommodate the digital SCADA System installed in 2009 consisting of a high and low float system with transducer level control.

- Lift assist/lock on aluminum hatch to wet well should be repaired.
- Repair the leaking seals on Pump #1. This might also be the time to rebuild again as 10 years have passed since the last rebuild. Replacing only the seals might require the removal of the pump and is recommended by Williamson, therefore a rebuild is recommended. Exact replacement of the pump is not an option because the pump manufacturer is no longer in business.

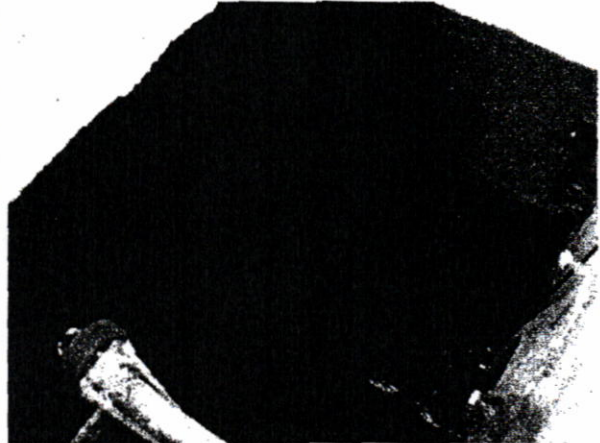
Interior of Wet Well

- Interior: The concrete walls of the wet well are in good shape with little signs of deterioration or groundwater leaks. The ventilator should be repaired for use during confined space entry. The platform and ladder system is unsafe and should be replaced. All abandoned wiring, conduit, valves, etc. should be removed as they are deteriorated and may fall into pump suction lines and cause damage to the pumps.
- Grease/floatables buildup: Some buildup 1" to 3" thick, but not excessive for this station volume. Cleaning and additives are definitively managing the severe grease problems observed in the past.
- Interior pipe penetrations: All interior connections are sealed and there are no visible groundwater leaks.

- Ventilator for wet well should be repaired for confined space entry.
- Platform, ladder, abandoned conduits and valves should be removed from the wet well before failure and falling into the flow causes problems with the pumps.

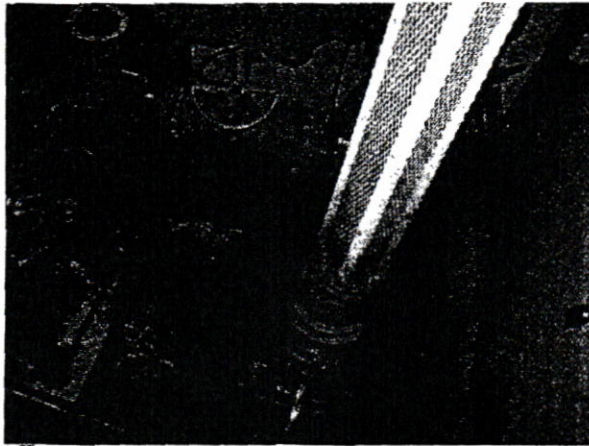
3rd level Pump #1/Valving

- Pump #1 - Metered Flow Rate and Hours: 840-900 gpm, 16,019 hours
- Pump #2 - Metered Flow Rate and Hours: 840-900 gpm, 16,250 hours
- Pump #1 Condition: Good condition, but mechanical seal leaking severely. Pumping rate seems to be reasonable. Pump was rebuilt and 8" knife valve replaced in 2002. New style-mechanical - pump seal, check valve and driveshaft u-joints rebuilt and motor starter installed in 2004.

- Pump #1 Piping/Valving: No leaks observed and all functioning normally .
- Pump #2 Condition: Good condition. No leaks and pumping rate seems to be reasonable. Pump rebuilt and new style-mechanical pump seal and check valve installed in 2004. Pump rebuilt, mechanical seals replaced and driveshaft u-joints rebuilt in 2012.

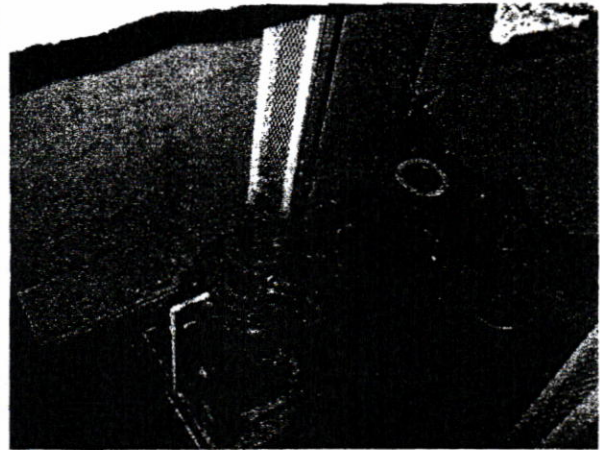
Pump #2/Valving

- Pump #2 Piping/Valving: No leaks observed and all functioning normally

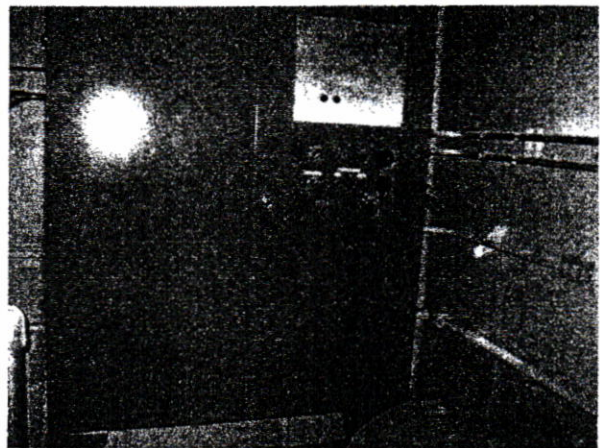
Pump Control Panel

- Flow meter and motor starter replaced in 2004. No major repair history. In 2009 a SCADA monitoring system and level control system were installed. The original station alarm system was incorporated into the SCADA system. There were false alarms indicated by SCADA system during inspection.

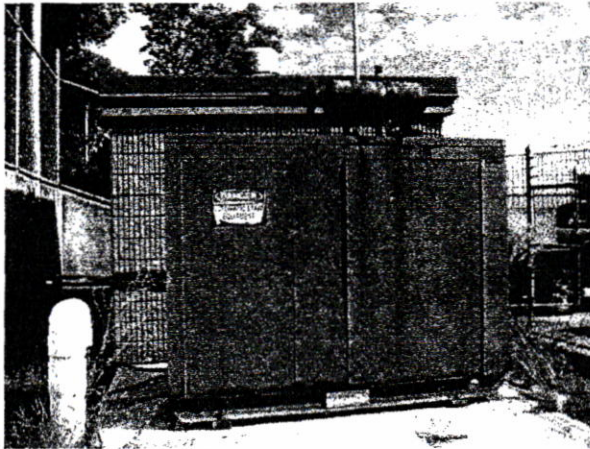
Generator

- Generator: 150KW - 277/480 - 3 phase - Diesel generator with 1065 hours and manufactured by Consolidated Power and serviced bi-annually. Above ground diesel storage tank installed around 2005.
- Condition: Exterior enclosure beginning to rust and could use repainting. New battery and charger installed during last servicing. Overall appears to be in good shape. Transfer switch located in pump station in good shape.
