12 February 2015

Project 150119 – Leakage Pre-Investigation at the Department of the Works Building,
7 Water Street, Millis, MA

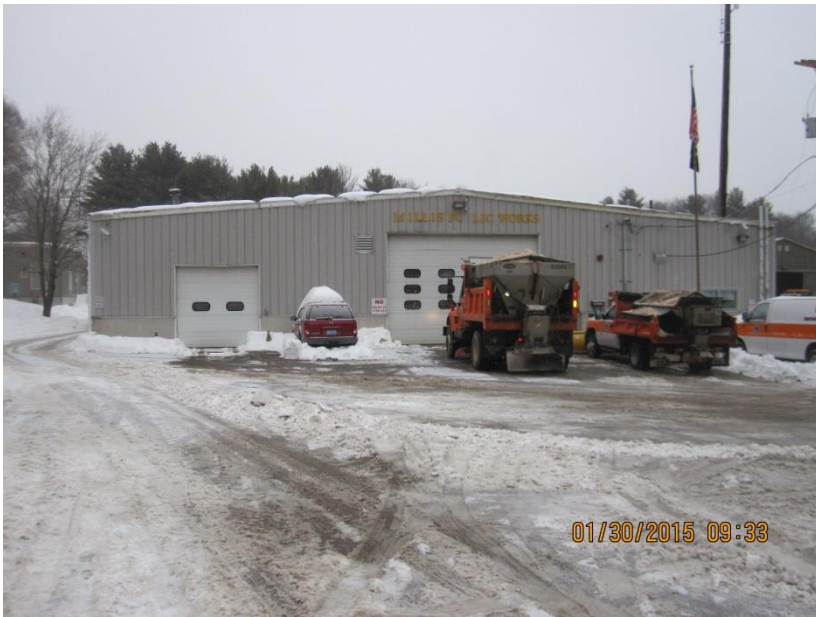
Photo 1

The DPW building is a prefabricated metal building with a 4 ft high exposed concrete foundation wall (Photo 1). Original construction date and documents were not available to us.

7 Water Street.

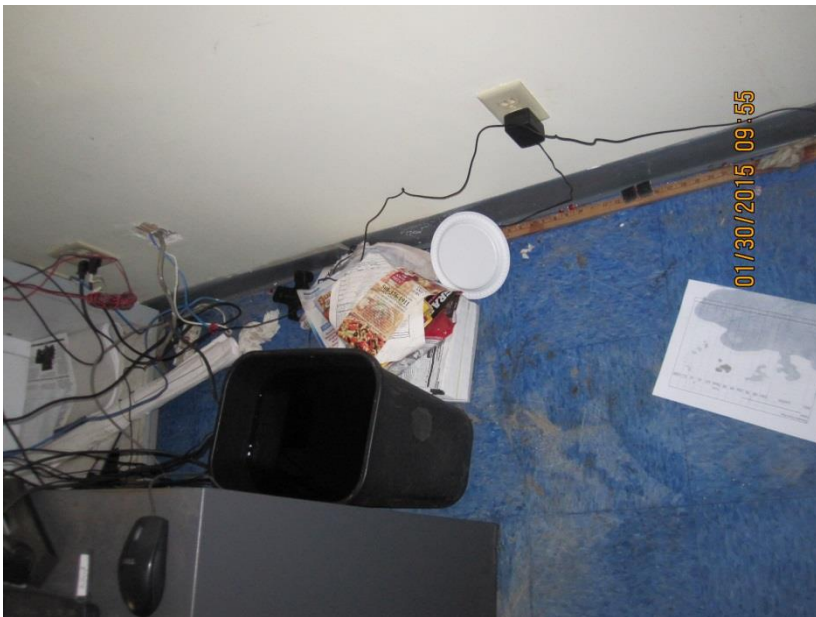
Photo 2

Office leakage area.

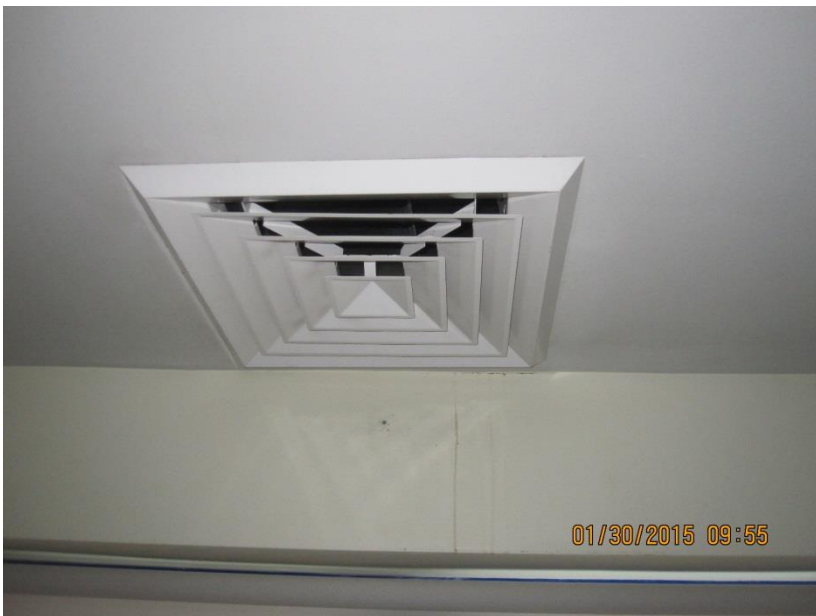
Photo 3

HVAC vent where leakage came through.

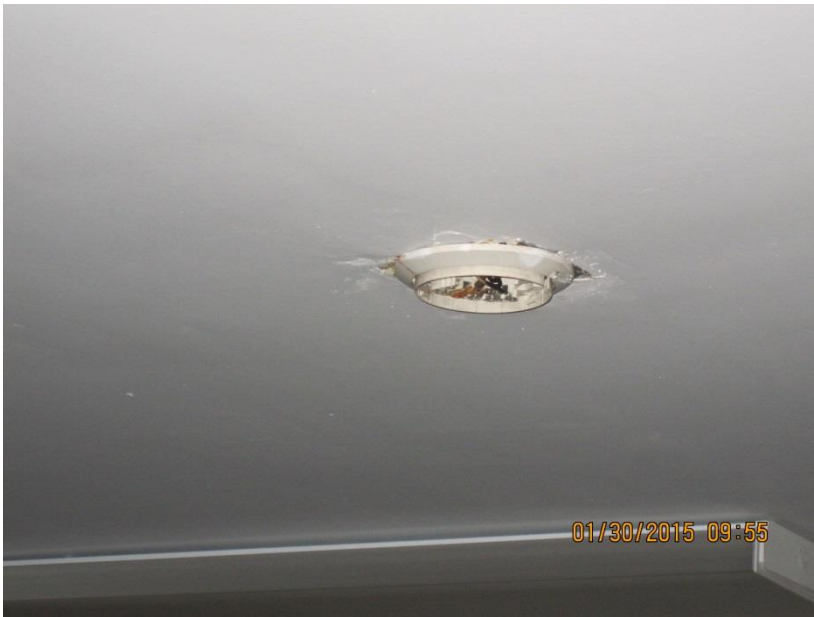
Photo 4

Smoke detector where leakage came through.

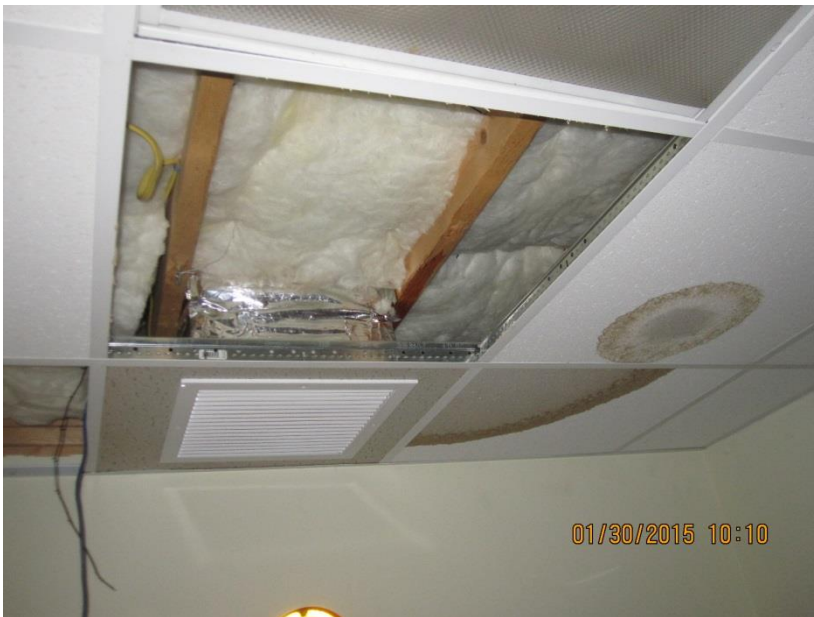
Photo 5

Mechanics area leakage at HVAC duct.

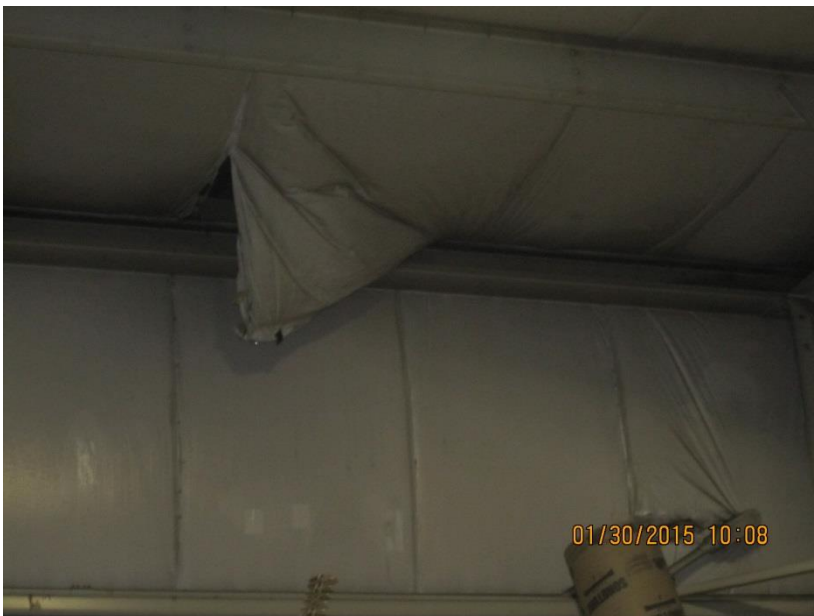
Photo 6

- A section of vinyl-faced roof insulation detached above the mechanics cage at the northwest corner of the building and dispersed a large amount of water on 27 January 2015 (Photo 6).

Detached insulation above mechanics tool storage area.

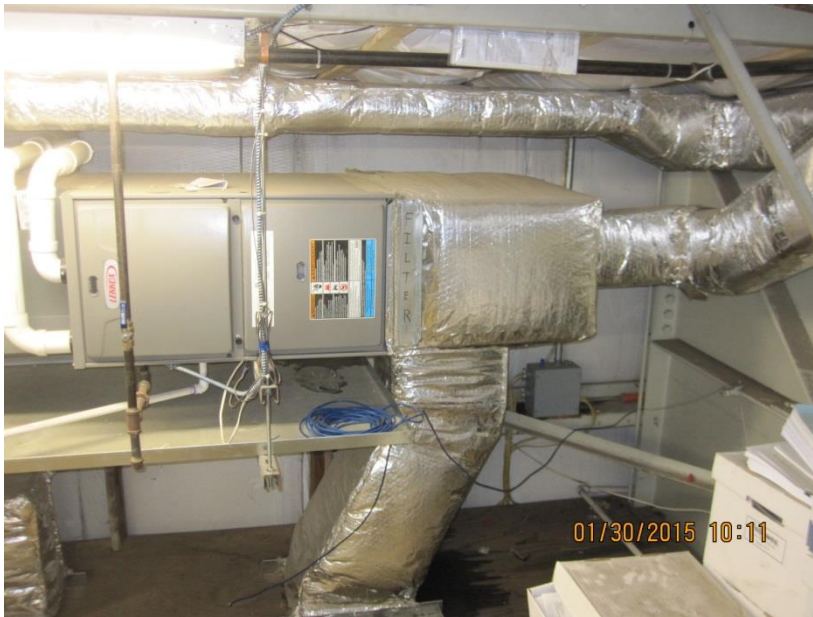
Photo 7

Loft area above mechanics work area.

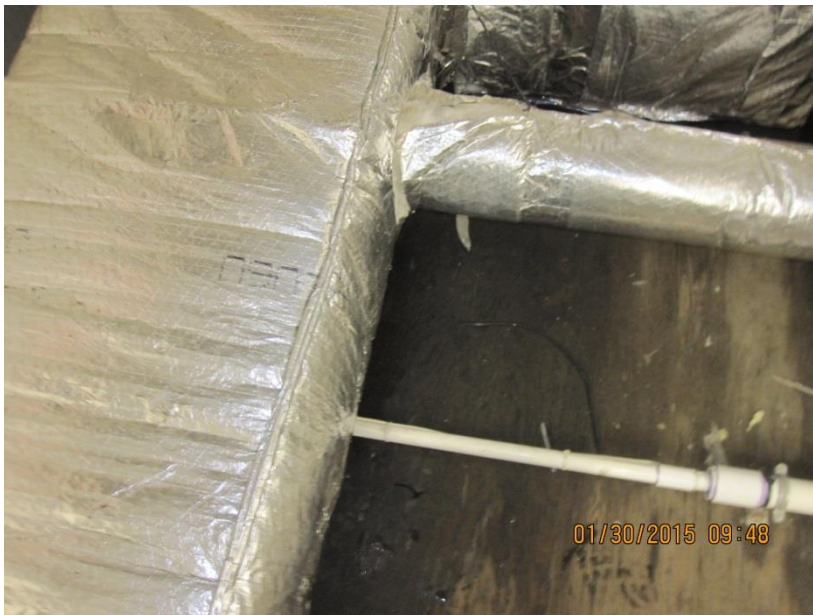
Photo 8

Wet loft area floor above office area.

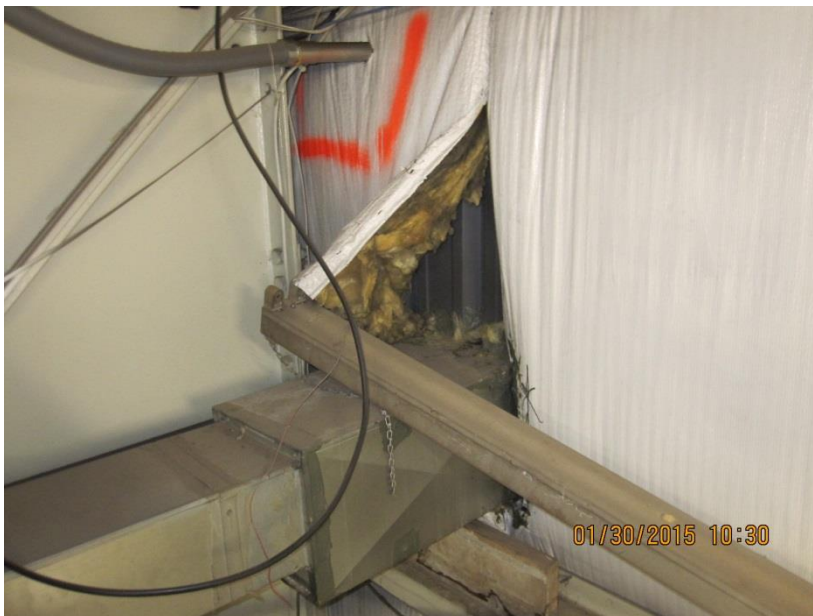
Photo 9

The insulation facer is intended to work as a vapor barrier. Damage to the insulation facer and gaps in the insulation allow warm moist air to reach the face of the metal wall and roof panels, where it can condense. As a result, condensation may exacerbate the water leakage problems.

Open insulation at leak area above mechanics room.

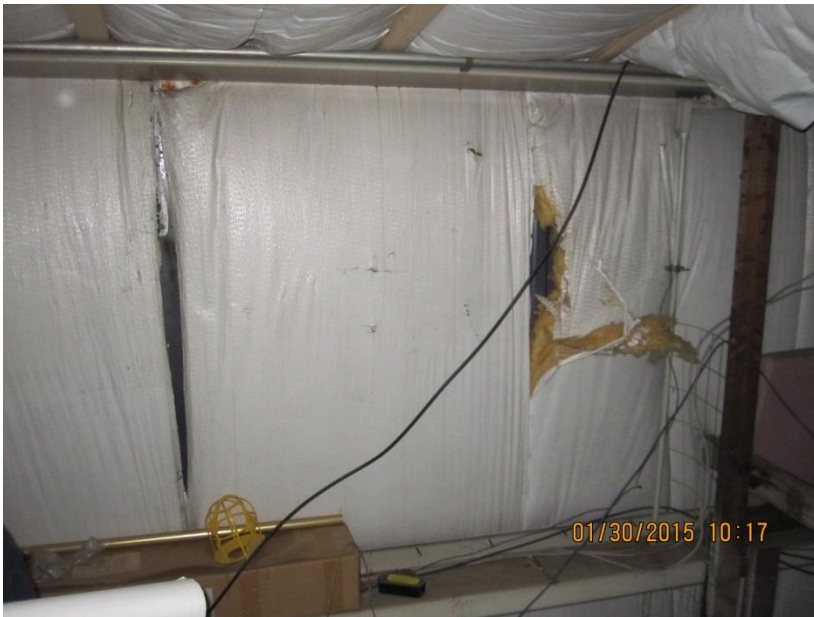
Photo 10

- The metal panels and insulation above and behind the damaged or open seam areas of insulation is wet and frozen (Photo 10).
- Daylight is visible at the roof-to-wall intersection in multiple areas (Photo 11).
- Equipment and tools leaning on the wall insulation causing damage to the vinyl insulation liner.

Wet metal panel and insulation.

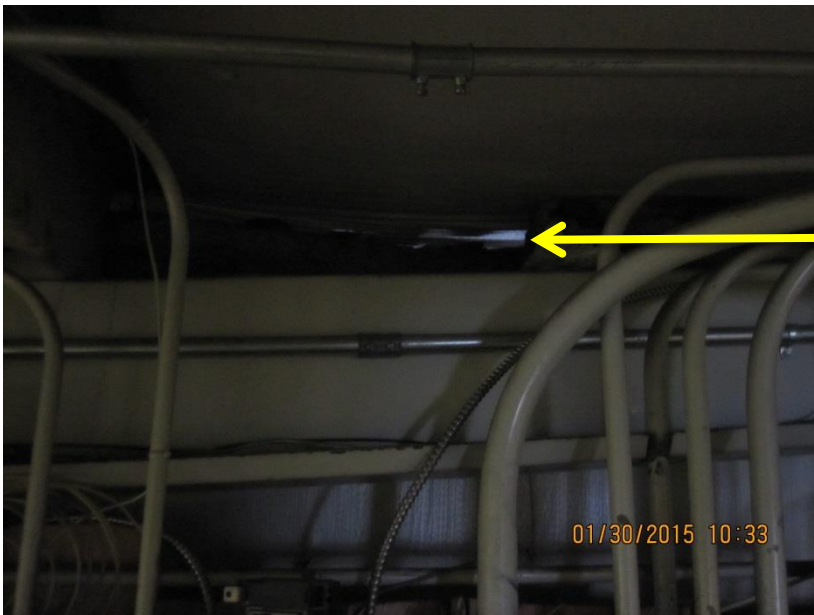
Photo 11

Daylight visible at wall-to-roof transition.

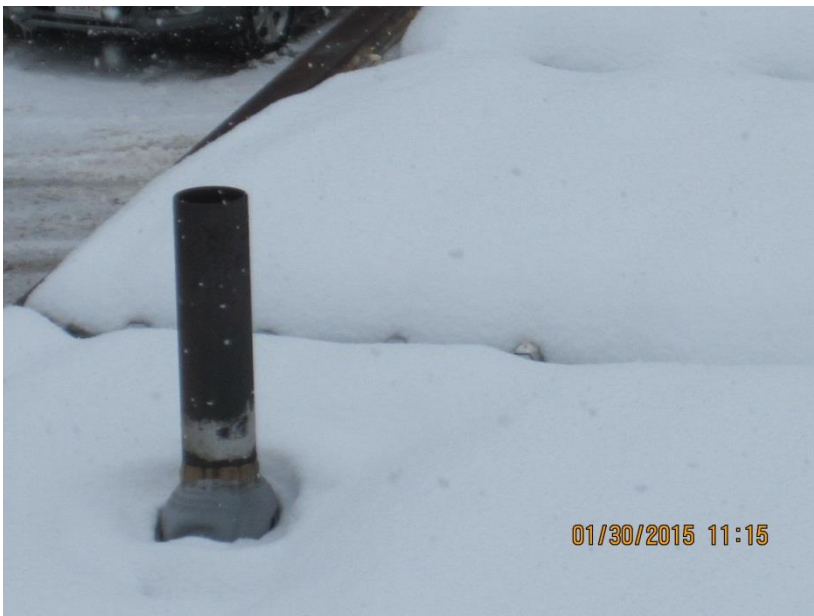
Photo 12

- The roof is face-fastened overlapping corrugated metal sheets with a transverse joint at the roof slope midpoint. The eave channels are closed with foam insulation (Photos 12 – 14).

Transverse lap in corrugated metal roofing.

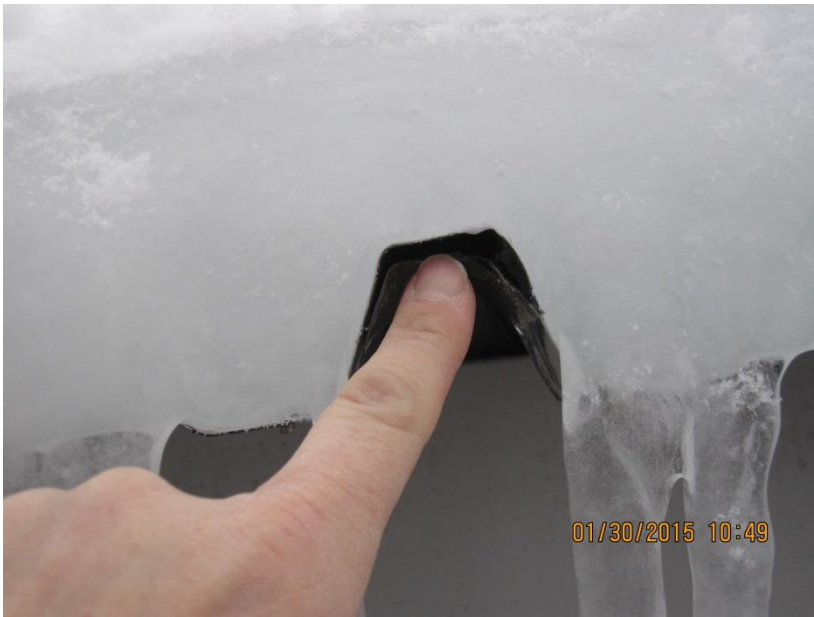
Photo 13

Corrugated metal roofing lap.

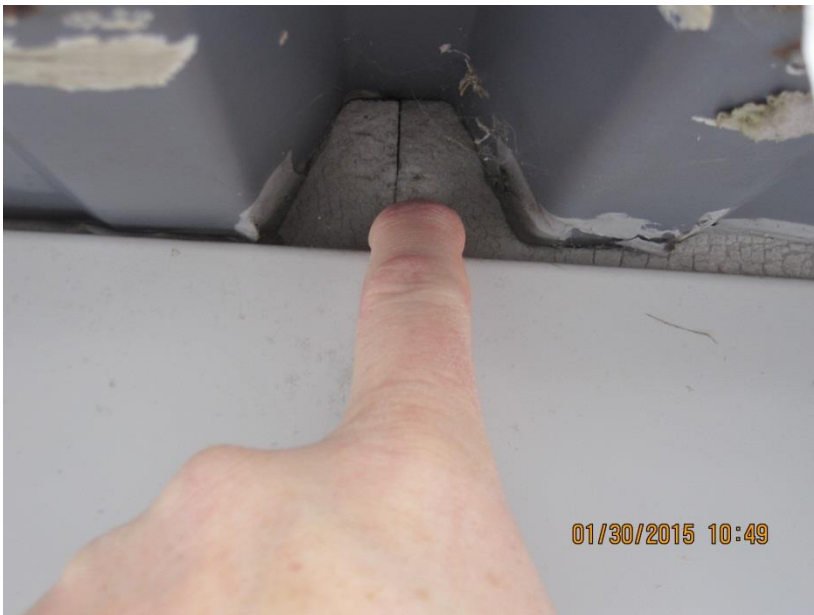
Photo 14

Insulation end cap at channel.

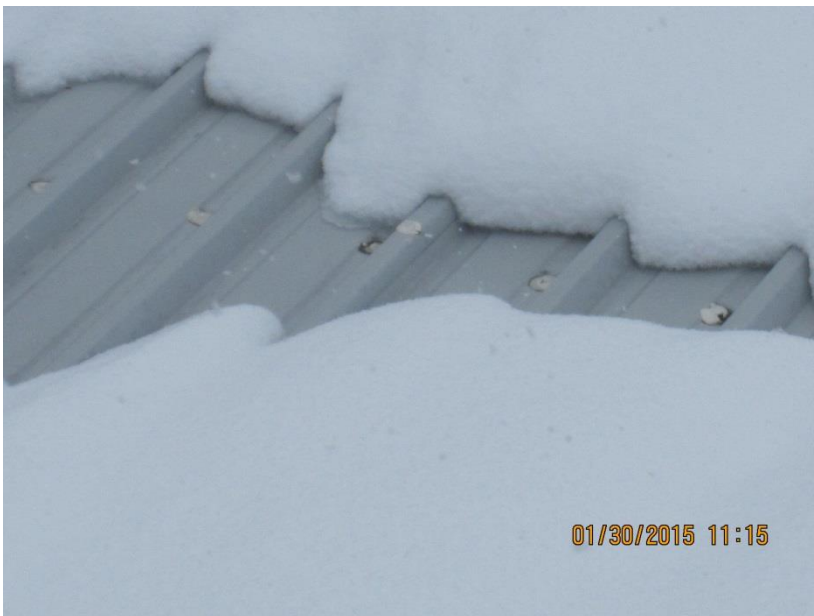
Photo 15

- The visible fasteners are coated with sealant (Photo 15).
- The existing building fastener spacing does not reflect the spacing shown in the drawings.

Face fasteners at corrugated metal roofing. Insulation below is open.

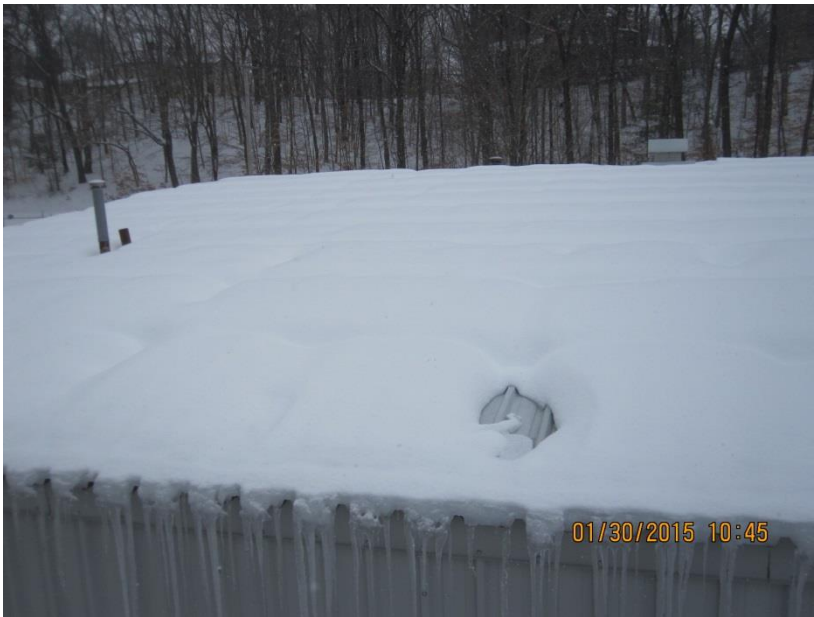
Photo 16

- The snow on the roof is approximately 6 in. deep.
- The metal roof is visible at melted areas above and adjacent to damaged insulation and open laps in the insulation directly below (Photo 16).

Melted snow above insulation gap.

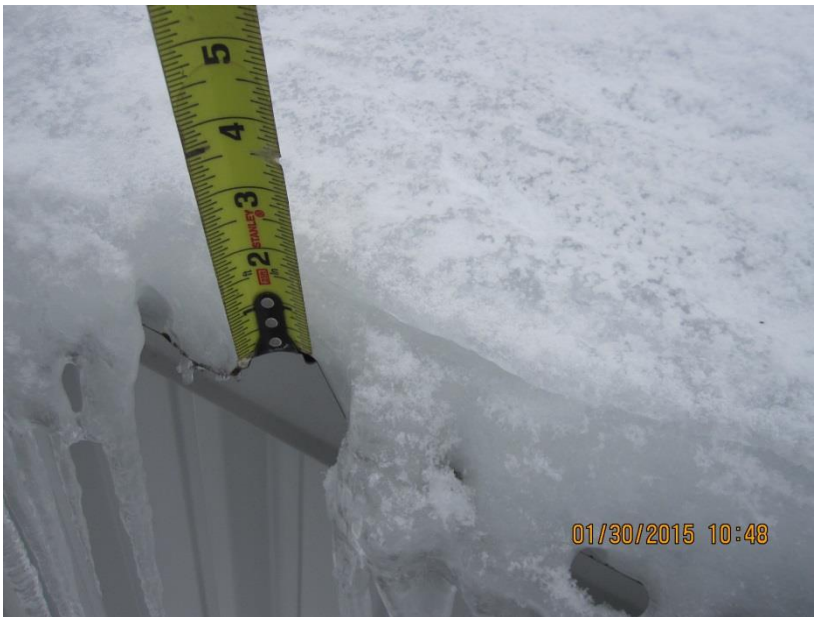
Photo 17

- Ice dams are approximately 2 in. thick and extend 2 ft or more from the roof eave toward the roof ridge (Photo 17).
- The internal purlins transmit heat through the roof, and their locations are visible from melted areas of snow (Photo 18).

Insufficient insulation and insulation gaps cause snow to melt on the roof, creating liquid water to form ice dams. Ice dams form when melting snow (warmed from the building interior) refreezes at the edge of a roof damming water drainage off the roof. The water collects and freezes, increasing the ice dam and the reservoir of water on the roof. Ice dams can allow water to build up and completely submerge the metal ribs and face fasteners, putting added pressure on fastener and lap seam seals.

Ice dam at eave edge.

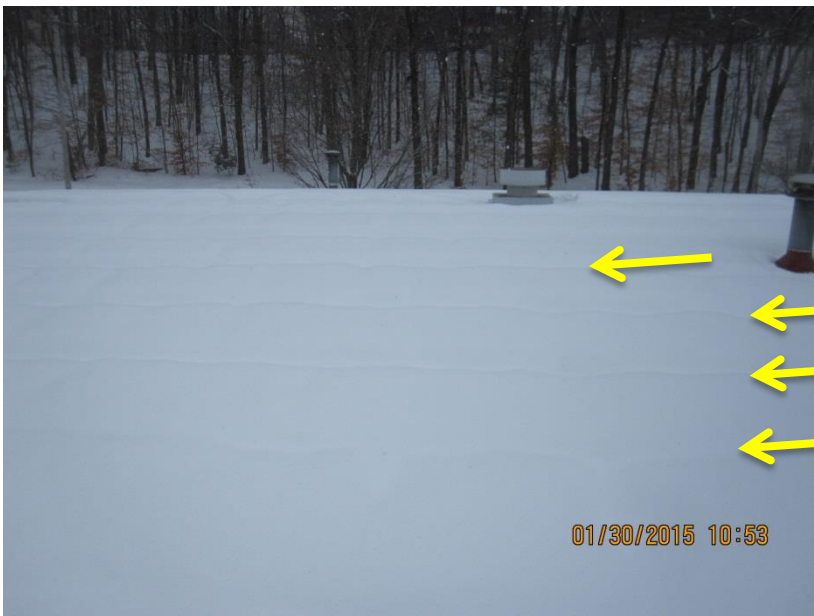
Photo 18

Perlin spacing transmitting through snow.

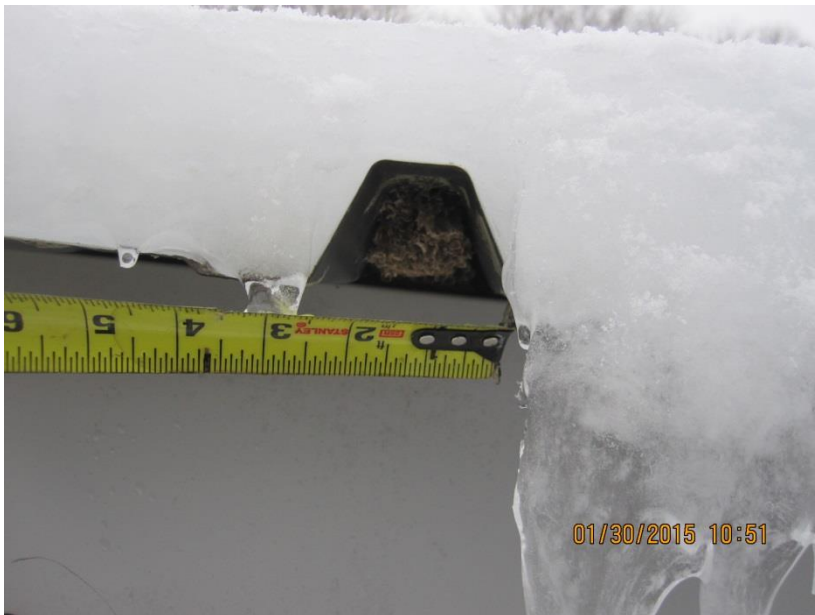
Photo 19

- After removing icicles at the end of a few corrugated ribs, water began flowing off the eave from below the ice dams (Photo 19).

Water draining from ice dam.
