GCG ASSOCIATES, INC.

RE: Sewage Pump Station Evaluation

STATION NAME: Water Street Wastewater Pump Station

DATE: 8/27/2012

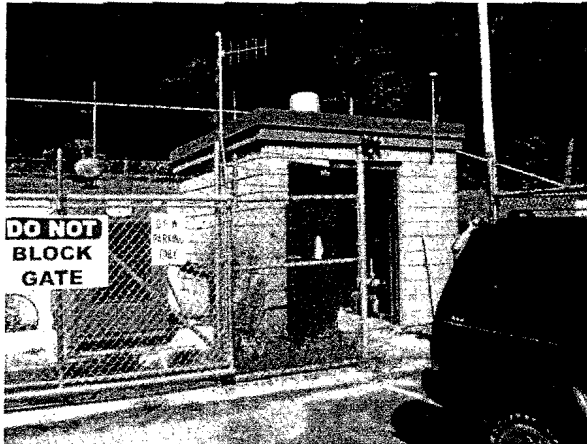
- Exterior: The building consists of textured masonry with aluminum trim in good shape. The rolled rubber roof is in fair shape with some seams lifting requiring patching-no leaks. Downspout disconnected from gutter and should be reattached.

Building

- Building rubber roofing should be patched.
- Building downspout should be repaired.
- Heating and ventilation on all levels within the building should be inspected by a licensed technician and repaired.

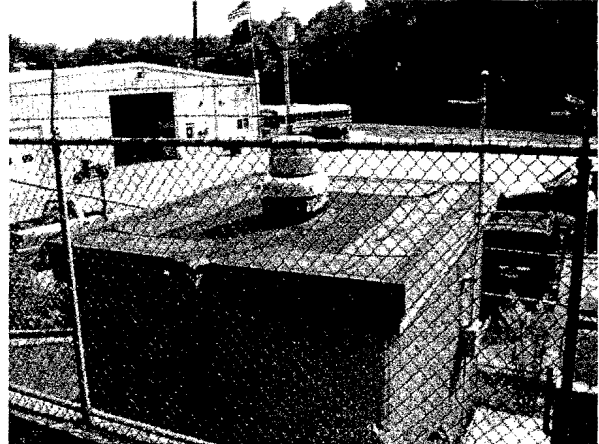
Building Roof

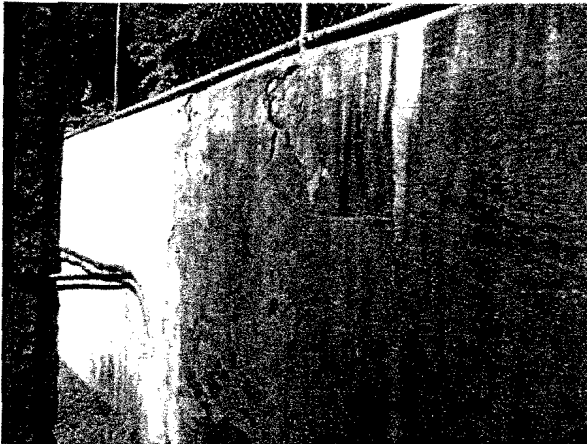
- Concrete slab: Slab over wet well and supporting generator in good shape with minor spalling observed.
- Asphalt: None
- Grounds: Pea Stone perimeter provides adequate surface drainage toward the parking lot, Concrete retaining wall in good shape with one area behind the building spalling and requiring patching.

Spalling Concrete Wall

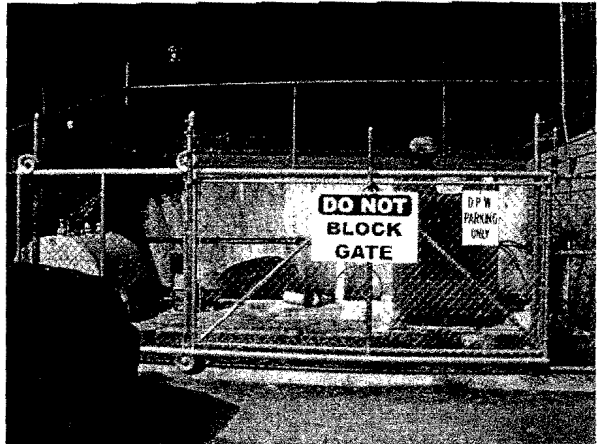
- Fencing and gate: Fencing in good shape with new roller gate providing access to the wet well for cleaning.

Fence Roller Gate

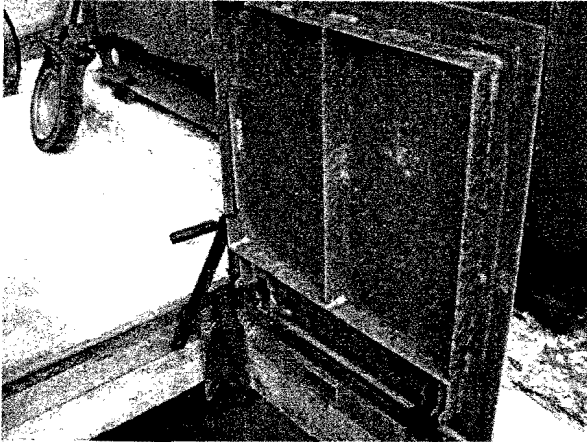
- Interior piping: Suction lines not visible.
- Aluminum hatch: Hatch in good shape but lift assist system rotted away and should be replaced.
- Level control system: Replaced to accommodate the digital SCADA System installed in 2009 consisting of a high and low float system with transducer level control.

Aluminum Hatch

- Lift assist/lock on aluminum hatch to wet well should be repaired.
- Repair the leaking seals on Pump #1. This might also be the time to rebuild again as 10 years have passed since the last rebuild. Replacing only the seals might require the removal of the pump and is recommended by Williamson, therefore a rebuild is recommended. Exact replacement of the pump is not an option because the pump manufacturer is no longer in business.

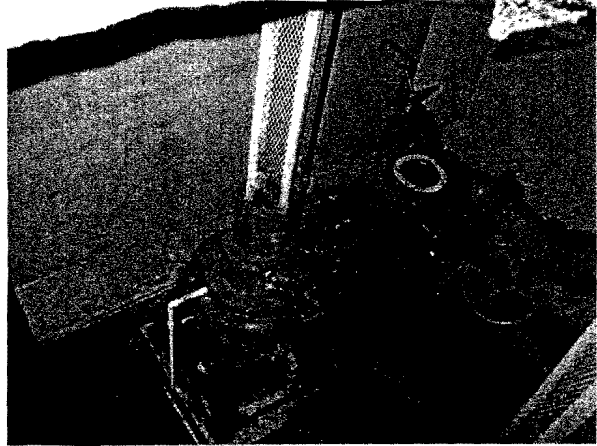
- Pump #1 Piping/Valving: No leaks observed and all functioning normally .
- Pump #2 Condition: Good condition. No leaks and pumping rate seems to be reasonable. Pump rebuilt and new style-mechanical pump seal and check valve installed in 2004. Pump rebuilt, mechanical seals replaced and driveshaft u-joints rebuilt in 2012.

- Pump #2 Piping/Valving: No leaks observed and all functioning normally

Pump #2/Valving

The pump manufacturer is no longer in business and exact pump replacement is not an option. Pump # 2 was rebuilt recently rebuilt for a second time in 8 years and pump #1 is now ready to be rebuilt for a second time in 10 years. The pump #2 was removed and brought to a Williamson's repair facility. Due to excessive wear of internal components, the pump required a major overhaul. The pump shaft required resleeving and boring, bearing and seal replacement; impeller trimming etc. By design, the pumps are not very serviceable in the field and require extensive work to remove from the lowest level of the station and then dismantle at a repair facility. The cost for this overhaul was approximately \$25,000. The pumps can only be rebuilt a limited number of times depending on the wear of the internal pump components and the sleeving and boring of components. Based upon this, our office recommends that the Town consider replacing the pumps in the near future which may require a major redesign of the pump system and/or station.

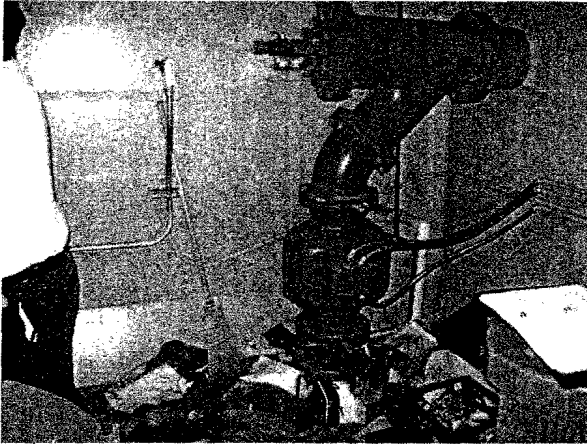
- Pump #1 and #2- Type and Size: Worthington Centrifugal Pumps located in the lower level and connected to by vertical driveshafts to 50 horsepower-460v-3ph- Westinghouse electric motors located on the second level.

2nd level-Electric Motors and Discharge Piping

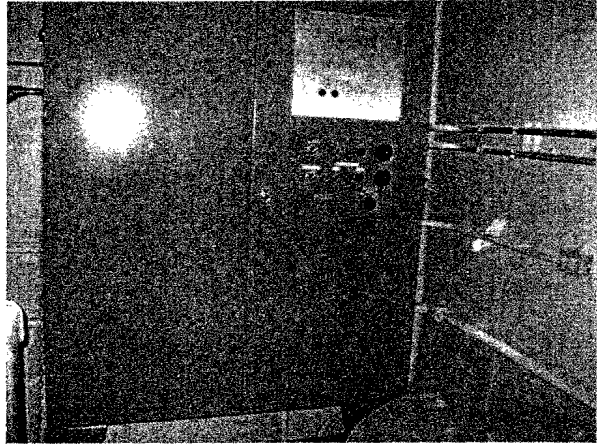
Pump Control Panel

- Flow meter and motor starter replaced in 2004. No major repair history. In 2009 a SCADA monitoring system and level control system were installed. The original station alarm system was incorporated into the SCADA system. There were false alarms indicated by SCADA system during inspection.

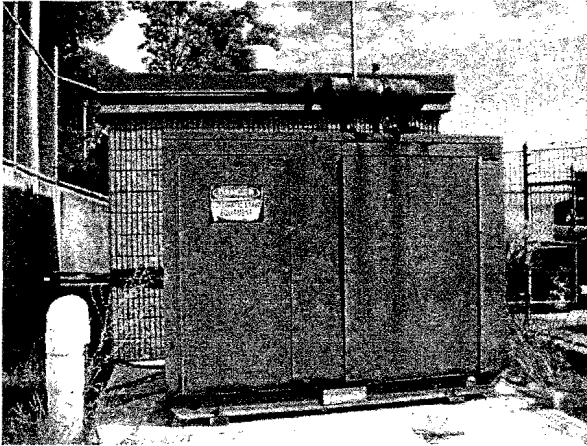
- Generator: 150KW - 277/480 - 3 phase - Diesel generator with 1065 hours and manufactured by Consolidated Power and serviced bi-annually. Above ground diesel storage tank installed around 2005.
- Condition: Exterior enclosure beginning to rust and could use repainting. New battery and charger installed during last servicing. Overall appears to be in good shape. Transfer switch located in pump station in good shape.

Generator
