GCG ASSOCIATES, INC.

October 21, 2014

RE: Union Street Sewer Repair  
Test Pit Results

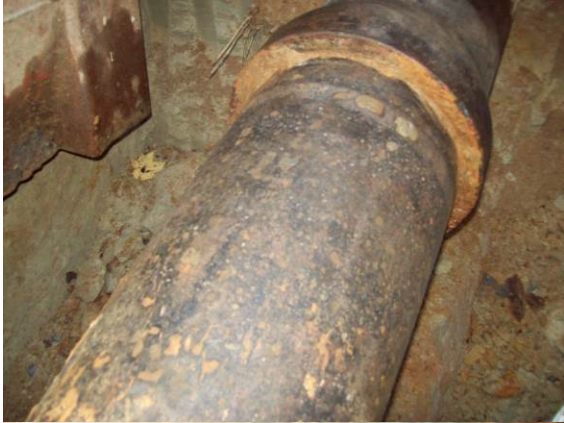
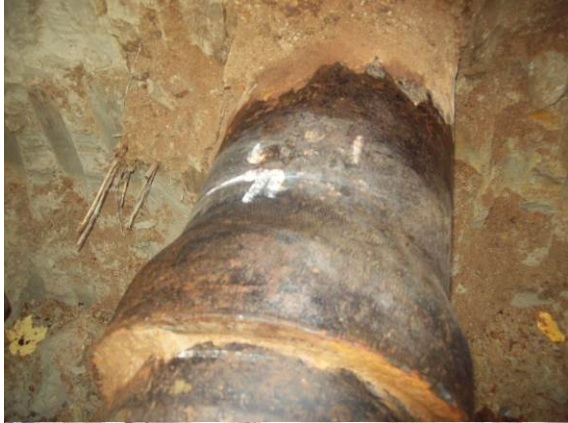
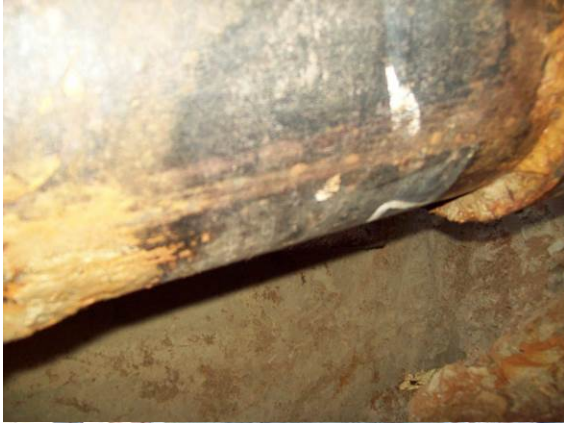
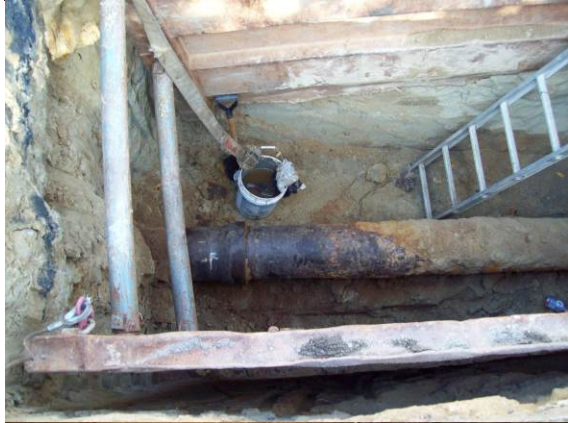
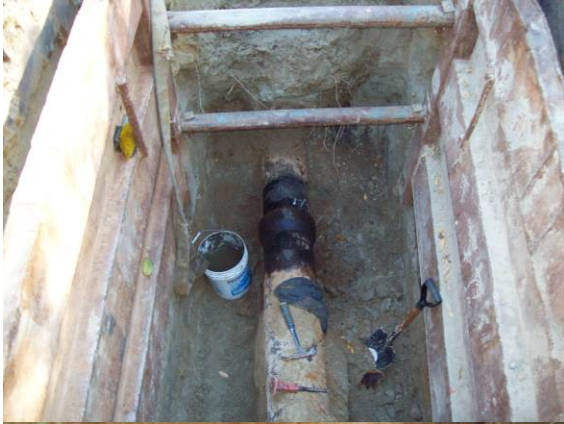
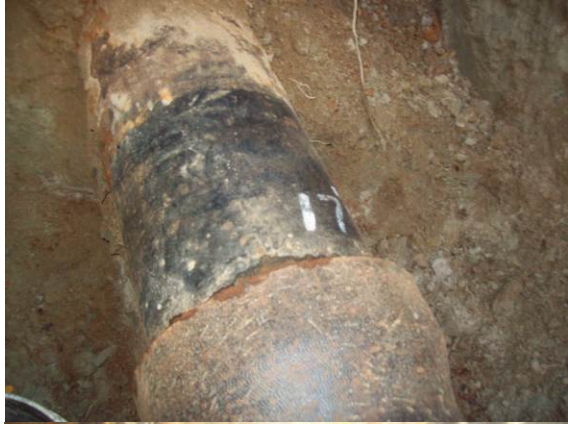
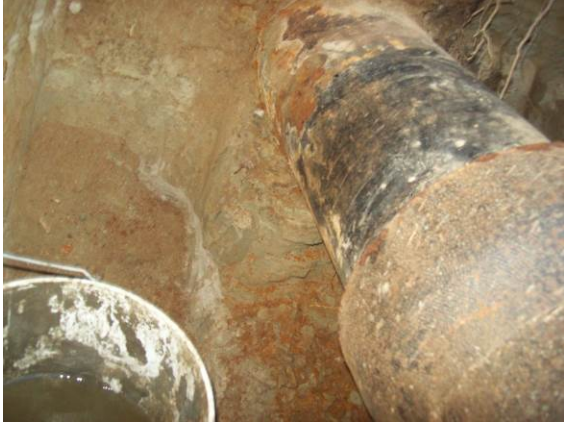
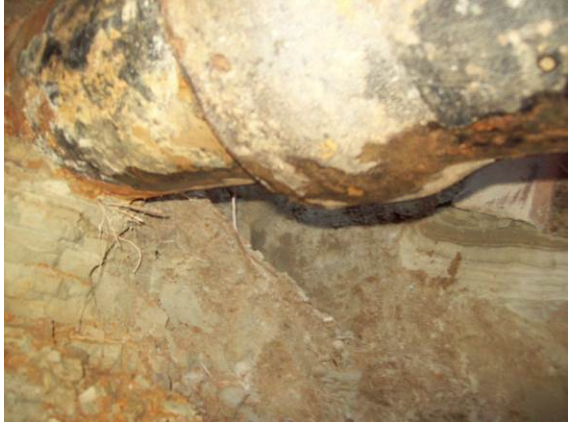
Within each test pit, the outside of each pipe was thoroughly cleaned and inspected for visible signs of corrosion. The pipe corrosion was not present, and therefore it was not necessary to take a soil sample from around the pipe for testing. GCG is of the opinion that the corrosion was local and due to a pipe joint that was most likely leaking from the day of installation and no additional investigation is required. The replacement of the affected pipe and the backfill material by the DPW during the last break has resolved the corrosion problem and the remainder of the pipe is unaffected. Normal and expected chipping of the asphaltic coating due to the removal of the mineralized soil coating on the pipe after approximately 25 years was observed as seen in the attached photos.
