Project 170970 – Millis Department of Public Works Garage Architectural Study

RE: Millis DPW Facilities, 7 Water Street, Millis MA

Assessment of Existing Conditions at the DPW Metal Garage

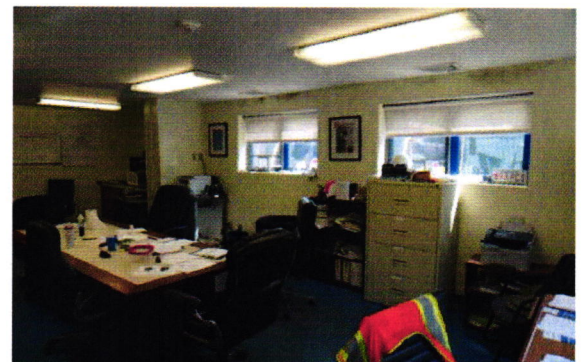
DPW Staff Office – note mold above windows

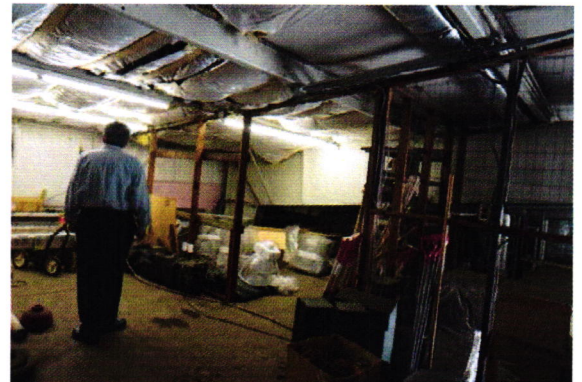
DPW Mezzanine Loft – note vapor barrier failures

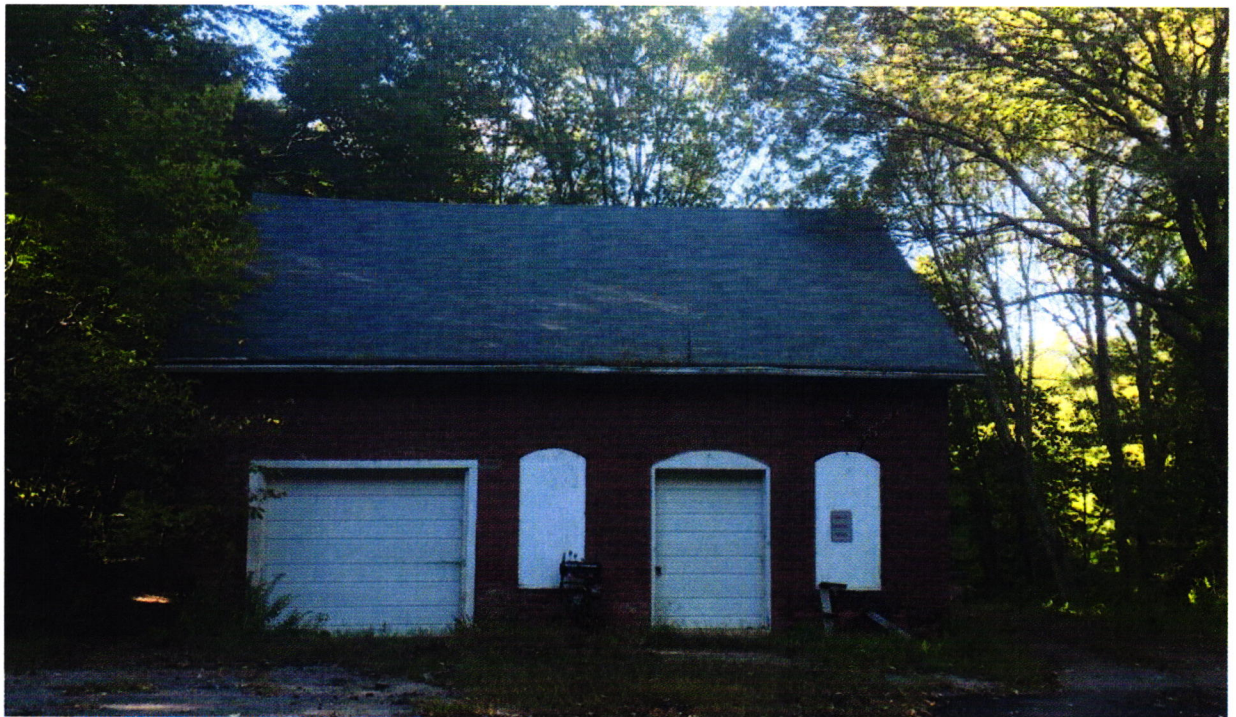
The asphalt shingled roofs intersect at a shallow valley with poor drainage, and masonry walls at this point are water damaged. Ceilings also show signs of water damage and deterioration. Roofing has exceeded expected service life; to stop further damage it should be replaced with new shingles and underlayment. Roof sheathing replacement might also be necessary, though this must be verified. A roof gutter on the south face is clogged with debris and has no apparent leaders or outlets. On the sides and rear of the building it appears that gutters and rain leaders were never installed, and the roof drains free from the eave which overhangs about one foot beyond the wall. Fascia boards, eaves, and eave soffits are deteriorated in places.

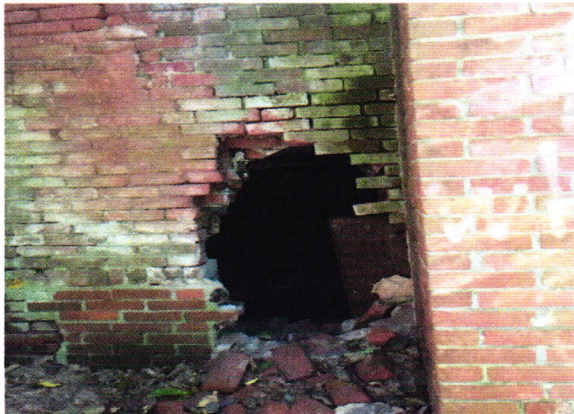
Masonry damage on Northwest wall

The brick garage can continue to be used as cold-storage with re-roofing and masonry repairs. For any higher use with human occupancy such as office, restroom or break space, the building should be gutted and rehabilitated and brought into compliance with the building code.

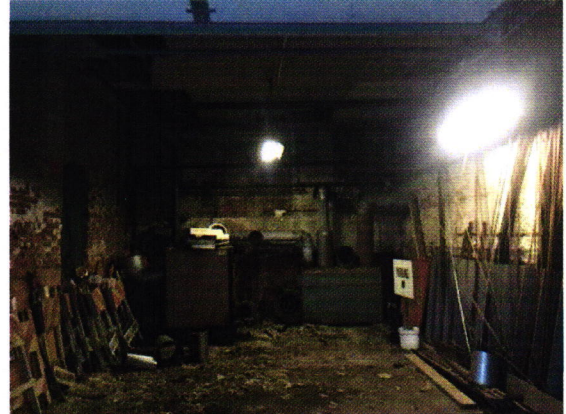
Interior finishes include concrete slab-on-grade floors, painted brick walls, and a failed plaster ceiling on the underside of roof truss cross-ties. All these surfaces were obscured by debris and stored DPW materials. Their condition and need for restoration and repair should be verified.
