**Municipal Buildings Strategic Plan  
Advisory Committee**

## Newtown Facilities Condition Assessment Report

JULY 20, 2015

# NEWTOWN FACILITIES CONDITION ASSESSMENT REPORT

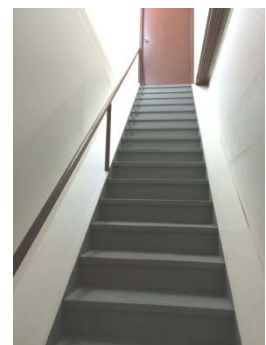
**2** Stair between Lower and Upper Levels has projecting nosings and only one handrail. There is also insufficient landing space at the bottom and top of the stair. This stair appears to be a service stair that is not used by other than the custodial staff but it does serve as an egress from what would otherwise be a dead end corridor. As such the stair needs to be upgraded to remove the projecting nosings by using beveled siding to create a gradual slope from the treads to the nosings. ADA compliant handrails need to be added on both sides. The bottom landing will need to be increased in size to allow for clearance space at the door. Similarly, the door at the top of the stair needs to be removed

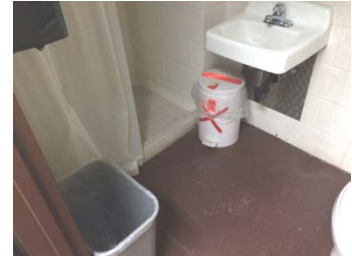
3 Shower room at cell area is not accessible for disabled persons. Redesign space to provide full accessibility to shower and fixtures.

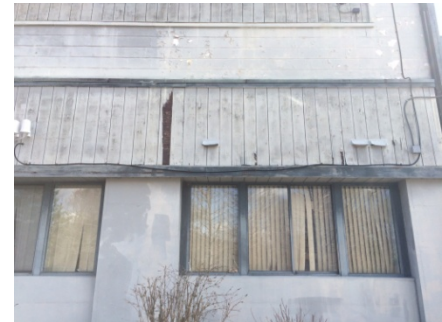
- 2 Exterior siding is deteriorating and is in need of replacement. The north and east sides of Texture 1-11 siding has been redone but the remaining two sides need to be replaced and painted.

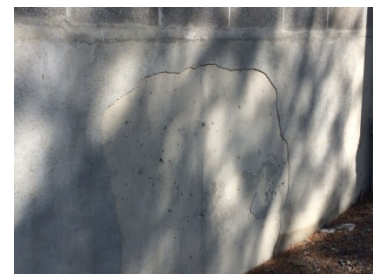
- 3 Parging is delaminating from concrete foundation wall. Remove loose material, apply bonding agent and re-parge exposed concrete areas.

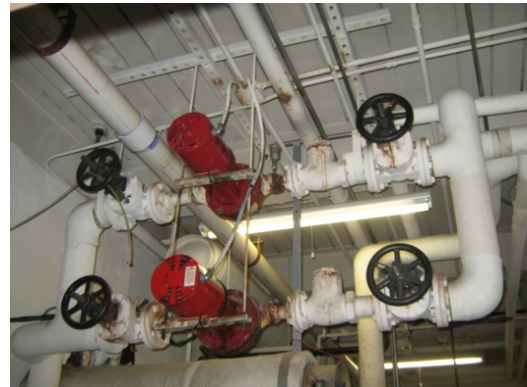
**Boiler Plant:** The building is heated by one Eighty Eight Series hot water boiler. The boiler is gas fired and reaching the end of its useful life. There are two pumps which provide redundancy in case one pump fails. The hot water system serves fin tube radiation and duct mound hot water coils. The hot water pumps are controlled by six temperature zones via electric relays. Recommend replacing the boiler with two high efficiency condensing boilers to provide redundancy and higher levels of energy efficiency (up to 95% versus current boilers with nominal efficiency of probably 75% to 80%). Replace hot water distribution and controls to provide more zones for energy efficiency and update controls to DDC type system.

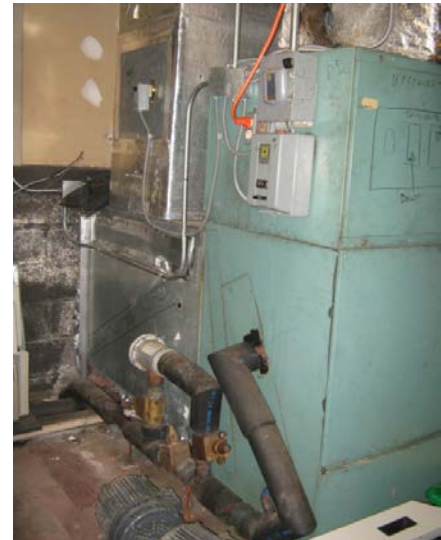
Most of the building is served by indoor mounted air handling units with remote compressor / condensers and duct mounted hot water coils. Most of the units are old are in fair to poor condition. Ductwork distribution to spaces below includes single zone hot water coils. "Local" air conditioning is also provided at specific areas with ductless split units. Temperature control system is via electric relays with electric actuated valves and dampers. Computer Operations Room needs improved air conditioning and ventilation. Recommend replacing air handling systems and replace and upgrade controls to web based DDC type system.

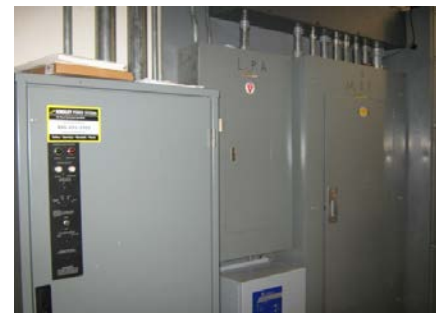
The building is served by a Square D distribution panel, rated at 400 amperes, 208Y/120 volts, 3-phase. The service equipment and main distribution panels are in good condition.

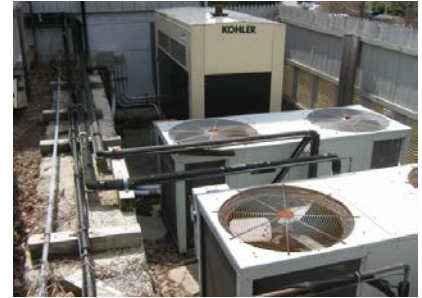
Emergency Generator: The generator is a 80 KW Kohler; gas fired generator and automatic transfer switch located inside; both are in good condition. Recommend upgrading electrical power distribution throughout the building with new local panels, new receptacles and wiring.

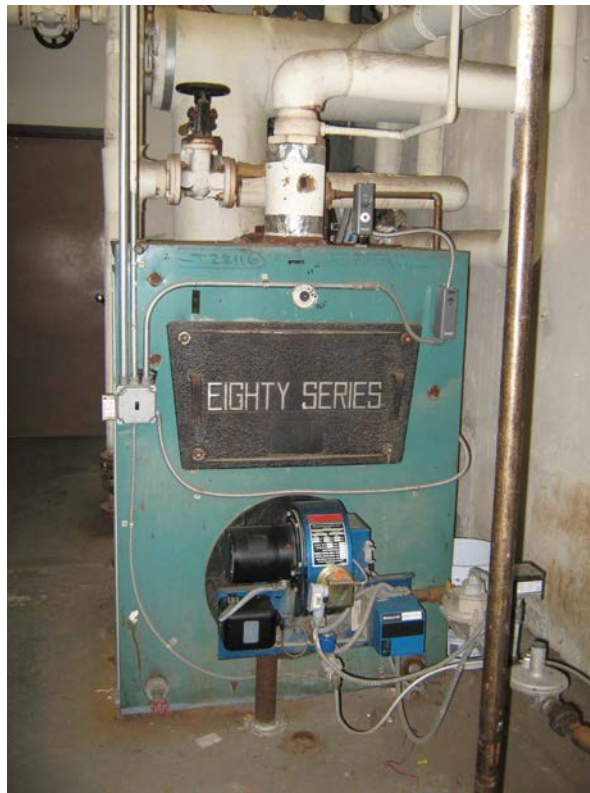
### HOT WATER BOILER

1. Boiler Plant: The building is heated by one Eighty Eight Series hot water boiler. The boiler is gas fired and reaching the end of its useful life. There are two pumps which provide redundancy in case one pump fails. The hot water system serves fin tube radiation and duct mound hot water coils.
2. The hot water pumps are controlled by six temperature zones via electric relays.

1. Replace the boiler with two high efficiency condensing boilers to provide redundancy and higher levels of energy efficiency (up to 95% versus current boilers with nominal efficiency of probably 75% to 80%). Replace hot water distribution and controls to provide more zones for energy efficiency and update controls to DDC type system.
2. Replace air handling systems.
3. Replace and upgrade controls to web based DDC type system.

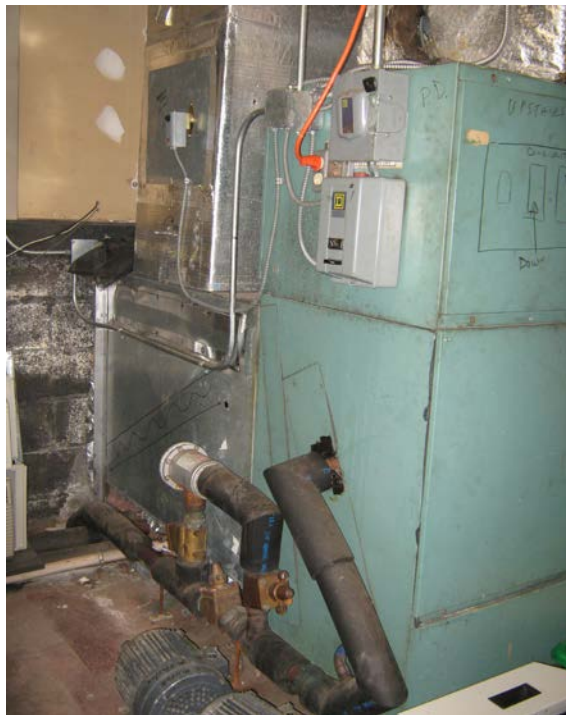
## **EXISTING AIR HANDLING SYSTEMS**

1. Most of the building is served by indoor mounted air handling units with remote compressor / condensers and duct mounted hot water coils. Most of the units are old and in fair to poor condition.

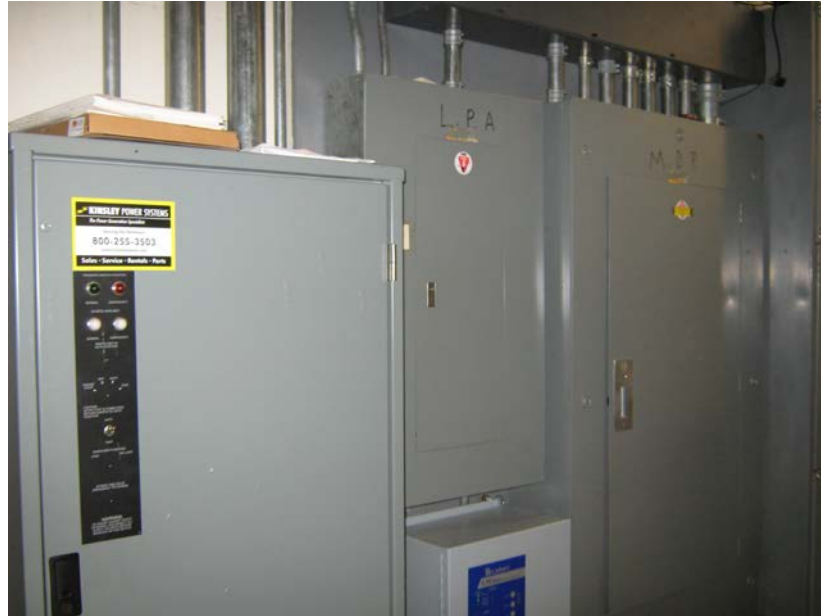
1. The building is served by a Square D distribution panel, rated at 400 amperes, 208Y/120 volts, 3-phase. The service equipment and main distribution panels are in good condition.

1. Upgrade electrical power distribution throughout the building with new local panels, new receptacles and wiring.
2. Replace lighting with new energy efficient fixtures and controls such as occupancy sensors and daylight harvesting. Where feasible, replace battery pack type emergency lights and re-circuit fixtures to be fed from the generator.
3. Replace and upgrade fire alarm system to an addressable system.

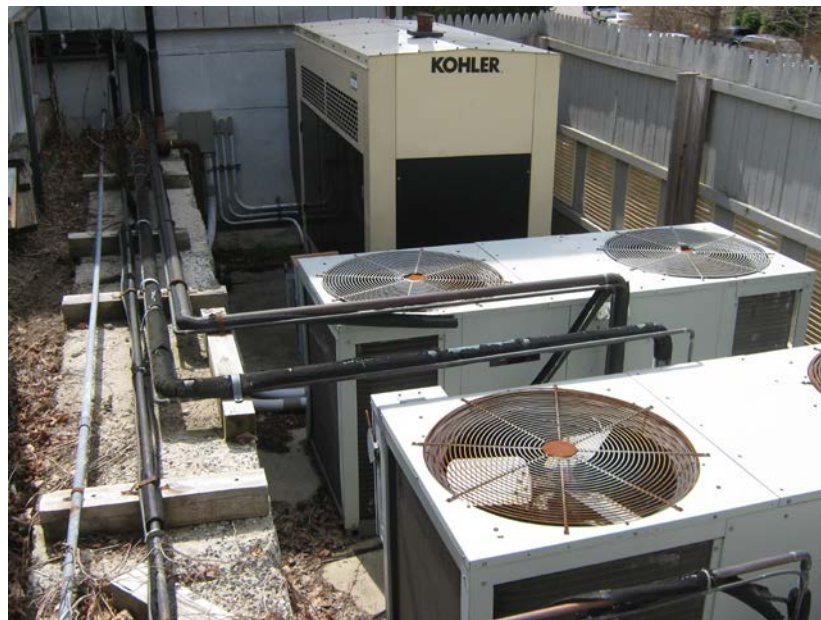
2. Emergency Generator: The generator is a 80 KW Kohler; gas fired generator and automatic transfer switch located inside; both are in good condition.

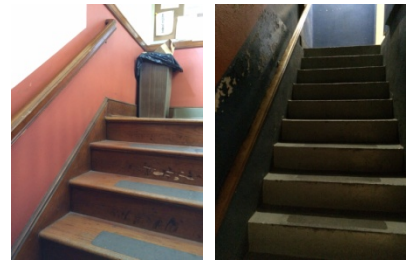
3 Rubber treads and risers should be added to concrete stairs to basement levels.

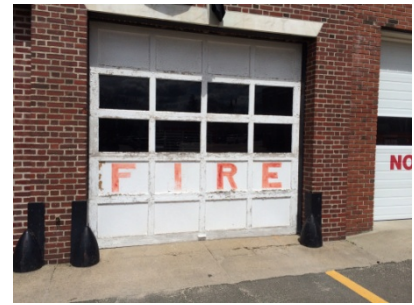
3 All wood windows, doors, overhead doors, plywood panels and wood trim have areas of peeling paint and bare wood is visible. Scrape paint down to solid material, and feather edges. Fill wood splits and holes. Repaint with a primer and two coats. Verify proper operation of all windows and doors and make necessary adjustments.

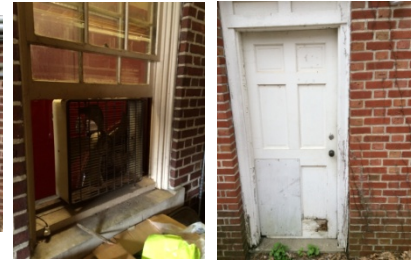
3 Replace exterior door from north addition.

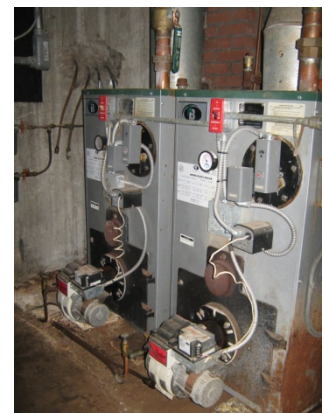
Boiler Plant: The building is heated by two (2) Peerless hot water boilers; each with nominal 350 MBH capacity. The boilers are fuel fired fed from a buried fuel oil tank outside the building. The buried fuel oil piping does not appear to be double wall. The boilers are in good condition. There are four (4) hot water pump zones controlled by local electric thermostats.

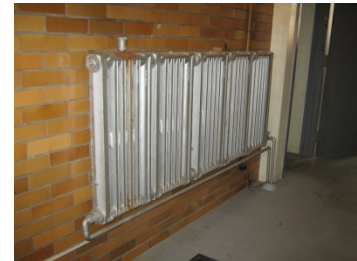
- 3 The hot water system serves unit heaters and cast iron radiators. The unit heaters are in good condition, the cast iron radiators are most original to the building and nearing the end of their useful life.

Recommend replacing cast iron radiators with fin tube radiation, Install air handling systems to provide mechanical ventilation. Install central air condition systems through new ducted units and/or ductless split AC units. Replace and upgrade controls to web based DDC type system.

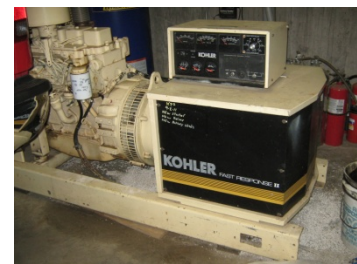
- 3 The building is served by General Electric distribution panels, service rated at 200 amperes, 208Y/120 volts, 3-phase. The service equipment and main distribution panels are in good condition. Emergency Generator: The generator is a 30 KW Kohler; fuel fired generator with day tank / pump set located inside the garage bay. The system is in fair condition.

Recommend upgrading Upgrade some of the electrical power distribution throughout the building with new local panels, new receptacles and wiring. Replace lighting with new energy efficient fixtures and controls such as occupancy sensors and daylight harvesting.

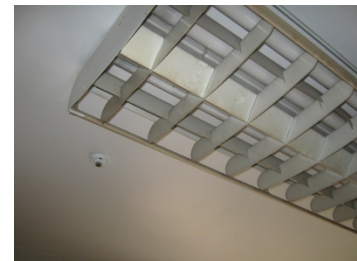
- 3 Lighting, in general, consists primarily of fixtures with T12 fluorescent lamps. Most of the fixtures are in poor condition and should be updated to more energy effacement lighting and controls. Emergency lighting is handled by an emergency generator. The fire alarm system is a FCI zoned system which is in fair condition.

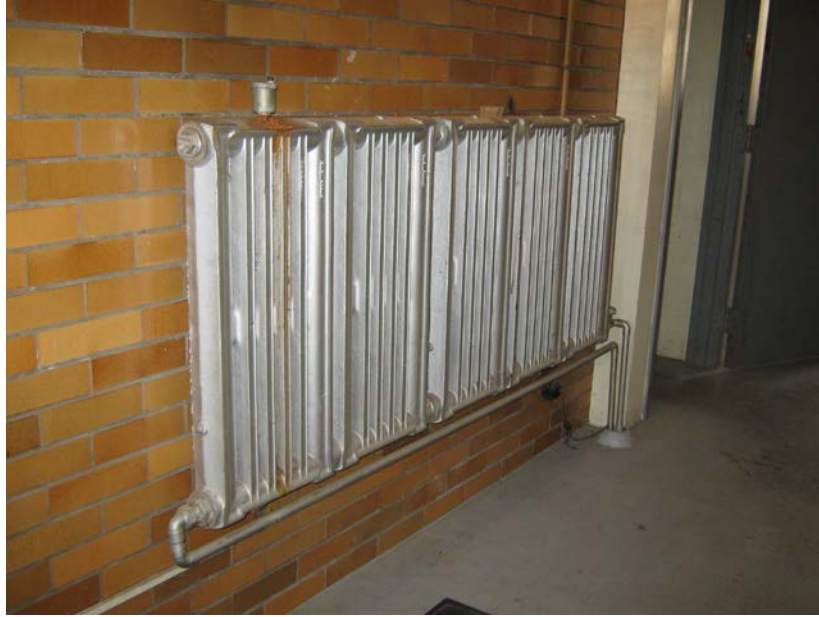
#### CAST IRON RADIATOR

3. The hot water system serves unit heaters and cast iron radiators. The unit heaters are in good condition, the cast iron radiators are most original to the building and nearing the end of their useful life.

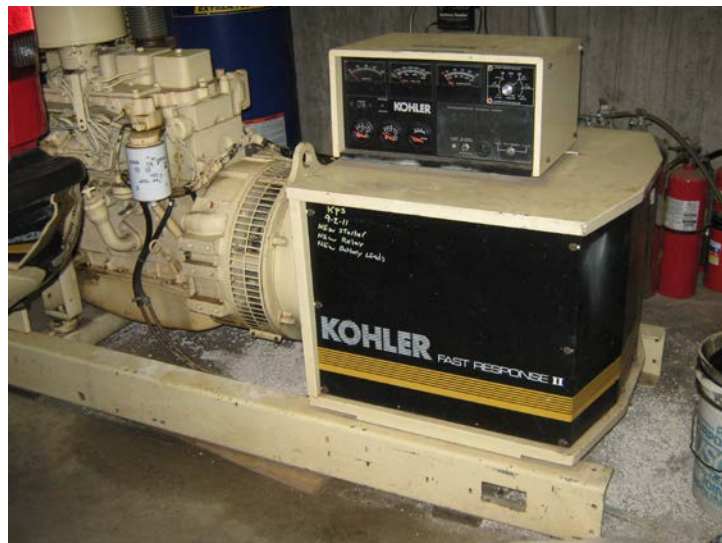
1. The building is served by General Electric distribution panels, service rated at 200 amperes, 208Y/120 volts, 3-phase. The service equipment and main distribution panels are in good condition.
2. Emergency Generator: The generator is a 30 KW Kohler; fuel fired generator with day tank / pump set located inside the garage bay. The system is in fair condition.

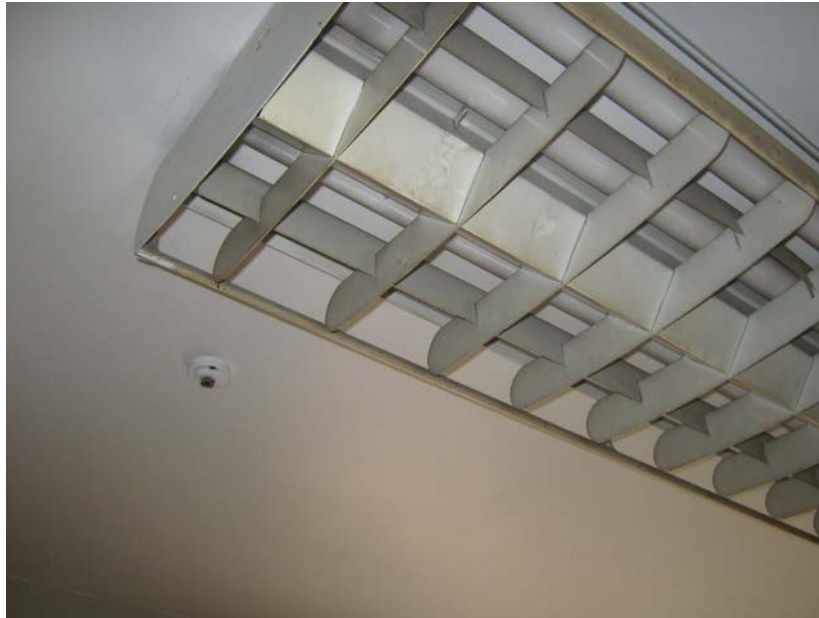
3. Lighting, in general, consists primarily of fixtures with T12 fluorescent lamps. Most of the fixtures are in poor condition and should be updated to more energy efficient lighting and controls. .

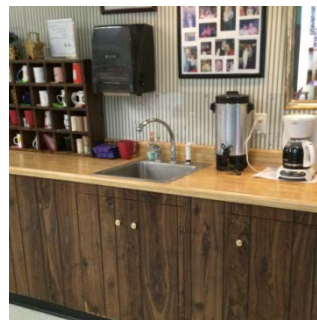
3 Sink and counter in Clinic and VNA Exam room (used for storage) are not ADA compliant. Change cabinets to provide knee space and replace sink.

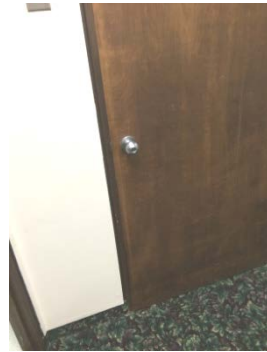
- 3 Doors throughout Senior Center building and Pre-school Area with the exception of the most recent 2010 additions (Sunroom, Workout Room and ADA restrooms) have knob sets but require lever sets for accessibility. Replace all knobsets with lever sets.

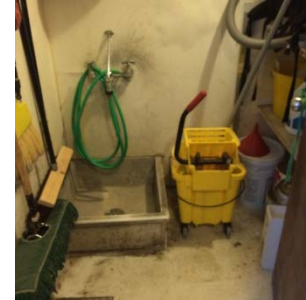
3 VCT in Janitors closet is dirty but in fair condition. Walls are in poor condition and need repainted. Clean or replace VCT and repaint all walls.
