ROOF EVALUATION REPORT

**PRINCETON TOWN HALL
(BAGG HALL)
6 TOWN HALL DRIVE
PRINCETON, MA 01541**

Date: August 23, 2015
NRC Project No. 150024

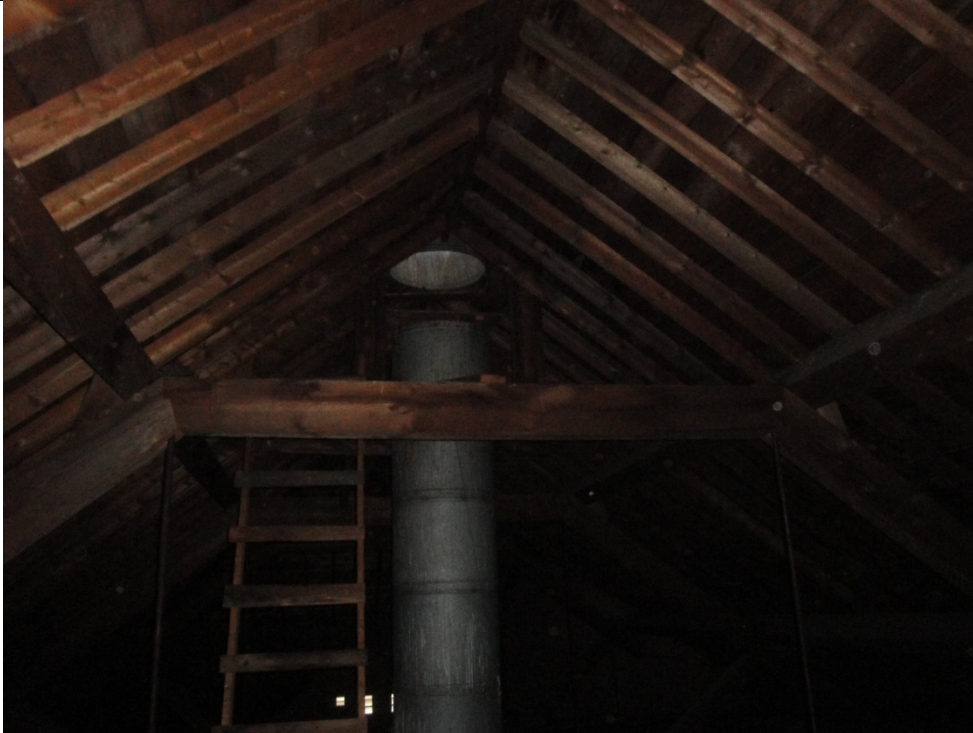
Photo R3
08/13/15
Photo Location:
Attic interior.

An inspection of the attic space revealed that the center cupola had unobstructed opening from the roof level into the exposed attic space. The roof over the cupola was the only covering preventing water infiltration into the attic. In addition, we noted previous water staining on the wood rafters and decking in select areas. Several of the wood rafters under and around the remaining chimney are badly cracked at this time. The top finished floor of the building had numerous water stains and interior damage throughout the ceiling and upper half of the interior walls.

Description:
Opening directly
below center
cupola over main
roof ridge line.

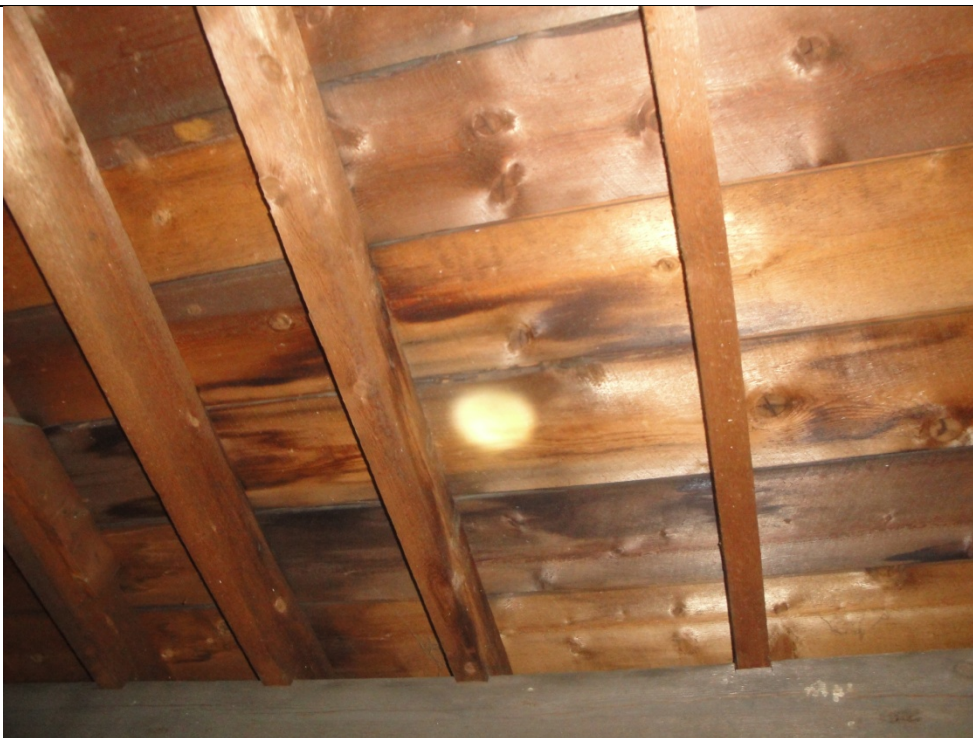
Photo R4
08/13/15
Photo Location:
Attic interior.

Description:
Old water stains on
existing wood
rafters below upper
main roof.

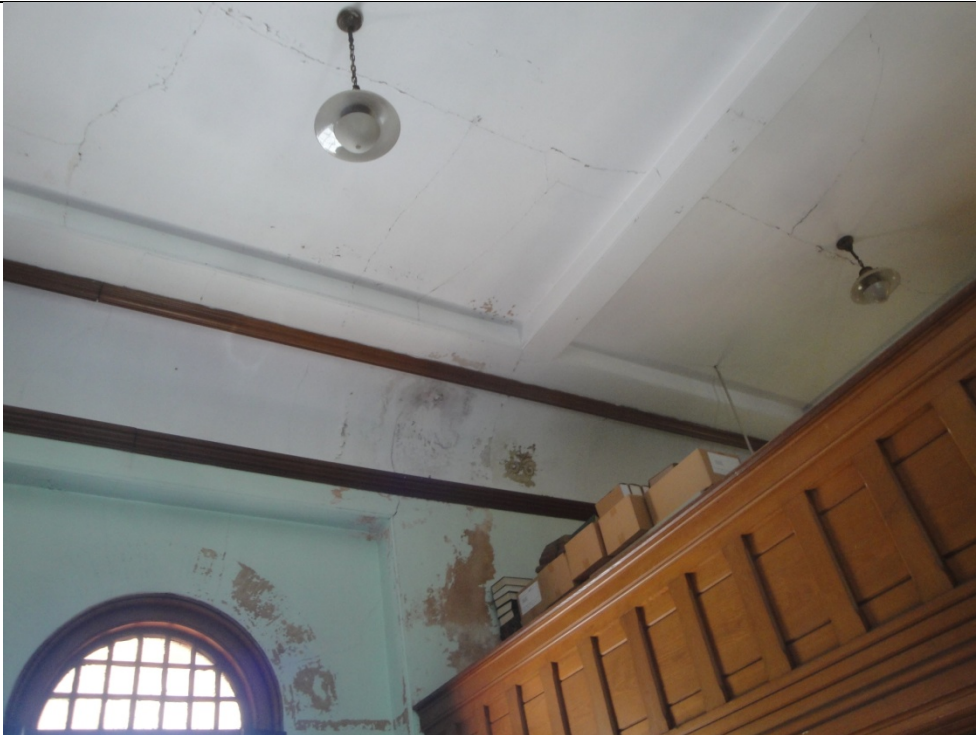
Photo R5
08/13/15
Photo Location:
Upper floor.

Description:
Peeling paint on ceiling and walls from roof leaks.

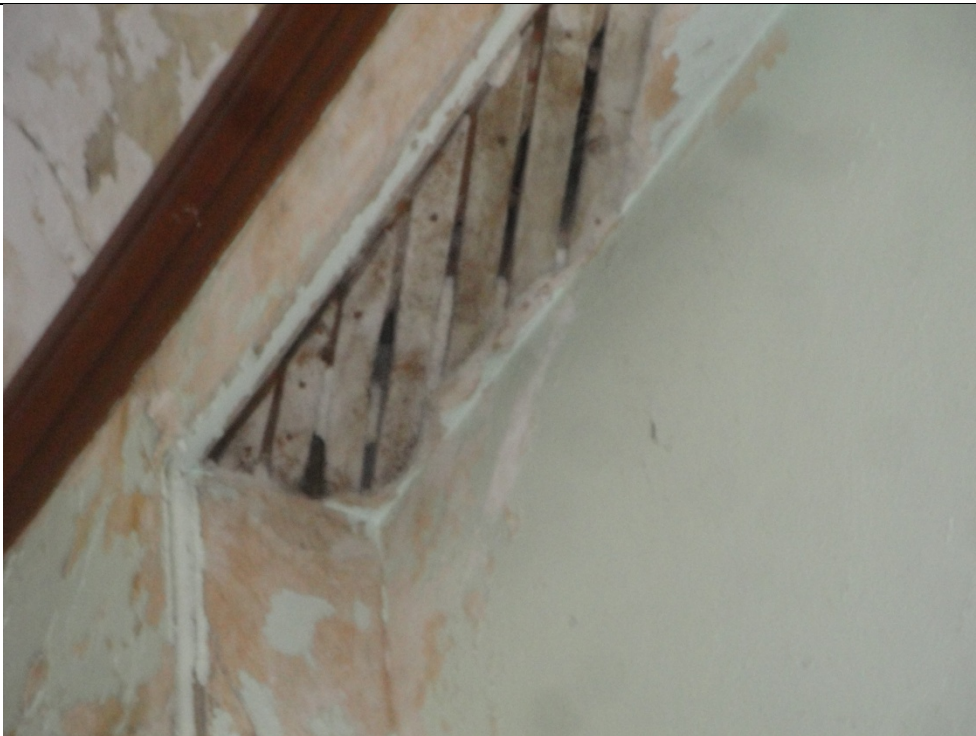
Photo R6
08/13/15
Photo Location:
Interior upper floor.

Description:
Water damage to plaster ceiling exposing wood lath.

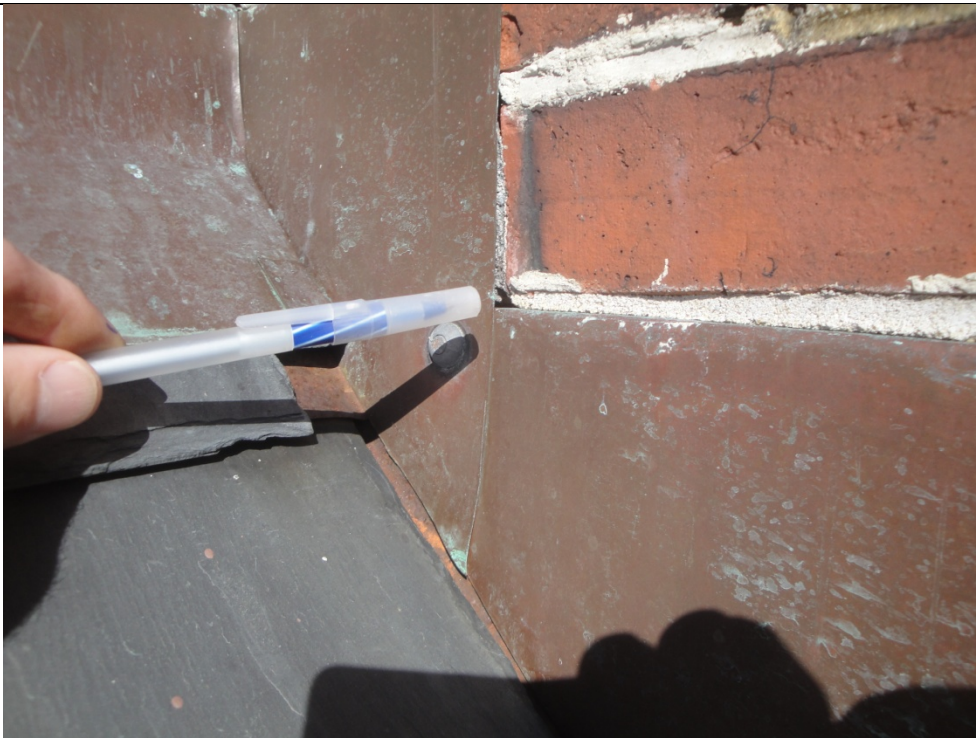
Photo R8
08/13/15
Photo Location:
Low front entrance
roof.

Description:
New red copper
counter flashing
and step flashing at
roof to wall
intersection. Note:
void in masonry
joint at new work.

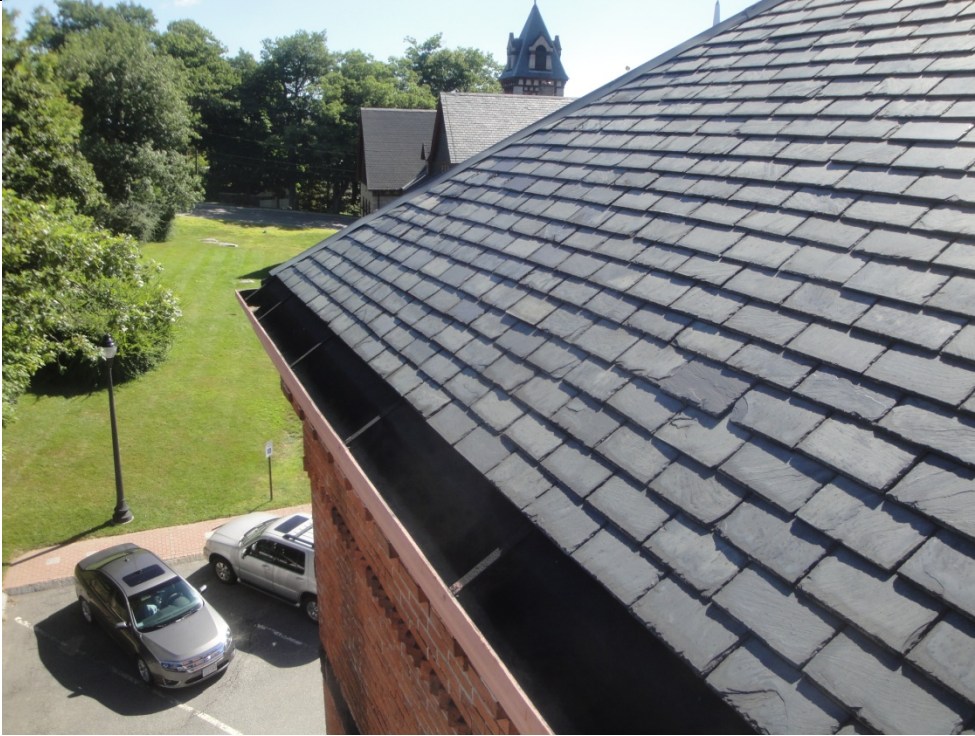
Photo R9
08/13/15
Photo Location:
Upper main roof
northwest
elevation.

Gutter and Down Spouts: Although portions of the gutter have been recently replaced with new copper hanging gutters, the majority of the gutters are aged and in need of future replacement. The gutters have been coated with an asphaltic based coating to extend the useful service life. Sections of the gutter were holding water on the day of the inspection. Several of the down spouts were found to be severely corroded where they intersect the bottom of the gutter. This may be due to ice formation during winter or the use of dissimilar metals, which can accelerate corrosion of the metals.

Description:
View of existing
hung gutter at base
of slate roof.

The gutters and down spouts are nearing the end of their useful service life and should be replaced over the next few years or as budget allows. Replacement of the hung gutter will require removal of the first few courses of slate to expose the gutter strap fasteners. Once the old gutters are removed a new gutter can be installed. The new attachment method can vary from the original, unless the local historic commission is involved. Once a new gutter design is accepted, replacement of the cant, eave slate and new drip edge can be completed.

2. Replace existing hung gutter as follows: Remove several courses of existing slate to expose gutter strap fasteners. Once exposed remove existing gutter, straps and down spouts. Install new wood cant along edge of roof and new copper drip edge. Strip in flange of drip edge with strip and ice and water shield. Install new 20 ounce red copper hung gutter and hook back of gutter to drip edge. Install gutter spacers as required. Secure and attach new down spouts in original locations. (Gutter attachment must not only take the weight of the gutter, but any loads associated with snow and ice.)

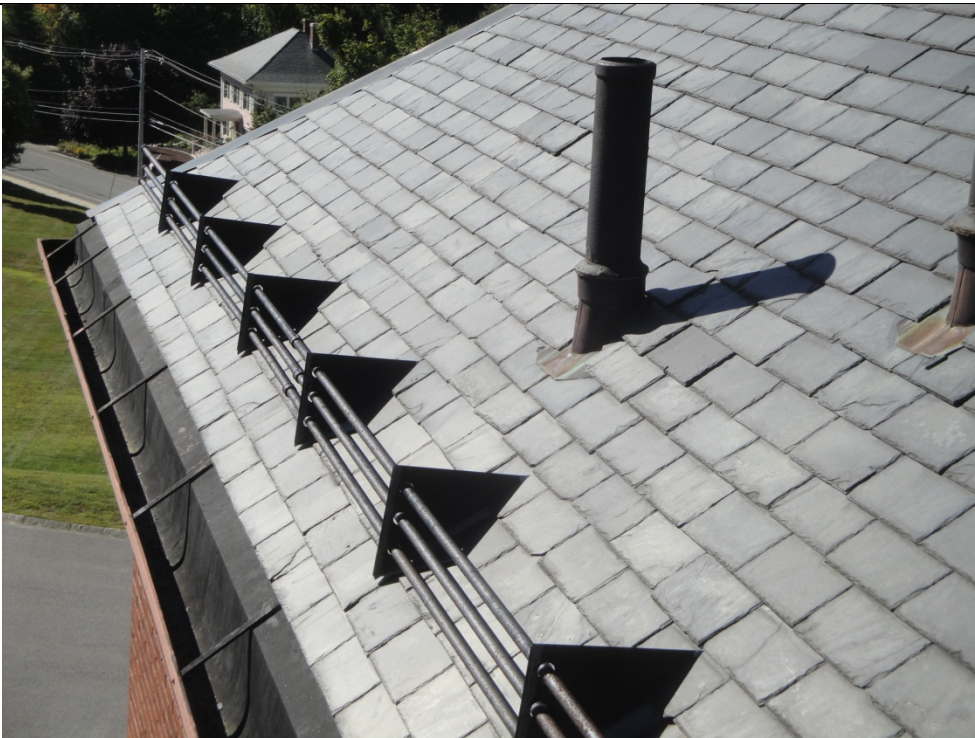
Photo R10
08/13/15
Photo Location:
Northeast
elevation.

Description:
Existing snow
fence along edge of
slate roof over
parking area. Note:
two plumbing vents
with copper cone
flashing above
snow fence.

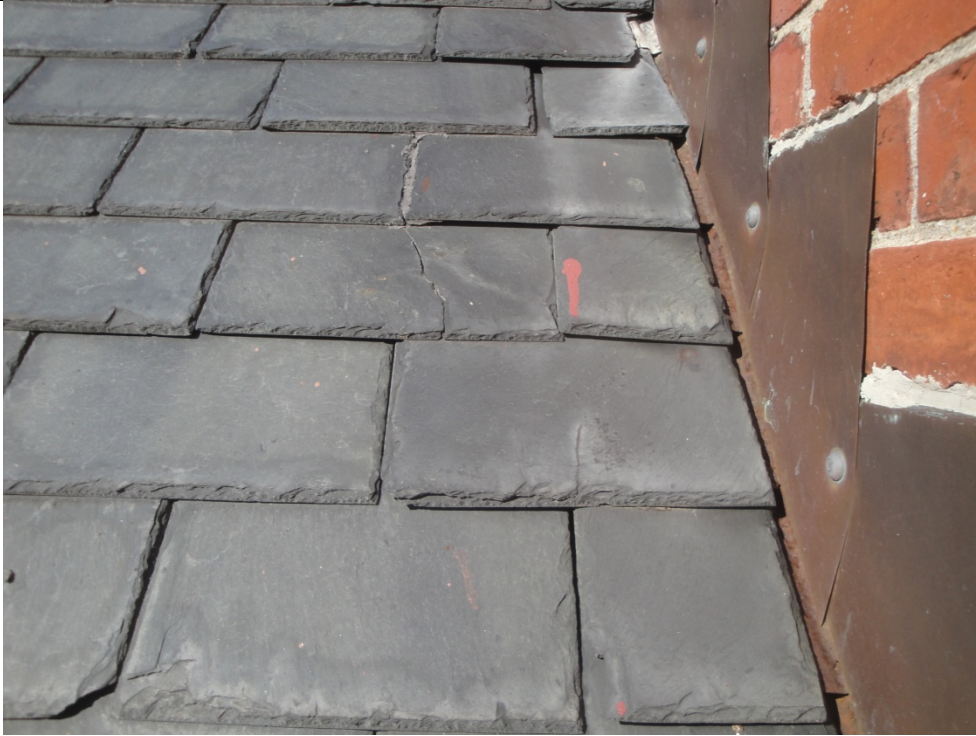
Photo R11

Cracked slate adjacent to new copper flashing. Most likely caused by installers of new copper flashing.

Damaged or loose slate should be removed using a slate ripper. Loose slate that are still in acceptable condition may be reused. Slate should never be turned over and reused in the fashion. New slate should be secured with one of two methods: the nail and copper bib, or using a slate hook. The bib method allows for the replacement slate to be slid back into the void where the broken slate was removed. A copper or stainless steel nail is driven between the vertical joint of the two slate above. A copper bib (small piece of sheet metal) is slid into place over the top of the repair slate and under the slate that form the vertical joint. The top of the bib is often folded to hook over the top of the repair piece. Sealant should be applied over the head of the nail before the bib is applied. A slate hook is generally 3 inches long and nailed through the vertical joint in the underlying slate. The replacement slate is slid in place and the butt of the slate will rest on the hook. Heavy wire and nails are also an acceptable alternative to the slate hook. Only copper or stainless steel nails are recommended.

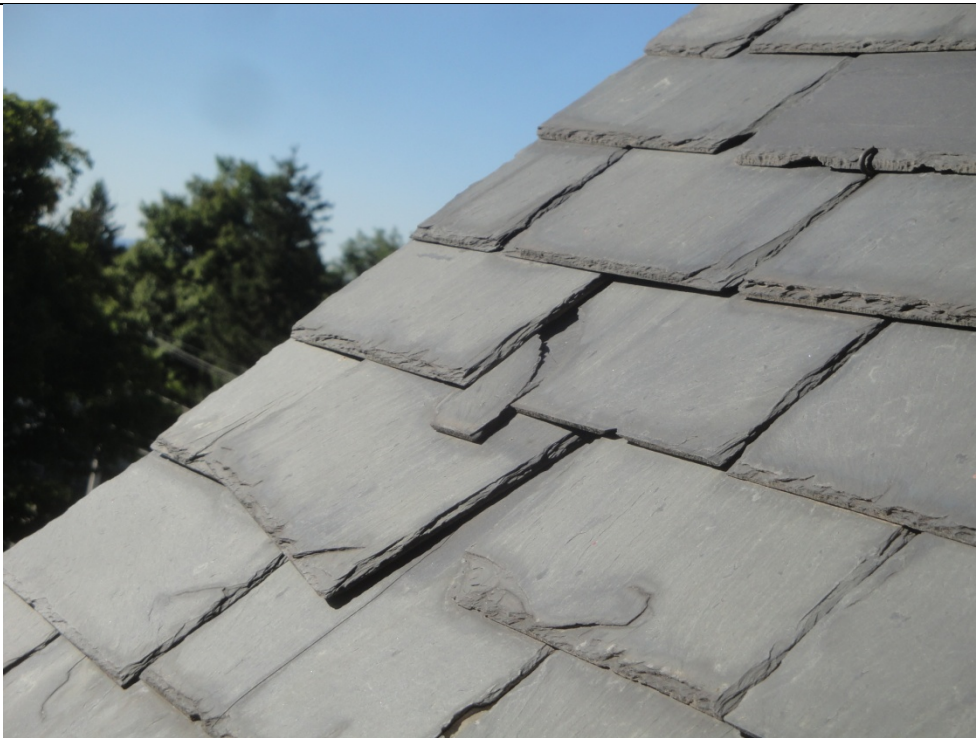
Photo R12

Broken and loose slate along rake edge of roof.

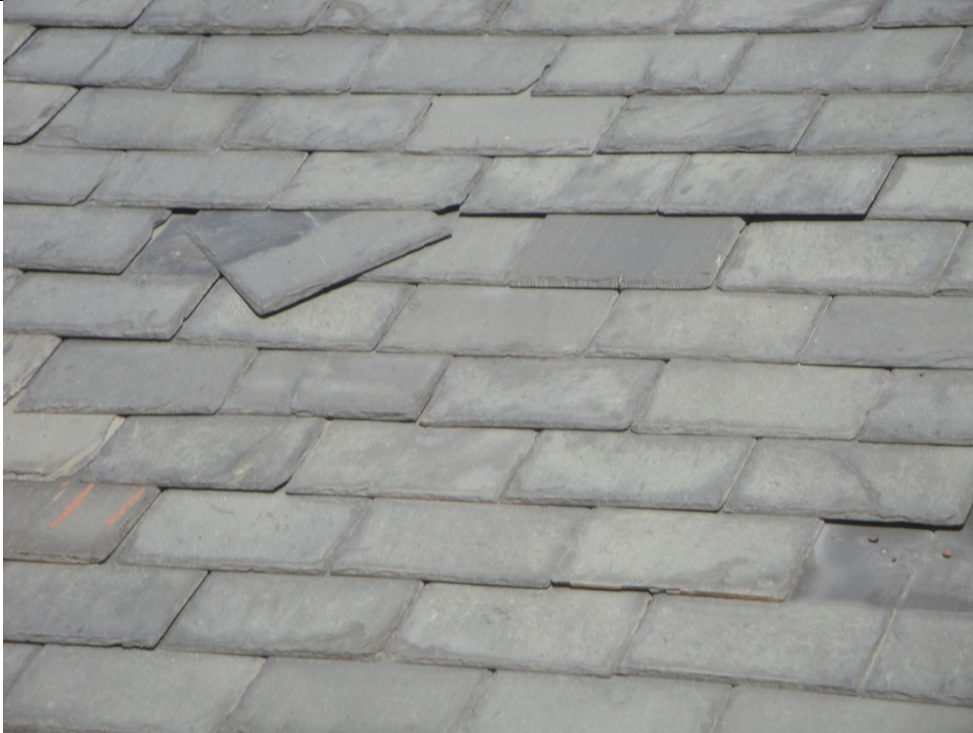
Photo R13

Loose slate in field of the roof.

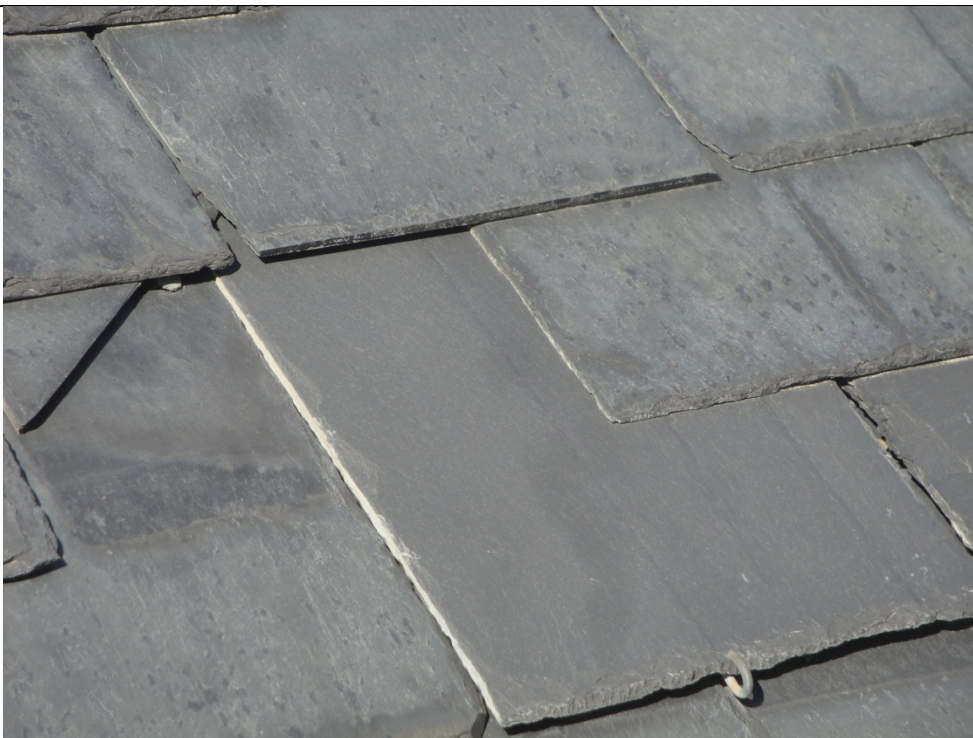
Photo R14

Broken slate adjacent to replaced slate.
Note: Bottom of slate hook visible at butt end of slate.
Adjacent slate most likely caused by replacement of underlying slate.

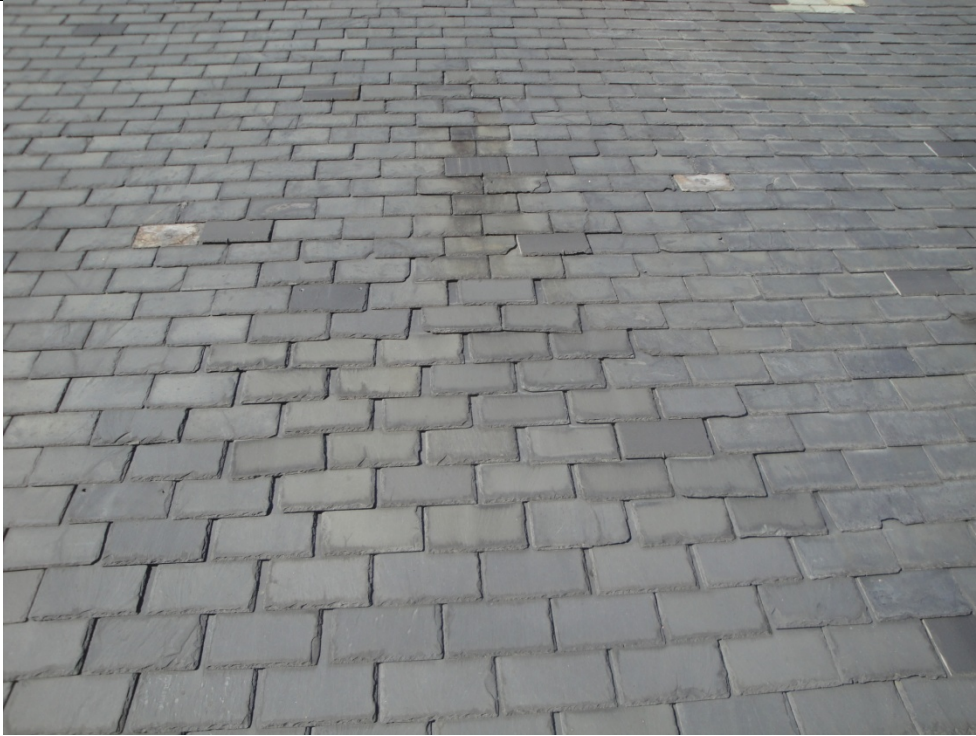
Photo R15
08/33/15
Photo Location:
Upper main hip
roof.

Description:
Large area of
replaced slate.
Note: Use of slate
smaller than
original does not
provide adequate
coverage of
underlying slate.

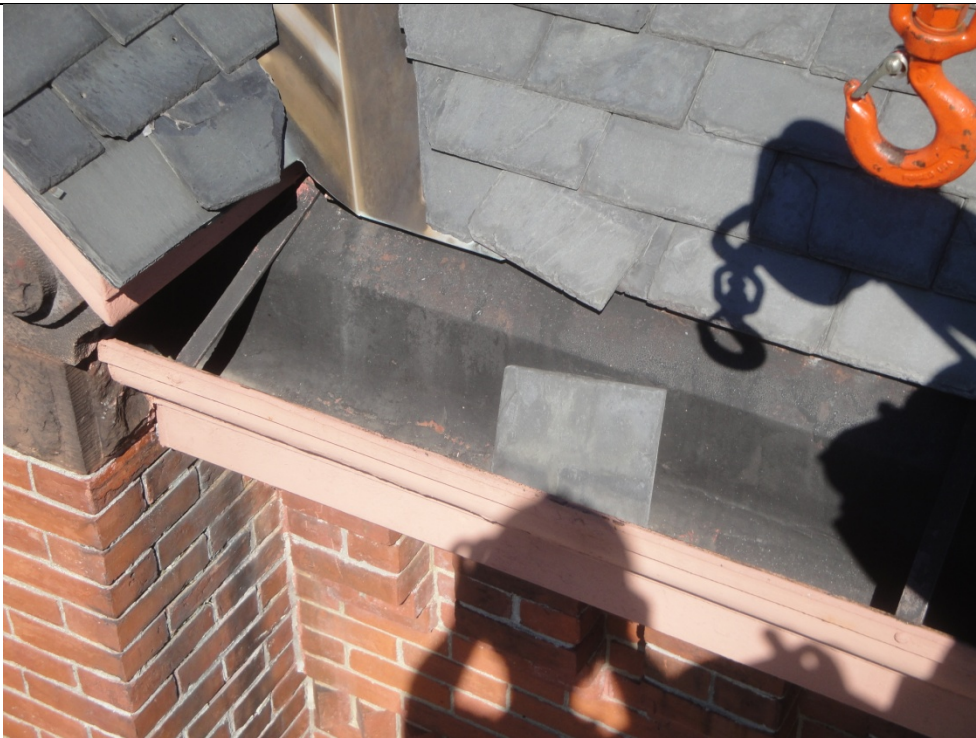
Photo R16
08/13/15
Photo Location:
Valley of front
dormer roof.

Description:
Loose slate at base
of copper valley
flashing. Note:
broken slate from
above caught in
gutter.

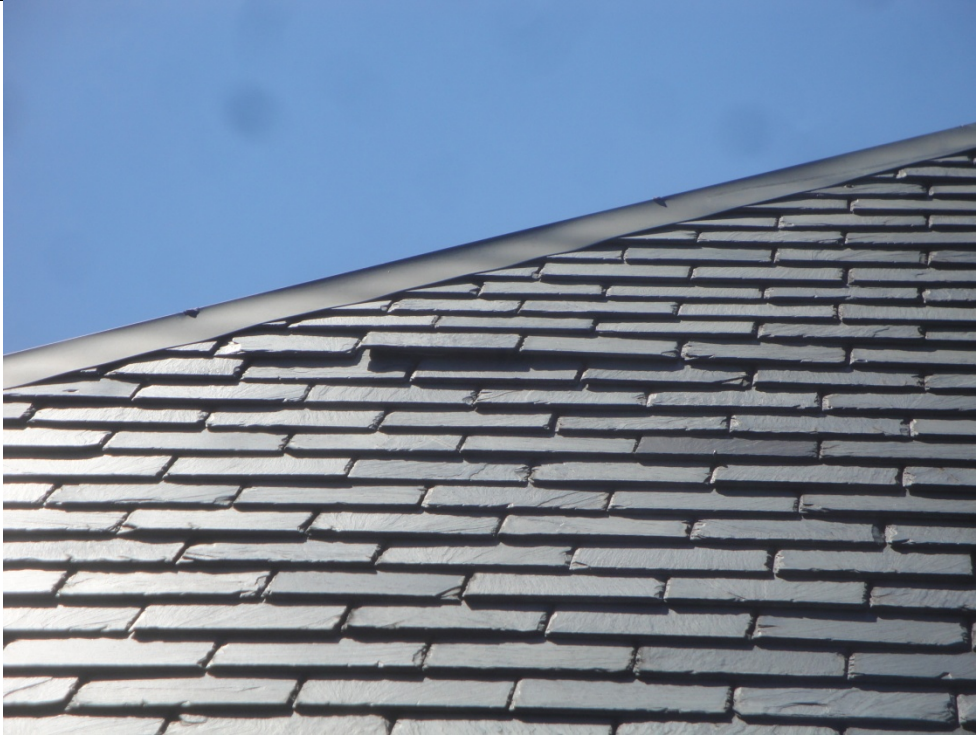
Photo R17
08/13/15
Photo Location:
Upper main hip
roof.

Description:
Lifting slate along
hip line of main
roof. Underlying
nail may not have
been set properly.
These slate are
likely to break in
time.

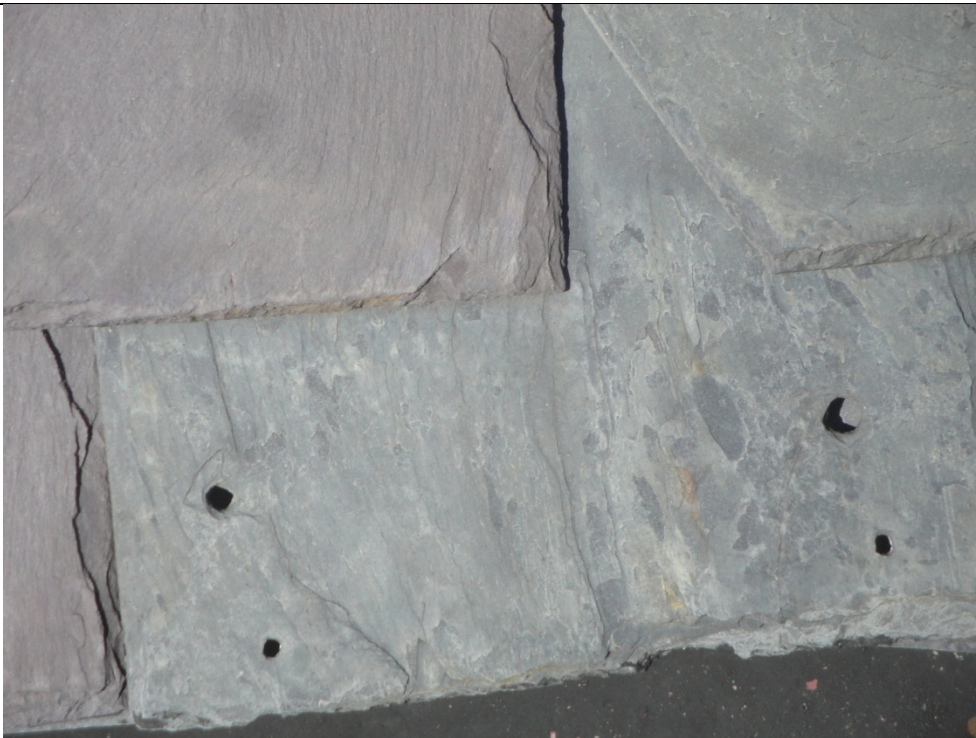
Photo R18
08/13/15
Photo Location:
Upper main hip
roof.

Description:
Slate installed
upside down with
pre-punched holes
exposed to the
weather.

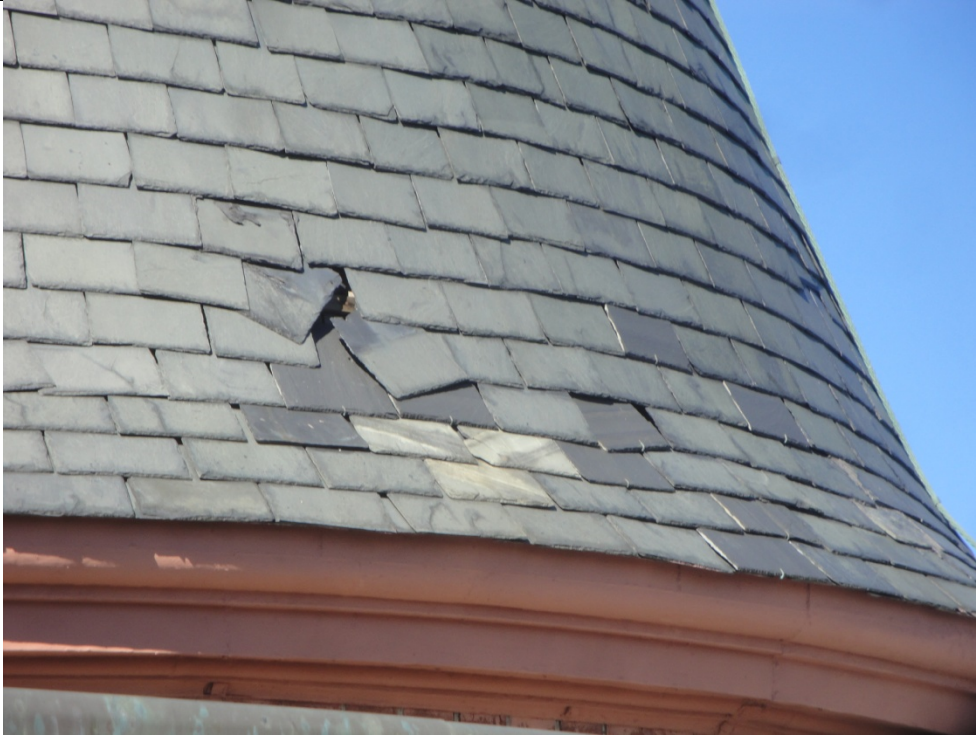
Photo R19

Numerous loose slate at curve in steeple roof. Longer nails required to conform to curved section.

Repairs to the upper main roof could be done by utilizing hook ladders and planks as necessary. This would distribute the weight of the roofers and prevent additional damage to the slate roof by walking on the slate. Work on the steeple roof will require either staging or the use of a lift/ bucket truck. In areas where multiple repairs need to be done slate roof scaffolding brackets may be necessary.

For budgetary purposes, repairs to the steeple roof are estimated at \$15,000. This is based on 75 slate @ \$200 per slate. This covers materials, shipping, access and insurance.

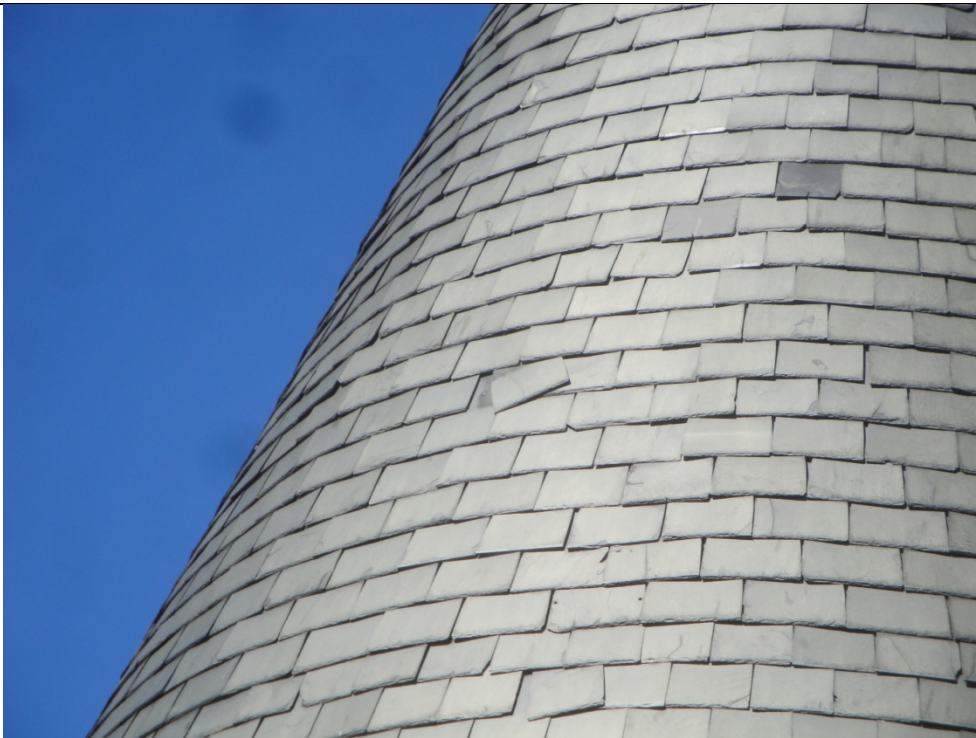
Photo R20

Loose slate in upper middle section of steeple.

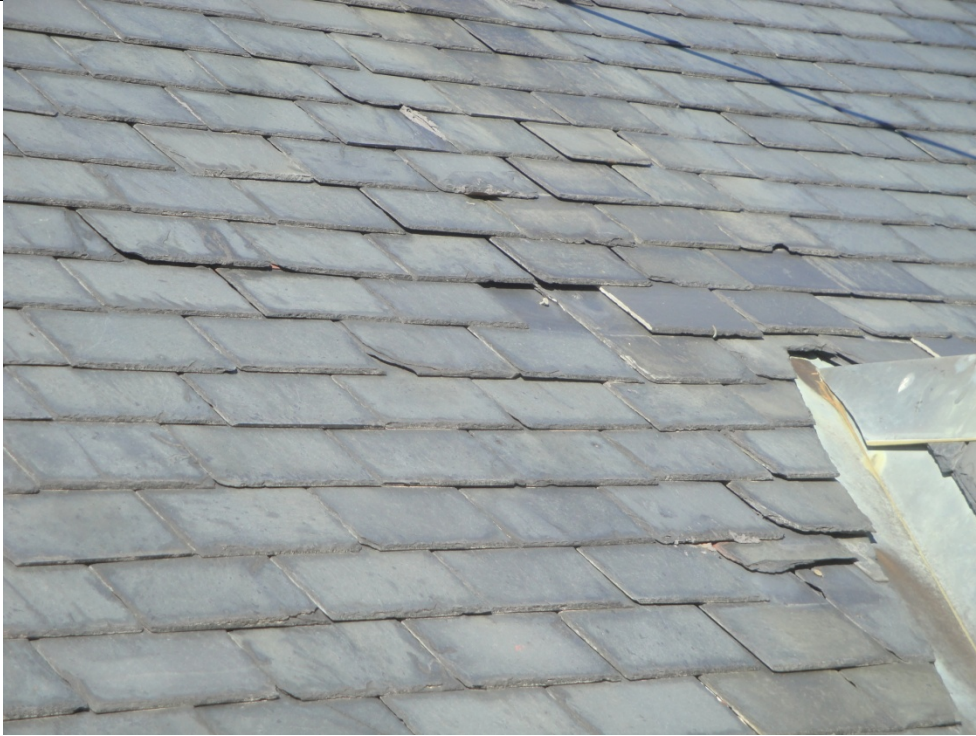
Photo R21
08/13/15
Photo Location:
Upper main hip roof.

Description:
Slate around new cricket flashing poorly installed.

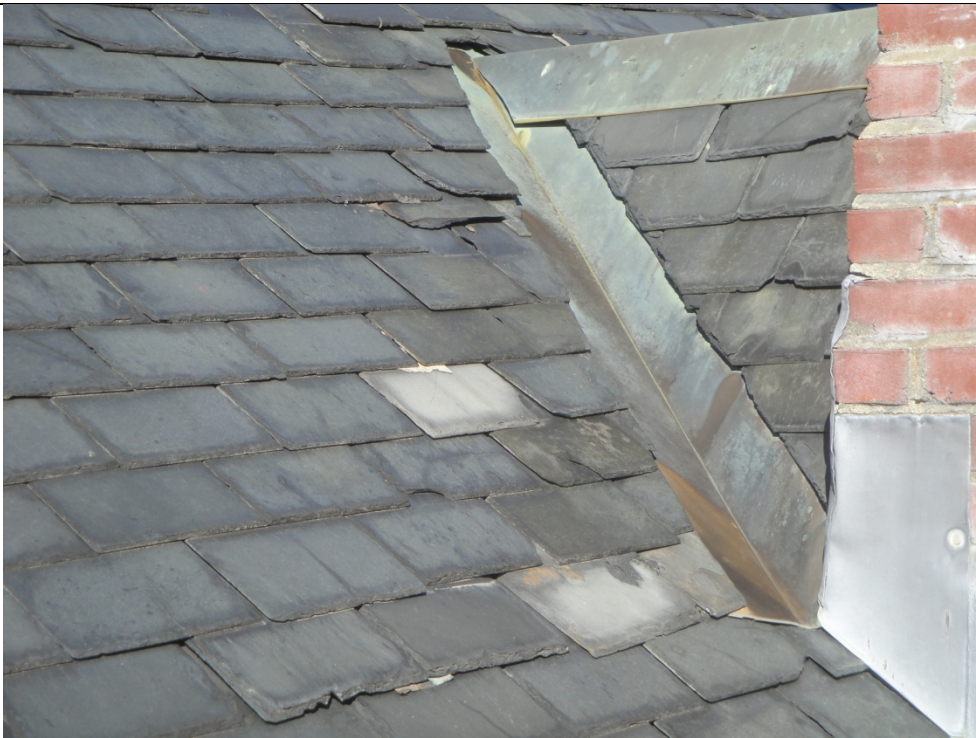
Photo R22
08/13/15
Photo Location:
Upper main hip roof adjacent to remaining chimney.

Description:
Poorly matched slate and poorly installed slate around chimney repair.

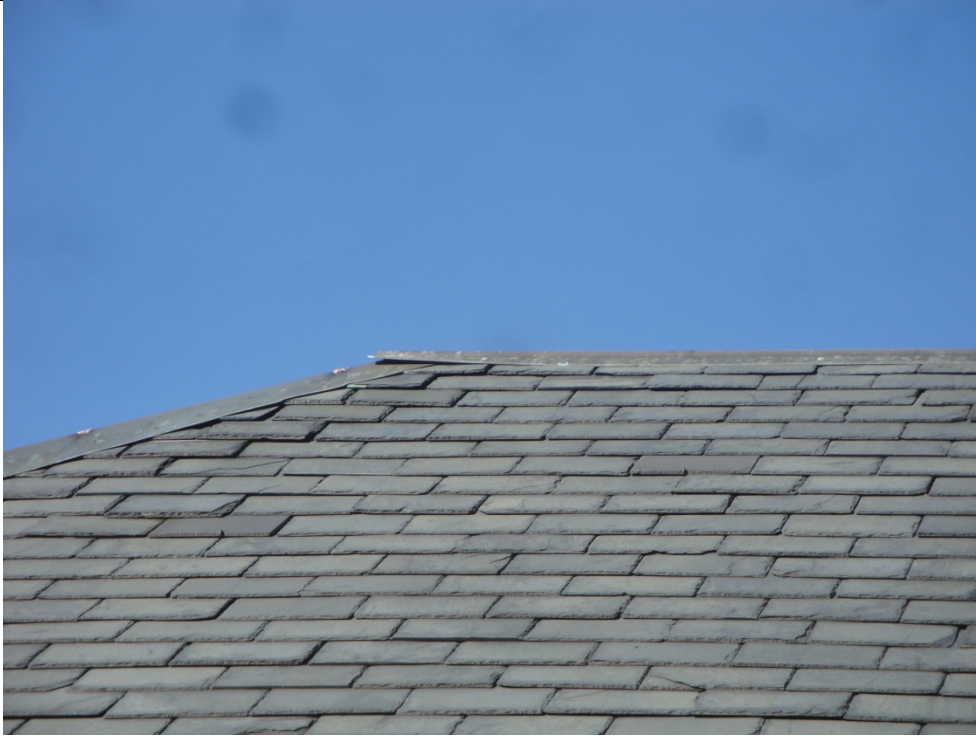
Photo R23

Lifting ridge cap at end of ridge line. Heavy winds can lift cap even high and allow wind driven rain under the cap.

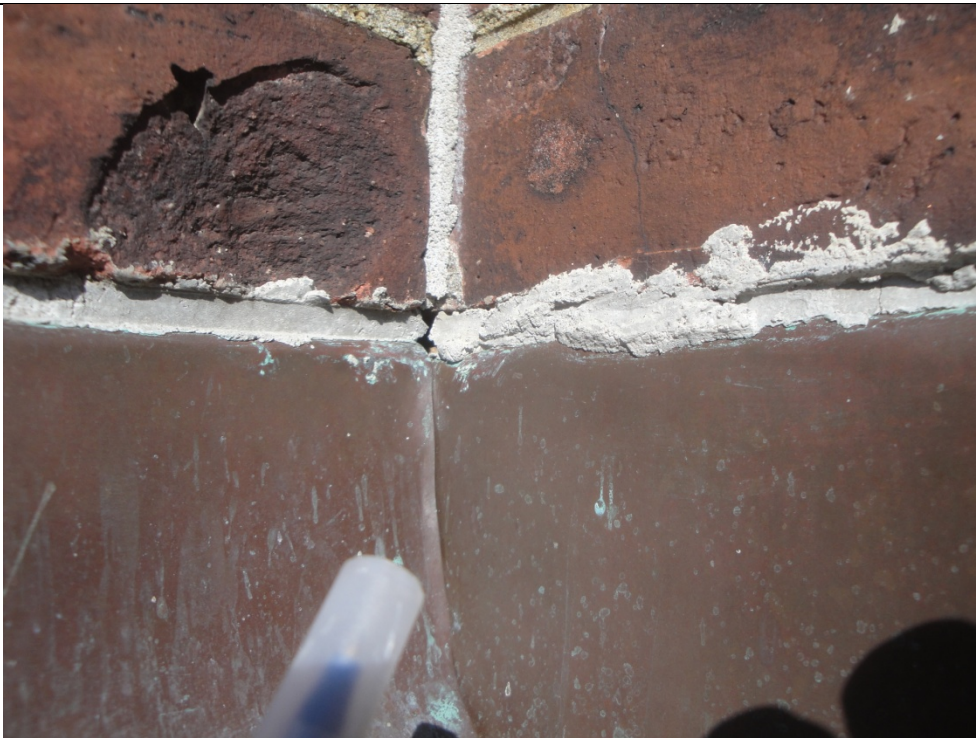
Photo R24

Void in masonry joint at inside corner above new red copper counter flashing.

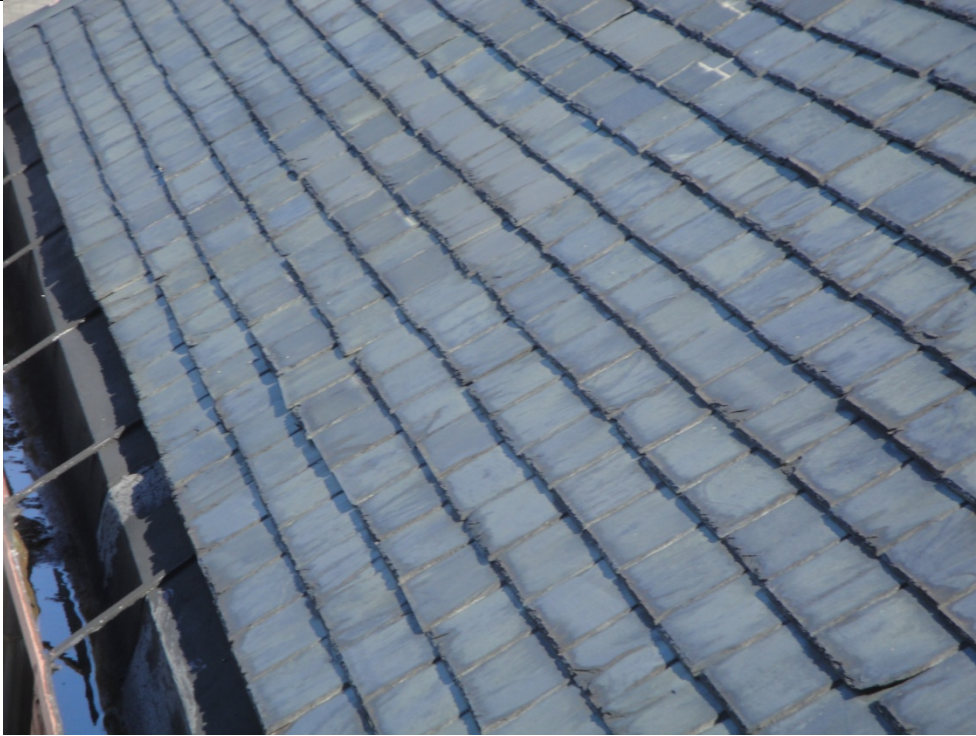
Photo R25
08/13/15
Photo Location:
Upper main hip roof edge.

Description:
Existing hung gutter is holding water despite little or no rain the previous few days.

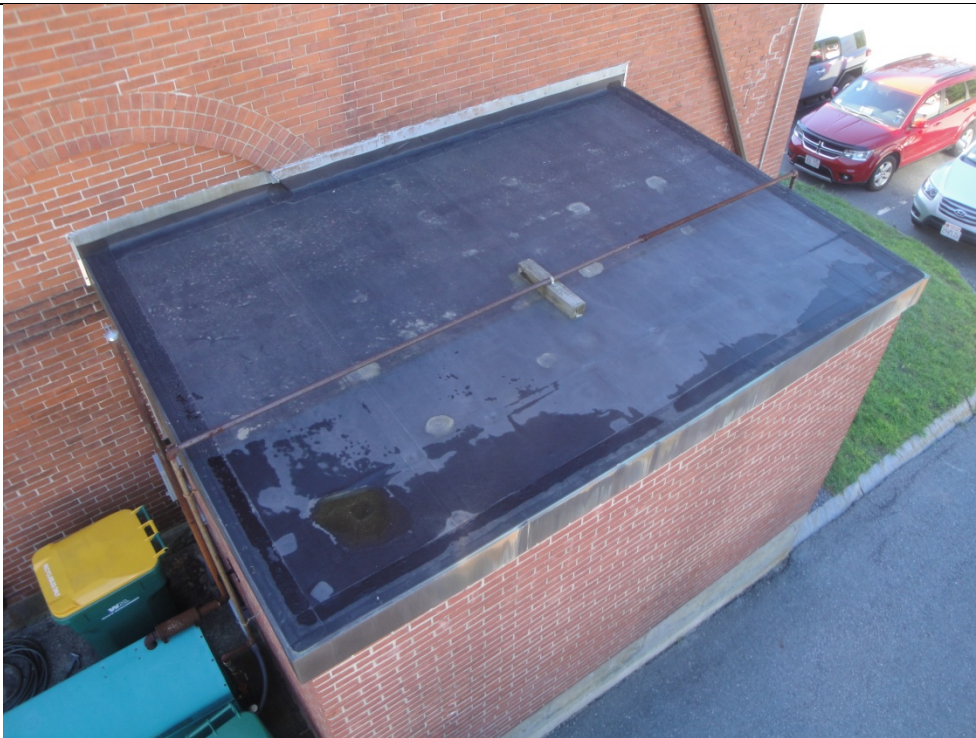
Photo R26
08/13/15
Photo Location:
Rear of building above low-slope roof.

Low Rear EPDM Roof: Although not part of the scope of work, a brief inspection of the adhered, unreinforced Ethylene Propylene Diene Monomer (EPDM) roof was performed. The roof appears to have been installed in accordance with manufacturer's requirements and is in good condition. A small area of edge metal has detached from the cleat and is loose.

Description:
Overview of adhered EPDM roof system. Wood blocking should have buffer pad between wood and EPDM membrane.

The newer EPDM roof over the rear one story structure is in good condition and needs no repair work at this time. The small section of edge metal referenced previously should be re-crimped on to the underlying cleat to prevent wind blow-off. It is important to review the warranty language (if applicable) as some manufacturer's require yearly inspections be documented for the continuation of the warranty coverage.
