CONDITION ASSESSMENT - 223 Inspection Date: 3/25/04 By:

MONUMENT CONSERVATION COLLABORATIVE LLC

Cemetery: North Cemetery, Route 27, Wayland, MA

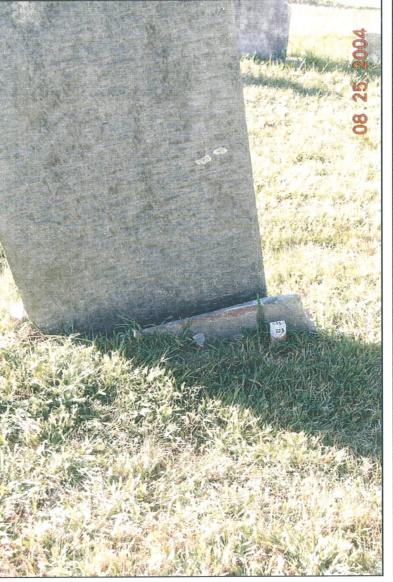
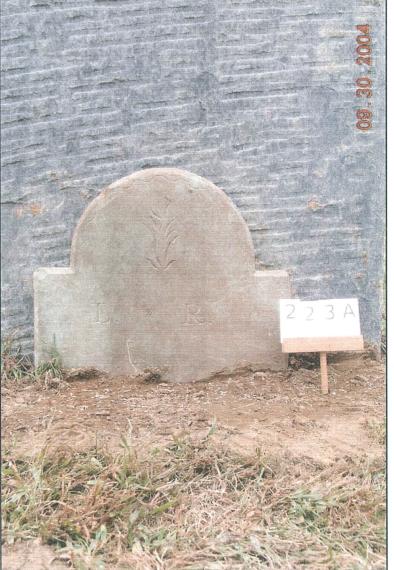
Marker# 223

Condition of Inscrip: Clear but worn

POSITION Fallen

**EXTENT** Re-set in ground

- 1. Footstone excavated, soil removed from setting area to appropriate depth.
- 2. Footstone re-set plumb at appropriate height and level onto gravel bed, aligned with adjacent markers
- 3. Area around footstone backfilled with tamped sand and gravel
- 4. Disturbed areas re-graded with topsoil and seeded
- 5. All surfaces treated with antimicrobial D/2 and scrubbed with nylon brushes.
- 6. Full rinse with water at no greater than 300psi

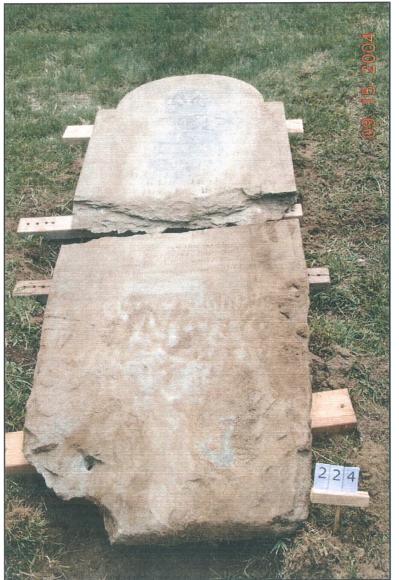
Condition of Inscrip: Clear but worn

EXISTING CONDITION	CONSERVATION STRATEGY		
POSITION Unstable	EXTENT 3)Extensive >50% 2)Partial 25% - 50% 1)Minimal <25%	Re-set in ground	
DETERIORATION Broken Cracked Losses	2 1 2	Structual adhesion Repair mortars Crack fillers	
SOILING Biological	1	Chemical Pressure wash

- 1. Area around lower marker fragment excavated and removed from ground.
- 2. All surfaces treated with antimicrobial D/2 and scrubbed with nylon brushes.
- 3. Full rinse with water at no greater than 300psi
- 4. Lower portion of marker reset plumb and aligned with adjacent markers. Backfilled with tamped gravel.
- 5. Fragments attached with structural adhesive ( Abatron 55-22), clamped and braced until cured. Excess epoxy removed by hand chisels
- 6. Cracks and voids filled with RepliCal products.
- 7. Filled areas misted with water and covered for 3 days minimum
- 8. Filled surface areas treated with light acid wash rinsed thoroughly

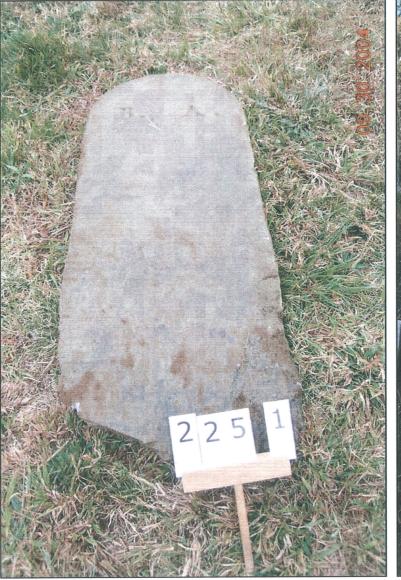
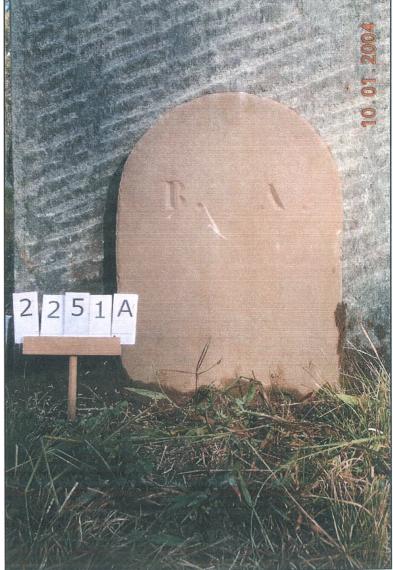
Condition of Inscrip: Clear but worn

- 1. Footstone excavated, soil removed from setting area to appropriate depth.
- 2. Footstone re-set plumb at appropriate height and level onto gravel bed, aligned with adjacent markers
- 3. Area around footstone backfilled with tamped sand and gravel
- 4. Disturbed areas re-graded with topsoil and seeded
- 5. All surfaces treated with antimicrobial D/2 and scrubbed with nylon brushes.
- 6. Full rinse with water at no greater than 300psi

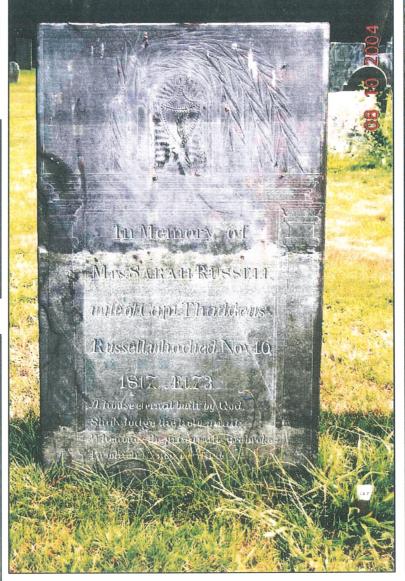
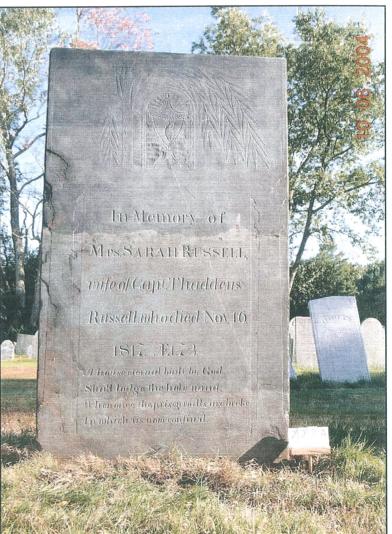
Marker# 227 Location D-138

Condition of Inscrip: Clear but worn

- 1. Soil removed around marker to an appropriate depth.
- 2. Marker removed from ground if necessary
- 3. Marker re-set plumb at appropriate height and level onto gravel bed, aligned with adjacent markers
- 4. Area around marker backfilled with tamped sand and gravel
- 5. Disturbed areas re-graded with topsoil and seeded
- 6. All surfaces treated with antimicrobial D/2 and scrubbed with nylon
- 7. Full rinse with water at no greater than 300psi

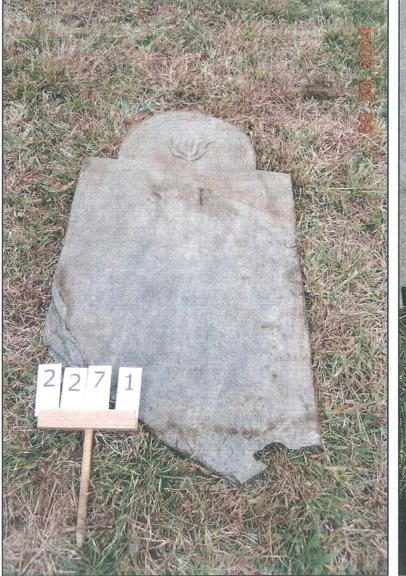
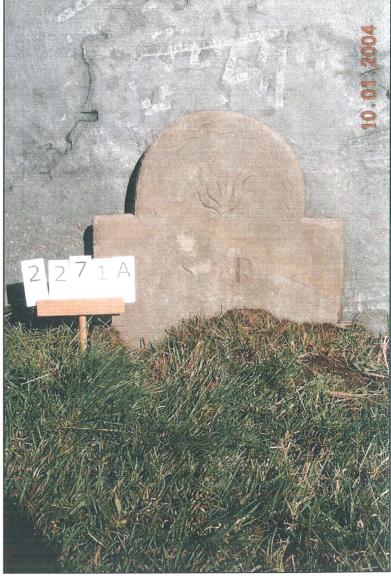
Condition of Inscrip: Clear but worn

- 1. Footstone excavated, soil removed from setting area to appropriate depth.
- 2. Footstone re-set plumb at appropriate height and level onto gravel bed, aligned with adjacent markers
- 3. Area around footstone backfilled with tamped sand and gravel
- 4. Disturbed areas re-graded with topsoil and seeded
- 5. All surfaces treated with antimicrobial D/2 and scrubbed with nylon brushes.
- 6. Full rinse with water at no greater than 300psi

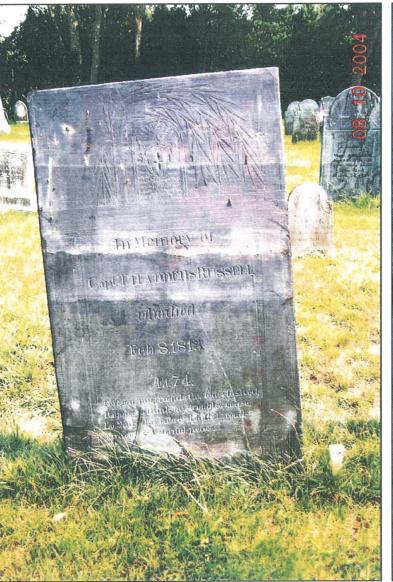
**DETERIORATION Delamination/Detachment**

- 7. Interior voids flushed with water and any loose debris removed.
- 8. "Dams" created along sides of delamination using a Replical pigmented crack filler. Backer rod used to fill larger delaminations. Stone is misted with water and wrapped in plastic for min 3 days during curing.

- 9. All interior voids caused by splitting or delaminations filled with a pigmented pourable grout.
- 10. After partial cure, any remaining open areas filled with Replical pigmented crack filler and stone is misted with water and wrapped again for min 3 days.

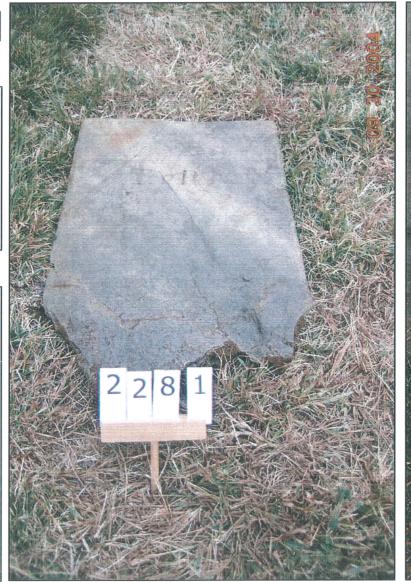
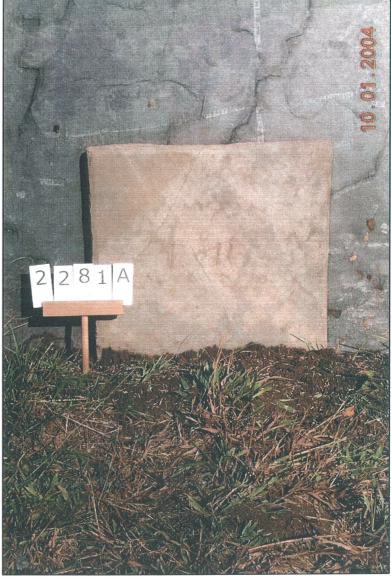
Condition of Inscrip: Clear but worn

- 1. Footstone excavated, soil removed from setting area to appropriate depth.
- 2. Footstone re-set plumb at appropriate height and level onto gravel bed, aligned with adjacent markers
- 3. Area around footstone backfilled with tamped sand and gravel
- 4. Disturbed areas re-graded with topsoil and seeded
- 5. All surfaces treated with antimicrobial D/2 and scrubbed with nylon brushes.
- 6. Full rinse with water at no greater than 300psi

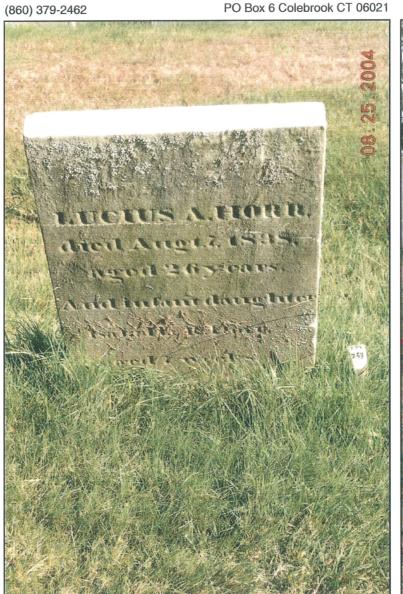
Condition of Inscrip: Mostly decipherable

- 1. Soil removed around marker to an appropriate depth.
- 2. Marker removed from ground if necessary
- 3. Marker re-set plumb at appropriate height and level onto gravel bed, aligned with adjacent markers
- 4. Area around marker backfilled with tamped sand and gravel
- 5. Disturbed areas re-graded with topsoil and seeded
- 6. All surfaces treated with antimicrobial D/2 and scrubbed with nylon brushes.
- 7. Full rinse with water at no greater than 300psi

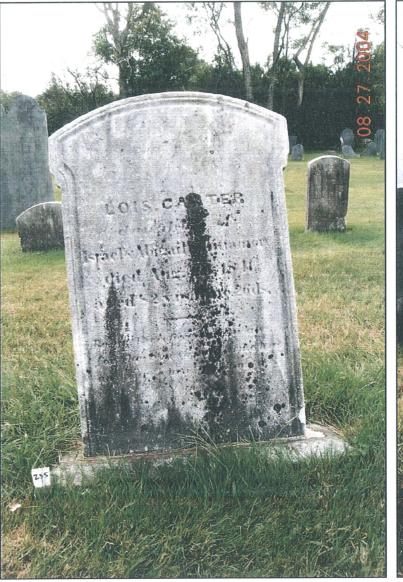
**POSITION Tilted Marker Tilted Base** Loose or detached from base

- 1. Marker lifted clear from base.
- 2. Setting pins examined, if sound they were re-used, if rusted or failed and required, replaced with stainless steel threaded studs.
- 3. Setting areas cleared of debris and failed setting mortar removed from setting bed.
- 4. Setting base aligned with adjacent markers and re-set level, backfilled w/ gravel
- 5. All surfaces treated with D/2 antimicrobial, rinsed with 300psi water.
- 6. Setting bed area primed with Acryl 60, marker reset with 000 grout.
- 7. Excess grout removed and joint area cleaned.

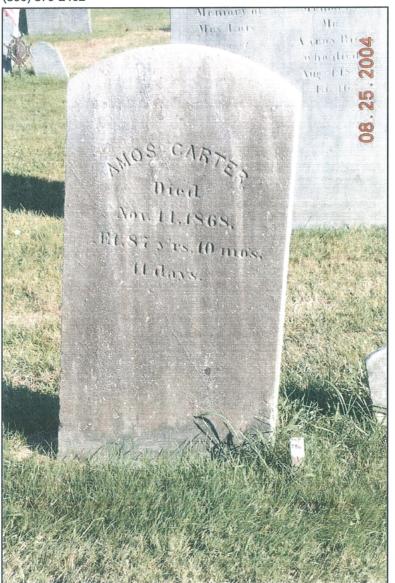
**Tilted Base** Loose or detached from base

- 1. Marker lifted clear from base.
- 2. Setting pins examined, if sound they were re-used, if rusted or failed and required, replaced with stainless steel threaded studs.
- 3. Setting areas cleared of debris and failed setting mortar removed from setting bed.
- 4. Setting base aligned with adjacent markers and re-set level, backfilled w/ gravel
- 5. All surfaces treated with D/2 antimicrobial, rinsed with 300psi water.
- 6. Setting bed area primed with Acryl 60, marker reset with 000 grout.
- 7. Excess grout removed and joint area cleaned.

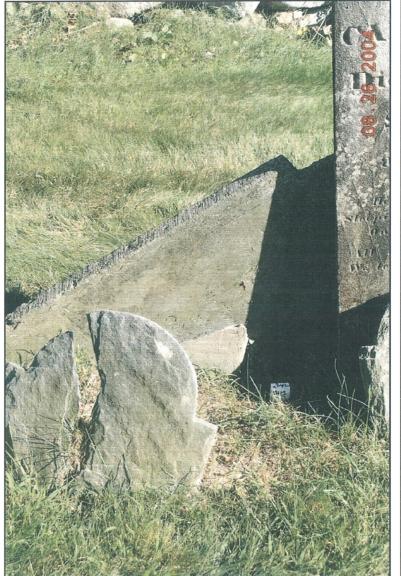
#### **CONSERVATION STRATEGY EXISTING CONDITION** Construct new base POSITION Unstable **EXTENT** New base required 3)Extensive >50% 2)Partial 25% - 50% 1)Minimal <25% Structual adhesion **Repair mortars DETERIORATION Broken Crack fillers** Losses Chemical **SOILING Biological** Pressure wash

- 7. Cracks and losses filled with RepliCal products.
- 8. Filled areas misted with water and covered for 3 days minimum
- 9. Filled surface areas treated with light acid wash rinsed thoroughly

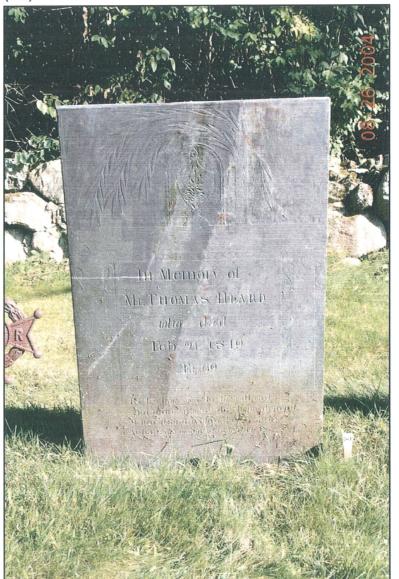
**DETERIORATION**

- 7. Interior voids flushed with water and any loose debris removed.
- 8. "Dams" created along sides of delamination using a Replical pigmented crack filler. Backer rod used to fill larger delaminations. Stone is misted with water and wrapped in plastic for min 3 days during curing.

- 9. All interior voids caused by splitting or delaminations filled with a pigmented pourable grout.
- 10. After partial cure, any remaining open areas filled with Replical pigmented crack filler and stone is misted with water and wrapped again for min 3 days.
