Inspection Date: 3/25/04 By: Fannin-Lehner

Cemetery: South Cemetery, Route 27, Wayland, MA

MONUMENT CONSERVATION COLLABORATIVE LLC

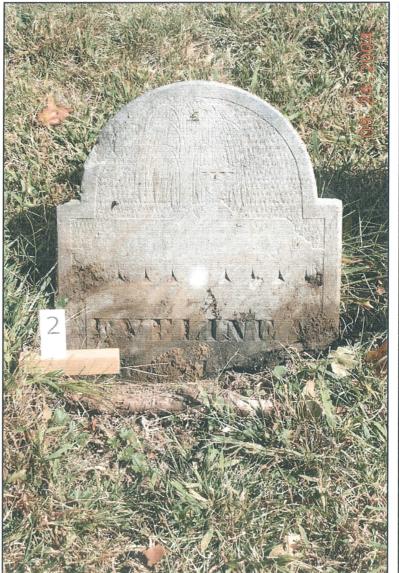
Condition of Inscrip: Clear but worn

POSITION missing fragments

DETERIORATION Broken

- 1. Area around marker excavated
- 2. Lower fragment located
- 3. Fragments attached with structural adhesive (Abatron 55-22), clamped and braced until cured. Excess epoxy removed by hand chisels
- 4. Marker reset plumb and cleaned with D/2 Antimicrobial
- 5. Cracks and voids filled with RepliCal products.
- 6. Filled areas misted with water and covered for 3 days minimum
- 7. Filled surface areas treated with light acid wash rinsed thoroughly

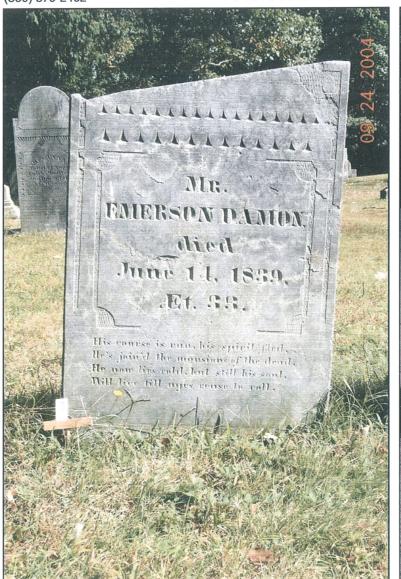
DETERIORATION Broken

- 1. Area around marker excavated
- 2. Fragments attached with structural adhesive (Abatron 55-22), clamped and braced until cured. Excess epoxy removed by hand chisels
- 3. Marker reset plumb and cleaned with D/2 Antimicrobial
- 4. Cracks and voids filled with RepliCal products.
- 5. Filled areas misted with water and covered for 3 days minimum
- 6. Filled surface areas treated with light acid wash rinsed thoroughly

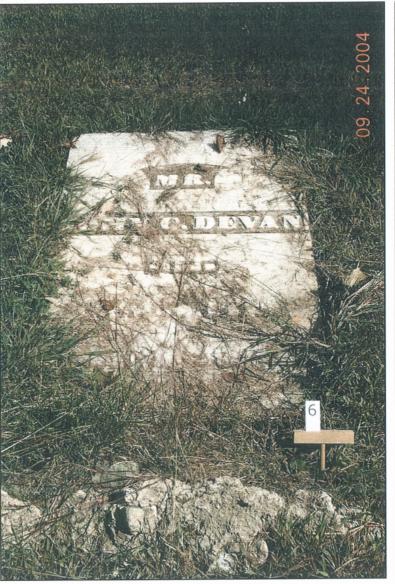
Marker# 6 Location 5

POSITION Fallen Loose or detached from base

- 1. All surfaces treated with D/2 antimicrobial, rinsed with 300psi water
- 2. Buried, original base located, old setting mortar removed from slot
- 3. Base aligned with adjacent markers and re-set level, backfilled w/ gravel
- 4. Bottom of marker re-squared with minimal loss
- 5. Marker plumbed and re-set into setting slot with flowable 000 grout
- 6. Braced until cured

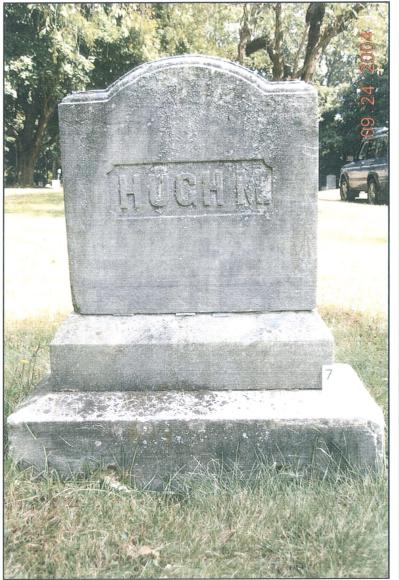
POSITION Unstable Loose or detached from base

- 1. Marker lifted clear from base with mechanical assistance
- 2. Setting areas cleared of debris and failed setting mortar removed from setting bed.
- 3. All surfaces treated with D/2 antimicrobial, rinsed with 300psi water
- 4. Setting bed area primed with Acryl 60, marker reset with 000 grout
- 5. Excess grout removed and joint area cleaned.

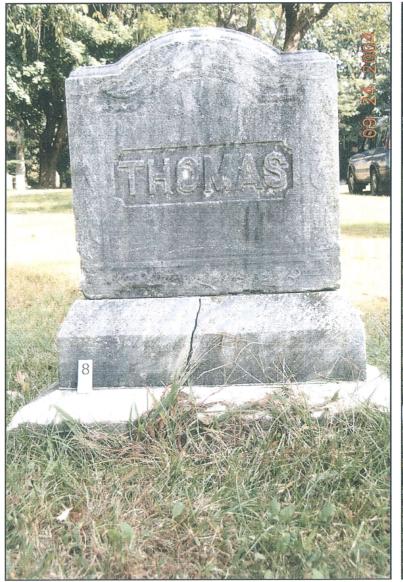
Tilted Base Loose or detached from base

- 1. Marker lifted clear from base.
- 2. Area around base excavated and base reset level
- 3. Setting areas cleared of debris and failed setting mortar removed from setting bed.
- 4. All surfaces treated with D/2 antimicrobial, rinsed with 300psi water.
- 5. Setting bed area primed with Acryl 60, marker reset with 000 grout.
- 6. Crack in base filled with grout
- 7. Excess grout removed and joint area cleaned.

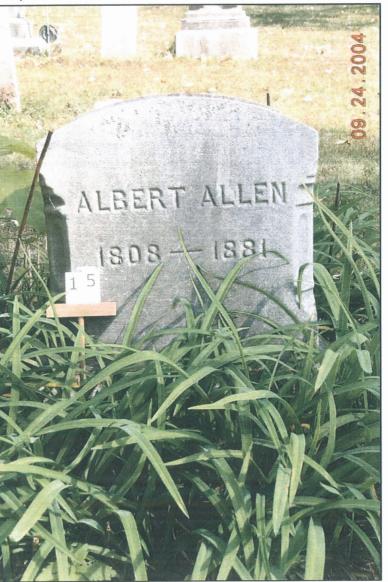
POSITION Unstable Loose or detached from base

- 1. Marker lifted clear from base.
- 2. Setting areas cleared of debris and failed setting mortar removed from setting bed.
- 3. All surfaces treated with D/2 antimicrobial, rinsed with 300psi water.
- 4. Setting bed area primed with Acryl 60, marker reset with 000 grout.
- 5. Excess grout removed and joint area cleaned.

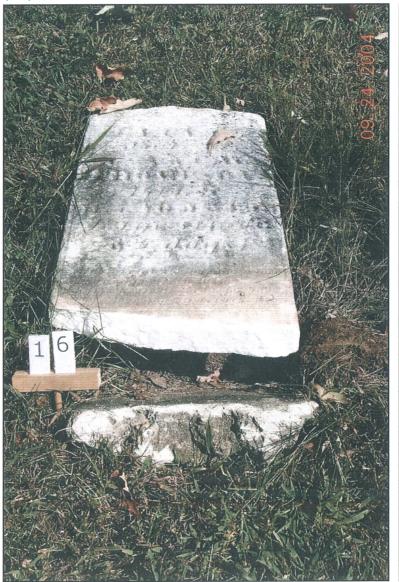
Loose or detached from base

FAILED TREATMENTS Mortar

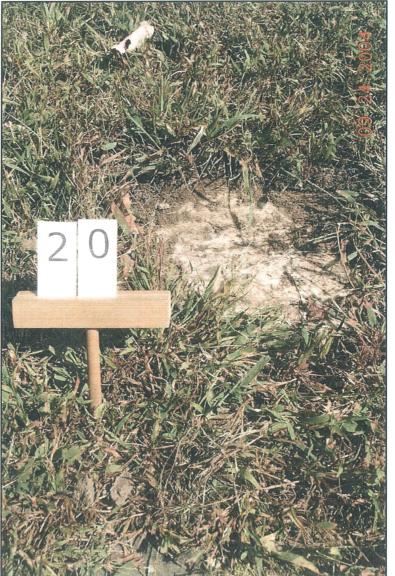
Location 18 Marker# 20

Loose or detached from base New base required EXTENT

DETERIORATION Broken

- 1. Area around existing marker excavated and original base unit located and leveled
- 2. Remaining fragments from lower edge of marker removed from base slot
- 3. The lower edge of marker fragment is re-squared
- 4. Lower fragment re-set into base slot with cement/lime grout (3/2/5)
- 5. Lower fragment is set plumb and level, braced until 5 days minimum
- 6. Mating edges of marker treated with D/2 antimicrobial and rinsed thoroughly with water
- 7. Fragments attached with structural adhesive (Abatron 55-22), clamped and braced until cured. Excess epoxy removed by hand chisels.
- 8. Cracks and losses filled with RepliCal Marble products (white).
- 9. Filled areas misted with water and covered for 3 days minimum
- 10. Filled surface areas treated with light acid wash rinsed thoroughly
