TOWN OF WESTBOROUGH, MA

**WESTBOROUGH FIRE STATION
EXTERIOR ENVELOPE REPAIRS**

September 2001

**Maguire Group Inc.
225 Foxborough Boulevard
Foxborough, MA 02035**

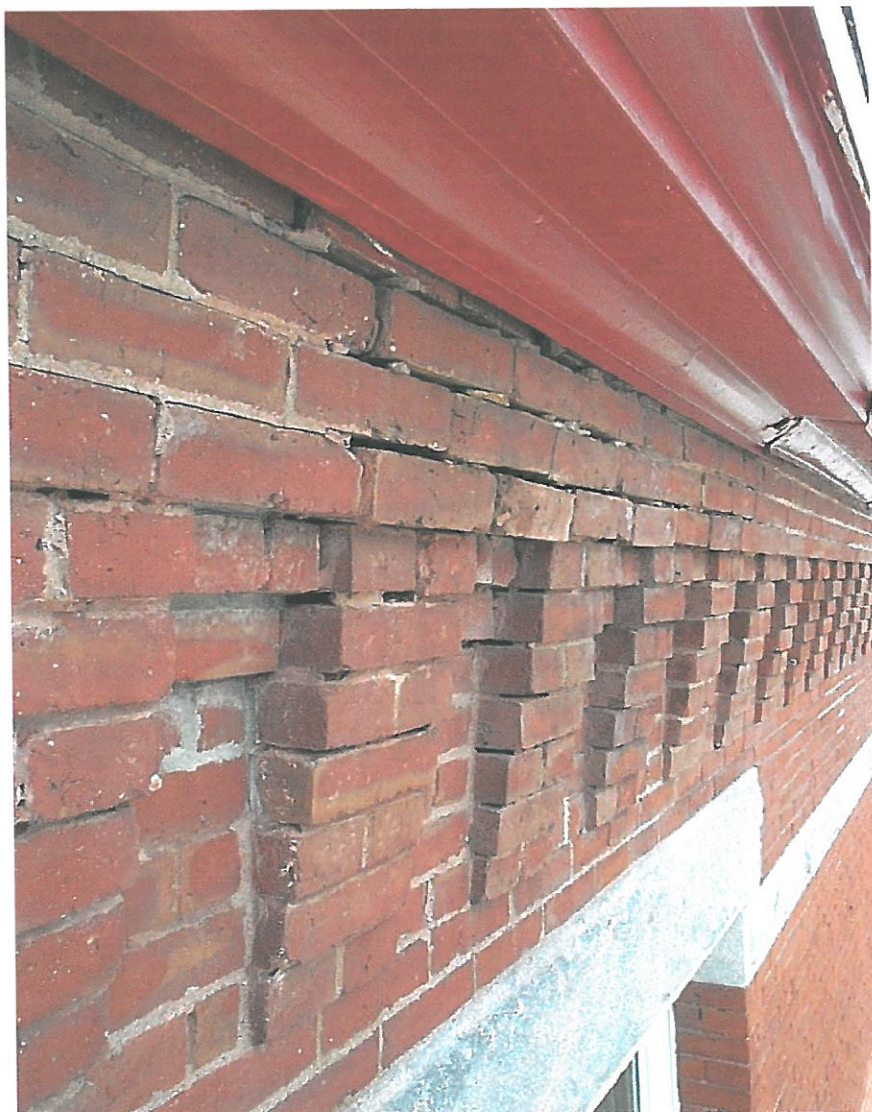
The original exterior walls exhibit severe weathering and deterioration. These masonry walls have many open joints, and mortar is missing entirely in areas of the walls. In the areas where mortar is missing, it appears that significant water infiltration and the east-southeast weather exposure are the main culprits. The combined effects of leaks in the cornice gutter system along the perimeter of the pitched roof areas, water trapped and infiltrating the hose tower walls at the metal banding, weathering and lack of wall maintenance, have weakened the mortar materials as the soluble minerals have and are leaching out. This does occur, to an extent, naturally as masonry ages; however, water infiltration and severe weathering exacerbates the process.

Wall deterioration at east wall.

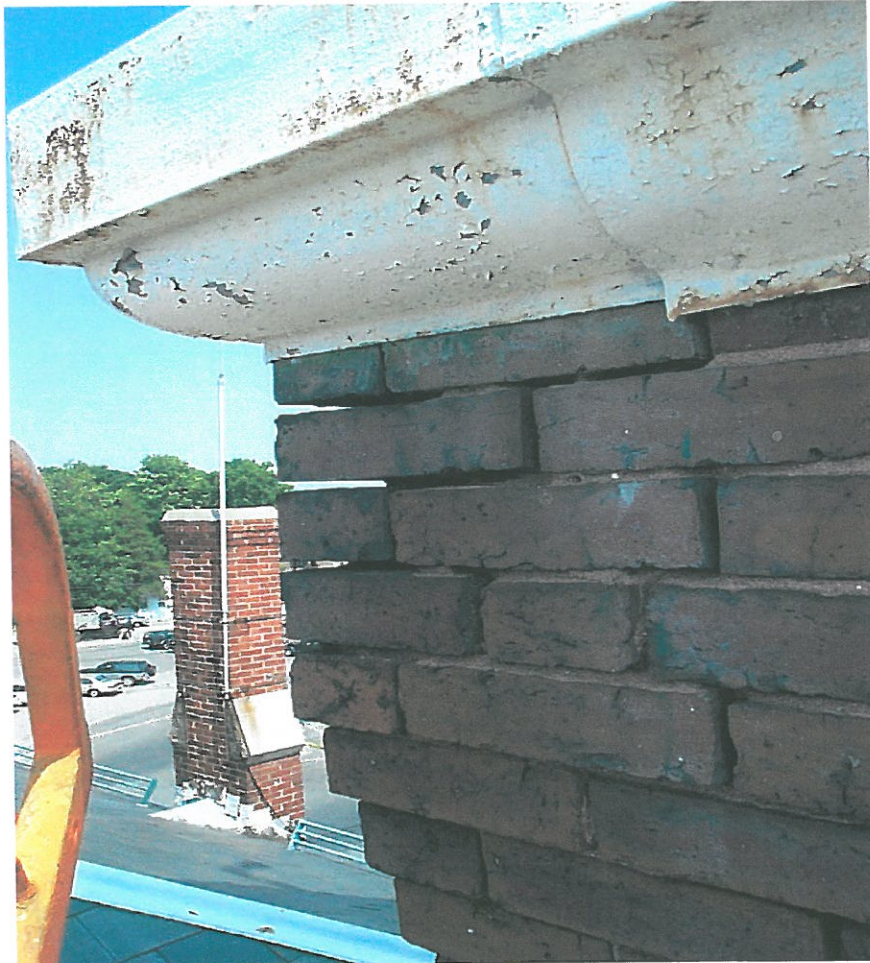
Wall deterioration at hose tower

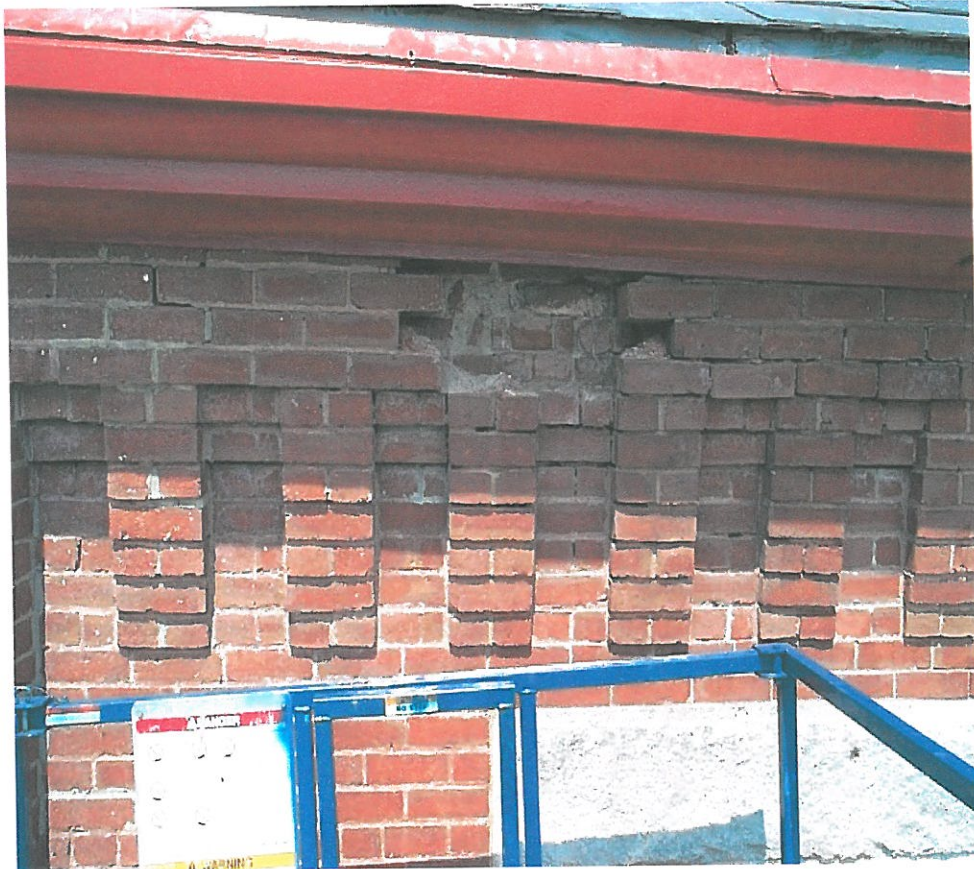
Wall deterioration at east wall

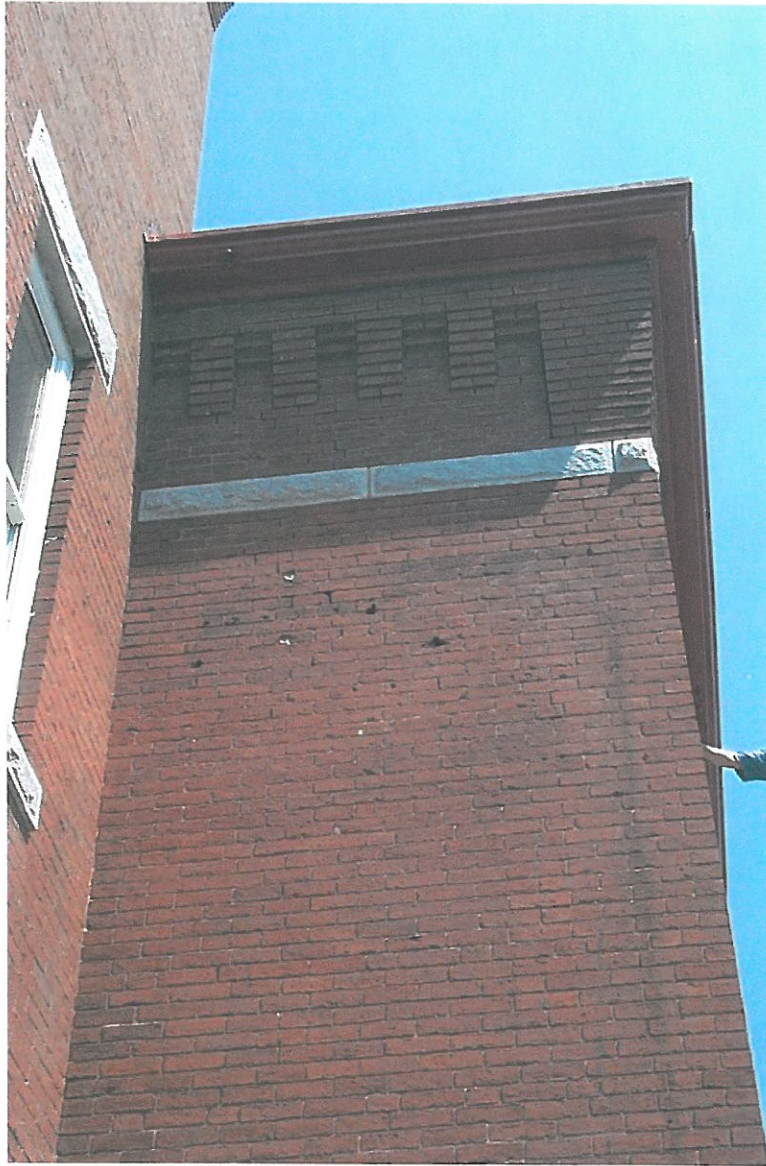
Typical condition of original walls.

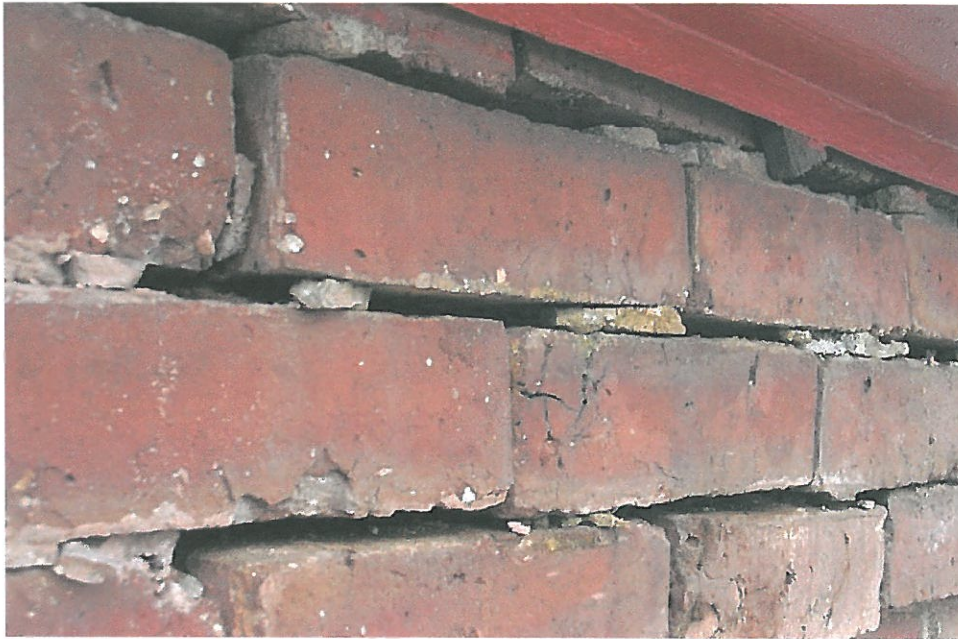
Wall deterioration.

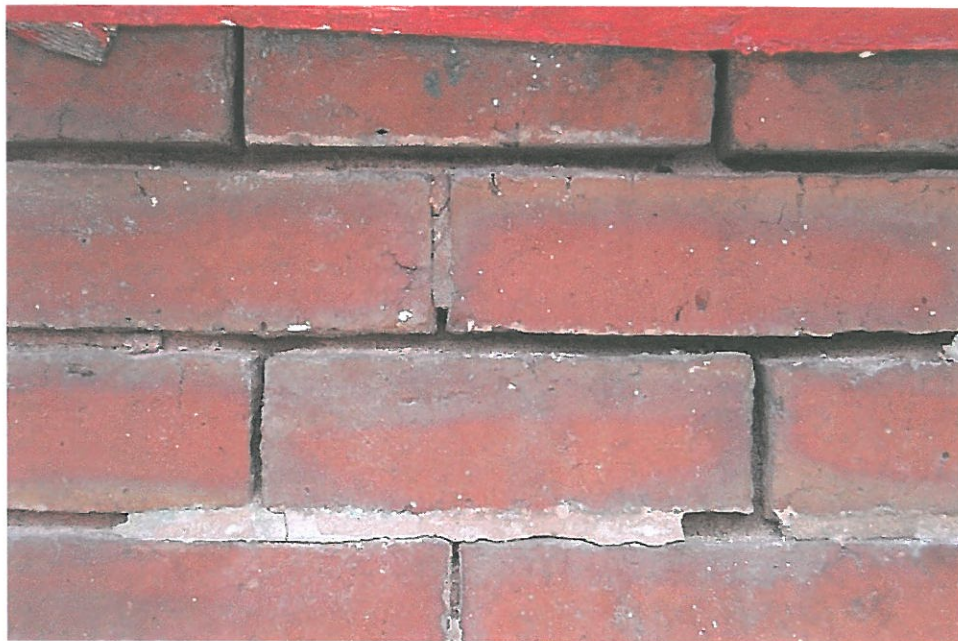
Mortar disintegration will ultimately be the downfall of the original walls. It appears that a significant amount of the lime has leached out of the original mortar, thus the disintegration. Even in areas not exhibiting water infiltration problems, the mortar was found to have lost strength and in the process of decomposing. There was evidence of three different repointing mortars on the original wall. These mortars were all significantly harder than the original mortar. While currently the mortar has enough strength to bond the wall composition sufficiently for the wall to function appropriately structurally, remedial measures must be undertaken to protect and ultimately prolong the life of the original walls.

Missing mortar typical of original walls.

The original masonry walls should have all the masonry joints cut out on the exterior and face and repointed with an ASTM Type O mortar. Specifications for this work should emphasize the importance of proper finishing and joint tooling when working with soft mortar. It should also be noted that in areas where repointing occurred in the past, the mortar is much harder and care should be taken to not damage the brick.

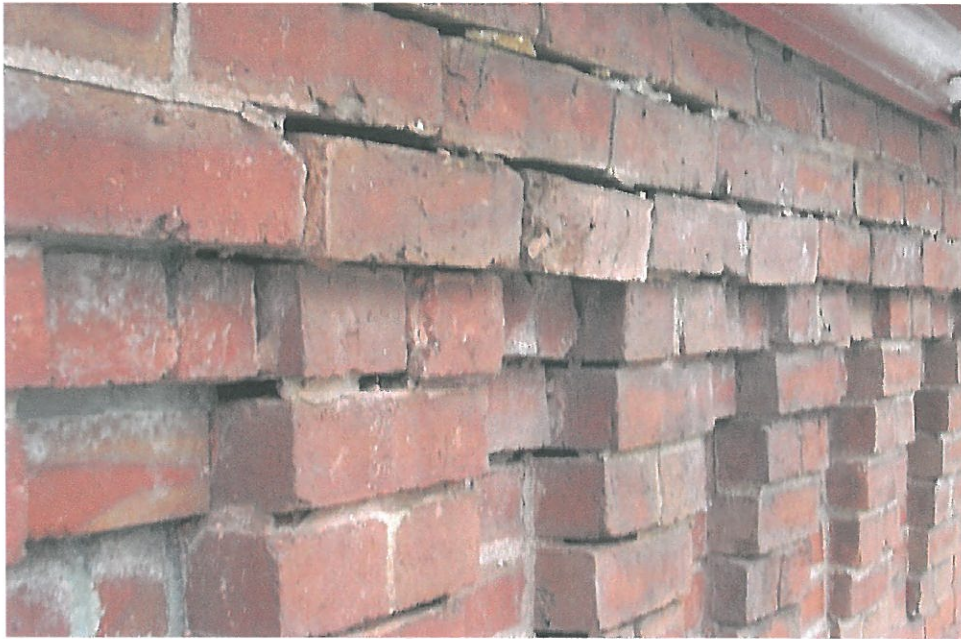
Dentil corbelling deterioration.

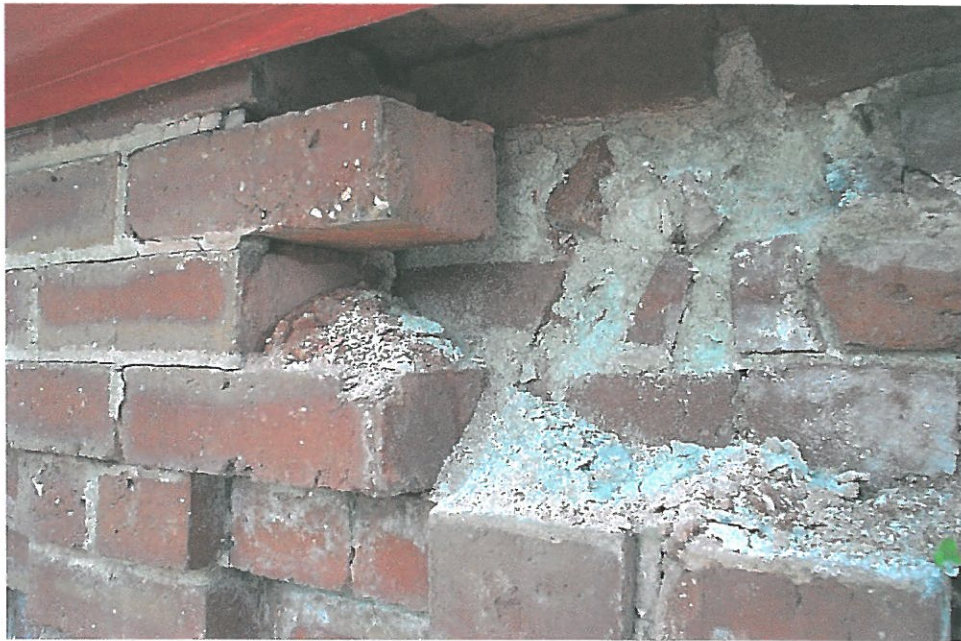
Mortar disintegration.

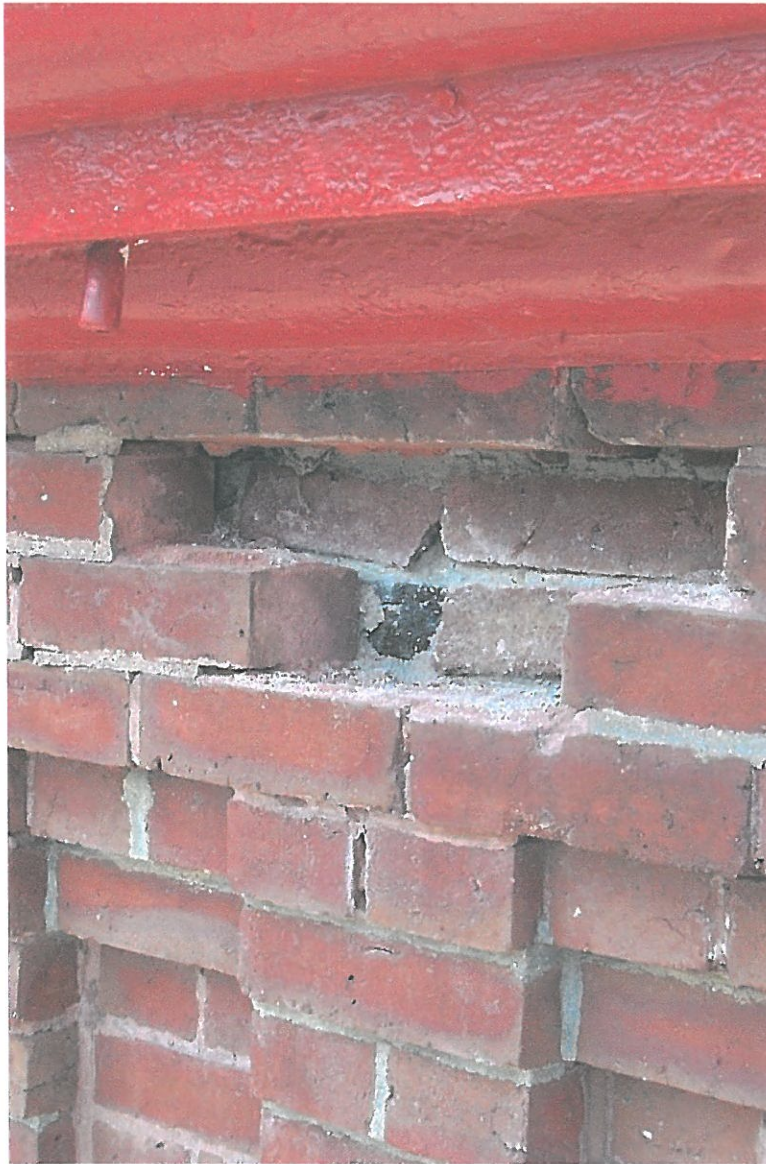
Deterioration.

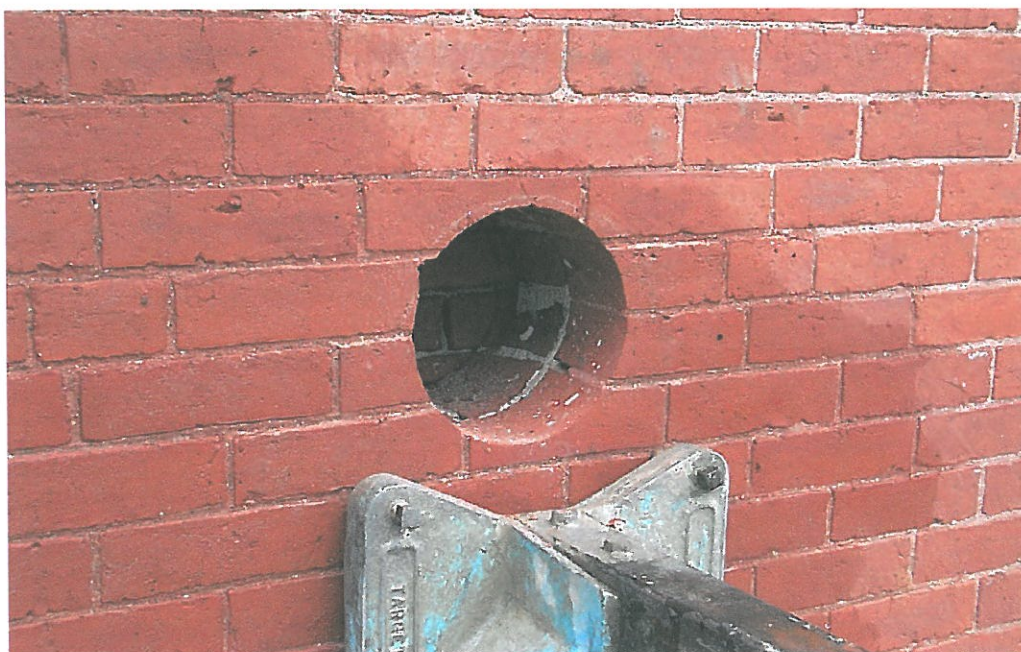
Geisser Engineering visited the site again on August 17, 2001, to drill two 8-inch diameter cores in the brick wall. The purpose of the core drilling was to observe the condition of the brick and mortar in all three wythes and to view conditions in several brick courses. One core was drilled approximately 4 feet above the base of the wall and the second core was drilled about mid-height of the wall. Two wythes of brick were removed by the core drilling. It was observed that the brick and mortar in all wythes of the lower core were in good condition. Examination of the upper core indicated that the brick there was in good condition, but the mortar had mostly disintegrated.

**Brick core at wall base.
Note good mortar condition.**

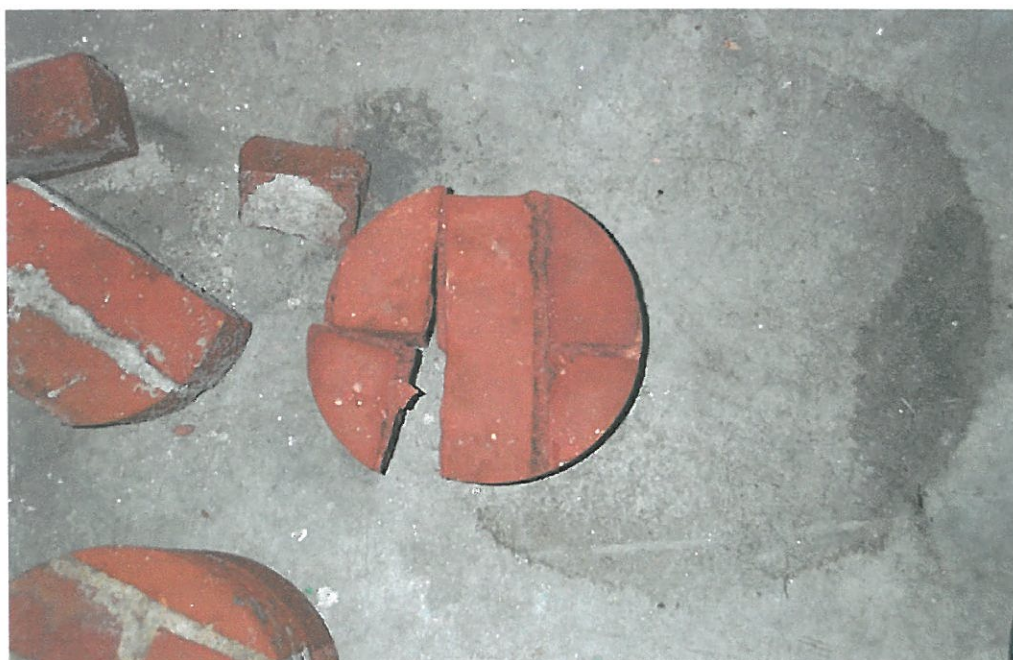
**Brick core at wall mid-height.
Note deteriorated mortar.**
