# Westborough Fire Station

Westborough, Massachusetts

## Building Structure - Limited Condition Survey

January 18, 2011

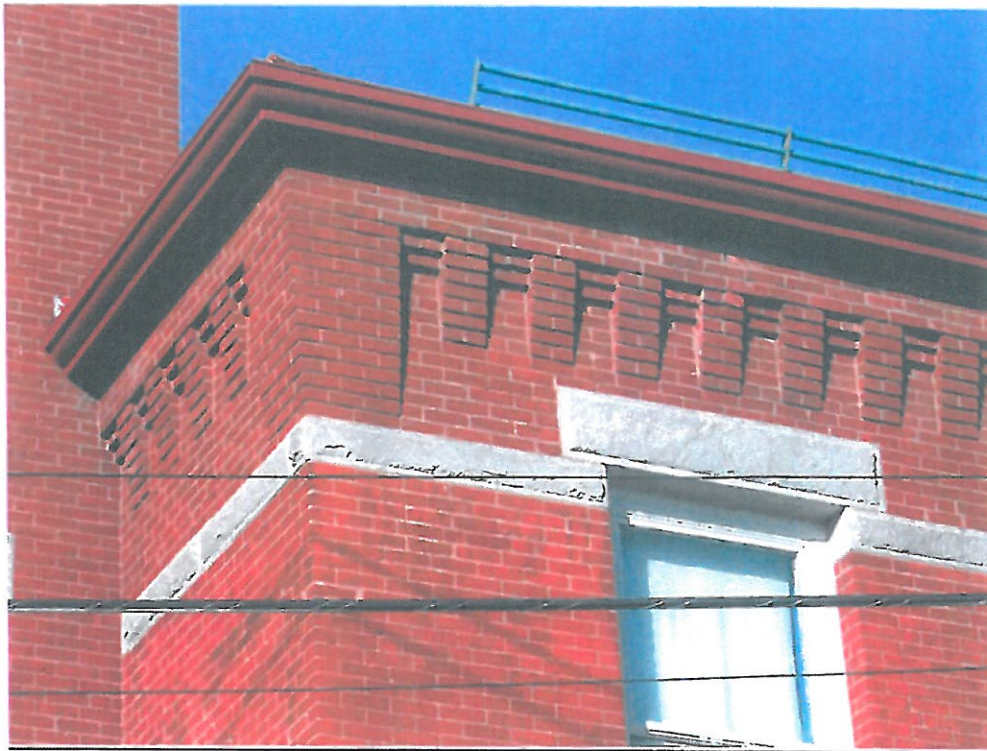
Decorative Dentil Corbelling at South Elevation of the Original 1888 Building

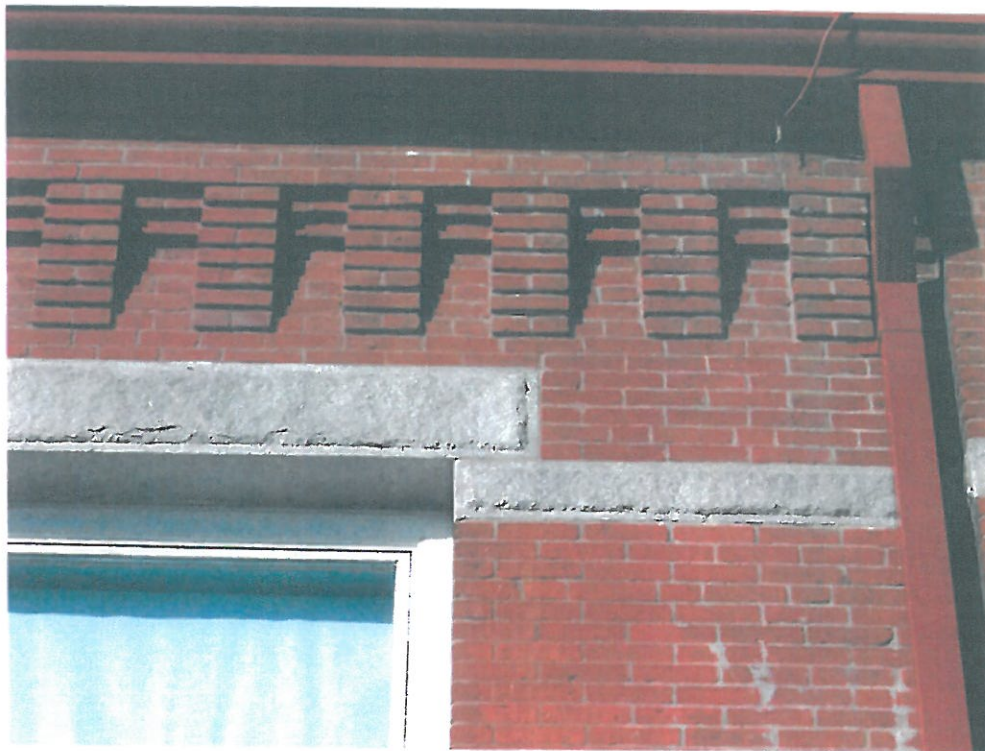
Repaired Decorative Corbel and New Rain Gutter/Leader

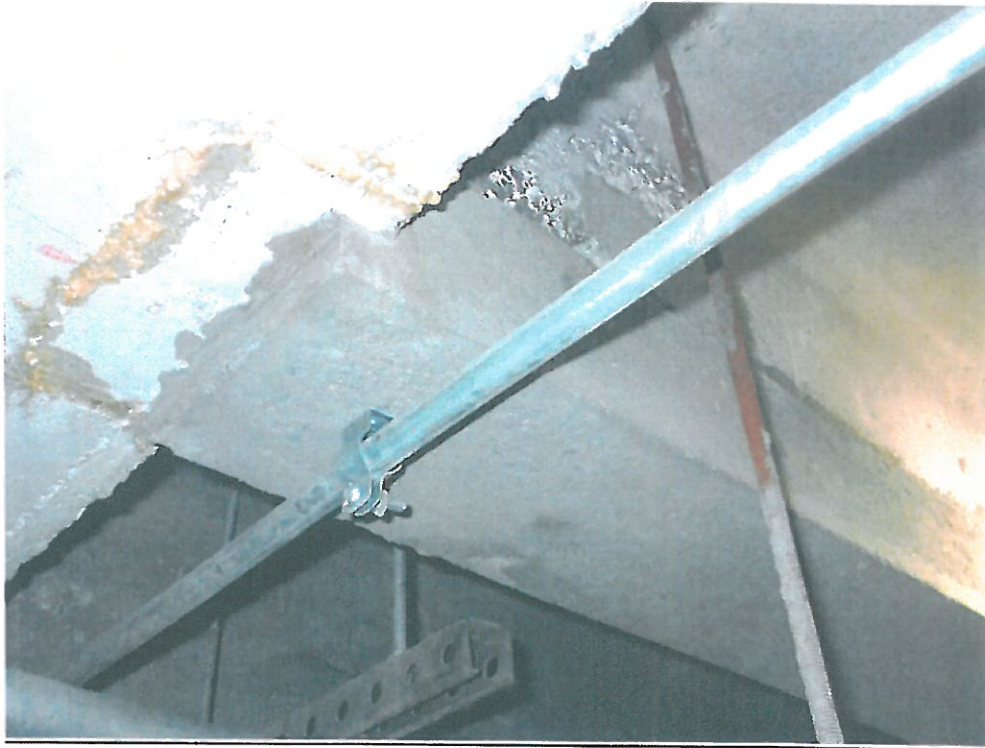
Repairs to Underside of Floor Structure

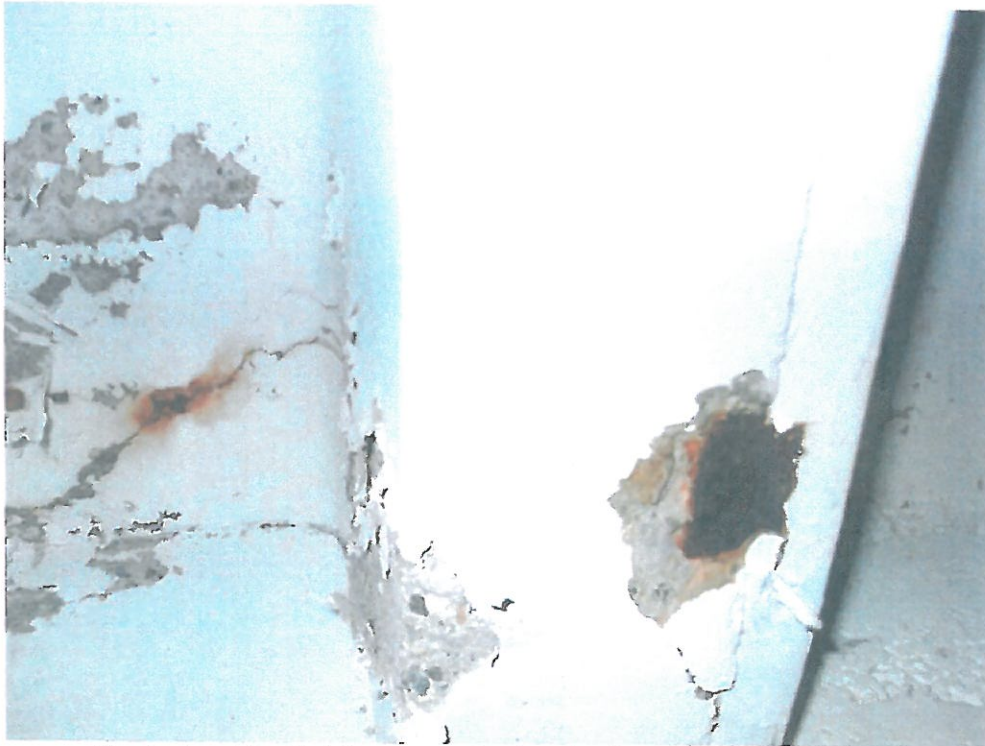
A review of the underside of the Apparatus Bay floor in the original 1888 building revealed honeycombing, minor cracking and minor spalling that was similar to the conditions noted in Maguire's 2005 report with no significant increase in the deterioration of the concrete structure.

Cracked and Spalled Concrete at Underside of Apparatus Bay Floor Slab

The concerns with the Apparatus Floor structure include the poor quality of concrete, the poor quality of workmanship, the on-going intrusion/build-up of chloride ions in the concrete and the compromised floor surface. If no additional repairs or improvements are implemented, it is likely that the floor structure will require major repairs within 5 to 10 years. The major repairs could include partial or full replacement of the structure with a cost range of \$200,000 to \$350,000, not including the cost of temporary space to park the apparatus, temporary mechanical systems and disruption to the Fire Station. The service life of the floor structure could be extended to 20 years by repairing all of the honeycombing and deterioration, removal and replacement of the spalled/deteriorated topping slab, application of a heavy duty floor sealer and regular maintenance of the repairs. The cost to implement these repairs and improvements could range from \$75,000 to \$100,000.

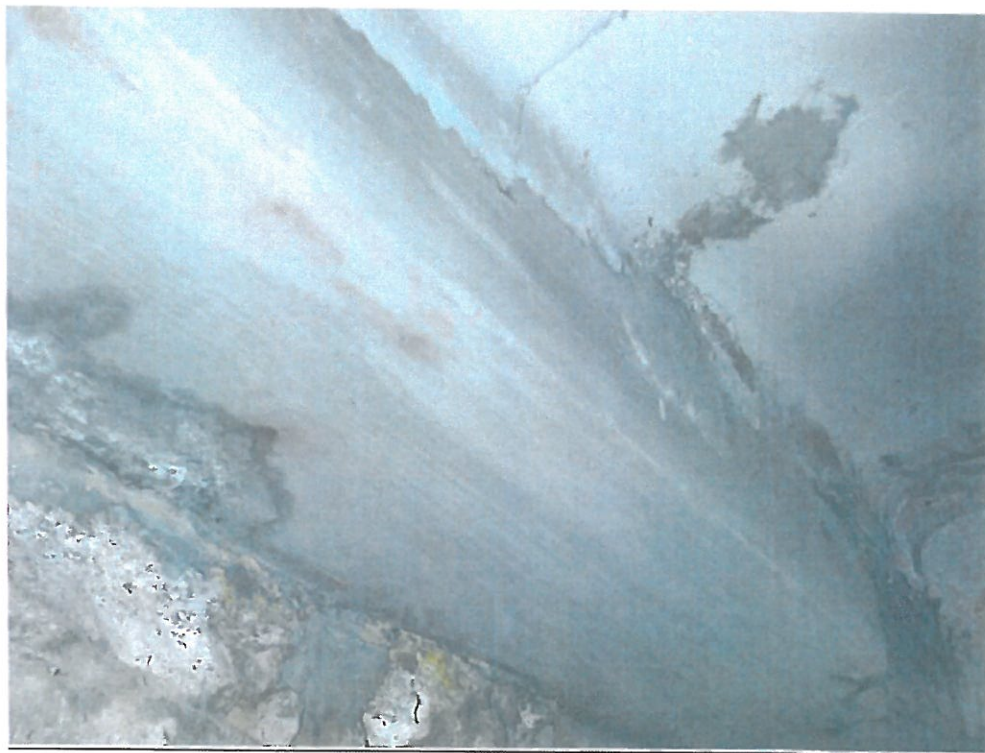
The repairs to the previously spalled concrete appeared to be performing well with no signs of additional concrete deterioration or spalling.

Concrete Repair

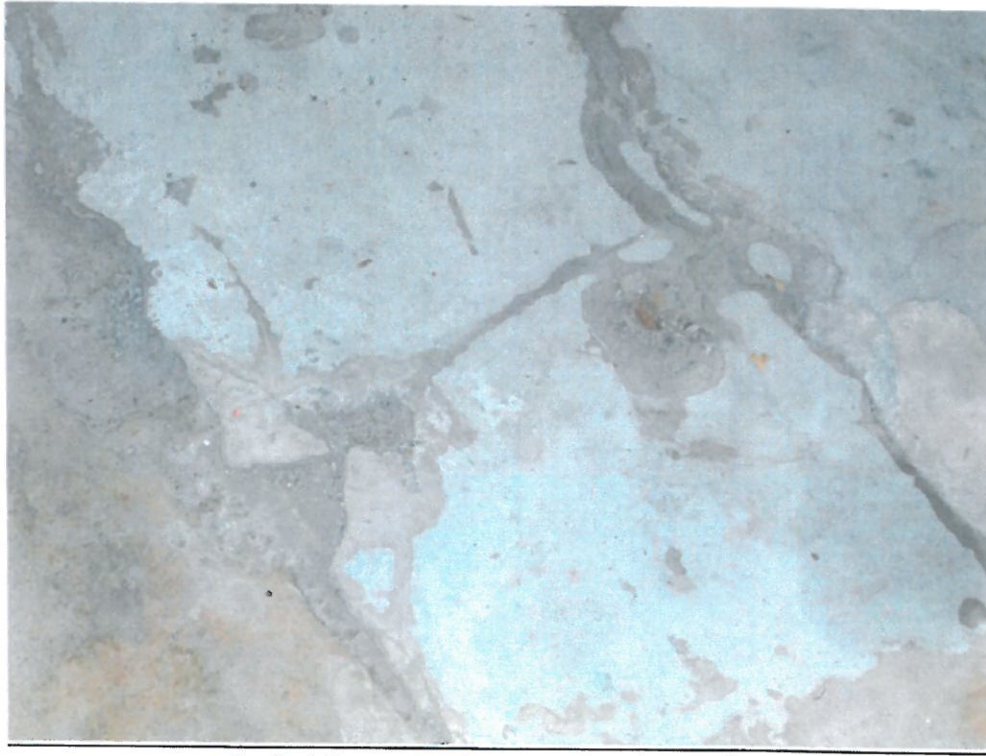
Deterioration and spalling of the floor surface of the Apparatus Bay was noted in several areas. The areas of slab surface that were patched to repair previous problems appeared to exhibit the most deterioration. Based on concrete cores that were part of Maguire's study, it appears that the surface deterioration is occurring in the 3" non-structural topping slab.

Spalled Concrete at Apparatus Bay Floor Surface

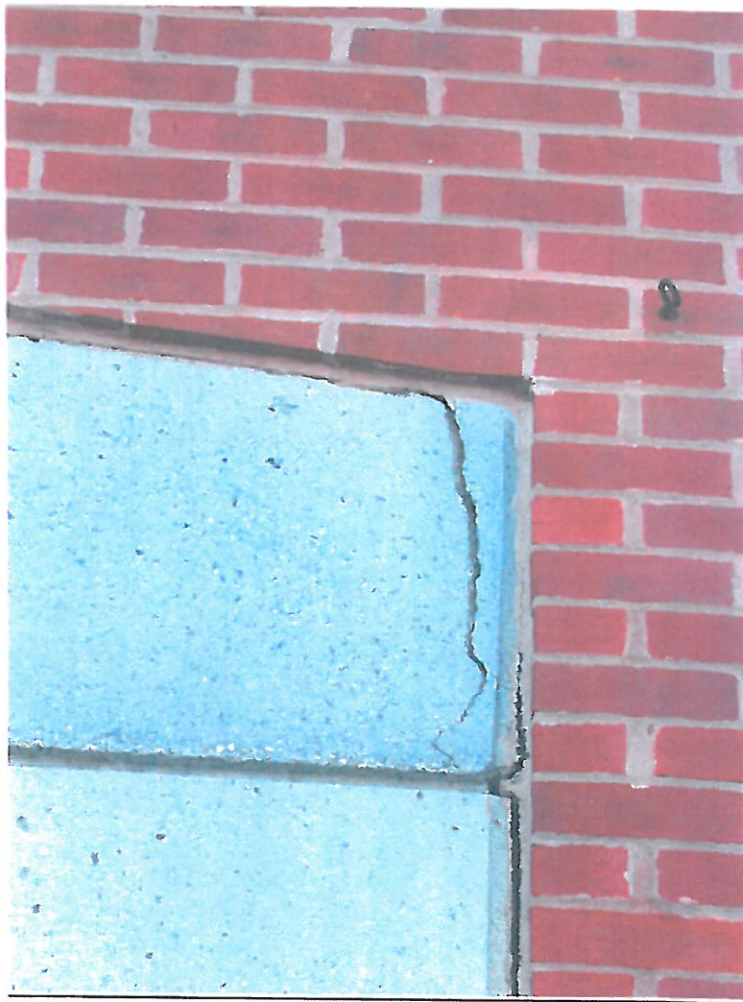
A review of the exterior of the buildings revealed several cracks in the exterior brick veneer. Cracks of significant size, up to 3/8", were noted on the East façade. The larger cracks have occurred at the jambs of the apparatus bay doors for the original 1888 building and the 1988 addition. The cracks extend horizontally over the head of the apparatus bay doors and extend diagonally to a window jamb or other opening in the wall construction. Smaller cracks were noted on the North and West elevations of the 1988 addition. All of cracks in the masonry veneer appear to be caused by lateral movement of the masonry veneer due to temperature changes and the absence of control joints in the veneer. Properly spaced control joints in the veneer would accommodate and control where the movement of the veneer occurs. Since no control joints were included, the reconstruction of the East elevation of the original 1888 building and no control joints were included in the construction of the 1988 addition the masonry has cracked where the stresses associated with the thermal variations are highest. At present, the cracks do not pose an immediate structural concern, but if left unaddressed the intrusion of water and potential freeze/thaw action could create a situation where the façade could be compromised.

Cracking and Separation at Precast Lintel of the 1988 Addition

The concern with the cracks in the masonry veneers is that if the cracks and the movement causing the cracking are not addressed, then the masonry veneer could become unstable and partially fail. A temporary repair would include sealing the cracks with caulk on a regular basis. This would only be a temporary repair and would likely need to be addressed on a 6 month interval. A more permanent repair would require the installation of vertical control joints in the masonry veneer to allow the thermal movement to occur at a controlled location. The control joints would be installed within 5 feet of a corner and at 20 foot spacing along the wall length and should be coordinated with the existing wall openings. Once the joints are in place, the cracks in the masonry would be routed out and repointed. The caulking of the control joints would likely need to be addressed on a 5 year interval. The cost for this work could range from \$40,000 to \$60,000.

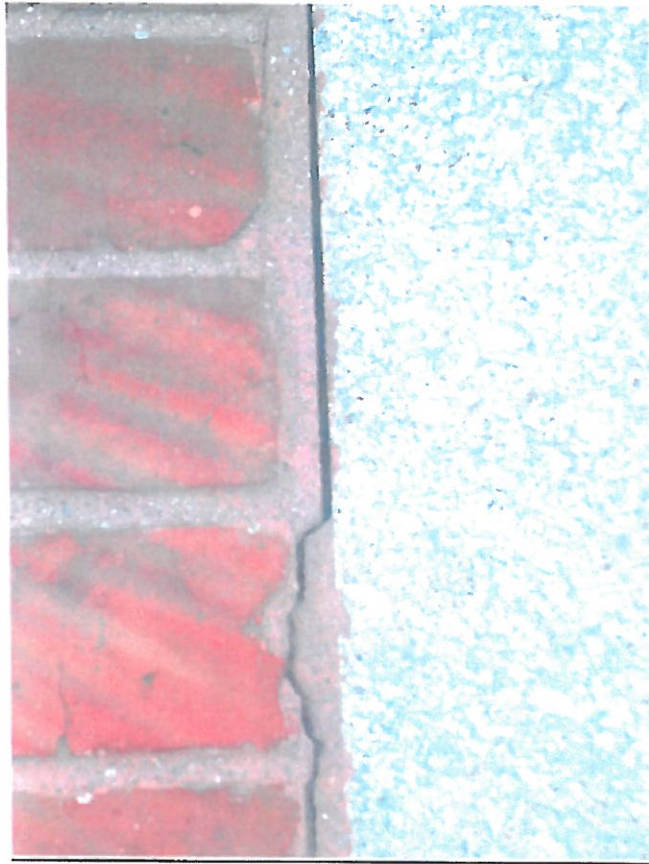
Crack at East Façade of Original 1888 Building

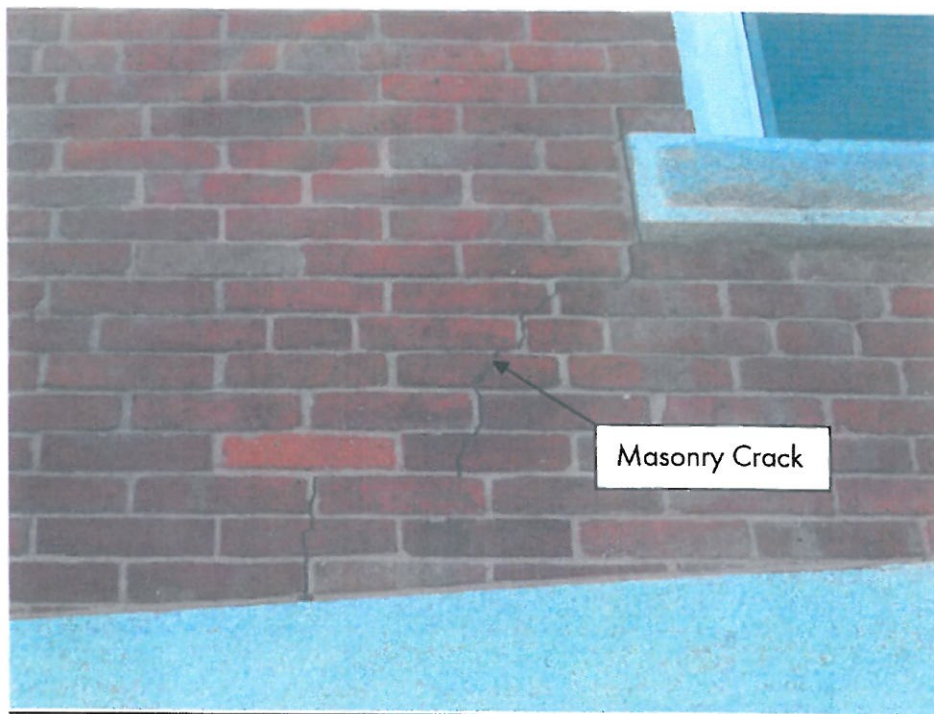
Masonry Crack at East Façade of Original 1888 Building

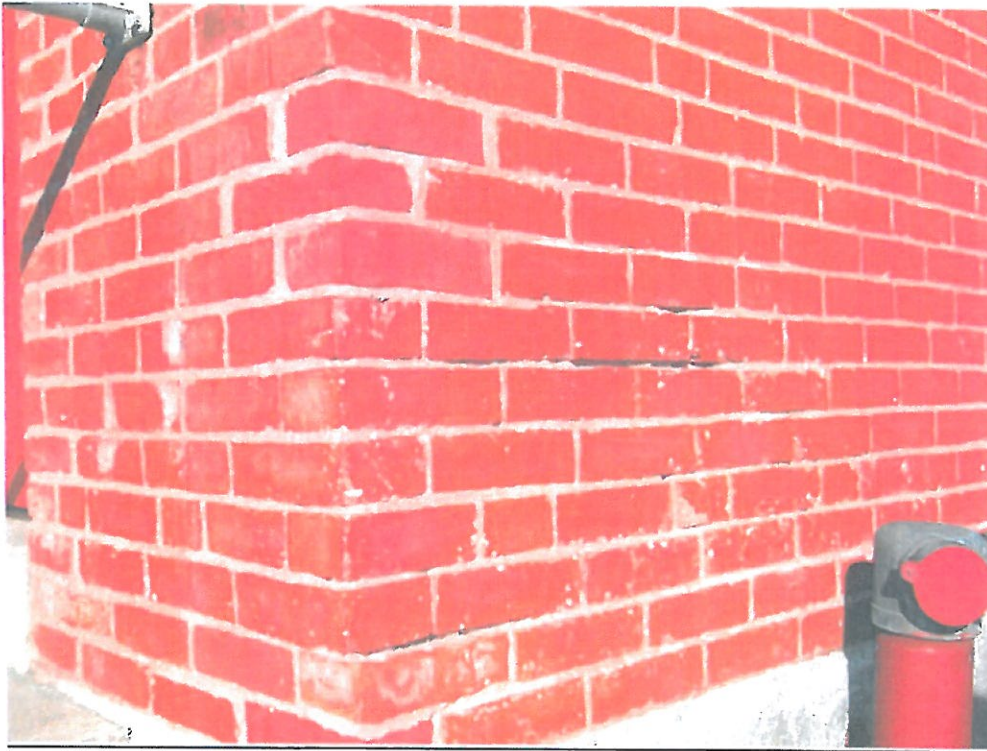
The repairs to the South elevation and Hose Tower masonry appears to be holding up well and show no signs of distress. At the Southwest corner of the South elevation a small area of the wall may have some minor deterioration of the mortar joints or the repointing in this area may not have been as complete as the surrounding areas.

Masonry Repair at Southwest Corner
