Wetland Consulting Services

WCS Proj #: Boxford-26A

RE: Supplemental Information, NOI Application, Culvert Replacement, 49 Woodcrest Road, Boxford, MA (DEP File # 114-1203)

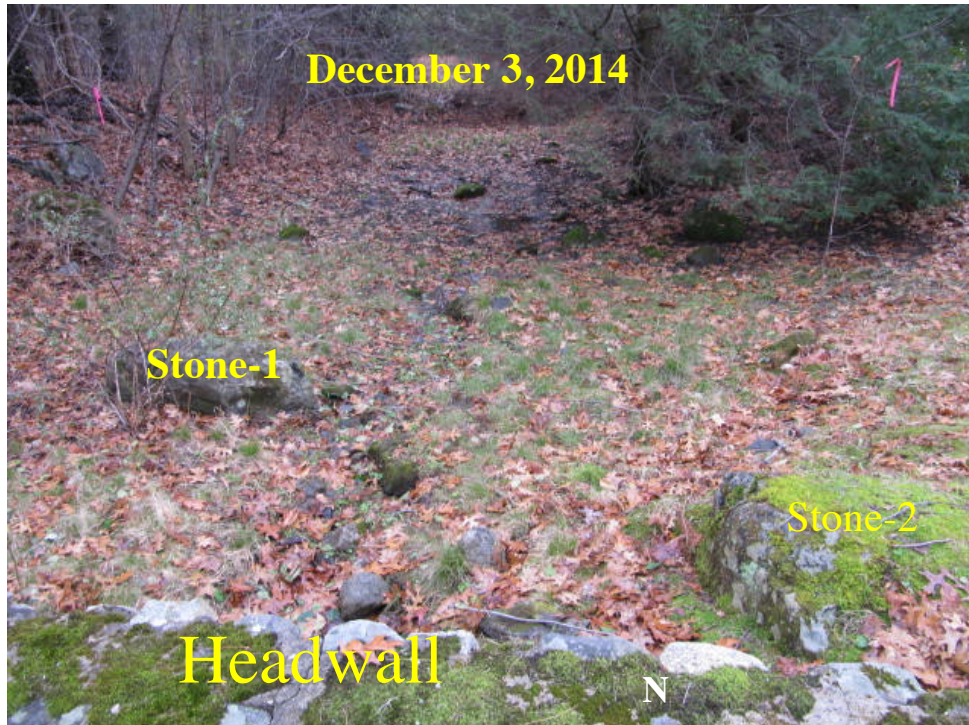
Flow on the outlet side of the culvert is somewhat dispersed and only partially contained within a channel. If any Bank exists, the Bank is only 2" to 3" high (see Photos A and B). Photo B shows water flow within a shallow channel in early Spring that subsequently disperses after a short distance.

Photo A. View of the downslope (outlet) side of the culvert at 49 Woodcrest Road in early winter 2014. Photo by B. Prokop.

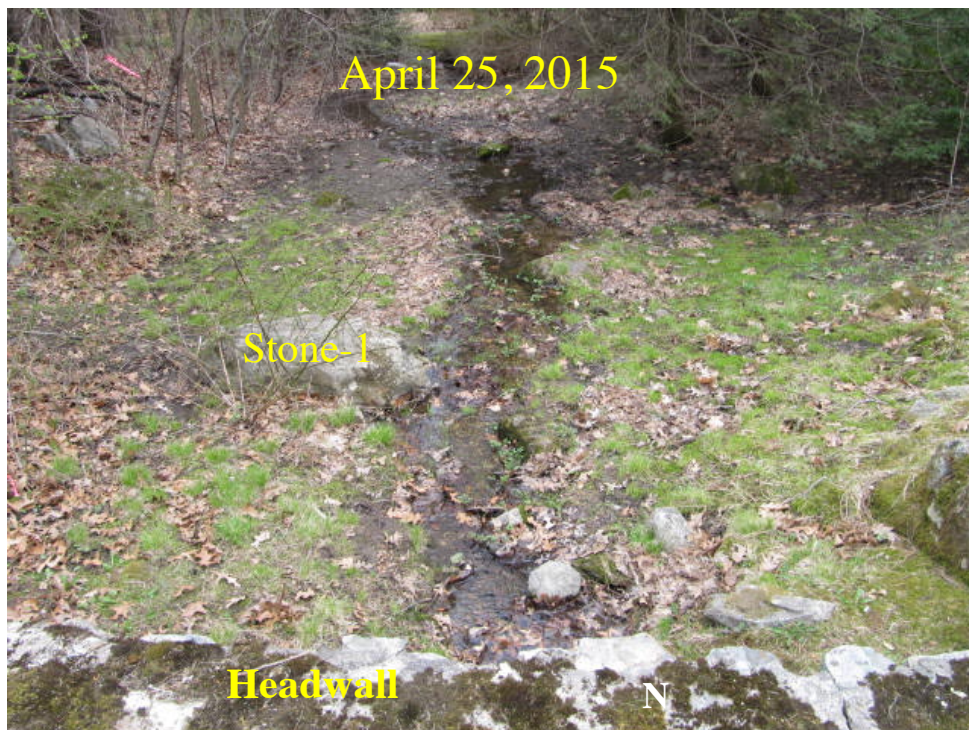
Photo B. View of the downslope side of the culvert at 49 Woodcrest Road in mid-spring 2015. Photo by B. Prokop.
