January 29, 2016

Re: Haynes Land Recreation Area Project
NHESP Conservation & Management Permit # 010-131.DFW
NHESP Tracking Number 04-16989
Boxford, Massachusetts

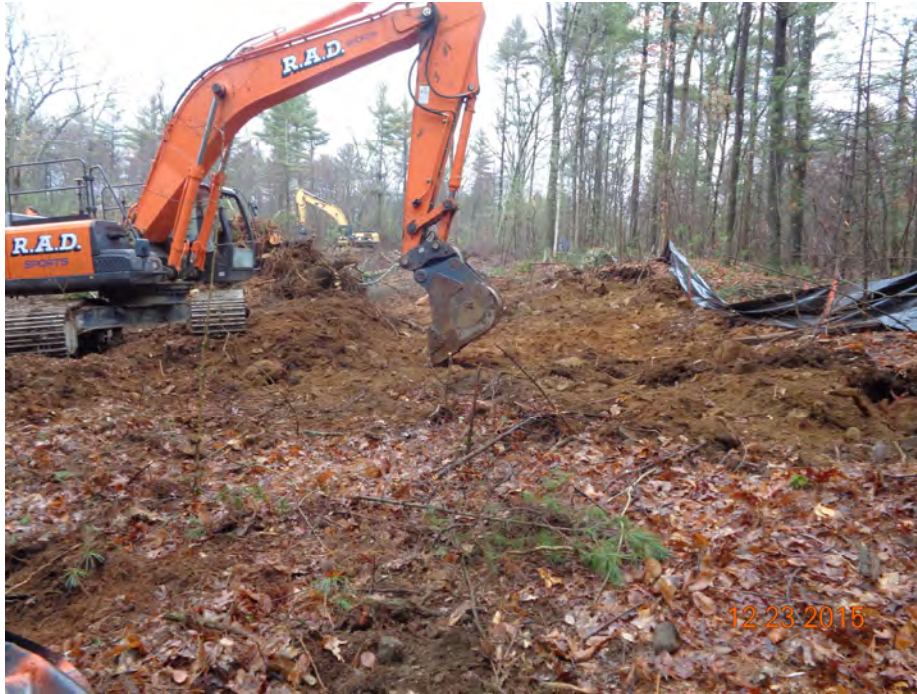
Photograph 1: Overview of Enhancement Area while top soil is being removed to expose native soil material.

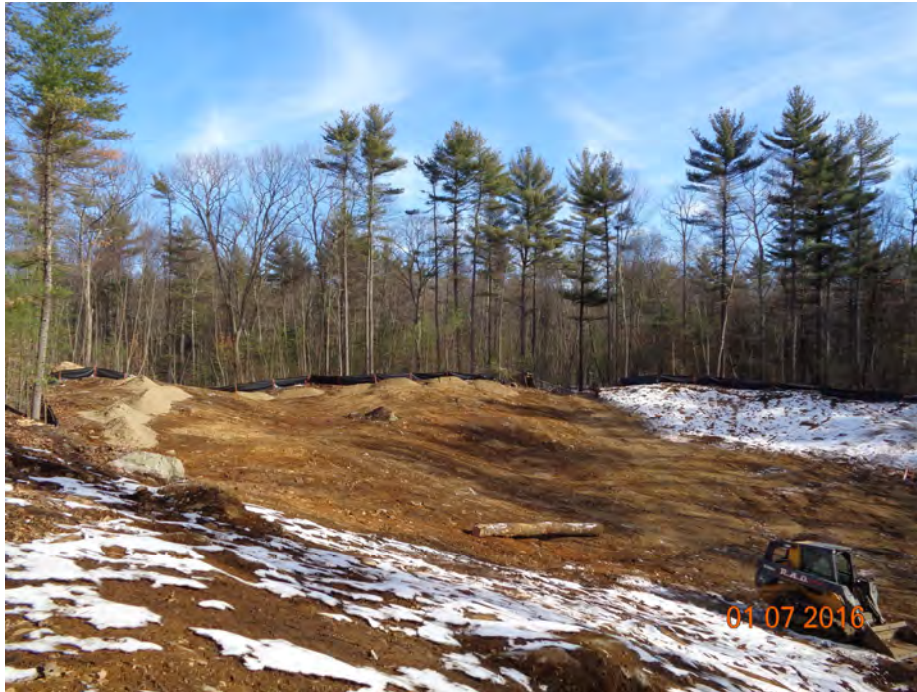
Photograph 3: Overview of Enhancement Area with top soil and vegetation removed, looking northeast.

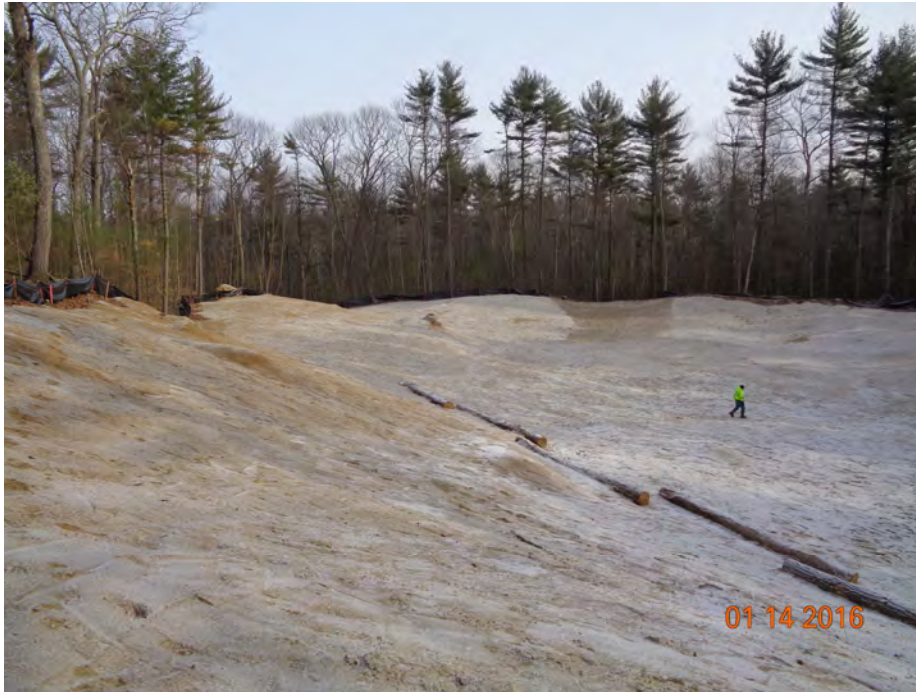
Photograph 7: Overview of Nesting Enhancement Area looking northeast with addition of supplemental soil completed.

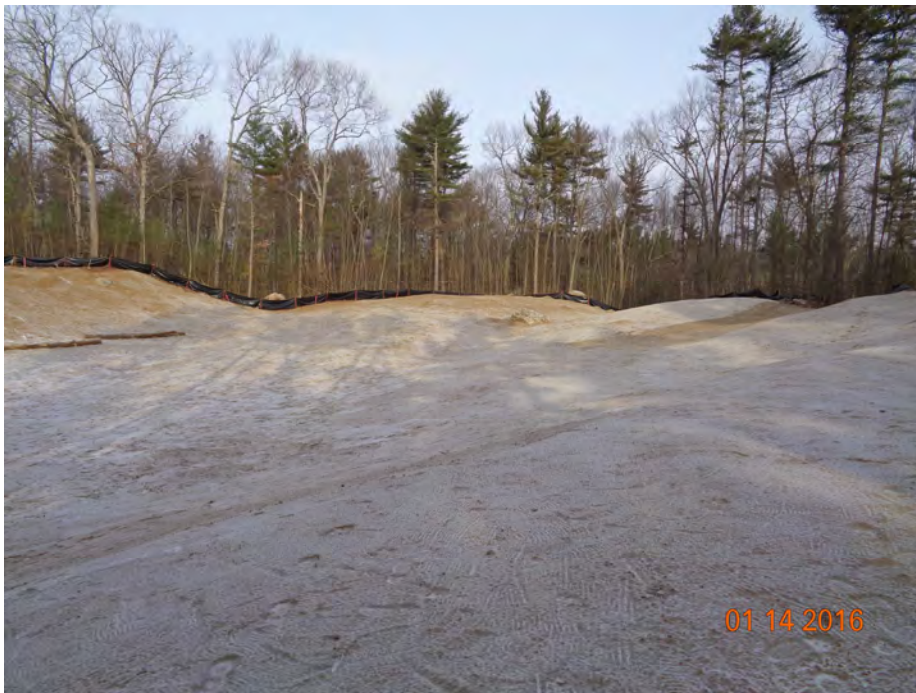
Photograph 8: Overview of Nesting Enhancement Area looking northwest with supplemental soil.
