Subject: Abbreviated Notice of Resource Area Delineation- Peer Review
Map 6, Block 2, Lot 2.2
DEP File Number 114-1235

Our office was hired by your Commission to conduct a peer review of the Abbreviated Notice of Resource Area Delineation, (ANRAD), prepared by Wetlands Preservation Inc., (WPI), for the above referenced property. Information reviewed included:

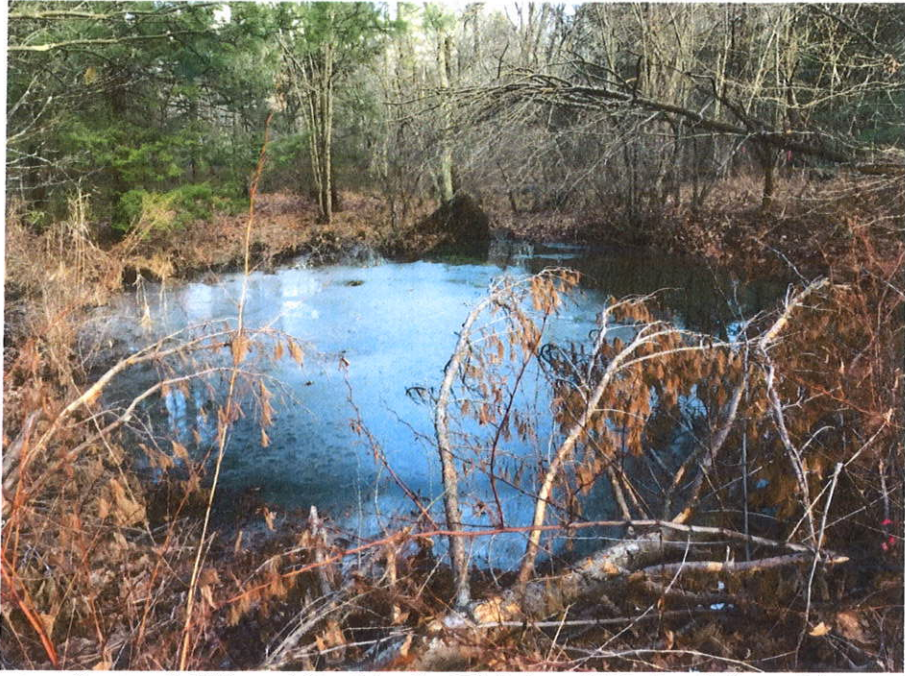
During our November 11, 2016 site visit with WPI we reviewed the delineated boundaries of the vernal pools and agreed with the flag locations. We questioned whether or not an impoundment in the vicinity of wetland flags L13-L15 was a vernal pool, (see attached photo). We have not heard back from the applicant's representative regarding this area.

Photo of potential Vernal Pool in the Vicinity of Wetland Flags L13 – L15

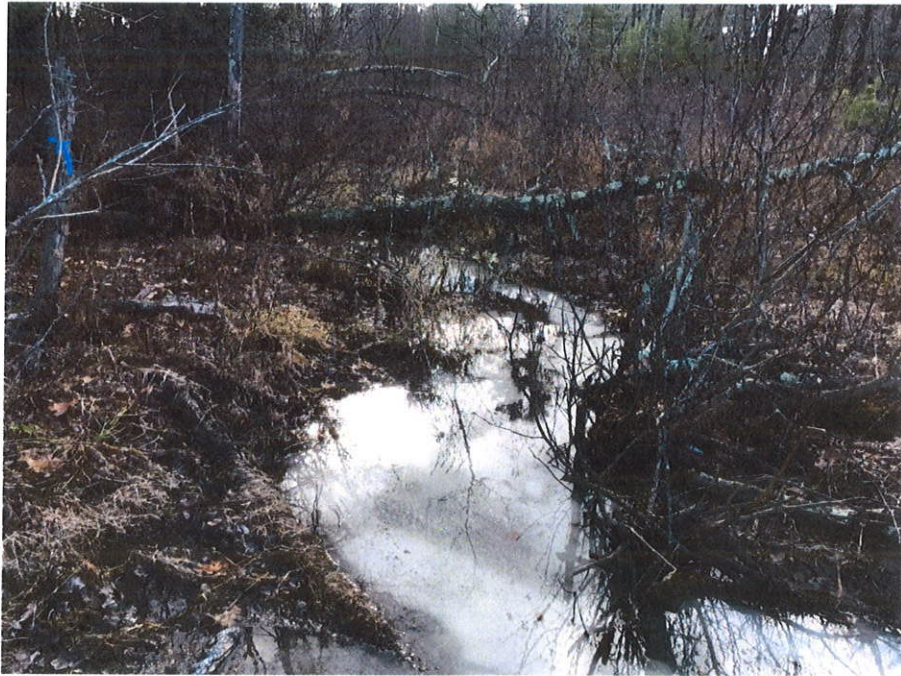
In addition we observed an oxbow in the vicinity of wetland flags M28 and M30 that comes within 10 feet of the BVW boundary and another oxbow in the vicinity of wetland flags N5 – N9. We would recommend that WPI take another look in those areas. The oxbows do not appear to be a result of beaver activity and flow was observed in each, (see attached photos).

Oxbow Near Wetland Flag N8

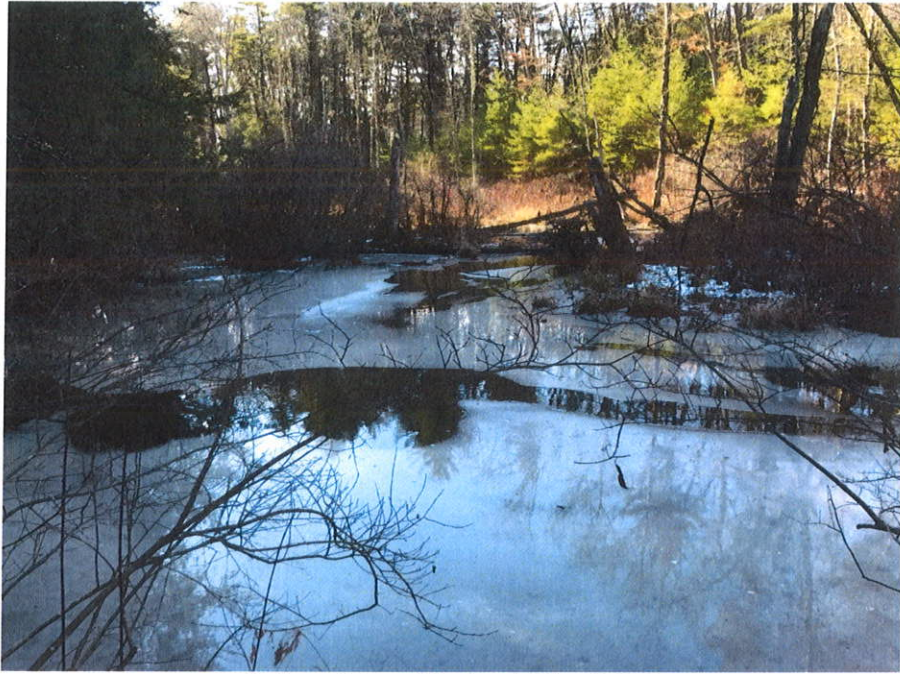
Oxbow Near Wetland Flag M28

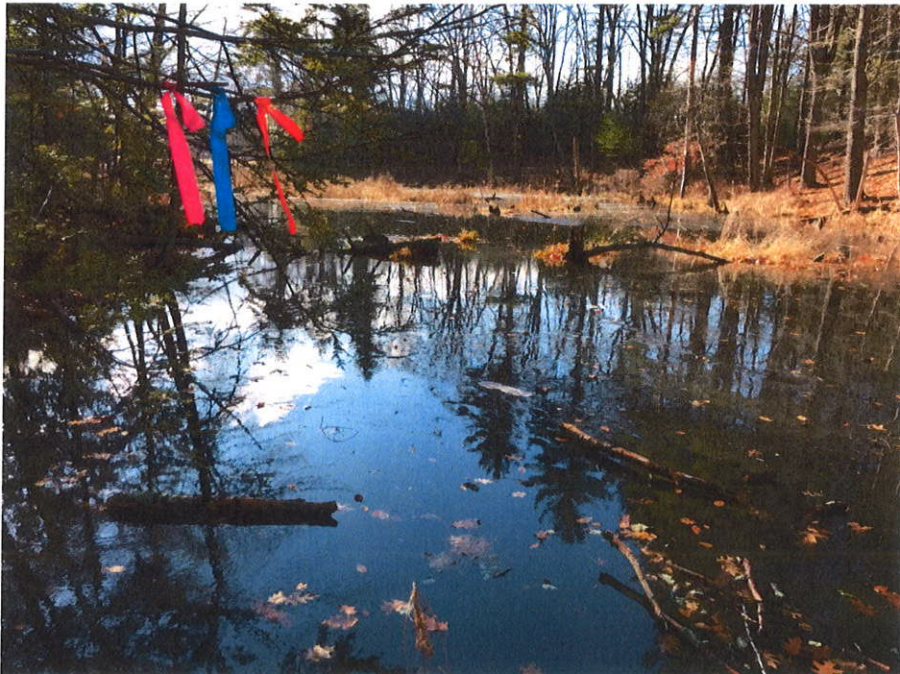
The reach of the Parker River above wetland flag M12 is flooded due to a beaver dam that exists to the north of wetland flag M13. Observations made during our site visit showed flow within the ponded area. The plan shows the river tailing away to the west of the BVW edge; however, field observations show the edge of water running parallel with the BVW edge. If the beaver dam is

staying, and the current conditions are to remain, it would appear that the ponded area is more riverine than BLSF and that the mean annual high water in this reach would be coincident with the BVW boundary or just below it. This reach is not identified on the USGS map as a lake, pond or reservoir and based on our observation it appears that the ponded area has primarily riverine characteristics. Unidirectional flow was also observed during our site visit on November 11, 2016 by looking at vegetation under the water.

Ponded Area of Parker River Above Beaver Dam At Wetland Flag M13

In summary we are recommending classifying the ponded area above the beaver dam at wetland flag M13 as primarily riverine, delineating the reach from M13 to Z1 using Bankfull field indicators and using WPI's methodology from Z1 to the property boundary; however with a more recent photo.
