# EELGRASS RESTORATION OF NASHAQUITSA POND, CHILMARK, MA

Submitted by  
Town of Chilmark  
Shellfish Department

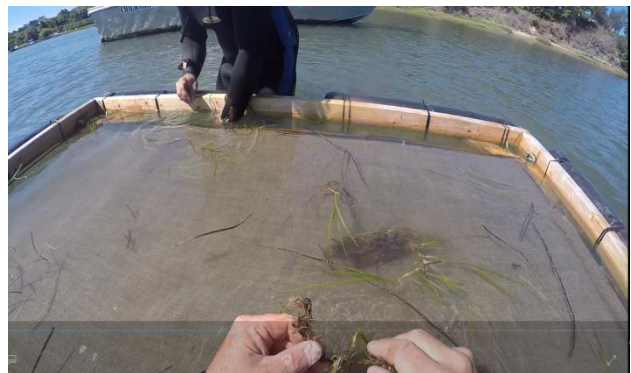
We began collecting eelgrass shoots that were free floating around Menemsha Pond with the rhizome still intact. This was an attractive source because they were abundant, easy to collect and would have been washed ashore to die, eventually. They were placed directly into tubs filled with water to keep them wet and reduce stress. After enough shoots were collected we traveled to the transplant site with the burlap outfitted frames that were constructed for this project. We began inserting shoots into the frames approximately 6 inches apart until the frames were completely filled. This work was done out of the water with the

frames stretched across the gunnels of the boat. During that time we were spraying seawater over the shoots to prevent them from drying out because this process took about 45 minutes to complete. After the frames were filled with shoots it was lowered over the side of the boat and placed on the bottom of Clam Cove Point. Frames were staked down and gravel mixed with sand was placed over the burlap. We gently pushed the root systems into the bottom. We decided to start out doing two frames at this site as a starting point to gather information and see how the frames would perform. The site was monitored daily when weather conditions would allow us to see the shoots on the bottom. As soon as we noticed that shoots were starting to die we made an adjustment to the method by constructing a floating jig to hold the frames in the water so we could plant shoots into the burlap while they were submerged. This was to prevent the shoots and root systems from drying out and increasing stress. As a result, we saw slightly longer survival of the eelgrass, but ultimately all the shoots died. After trying five variations to the method using the frames we decided to see if we could collect eelgrass along the channel of Menemsha Creek that was being undercut by tidal currents. There was plenty of eelgrass intact with root systems, some that looked as if they were newly uprooted. We collected it by diving and pulling gently until the clumps were dislodged without disturbing those plants that still had their root systems in the bottom. The donor shoots were placed in mesh bags and kept submerged while being transported to the transplant site. We used the same method of transplanting with the floating jig and placing the frames on the bottom using sand and small gravel to cover the frames. The majority of shoots looked much healthier and for a longer period of time, which you can see from the data sheets below. However, they eventually all died and the frames were removed.

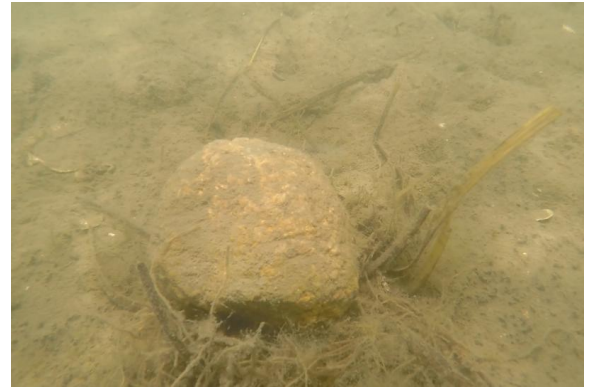
The rock method, which can be seen in the picture to the right, was far easier than the frame method. Despite being an easier form of restoration we saw the exact same mortality rates until finally none of the eelgrass shoots we transplanted were alive, except for one shoot that was transplanted at the end of the summer when water temperatures were cooling off. The picture to the right is the one shoot that survived as of mid October 2016. It actually seemed to recover and become green again before the water cooled off and it went dormant.

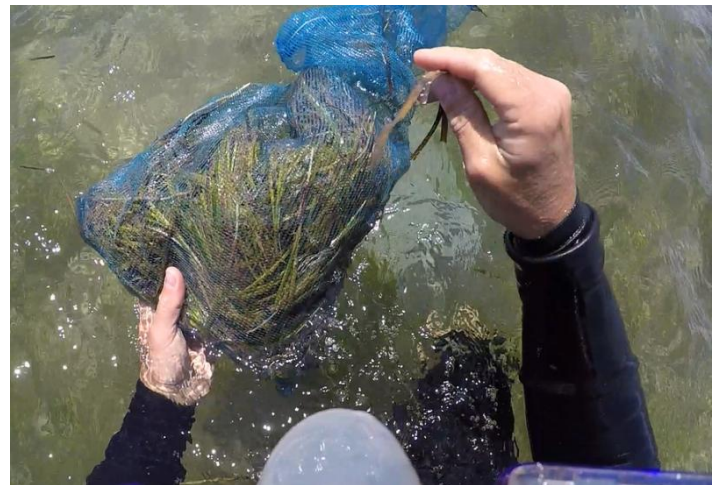
Seed shoots were gathered from July 10th to July 21st, 2016. Seed shoots were extremely easy to collect, especially at a slack tide when shoots were vertical in the water. The seed shoots are designed to detach from the plant, and were taller than the blades around them so handfuls could be harvested without tugging on the plant itself. The seed shoots were placed in mesh bags and attached to a floating line at each of the restoration sites. The bags were left to distribute the seeds as the seed ripened and shoots decayed. At the end of October bags were removed and the contents were evaluated to confirm that all seeds were released. Only a few seeds were left in each bags.

Collecting seed shoots and floating them over the restoration sites to distribute seeds might prove itself to be the best method, and we will know in the spring if that was successful. We did this for each intended restoration site, so thousands of seeds were released. If they survive predation and winter conditions, the sprouts should emerge in the spring of 2017.
