To: Chilmark Board of Selectman  
From: Michael Mauro, Transportation Program Manager  
Date: November 6, 2018  
Subject: Multi-Way Stop Sign at Basin Road/North Road Intersection

At the request of the Chilmark Board of Selectmen, the Martha's Vineyard Commission staff carried out a multi-way stop sign warrant analysis at the intersection of North Road and Basin Road. Using the Manual on Uniform Traffic Control Devices (M.U.T.C.D.), the aim was to assess the application of a stop sign on the North Road westbound approach to the intersection.

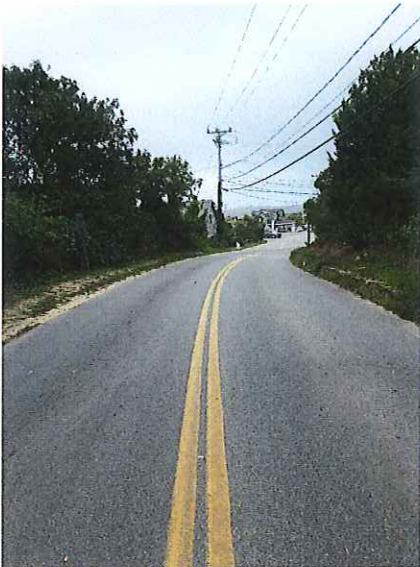
**North Rd – Westbound Approach**

**Sight Distances:** The minimum required sight distance – the length of road visible for a driver – along a road with a posted speed limit of 25 mph is 155 feet. The existing sight distance for vehicles turning from Basin Road onto North Road looking eastbound is roughly 190 feet, which is adequate. The sight distances also exceed the required distances on roadways with upgrade percentages of 3% = 147 ft., 6% = 143 ft., and 9% = 140 ft. The existing sight distance for vehicles turning from Basin Road onto North Road looking westbound is well over 200 ft, which is adequate. The sight distances also exceed the required distances on roadways with downgrade percentages of 0% = 155 ft., 3% = 158 ft., 6% = 165 ft., and 9% = 173 ft. The site distance on North Road looking westbound is also 190 feet which though satisfies the adequacy requirement is limited by the vegetation along the roadway shoulder.

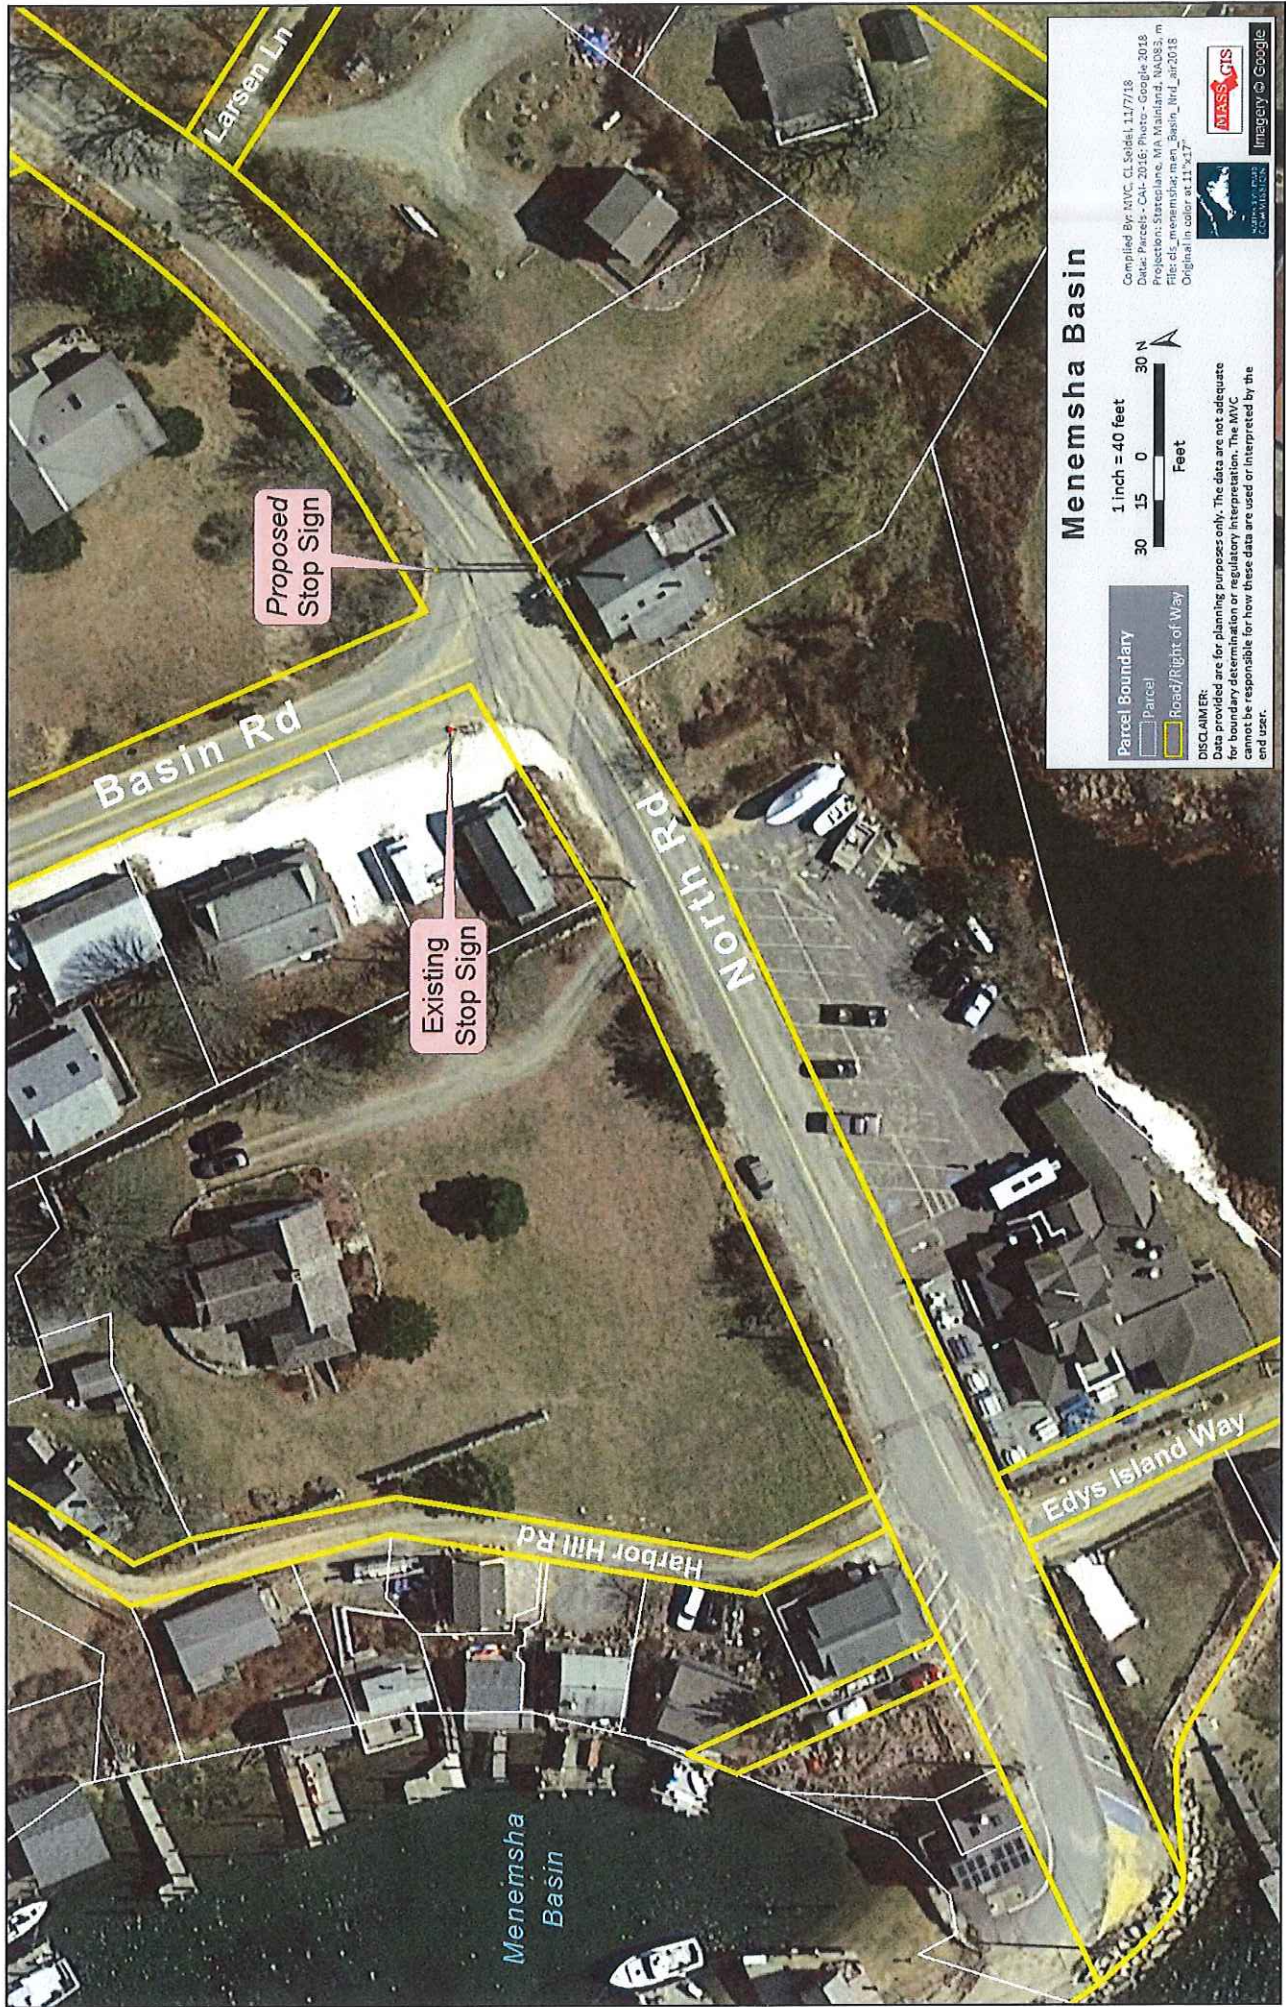
# Menemsha Basin

A study area map is included in this packet highlighting both the existing stop sign on the Basin Road southbound approach as well as the proposed stop sign on the North Road westbound approach.

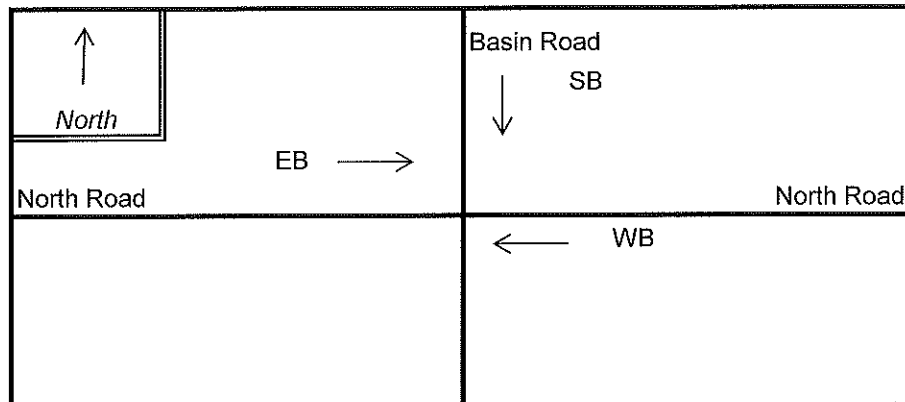
**INTERSECTION  
DIAGRAM**  
(Label Approaches)

APPROACH :	1	2	3	4	5	Total Peak Hourly Approach Volume
DIRECTION :	EB	NB	WB	SB		
PEAK HOURLY VOLUMES (AM/PM) :	88	0	170	140		398
