Fairhaven Board of Selectmen

July 10, 2017 Meeting Minutes

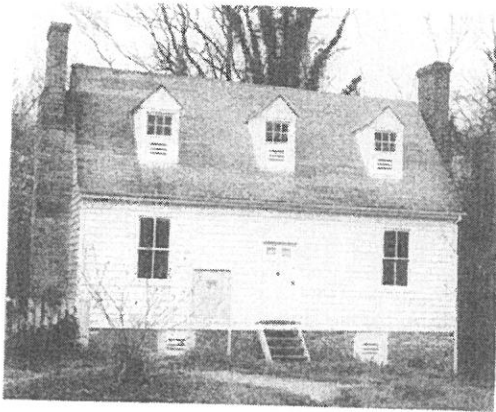
Figure 10. Regrading around the Booker Tenement at Colonial Williamsburg has protected the masonry foundation wall from excessive damp. This building has been successfully mothballed for over 10 years. Note the attic and basement vents, the temporary stairs, and the informative sign interpreting the history of this building.

If there are no significant landscape or exposed archeological elements around the foundation, consideration should be given to regrading the site if there is a documented drainage problem (see fig. 10). If building up the grade, use a fiber mesh membrane to separate the new soil from the old and slope the new soil 6 to 8 feet (200 cm-266 cm) away from the foundation making sure not to cover up the dampcourse layer or come into contact with skirting boards. To keep vegetation under control, put down a layer of 6 mil black polyethylene sheeting or fiber mesh matting covered with a 2"-4" (5-10 cm.) of washed gravel. If the building suffers a serious rising damp problem, it may be advisable to eliminate the plastic sheeting to avoid trapping ground moisture against foundations.

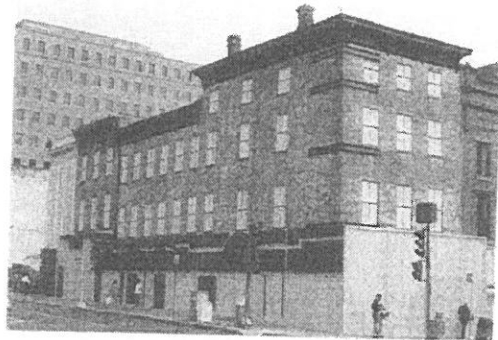
Figure 11. Urban buildings often need additional protection from unwanted entry and graffiti. This commercial building uses painted plywood panels to cover expansive glass storefronts and chain link fencing is applied on top of the panels. The upper windows on the street sides have been covered and painted to resemble 19th century sash. Photo: Thomas Jester, NPS.

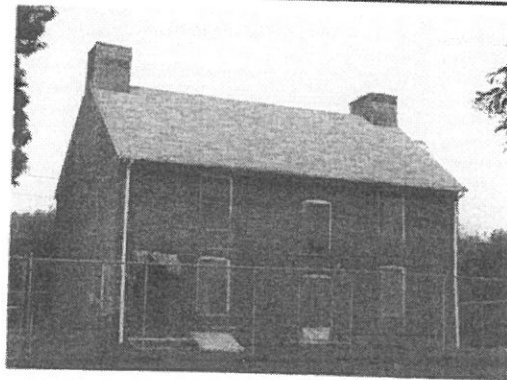
a. A view showing the exterior of the house in its mothballed condition.
