CITY OF FRANKLIN, NH
COUNCIL AGENDA REPORT
JANUARY 5, 2015

The first public hearing is on Resolution 05-15, to determine whether to fund the "Cross Street Tank Rehabilitation Project" and the "U.S. Route 3 / Industrial Park Drive Water Main Relocation Project".

***INSPECTION AND CLEANING OF THE CROSS STREET
500,000-GALLON WELDED STEEL WATER STORAGE TANK***

Cross St Standpipe

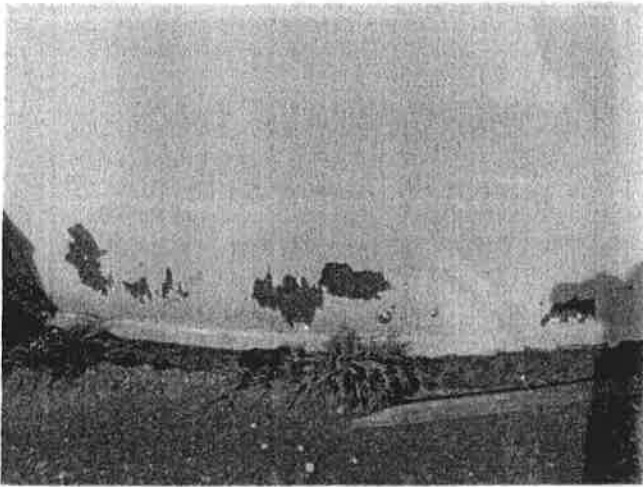
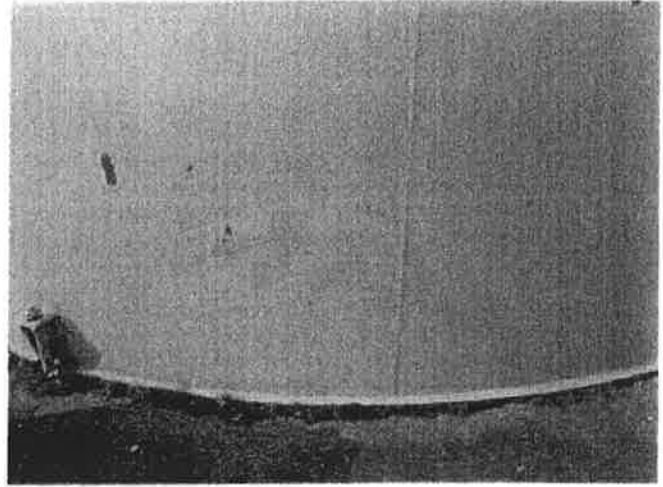
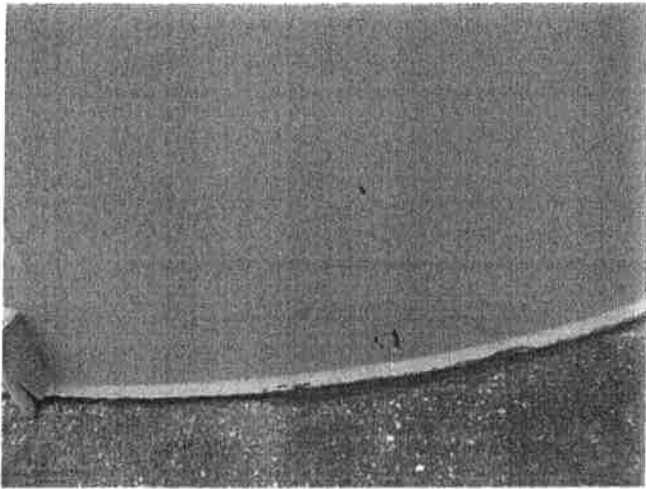
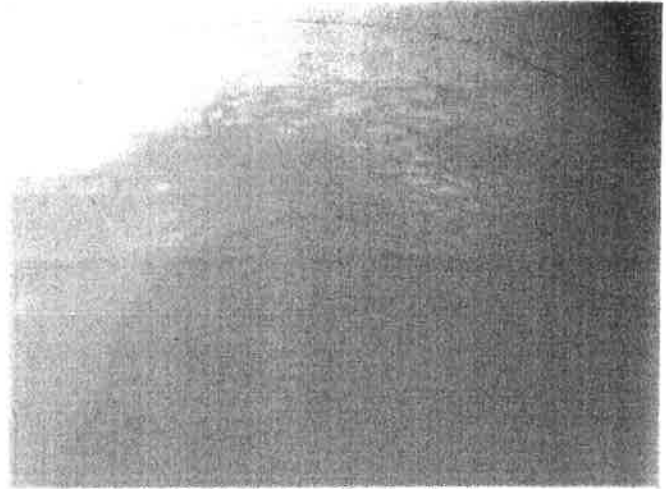
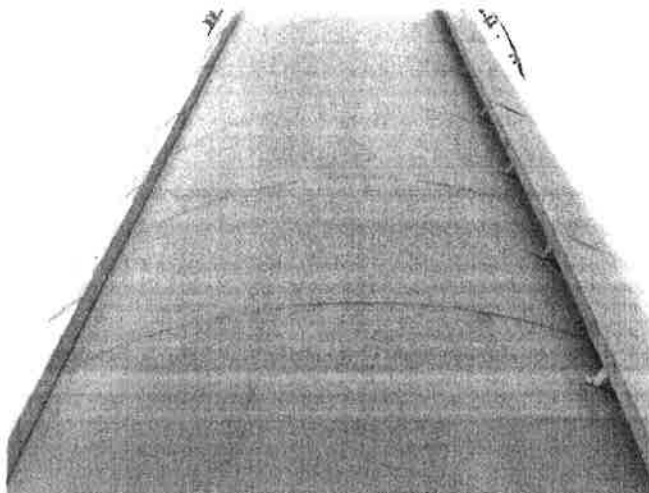
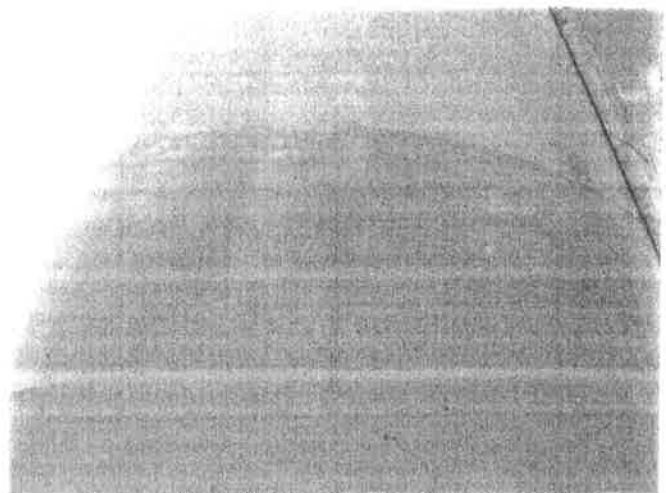
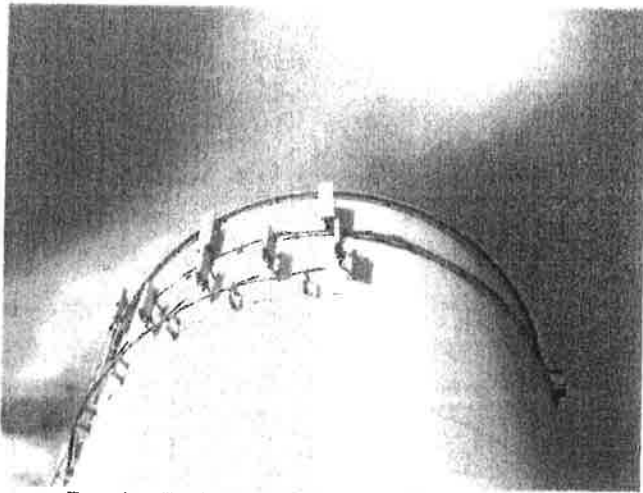
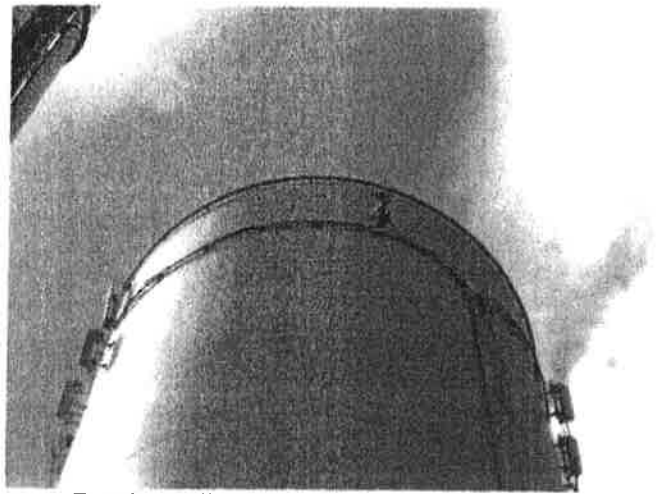
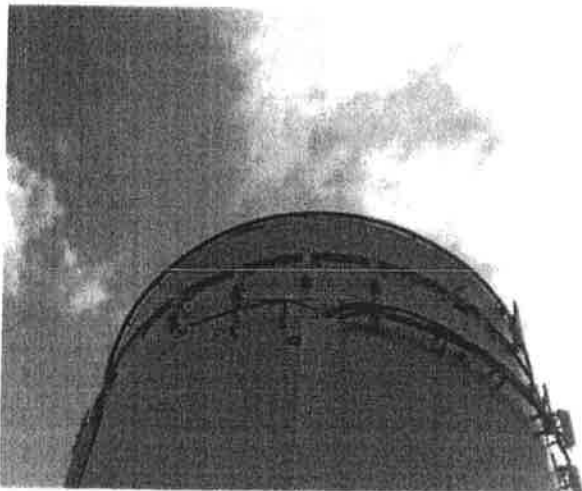
The exterior wall panel surfaces, to include all welds between panels, were inspected and found sound while numerous coating chips, ranging from 1/4" to 1" in diameter, exist throughout the lowest 25' of the tank causing exposure of the underlying of the steel.

These coating chips appear to be the result of objects striking the tank and cause mild surface corrosion of the steel.

Numerous coating chips, caused by objects striking the tank, have caused steel exposure throughout the lowest 25' of these walls, while no fatigue (pitting) of the steel was evident.

1 *Exterior Walls Yielding Coating Failure, Coating Chips, Exposed Steel And Corrosion*

We recommend re-coating the exterior wall panel and roof dome surfaces in an effort to protect the steel.

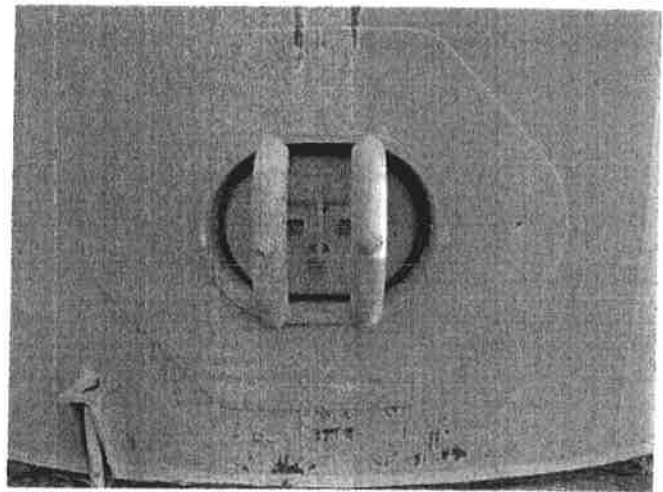
The protective coating applied to this manway was found with coating chips and failure on all hardware causing exposure of the steel.

10 *Manway*

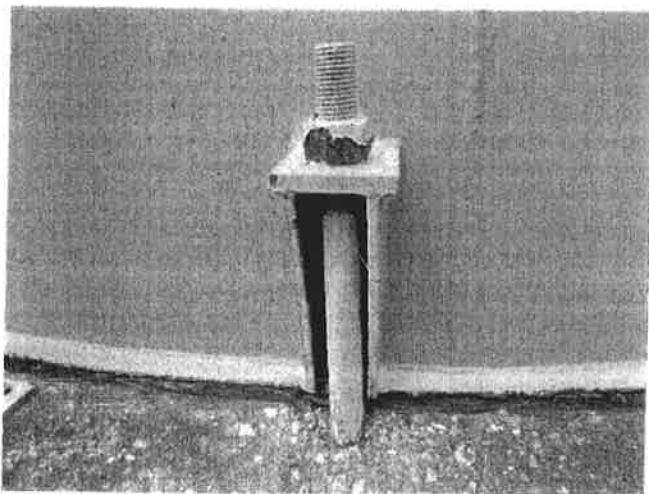
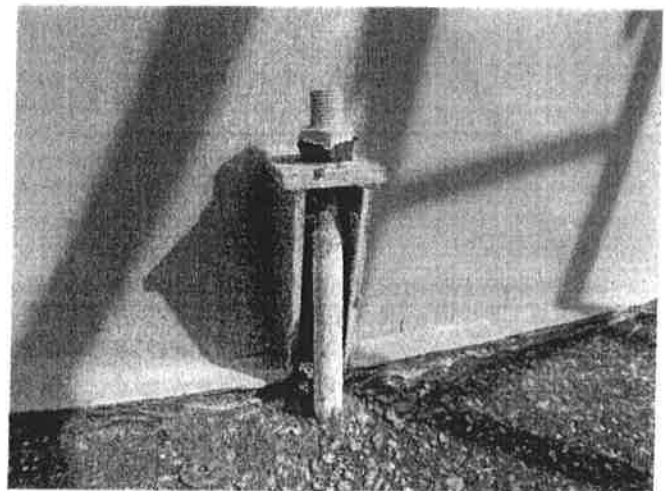
Ten, 1-1/2" diameter anchor bolts extend up from the concrete foundation through 12" tall chairs welded to the lowest row of wall panels.

Each bolt was found having a nut properly secured in place while the protective coating applied to the chairs, yields exposed primer and moderate surface corrosion where the nuts contact the chairs.

11 *One Of Ten Anchor Bolts With Coating Failure*

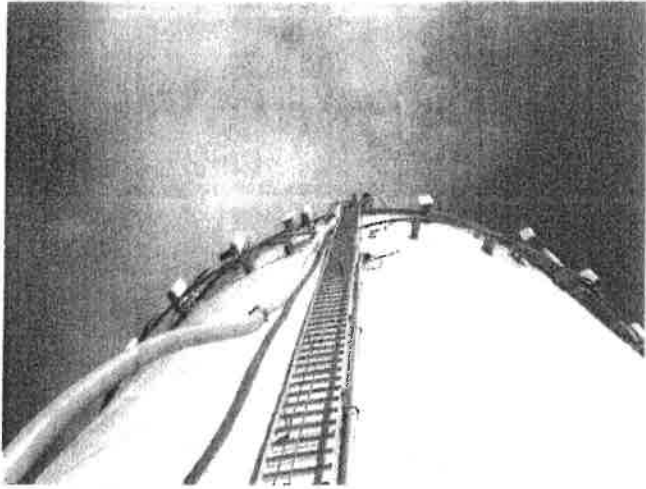
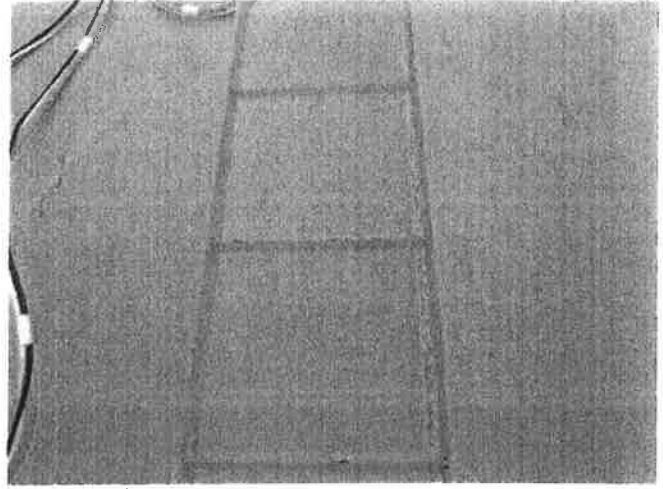
A fall prevention device is securely bolted to the ladder, remaining in good working condition at this time.

A second ladder (rotating) was found securely bolted to the vent extending down to the edge of the roof dome.

This ladder is sound and free of obvious failures at this time.

13 *Ladder*

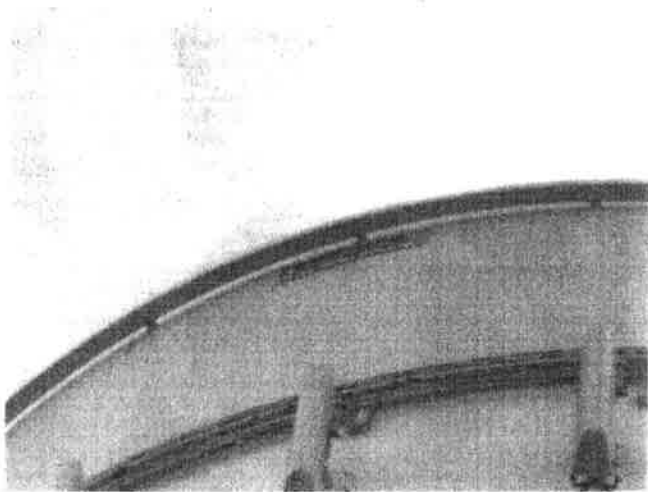
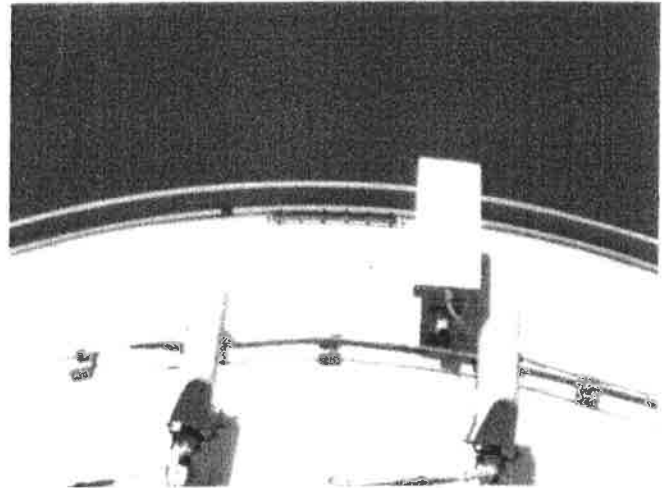
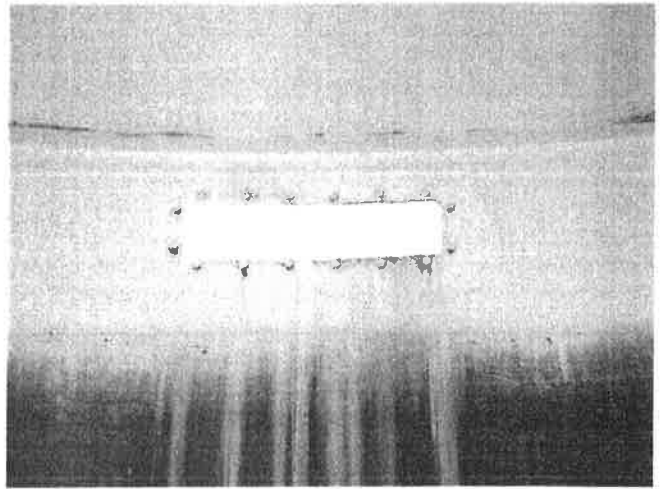
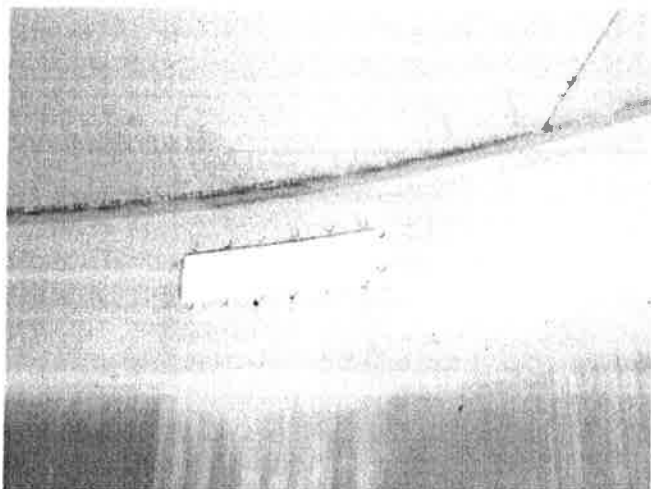
This overflow was found without obstructions at the time of this inspection.

15 *Overflow*

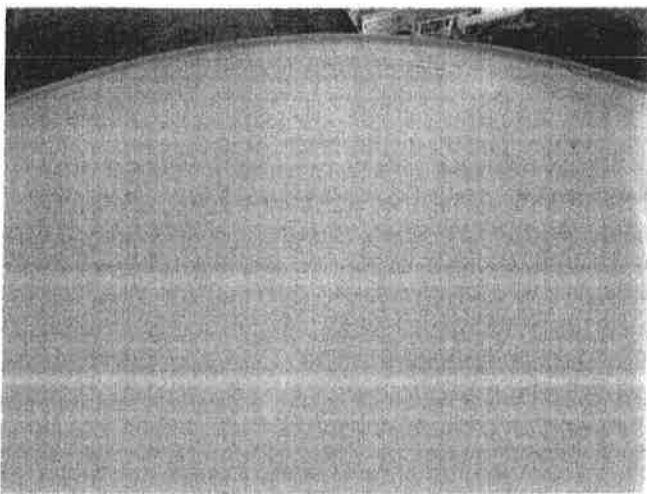
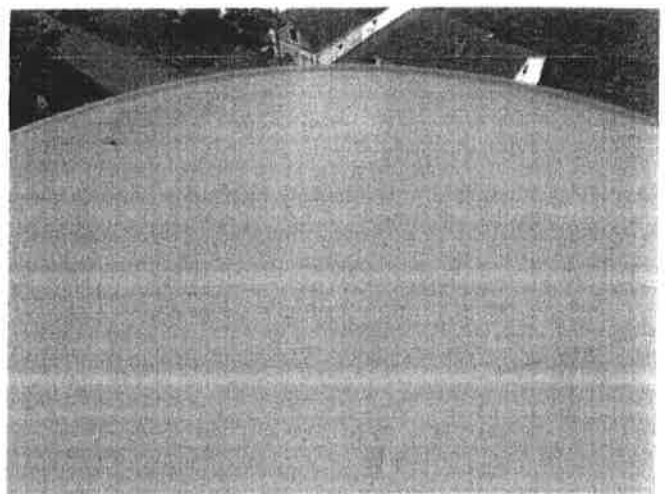
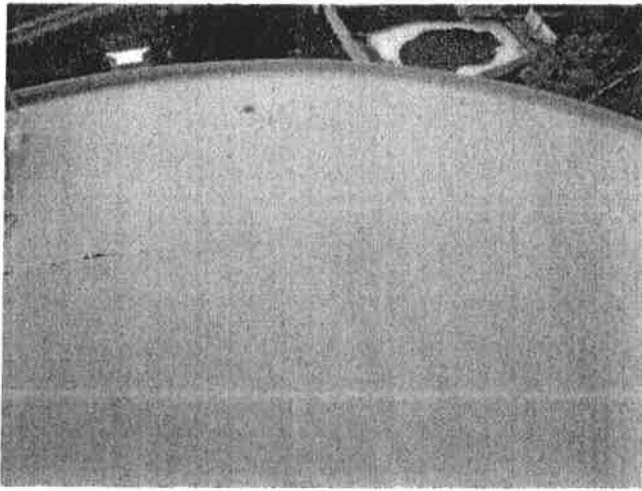
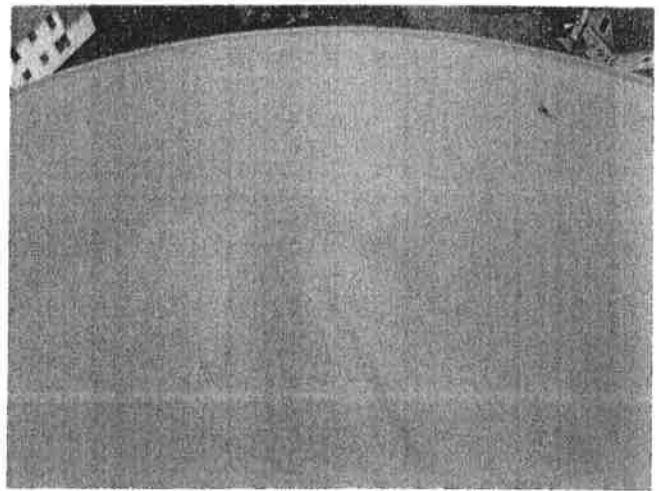
The steel panel roof dome, to include the welds between panels, appeared sound and free of obvious failures at the time of this inspection.

The protective coating applied to these roof dome surfaces was found weathered and chalky, due to decline in film thickness, causing exposure of the primer throughout approximately 15% of all panel surfaces.

The protective coating applied to these roof panel surfaces was found having decline in film thickness causing the primer to show through the coating.

17 *Roof Dome Panels Yielding Expired Coating*

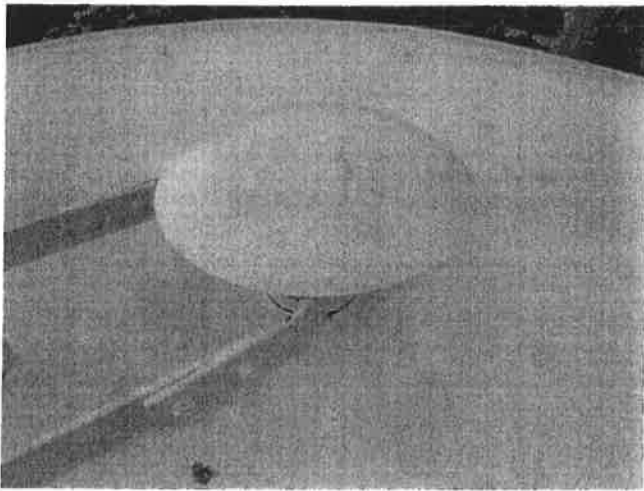
21 *Vent*

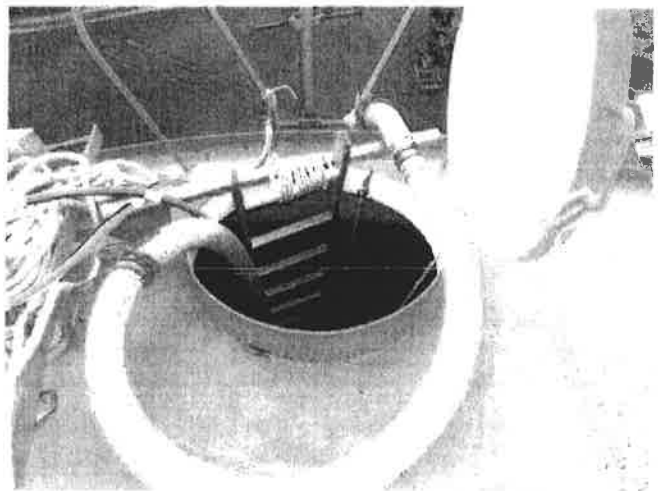
This hatch was found in good working condition and is properly secured with a lock preventing unwanted access to the tank interior.

22 *Hatch*

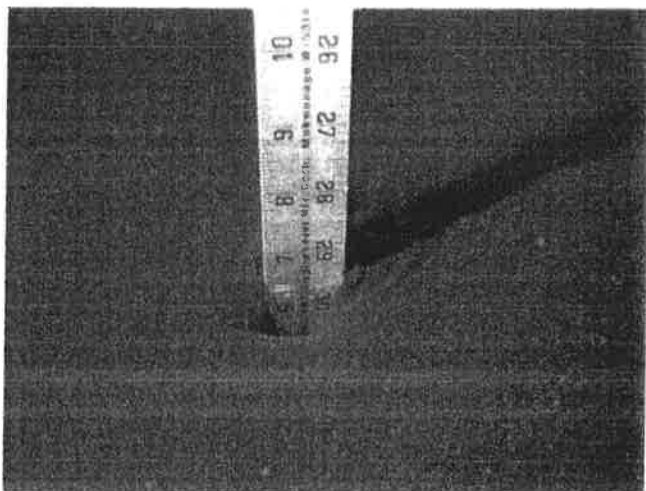
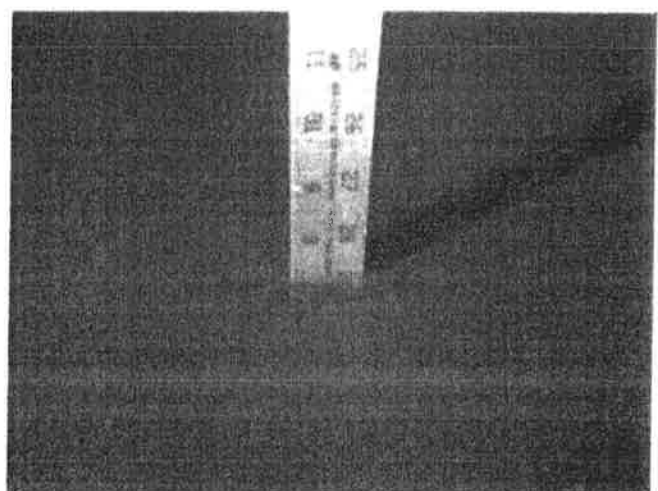
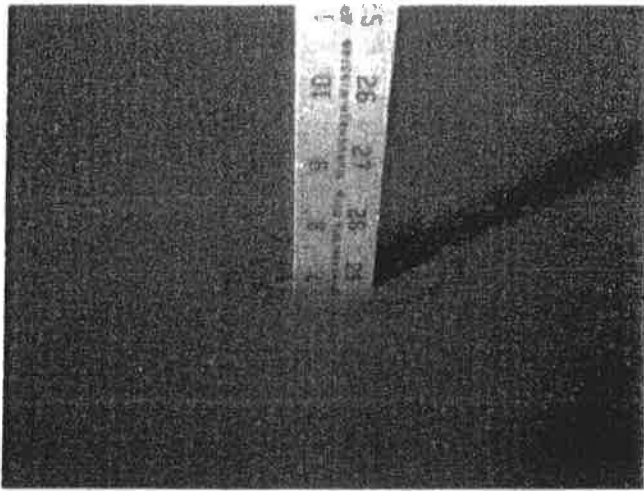
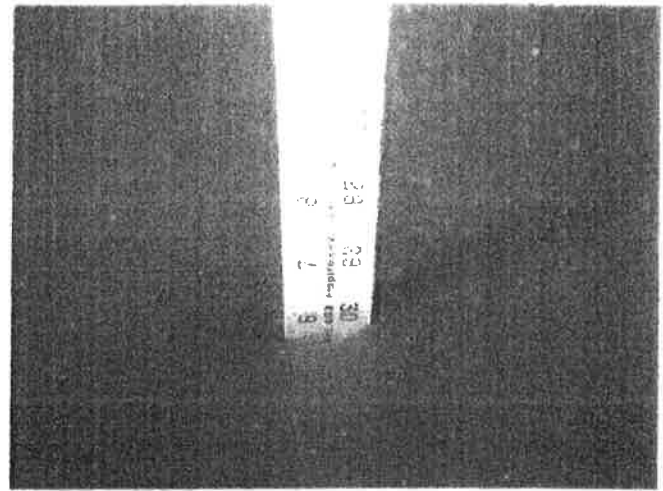
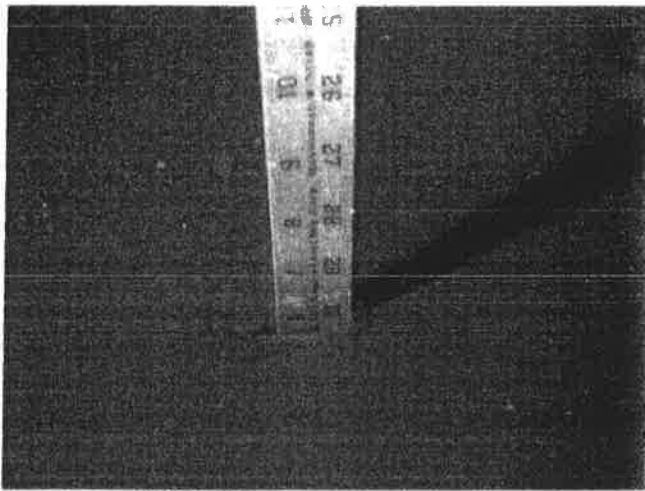
A uniform layer of accumulated precipitate was found on all floor surfaces averaging 6" in depth.

23 *Layer Of Precipitate*

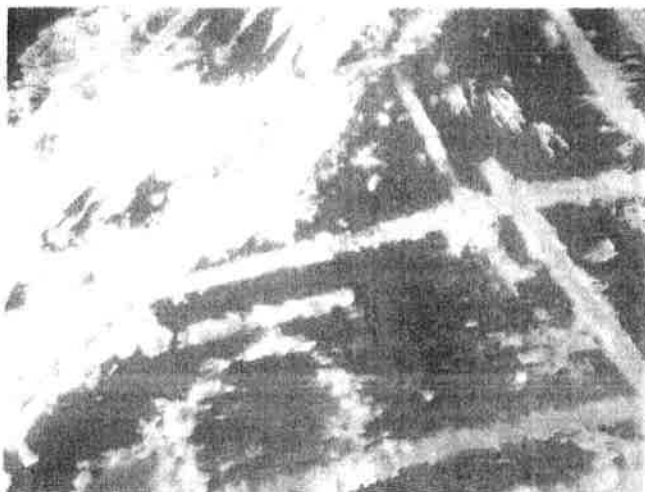
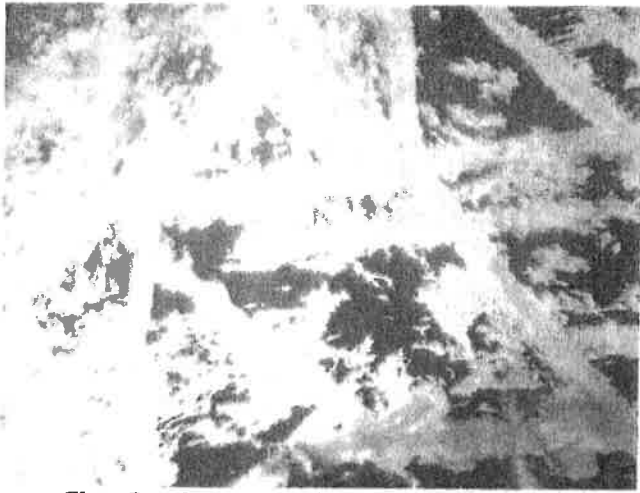
After removing all accumulated precipitate, these steel floor panels and welds between panels, were inspected and found free of obvious fatigue.

Heavy staining was found throughout all floor surfaces due to the accumulation of precipitate after cleaning.

Heavy staining exists throughout all floor surfaces due to the accumulation of precipitate.

28 *Floor Panels Found Yielding Heavy Staining After Cleaning*

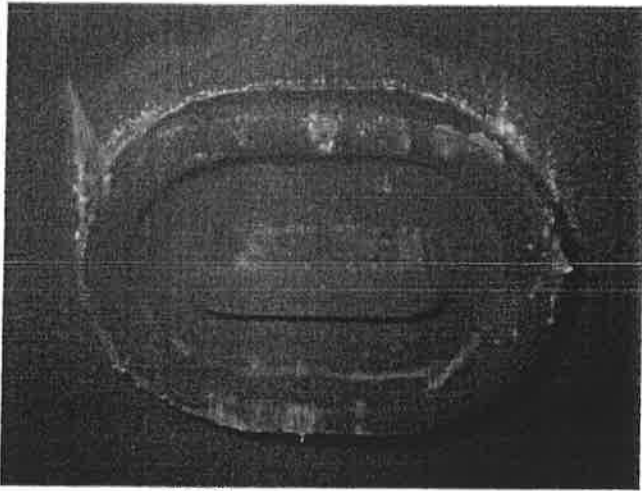
Approximately 40% of these coating blisters have ruptured and expose the underlying steel causing surface corrosion.

Fatigue, (pitting) of the steel was found within all areas having exposed steel ranging in depth from barely detectable levels to 1/16".

This manway was found properly and securely bolted in place and is free of leakage at this time.

33 *Manway Yielding Heavy Staining, Coating Failure And Corrosion*

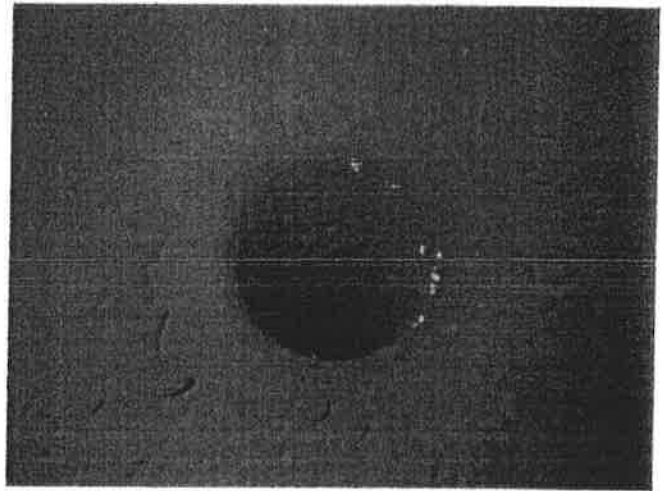
34 *Piping*

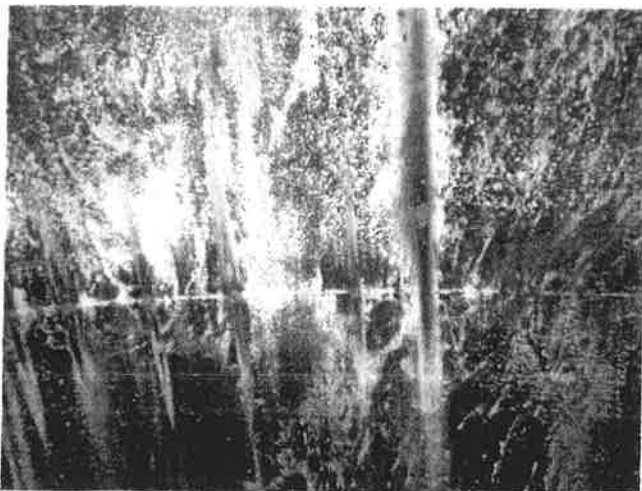
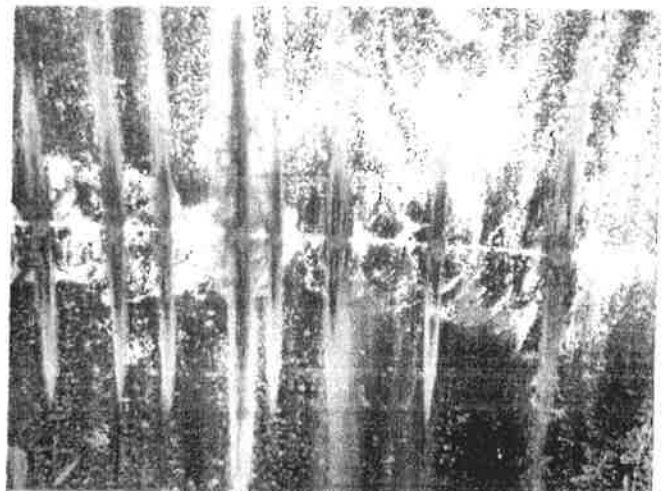
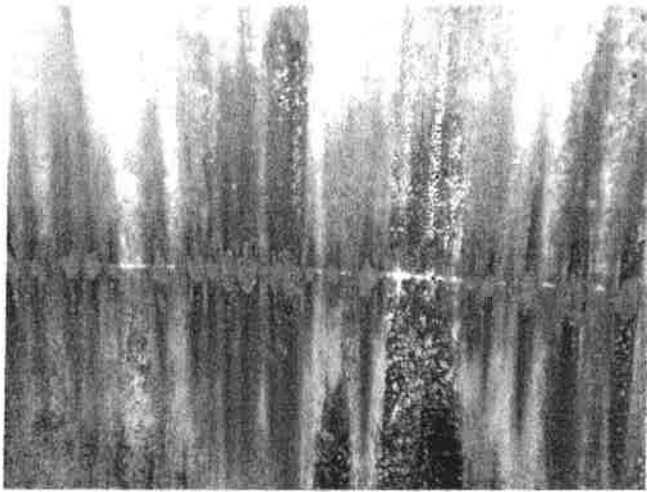
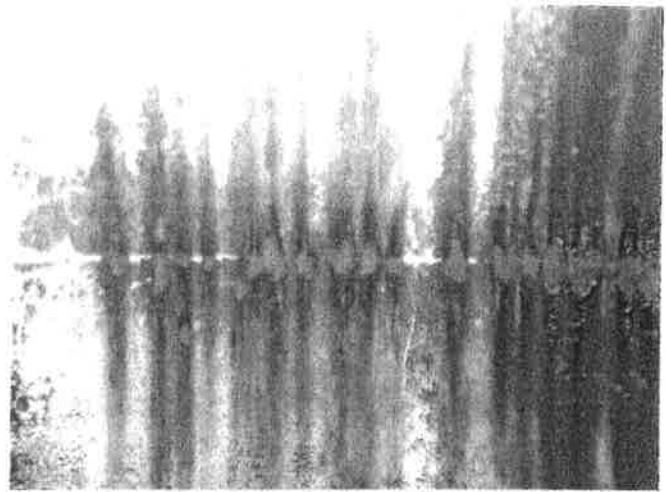
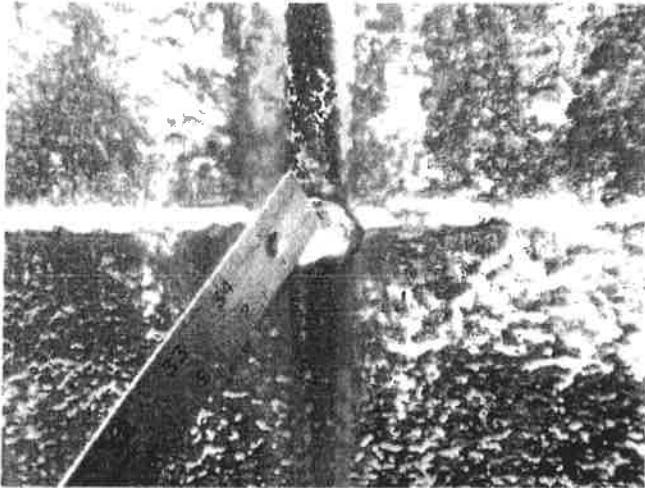
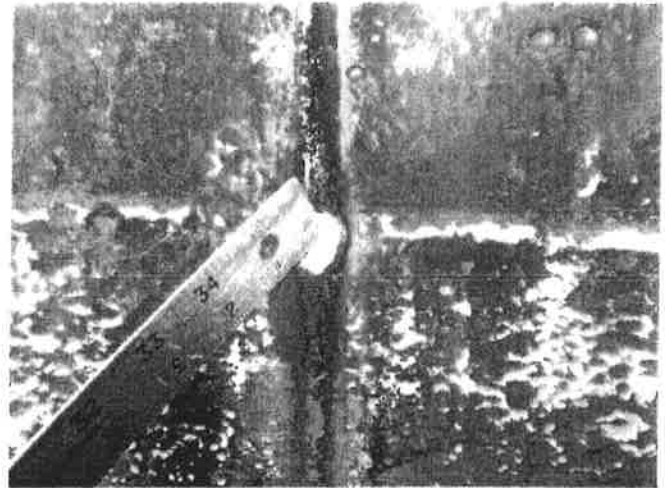
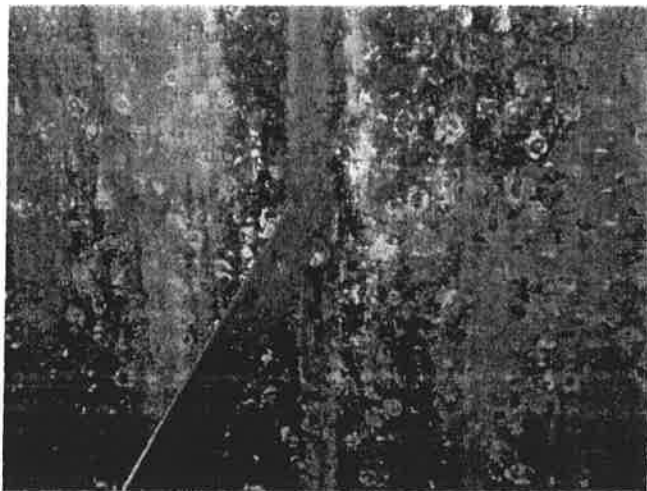
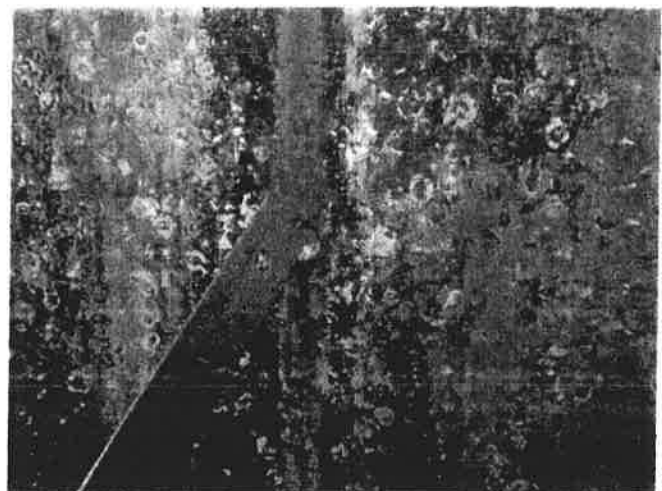
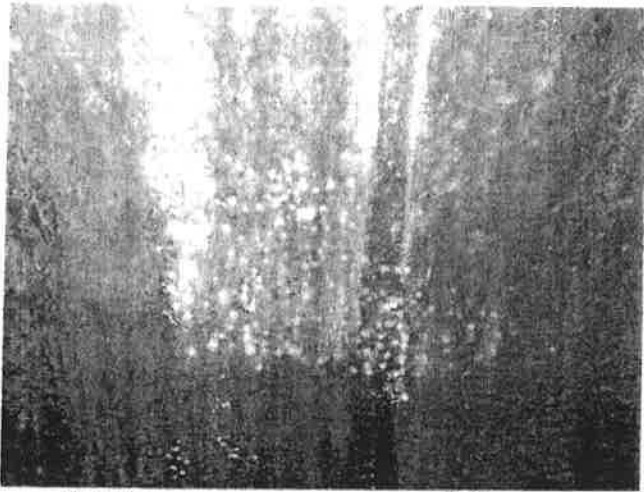
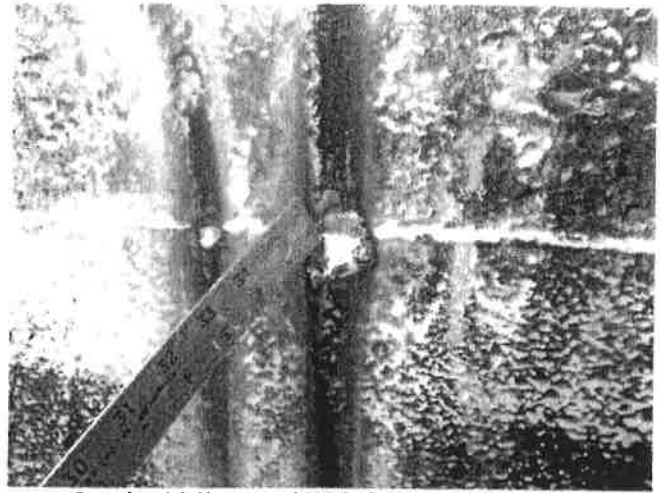
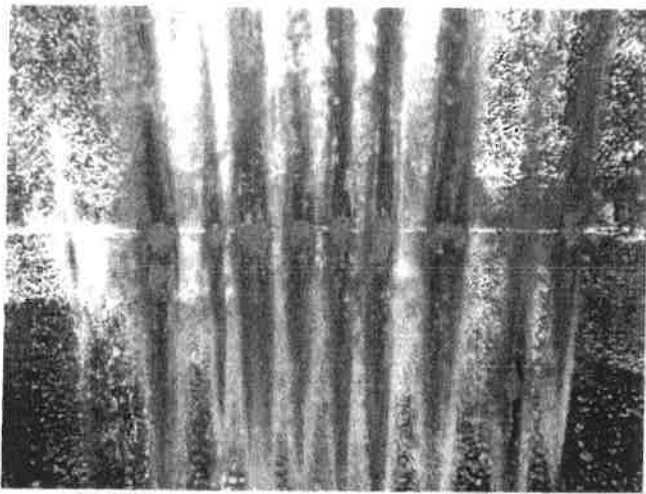
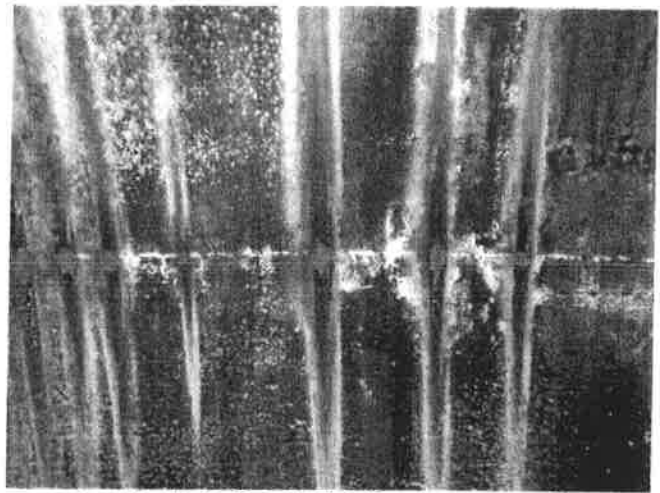
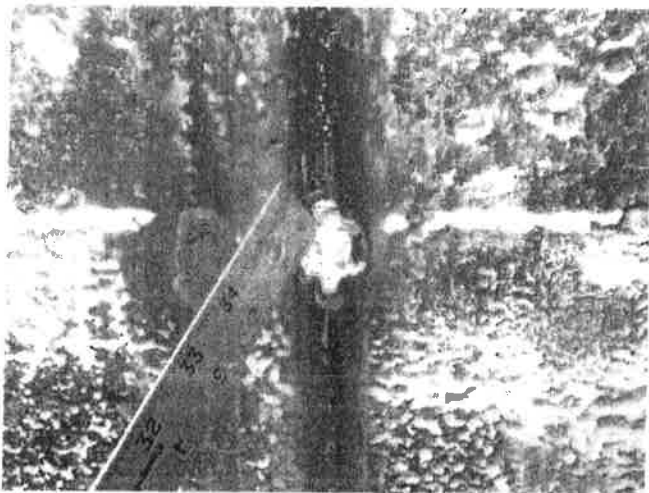
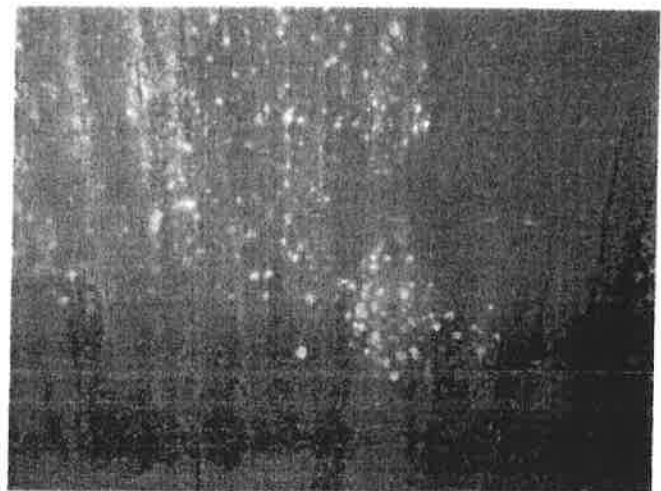
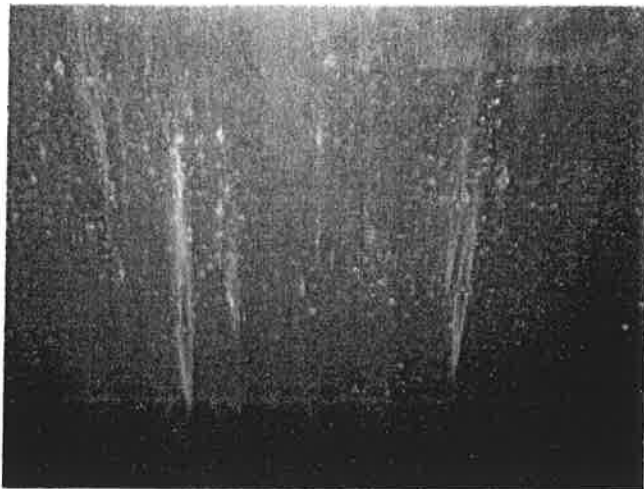
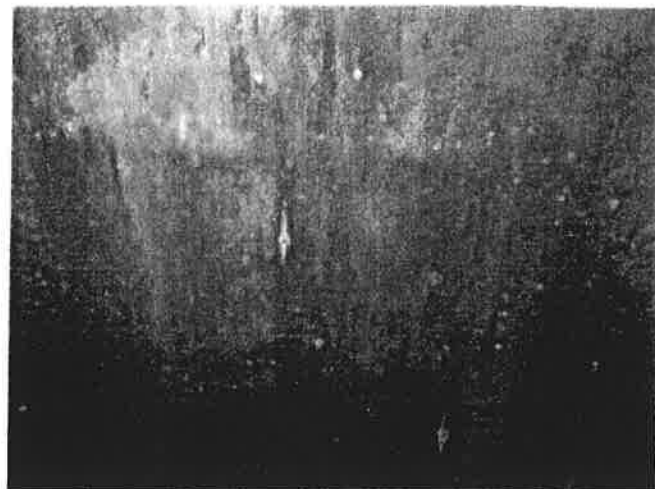
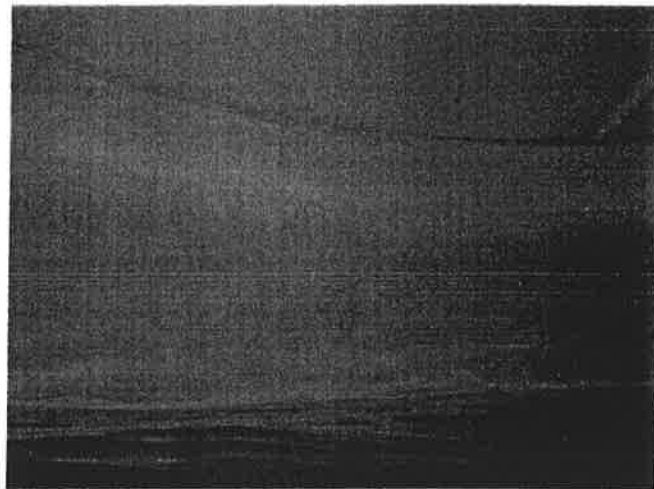
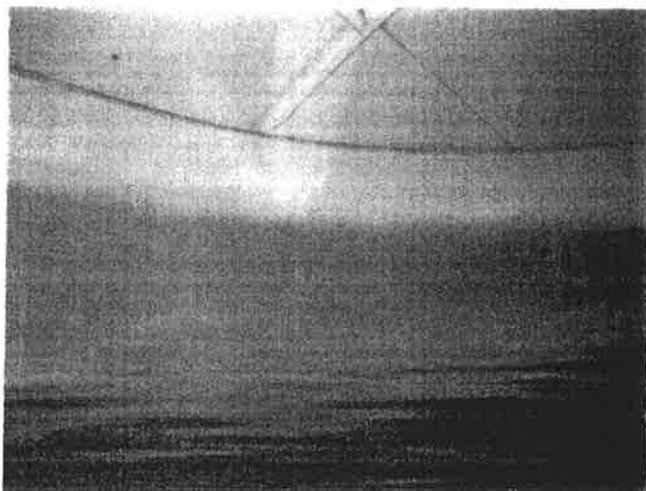
These interior wall panels and welds between panels, were inspected and found having coating blisters throughout approximately 80% of all surfaces and all elevations of the tank due to adhesion loss.

Approximately 40% of these coating blisters have ruptured, resulting in exposure of the underlying steel and cause surface corrosion.

Fatigue, (pitting) of the steel was found throughout all exposed areas of steel ranging in depth from 1/16" to 1/8".

Moderate staining exists on all wall surfaces beginning approximately 12" below the overflow cutouts and extends down to the floor.

These interior wall panel and weld surfaces yield poor adhesion value of the protective coating causing exposure of the underlying steel resulting in surface corrosion.

35 *Interior Walls Found With Coating Failure, Exposed Steel, Corrosion, Pitting And Staining*

We recommend removing the present interior wall coating system and re-coating these surfaces using an A.N.S.I./N.S.F.61 approved coating for use in structures containing potable water and should be done in the near future, as continued exposure of the steel will result in further fatigue (pitting) and eventually result in failure.

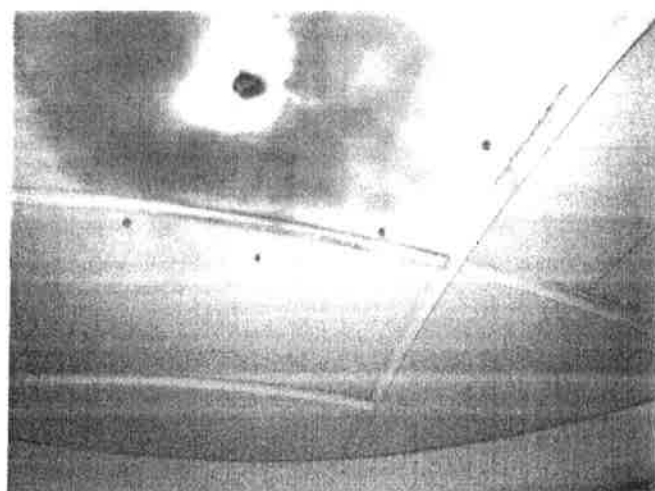
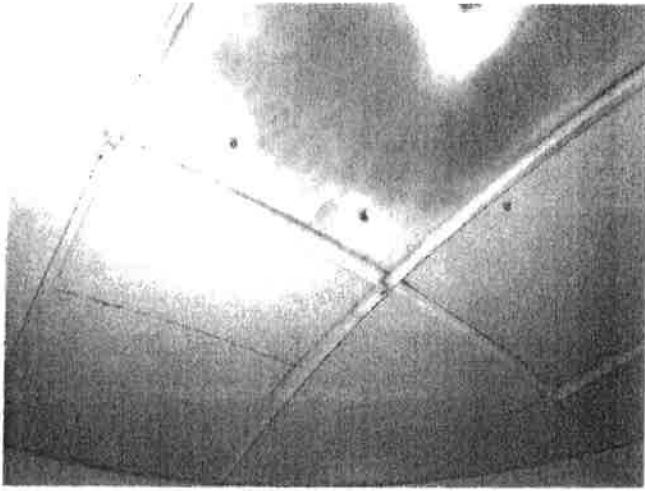
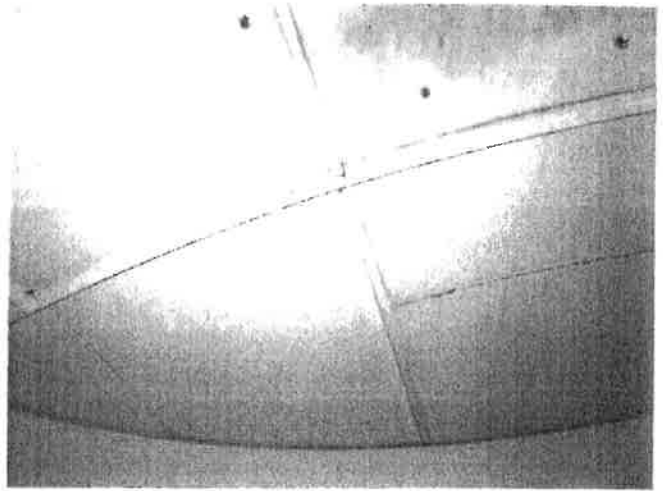
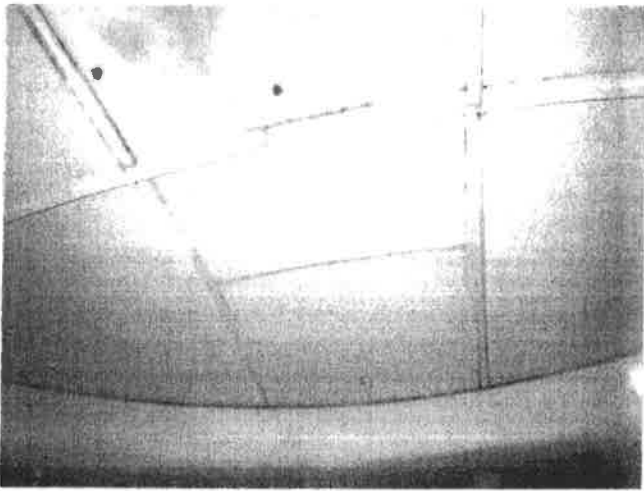
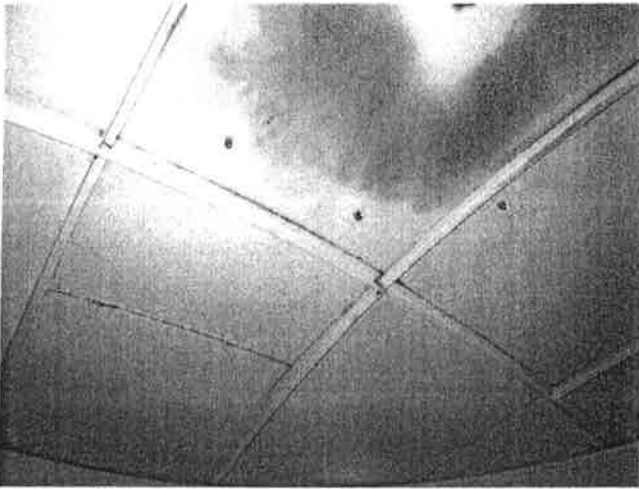
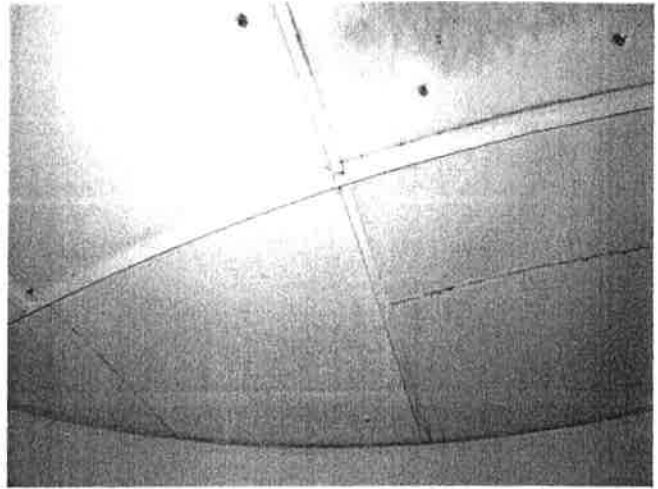
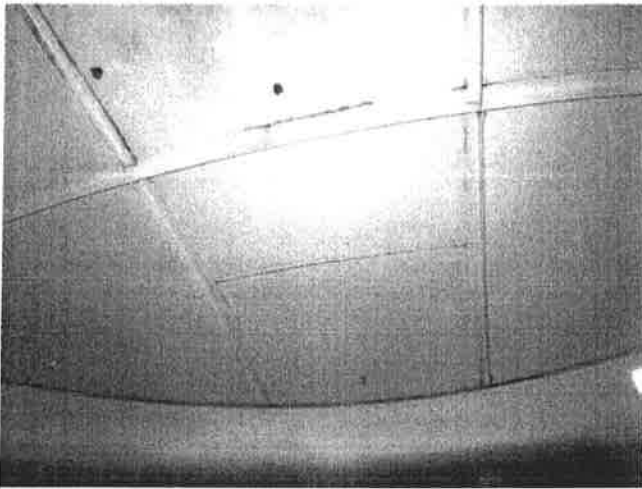
These overhead panel welds between panels and angle iron supports were found appearing sound at the time of this inspection.

The protective coating applied to all overhead surfaces shows mild blotch rusting throughout approximately 20% of all surfaces.

All overhead panels, welds and supports were found appearing sound while the protective coating applied to these surfaces yields decline in film thickness resulting in blotch rusting, yet no fatigue was seen at the time of this inspection.

54 *Overhead Panels Yielding Expired Coating And Blotch Rusting*

We recommend re-coating the interior overhead surfaces using an A.N.S.I./N.S.F.61 approved coating for use in structures containing potable water and should be done when the interior walls are rehabilitated.

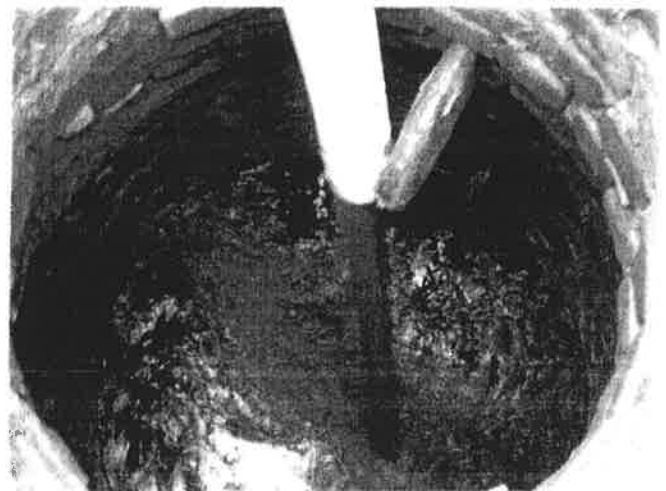
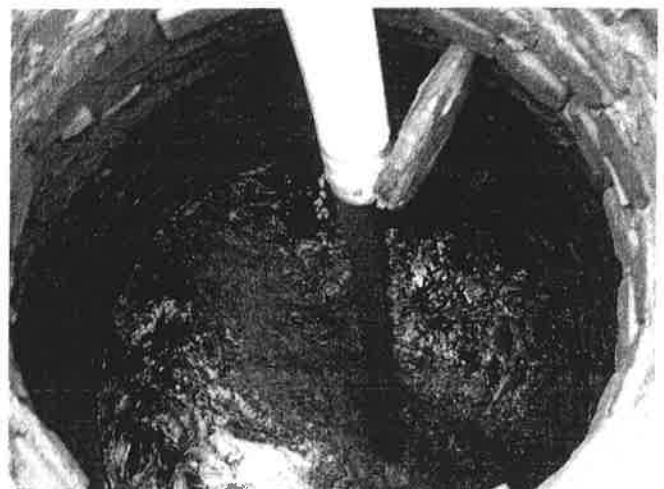
60 *Discharge During Cleaning*
