LONDONDERRY TOWN COUNCIL MEETING MINUTES

1 **July 10, 2017**

Dendrochronology Study

c.1722, 24 Griffin Rd

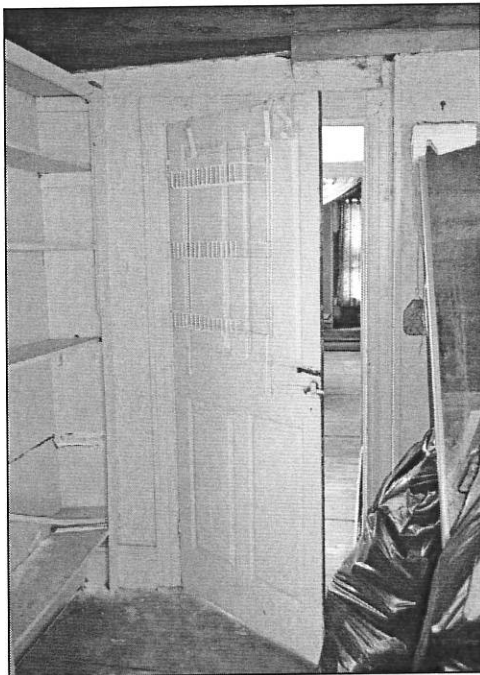
Remnants of the character of the interior work of circa 1850 are seen in the front entry of the house and the two partitions that extend from this entry toward the rear of the dwelling. The entry is fully plastered, as was the entire first story. The room to the north of the entry retains its mid-nineteenth-century door casings. These display a symmetrical profile and corner bosses that became fashionable around 1830 and remained so until about 1900.

Left: Doorway from front entry to northeast room.

Right: Detail and section of door casing in northeast room.

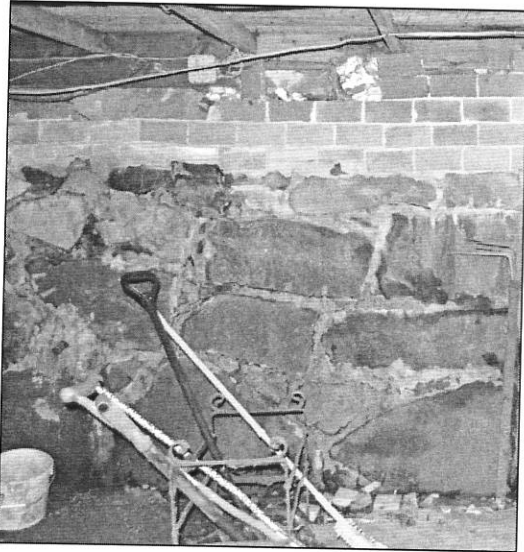
The fashion for full basements increased during the nineteenth century. In the case of the Holmes House, physical evidence shows that the entire house was lifted and supported, a full basement was excavated if it did not exist, and new cellar walls of split granite boulders was constructed up to the elevation of the exterior grade. Above grade, the house was underpinned with slabs of granite backed by a veneer of brickwork.

This granite foundation may be dated at 1830 or later through evidence of the splitting technique that was employed on the cellar walls and underpinning slabs, as explained in the Appendix to this report.

Left: North wall of the basement, showing the walls of split fieldstones and the brick backing for the granite underpinning that is visible above grade on the exterior of the house.
