WSWQC - East Dudley Septic Study

Developed by Toni Moores,

Presented June 13, 2012 by Mike Lowery, Bob Goldsmith to the

Wastewater Management District Commission

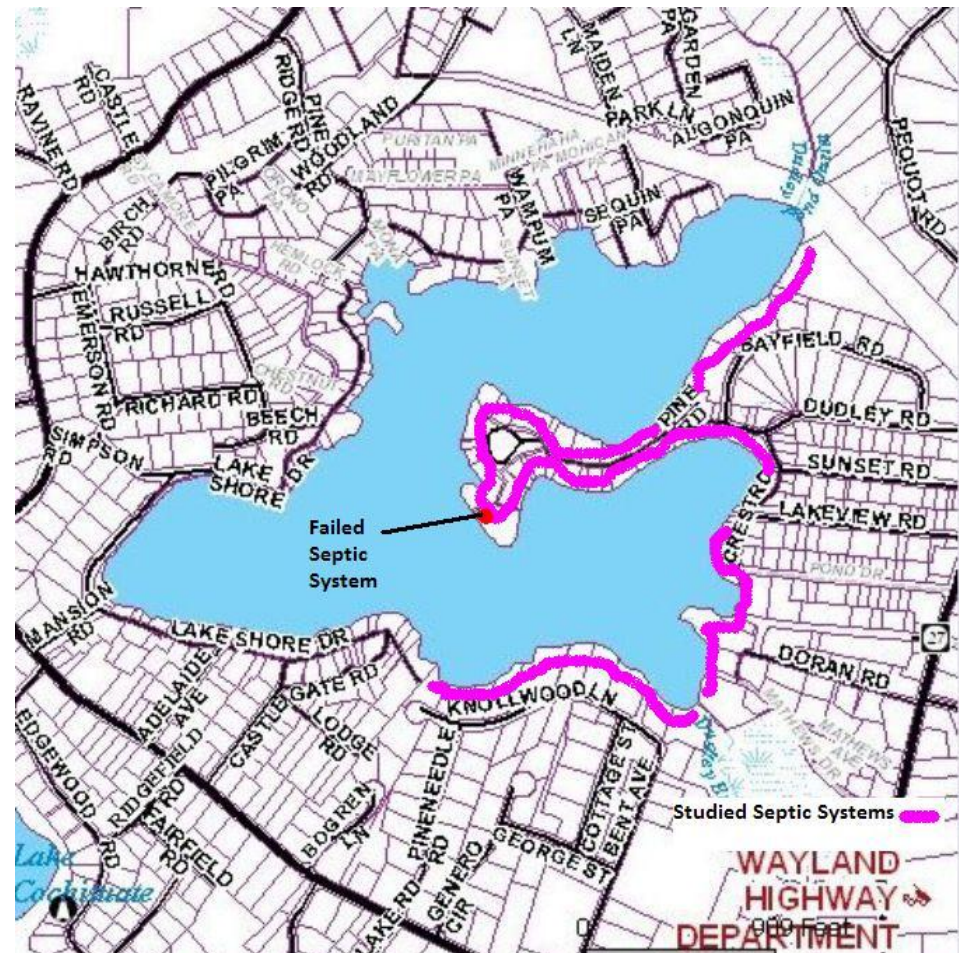
Dudley Pond Groundwater Hydrology: East to West flow

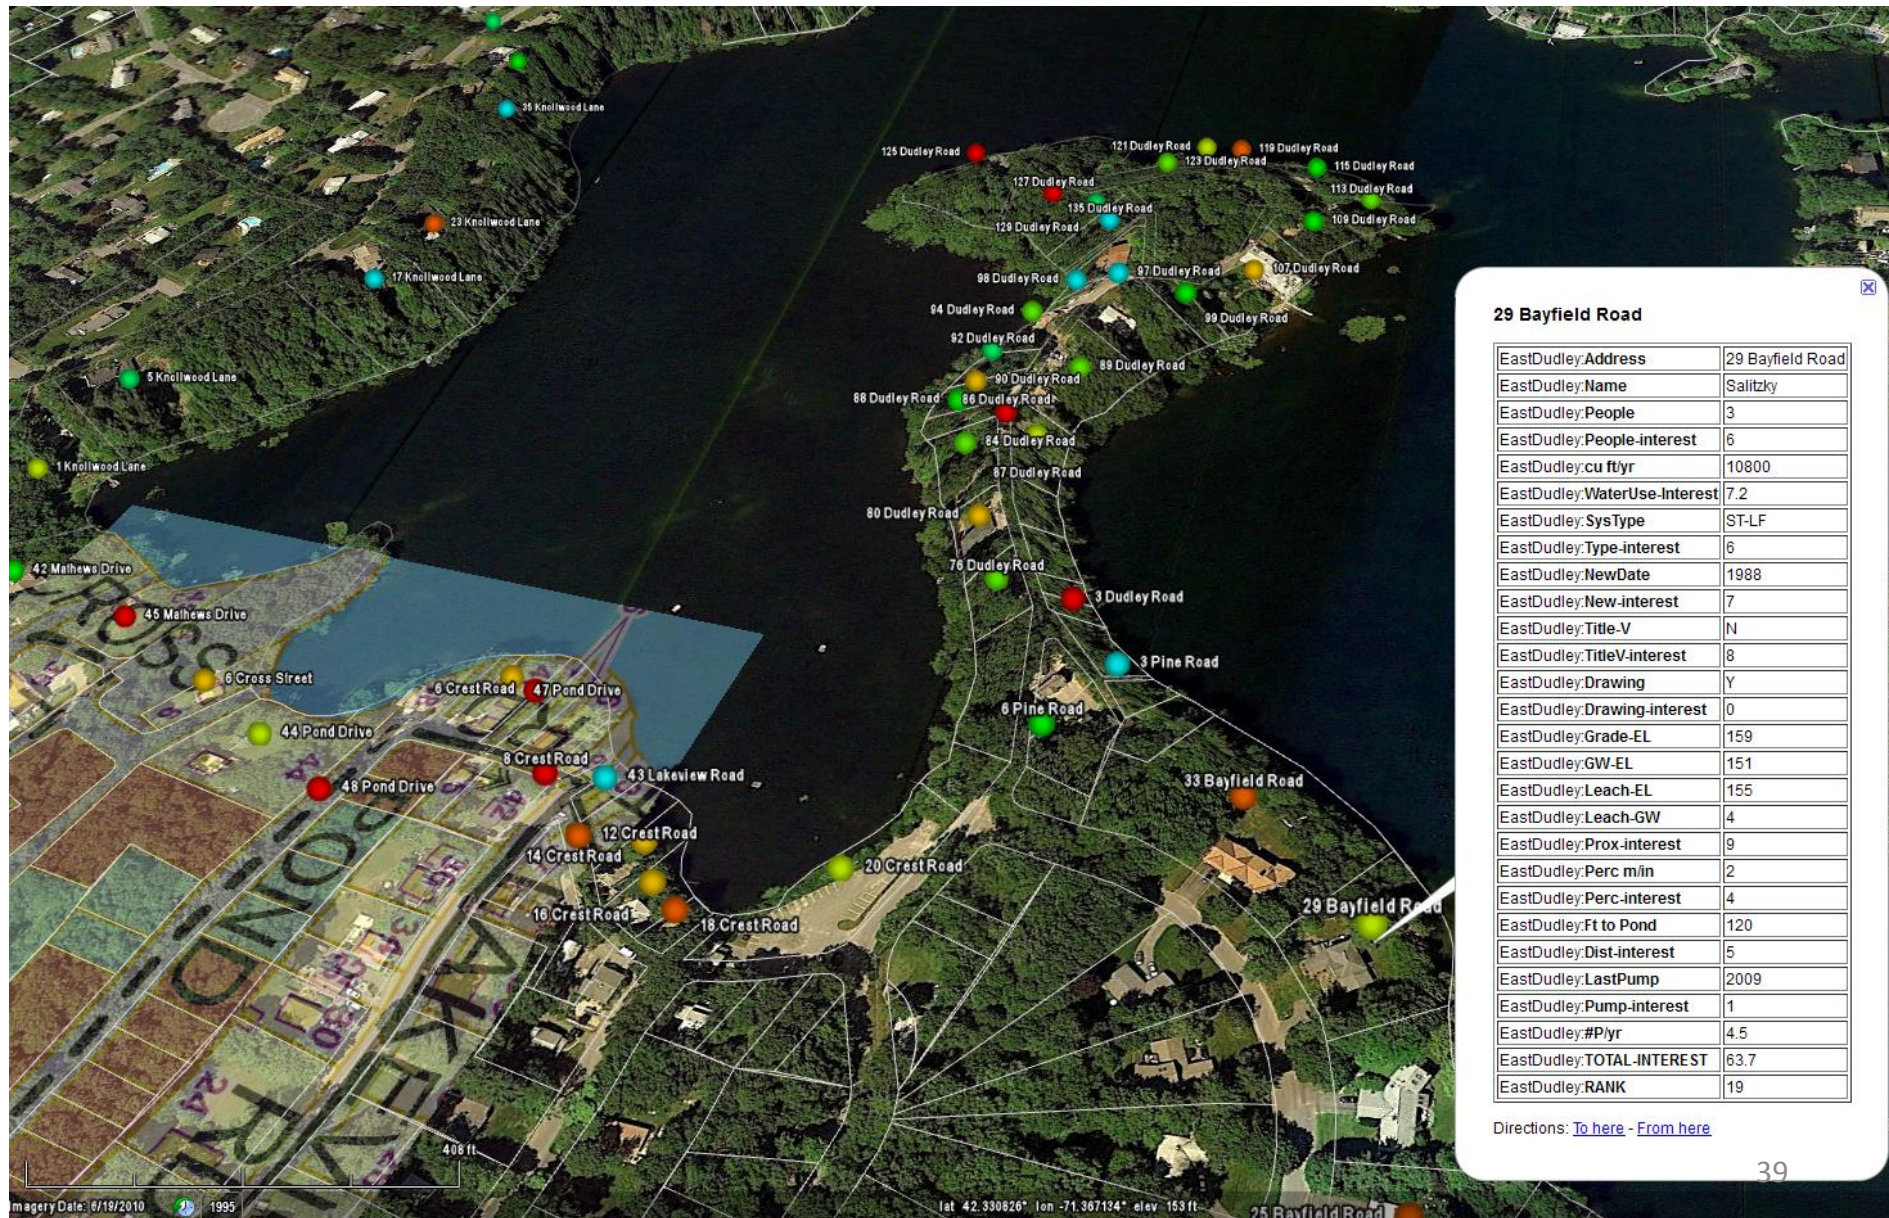
Clickable Septic Data Map:

enables tailored outreach to individual households
