Preservation Management Plan for the North Cemetery Wayland, Massachusetts

**Prepared For
The Town of Wayland**

June 30, 2015

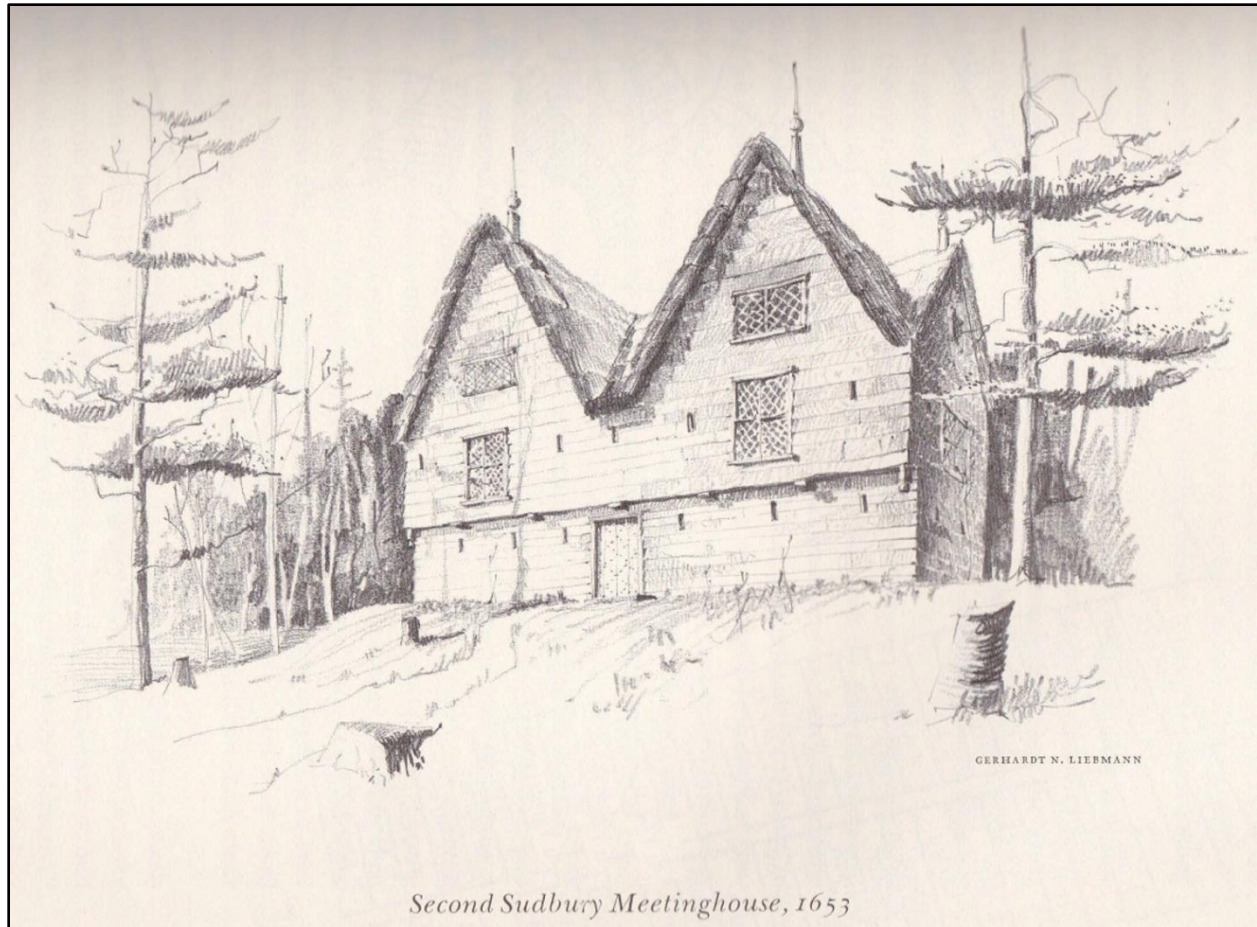
Figure 2-4. Conceptual drawing of the second meeting house (Powell 1963).

According to an account of the second meeting house dated December 27, 1652 the town appointed Thomas Plympton, Peter King & Hugh Griffin to find timber to fell, prepare and carry to the location of the proposed meeting house, to level the ground and to find sufficient help to raise the house. The outside of the building, which measured 40 ft by 20 ft, would be covered with clapboards, the inside would be lined with either cedar or good spruce boards, the roof covered with thatch and the walls filled with tempered clay. The sleepers of the doors would be either white oak or good swamp pine and planks would be used for the floors. The 12 men hired to do the work would be paid ½ a crown a day. It was also noted that the new meeting house would be erected in the site of the old meeting house (Hudson 1891). Additional details of the meeting house include constructing four 5-ft-wide transom windows (a window above a door or other window built on and commonly hinged to a transom or crosspiece in a structure [Gove 1959]) in the front of the building, one window at each end, pinnacles (an upright architectural member generally ending in a small spire to give additional weight to a buttress or an angle pier [Gove 1959]) at each end, and a gable at each end with a clearstory (an outside wall of a room or building carried above an adjoining roof and pierced with windows [Gove 1959]). As the town planned for galleries the structure would have two doors 3 ½ ft wide “nailed diamond fashion.” The builders were to use iron to hang the doors and “bolt to bolt” one of the doors on the inside. The meeting house structure, which was to stand 8 in above the ground, would be completed by the 16th of the following November at a cost to the town of 5 pounds, 20 shillings. Payment would be made with Indian corn, rye, cattle and money. The contract for the meeting house was witnessed by Edmund Goodwin and Thomas Noyes. From the above details the meeting house appears reminiscent of medieval architecture with gothic detail used for ecclesiastical buildings in Europe (Figure 2-4).

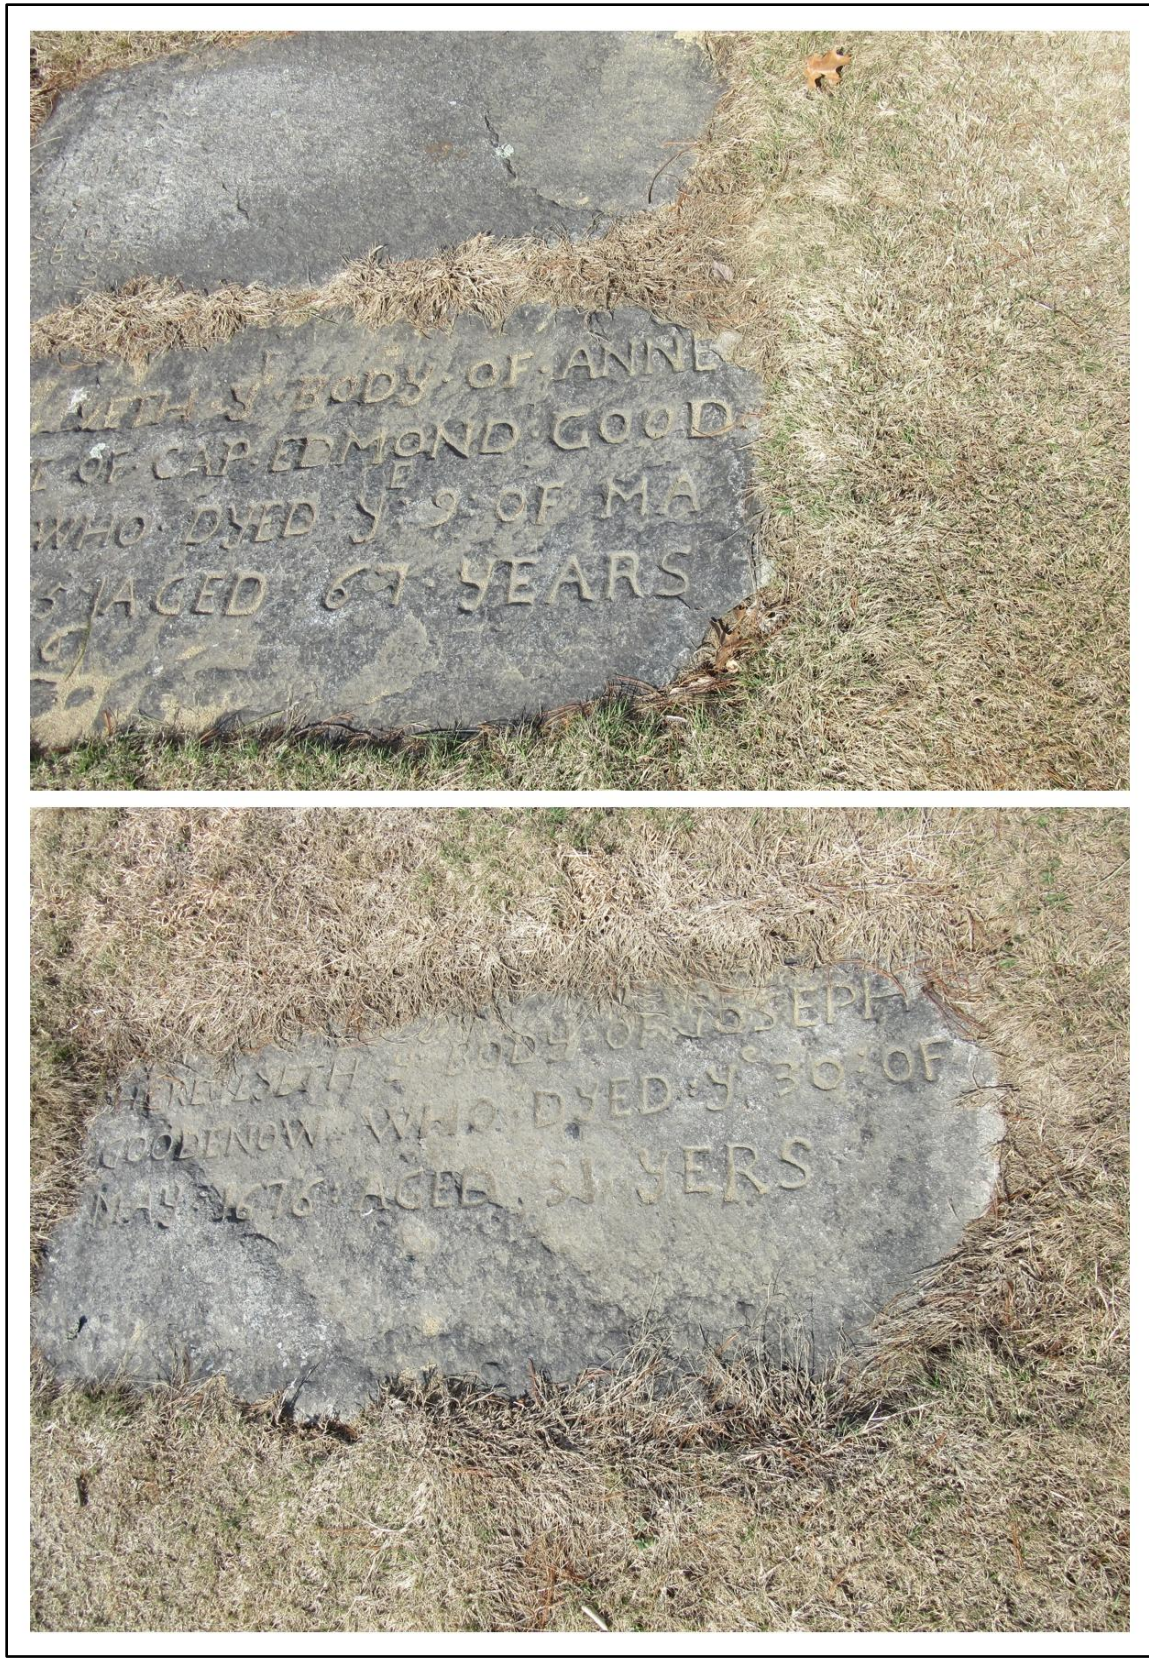
Figure 2-5. Anne Goodenow's marker (top) and her son, Joseph (bottom).

The two oldest grave markers in the cemetery date to the time period of the second meeting house. They belong to Anne Goodenow who died in 1675 at age 67 and her son Joseph who died in 1676 at age 31. Their flush stone markers with no motifs contain inscriptions that were likely done by the same carver given the similarity of the letters on each (Figure 2-5). The only other seventeenth century grave marker in the cemetery belongs to Capt Edmund Goodenow who died in 1688 at age 77. Edmund, the husband of Anne and father of Joseph, came from England in 1638 and was one of the original settlers of the town. A date of February 18, 1691 above Capt. Edmund's inscription conveys that the marker was carved

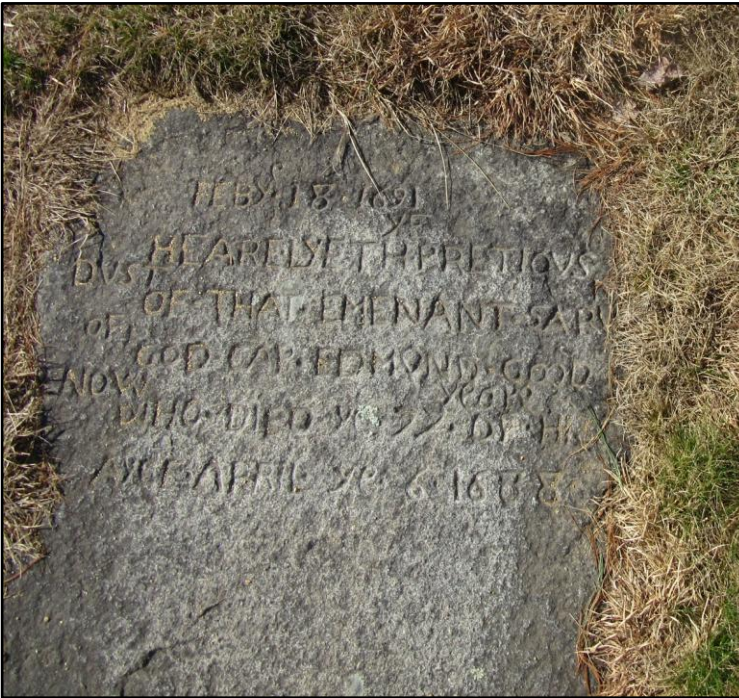
Figure 2-6. Capt. Edmund Goodenow's marker.

approximately three years after his death. The carved letters are quite different than those on his wife's and son's stones pointing to a different carver (Figure 2-6). Secondary sources state that the burials are located to the east of the "old meeting house."

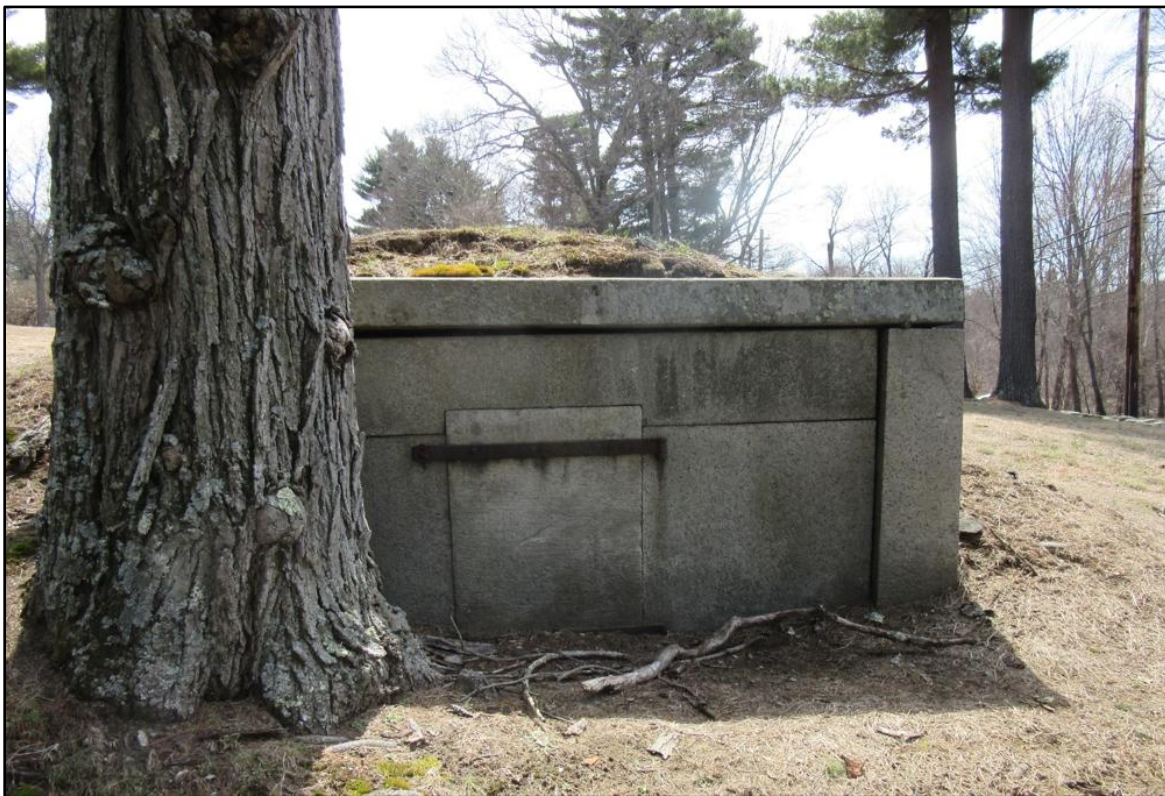
Figure 2-12. Example of a tomb in North Cemetery.

affairs within burying grounds led to the construction of family tombs, either as subterranean chambers, shafts, or above-ground rooms mounded over with turf (Figure 2-12). Vaults were deeply excavated and entered by stairs. The underground passages were lighted through iron grates on the surface. While many vaults were covered with ledger stones others were finished with a raised mound of earth. A depersonalization of death was heralded in with the Urn and Willow motif in the latter part of the eighteenth century. This new style was reminiscent of Greek revival symbols of mourning that were fashionable in Europe (Figure 2-13).

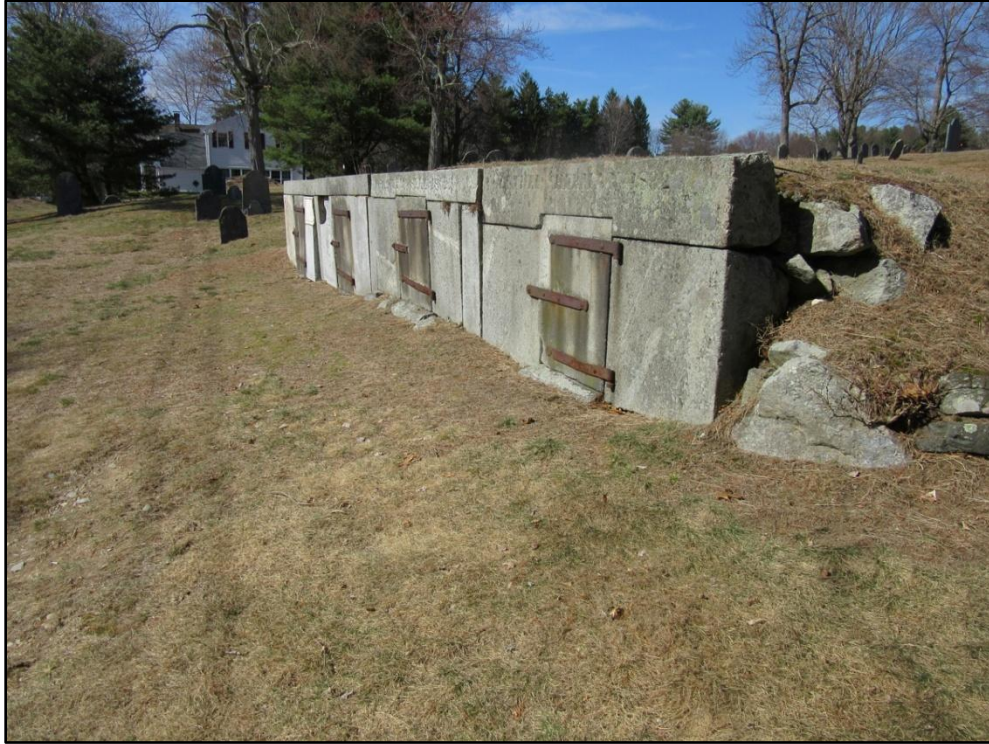
Figure 2-19. Photo of tombs facing Old Sudbury Road.

The burying ground did not appear in the town records again until the 1820s. In 1821 the town discussed selecting someone to make sure the graveyard was kept sufficiently enclosed. An article in the warrant of February of 1823 asked if the town would hear the report of a committee chosen at a former meeting to select suitable grounds in the burying yard to build tombs and then adopt those measures. At the meeting the article was postponed and not addressed. No further details regarding the tombs were found following the February meeting. The present tombs in the front of the cemetery adjacent to Old Sudbury Road date to that time period (Figure 2-19).

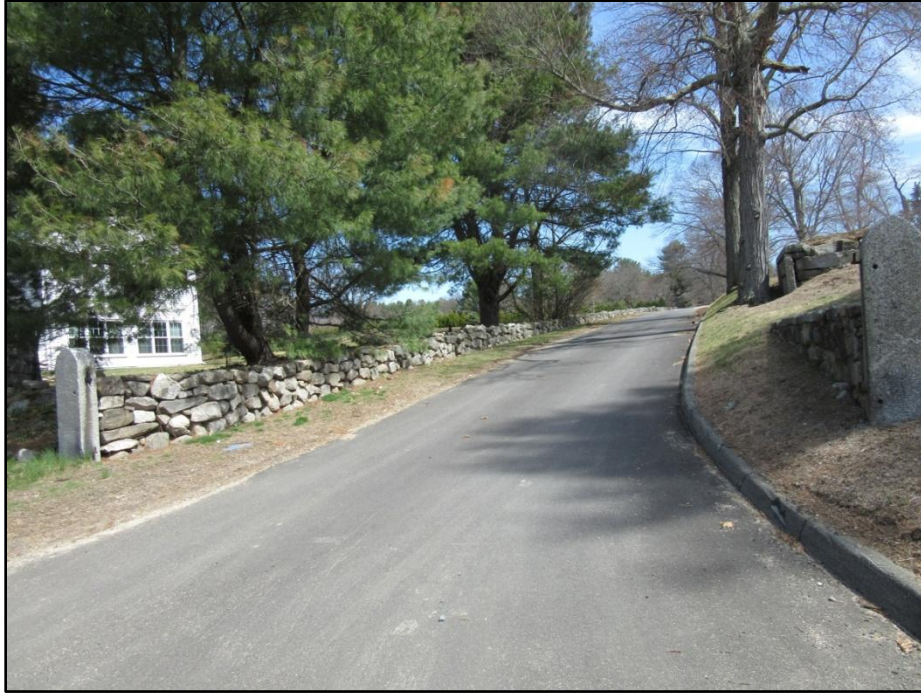
Figure 2-21. Photo of the stone wall along the northern boundary of the entrance drive.

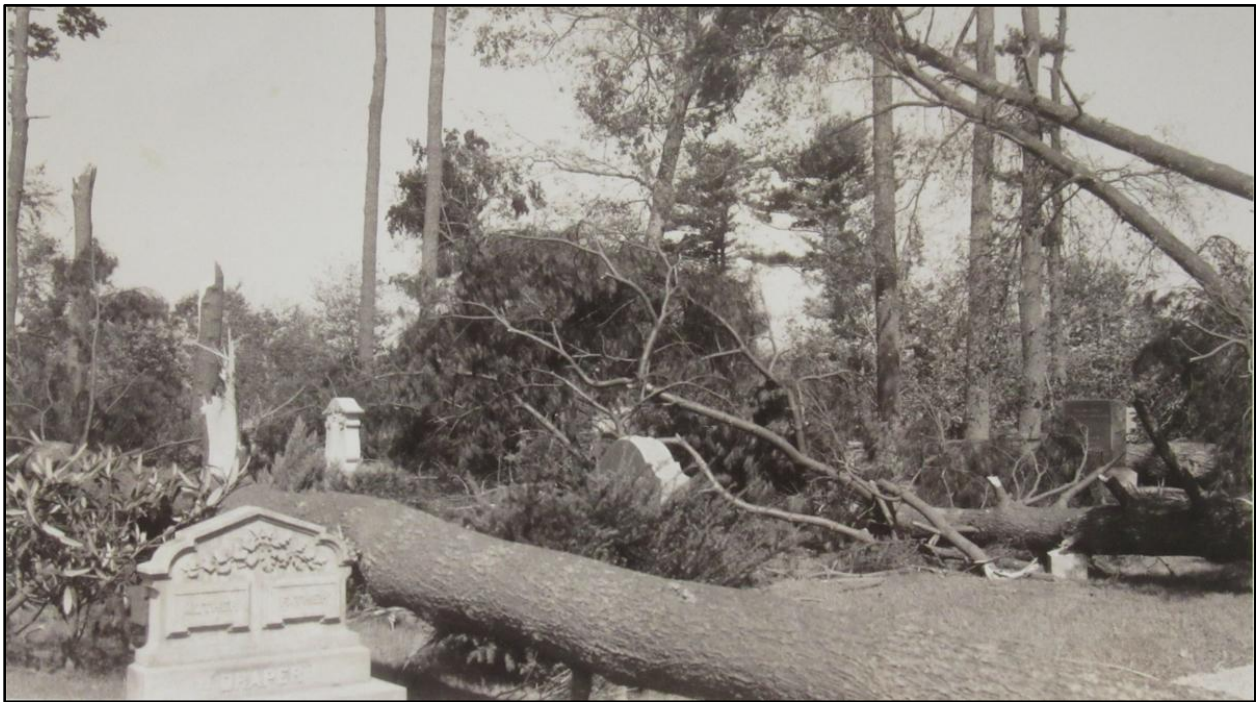
Figure 2-29. Historic photo of damage in North Cemetery due to the Hurricane of 1938
(Courtesy Wayland Historical Society).

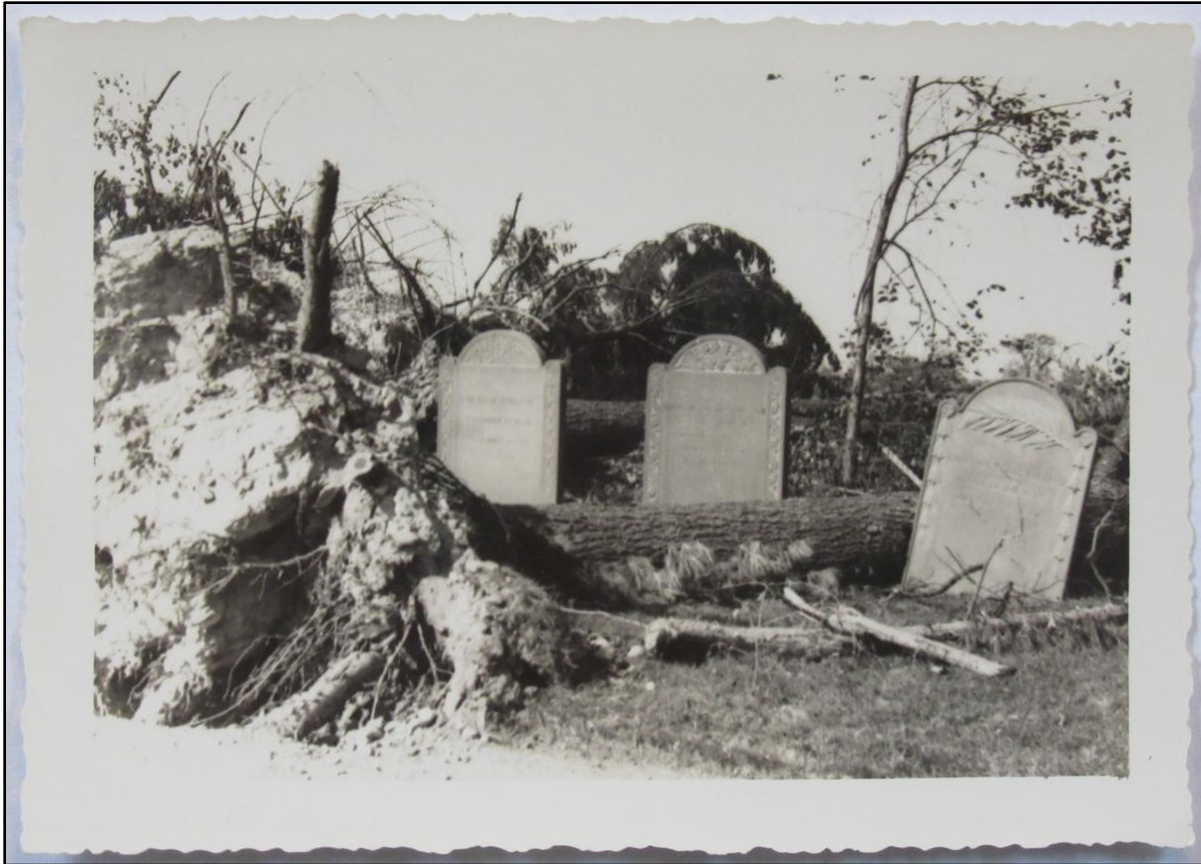
Figure 2-30. Historic photo of damage in North Cemetery due to the Hurricane of 1938
(Courtesy Wayland Historical Society).

While the town tried to procure more money from the WPA to finish cleaning up their cemeteries, the money did not come through. Between 1939 and 1943 the town continued to work on the cleanup effort. Cleanup in the North Cemetery consisted of clearing fallen trees and selling the logs with the proceeds going to the town treasury in 1939; removing uprooted and lodged trees, grading several sections, and repairing the roadway in 1940; continuing restoration and requesting an allotment to continue work in 1941; repairing and straightening displaced stones, widening and improving the entrance gateway, and treating the top of the roadways in 1942; and continuing to remove and dispose of stumps and widening the entrance in 1943. Figures 2-29, 2-30 and 2-31 show damage to North Cemetery resulting from the hurricane.

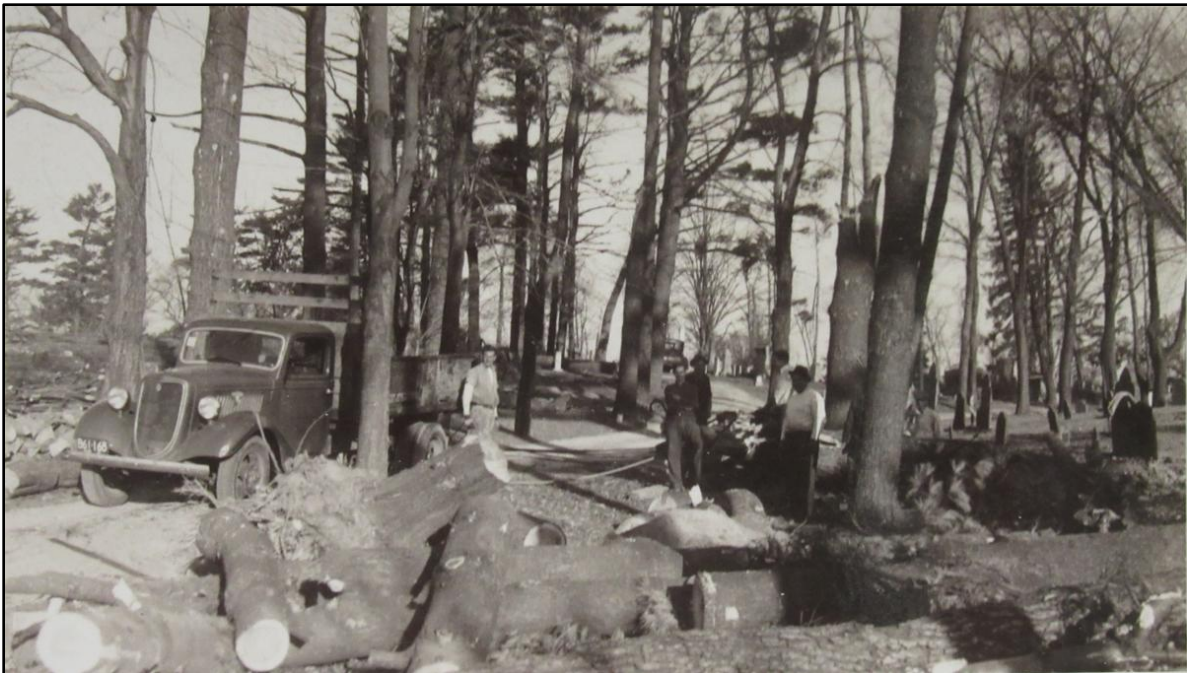
Figure 2-31. Historic photo of damage in North Cemetery due to the Hurricane of 1938
(Courtesy Wayland Historical Society).

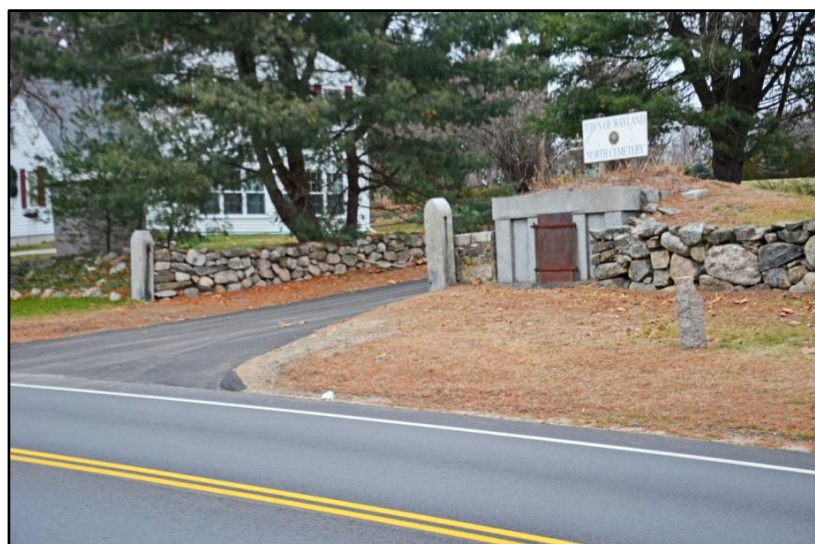
Figure 3-2. Entrance to the North Cemetery showing the narrow shoulder and no passing zone on the curve.

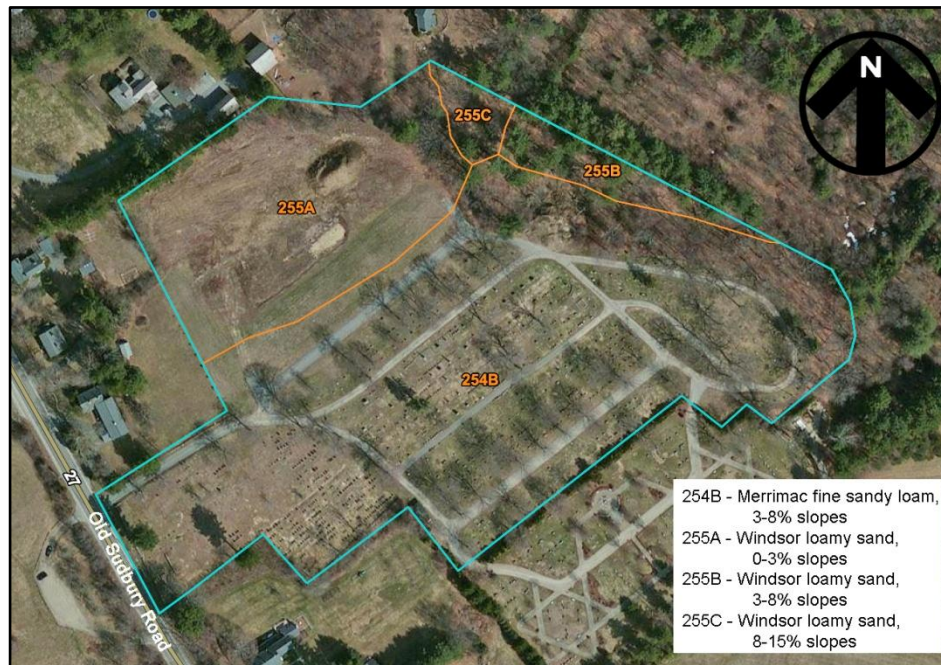
Figure 3-3. Soils in the North Cemetery.

Only two soil series are present in the cemetery (Figure 3-3). The most common soil, found in 70% of the cemetery area, is Merrimac fine sandy loam. The other soil series are found either on the steep slopes at the north and northeast edges of the property or in the yet to be developed sections.

Merrimac fine sandy loam is a very deep, nearly level, somewhat excessively drained soil found on terraces overlooking major stream valleys. The soils are strongly acidic and seasonal high water tables are at depths of about 6 feet. A typical profile consists of an Ap horizon about 10 inches in depth consisting of very dark grayish brown (10YR 3/2) fine sandy loam. Below is the Bw1 horizon to a depth of 15 inches. This is a brown (7.5YR 4/4) fine sandy loam with a granular structure. The Bw2 horizon consists of a dark yellowish brown (10YR 4/4) gravelly sandy loam to a depth of 22 inches. To 26 inches is the Bw3 horizon of dark yellowish brown (10YR 4/4) gravelly loamy sand. The 2C horizon is found to 65 inches and consists of yellowish brown (10YR 5/4) and dark grayish brown (10YR 4/2) very gravelly sand.

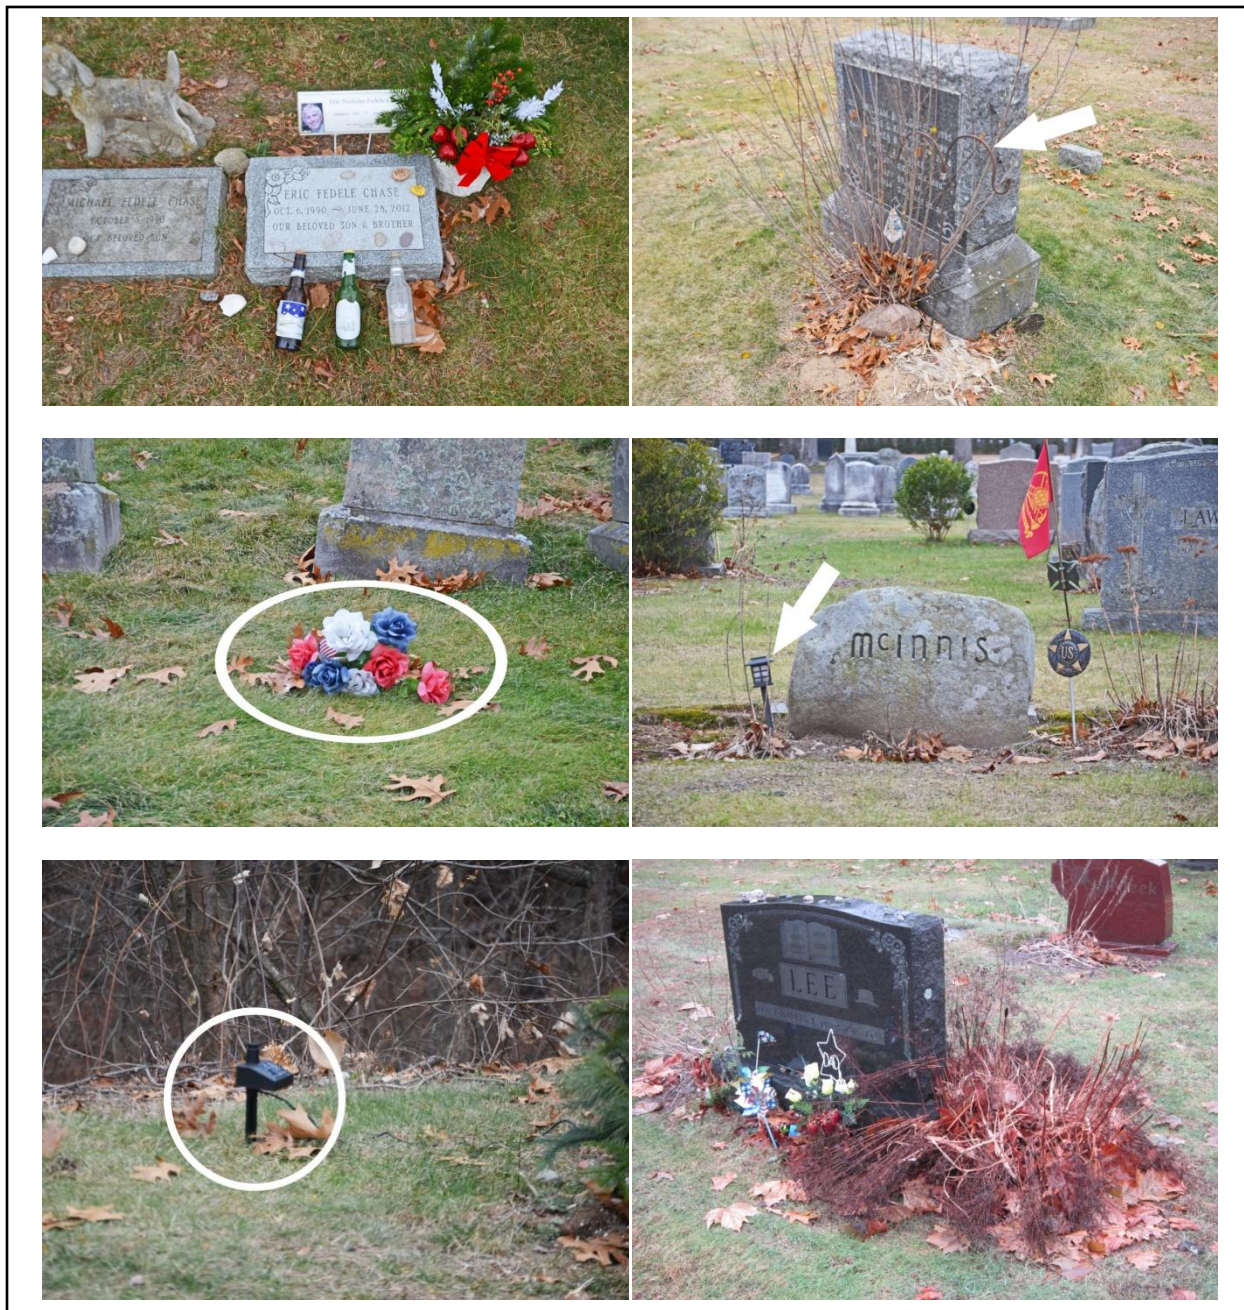
Figure 3-7. Failure to enforce rules at North Cemetery. Upper left photo shows display of alcohol, glass containers, and funeral home marker not removed after 6 months. Potted plant is not placed on the flush marker, but rather beside it. It appears that statues are allowed only at upright markers. Upper right photo shows non-evergreen shrub and hook at a grave. Middle left photo shows floral arrangement from July 4th still in the cemetery. Middle right photo shows a solar light at a monument. Lower left photo shows a solar light with cord extending to a Christmas tree on the grave. Lower right photo shows non-evergreen shrub and a variety of adornments at a grave.

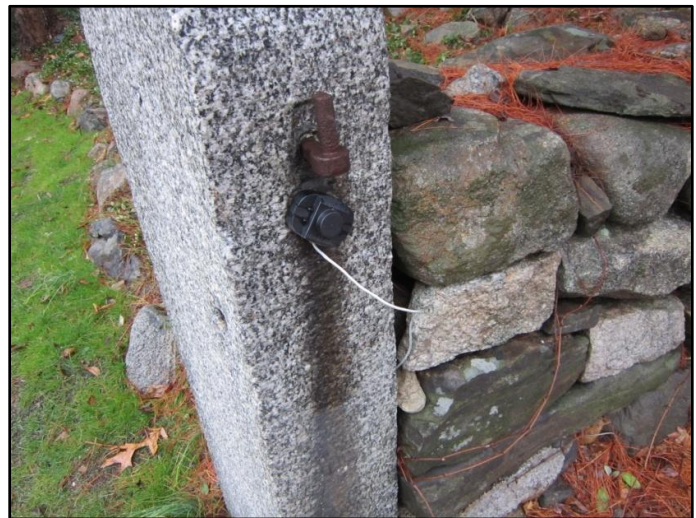
Indicative of a failure to understand the Secretary of Interior Standards, the Parks, Trees, and Cemeteries Division has mechanically attached a device to the northern post allowing water meter readings (Figure 3-9). Understanding the significance of the cemetery and its historic fabric would preclude this type of modification.

Figure 3-9. Device to read a water meter attached to the cemetery's southern granite entrance drive post.

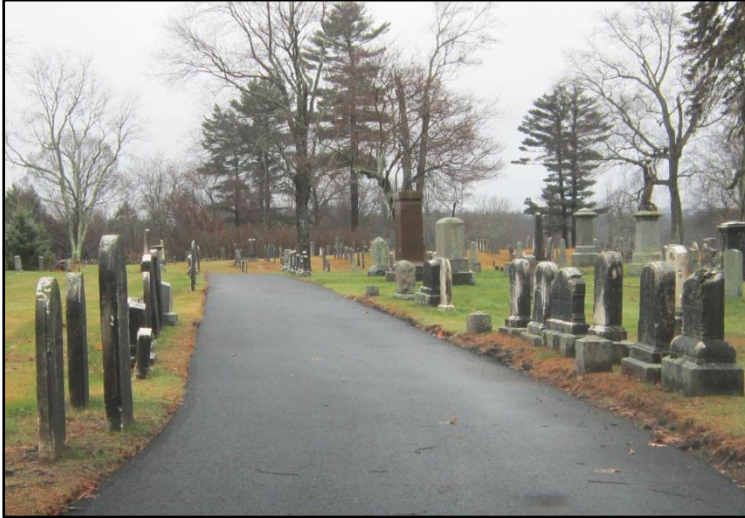
We calculate about 0.7 linear mile of roads in the cemetery, although the Parks, Trees, and Cemeteries Division reports 0.75 linear mile. The roads vary in width from about 10 to 16 feet. This variation suggests that the roads began as very narrow paths for horse-drawn hearses and were only recently widened where possible (see Figure 3-10).

Widening, however, has been only marginally effective and virtually all of the roads with the exception of the entrance, are no more than a single travel lane in width. Even on the roads that are 16 feet in width, passing is difficult and most vehicles partially pull off onto the

Figure 3-10. Road between Stoney and Lovell sections showing limited space between the road and monuments.

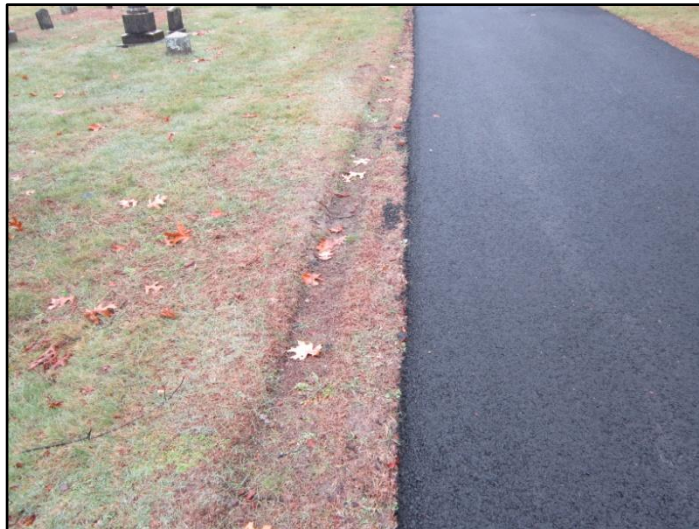
Figure 3-11. Damage to roadside by car leaving the road to park.

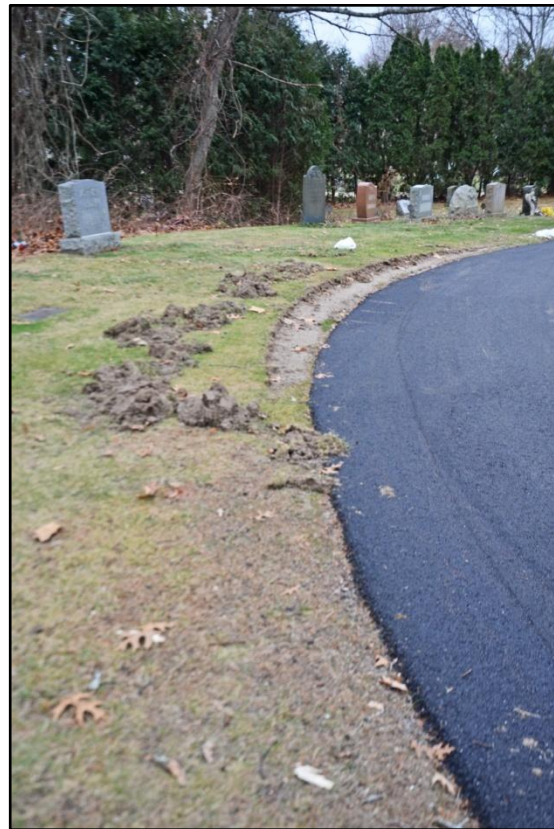
Figure 3-13. Snowplow damage to turf.

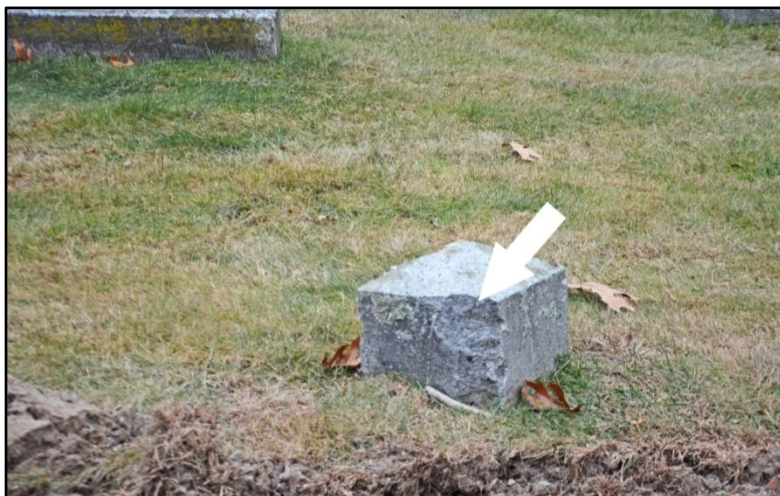
Figure 3-14. Damage to plot marker caused by snow plowing.

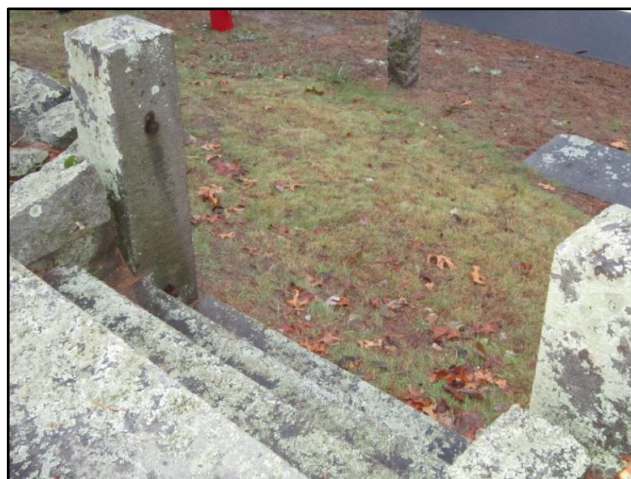
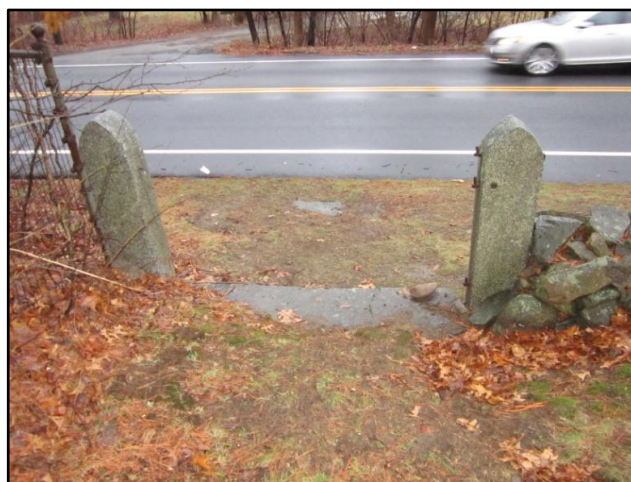
Figure 3-15. Pedestrian gates. The upper photo shows the central gate with pintles in the southern post. The lower photo shows the southern gate with pintles in both columns, indicating a double gate.

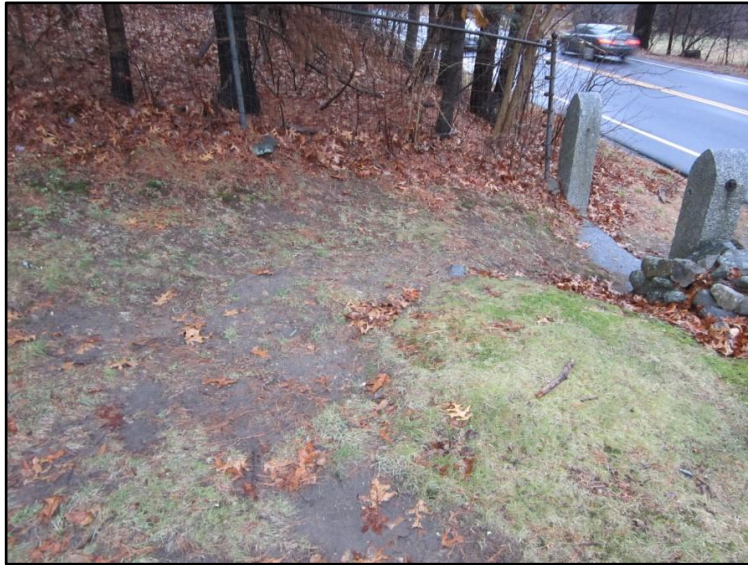
Figure 3-16. Erosion at the southern pedestrian gate fronting Old Sudbury Road.

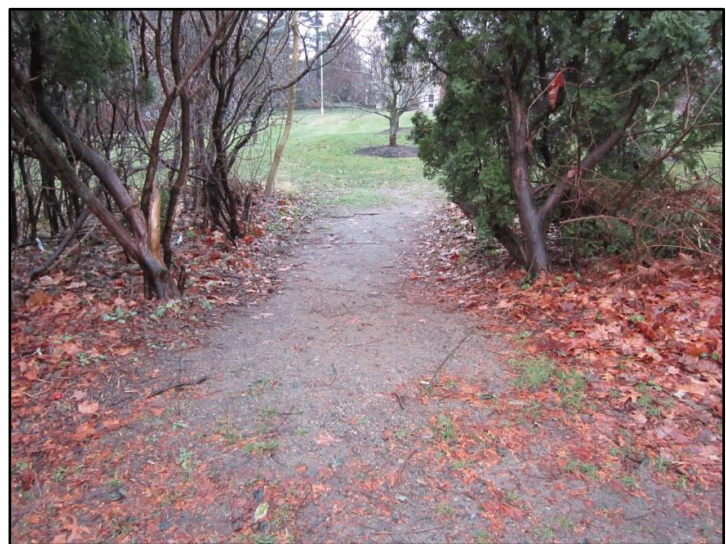
Figure 3-17. Path from adjacent property owner into the Lovell Section of the cemetery.

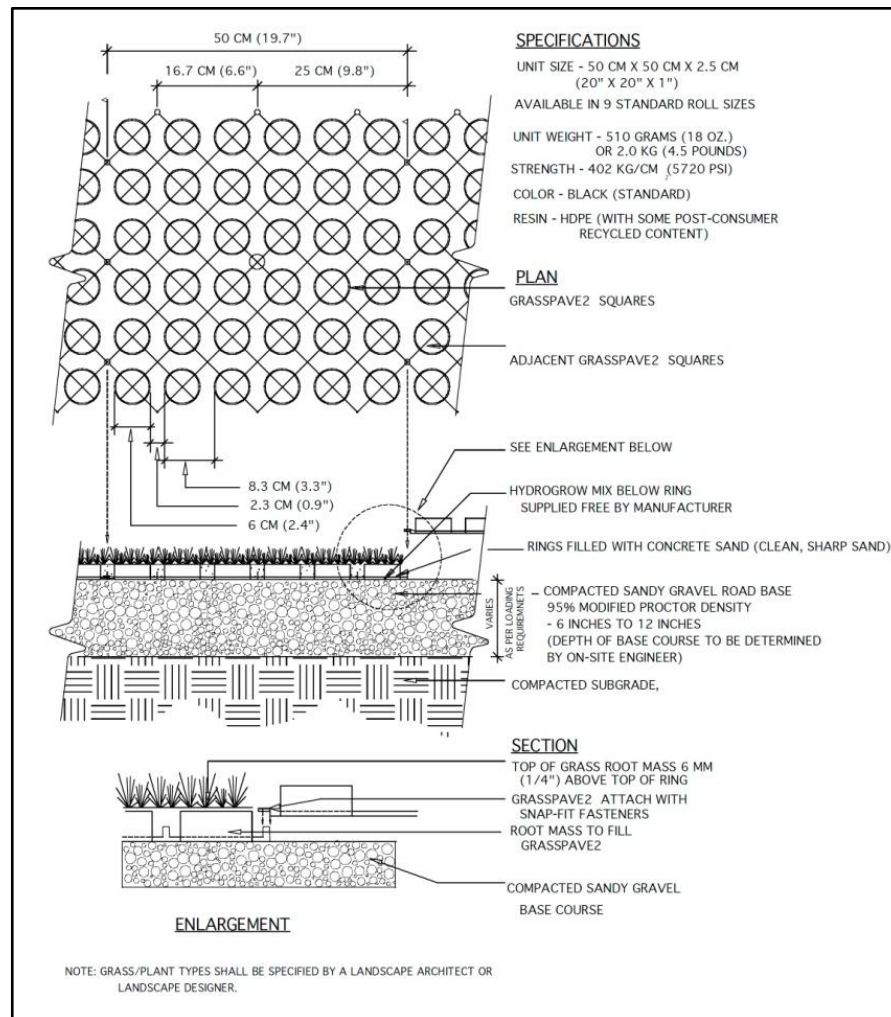
Figure 3-18. Specifications for one brand of grass reinforcement system.

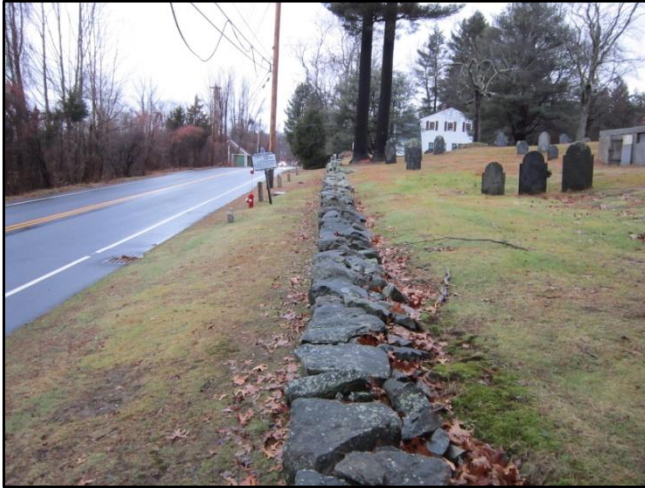
Figure 3-20. Wall along Old Sudbury Road.

The wall along Old Sudbury Road (Figure 3-20) serves as a retaining wall. Given the ground pressures involved, this wall is in excellent condition, offering a testimony to the dry laid construction technique and its builders. The wall heads are retained by stone stoups. The presence of foundation stones was not determined, but the builders were careful to use very large stones toward the base in order to ensure stability. The condition of the wall is generally excellent; they would be given an A Condition Class. Top stones are nearly all in place, the sides are smooth and straight. We observed no evidence of bowing, bellying, or slumping and there were virtually no fallen stones.

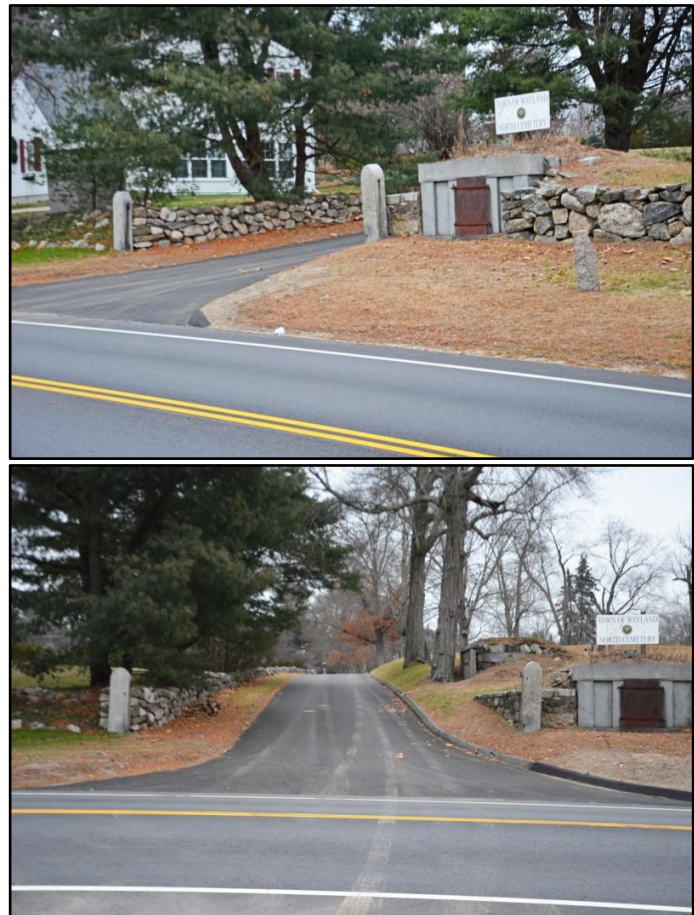
The wall along the entrance drive (Figure 3-21) is in nearly identical condition, although overall the stones appear smaller and less angular, suggesting a different construction episode. The wall was constructed at the time of the 1835 addition and was repaired in the twentieth century. A stone stoup is found at the southwest end of the wall; at the other end the wall terminates without a stoup. This wall would be considered “stockproof” and in excellent condition.

Figure 3-21. Wall on the northwest side of the cemetery entrance road. Upper view shows the wall at the entrance. The lower view shows the wall leading up the cemetery slope.

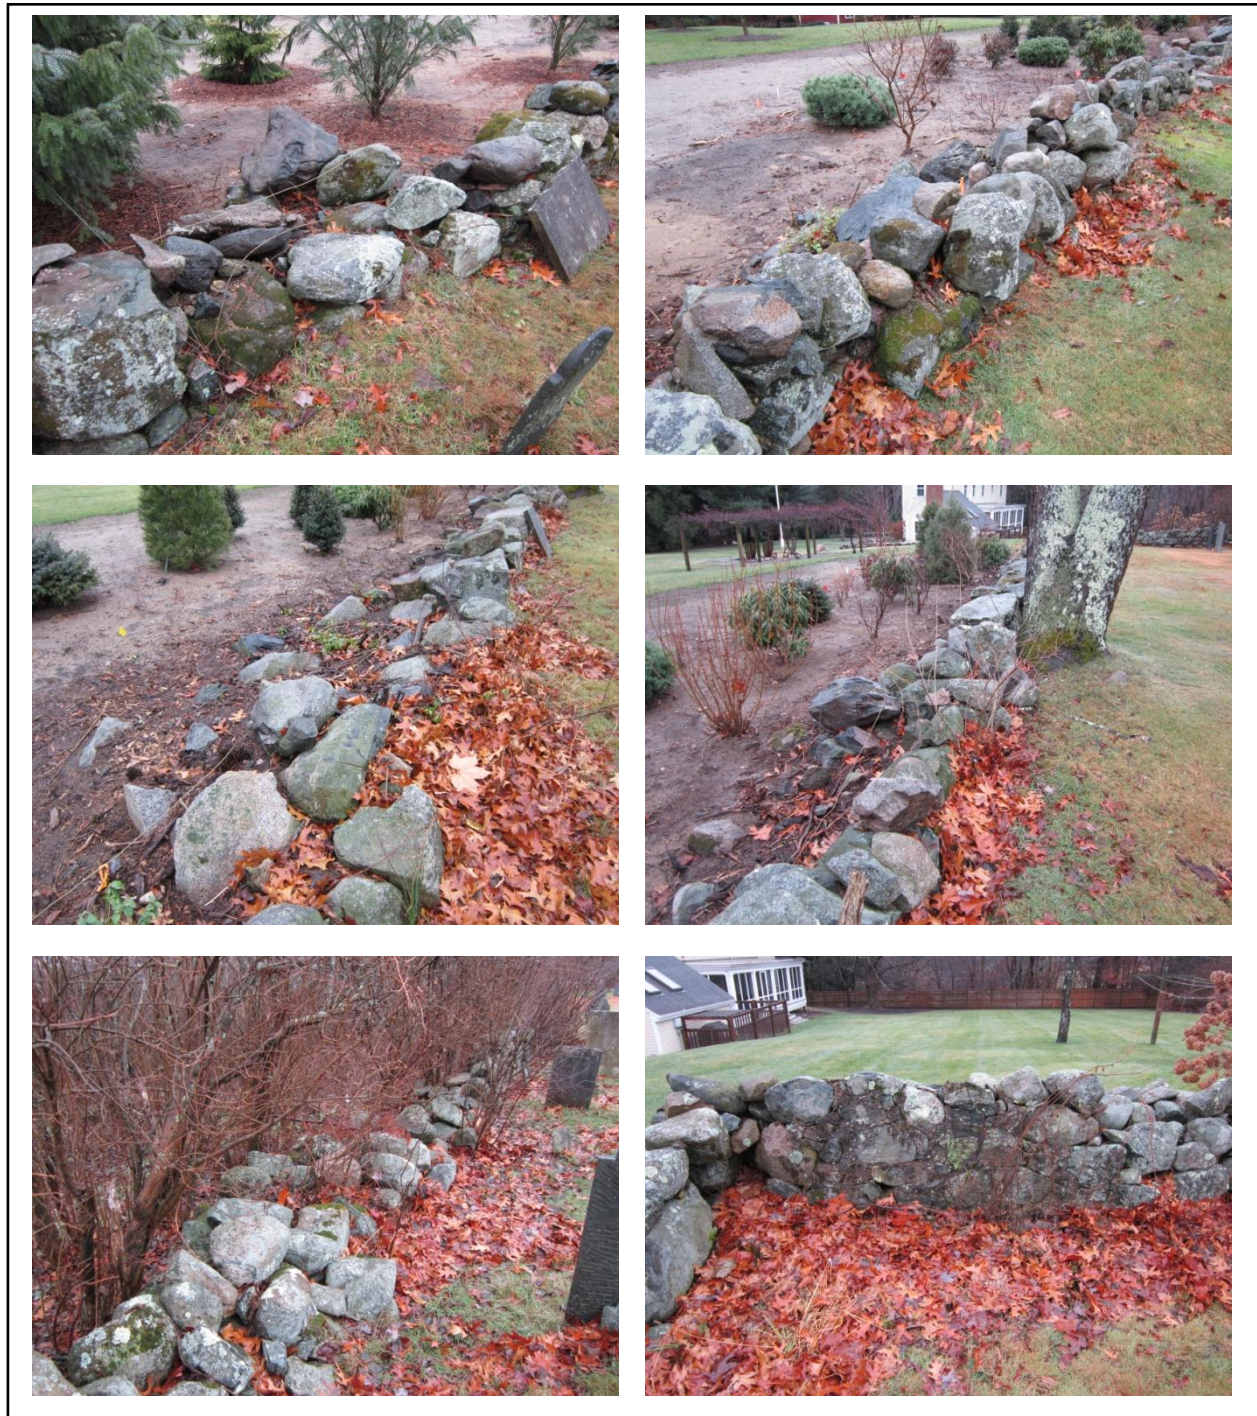
Figure 3-22. Examples of damage to the stone wall on the east side of the Old Section. The upper row shows examples of failing wall, with toppled stones. The middle left photo shows the wall barely protruding from the grade with fallen stones partially buried. The middle right photo shows a tree intruding into the wall. The lower left photo shows scrub vegetation intruding into the wall as well as collapsing stones. The lower right photo shows a wall section poorly pointed with a hard Portland cement mortar.
