Preservation Management Plan for the North Cemetery Wayland, Massachusetts

**Prepared For
The Town of Wayland**

June 30, 2015

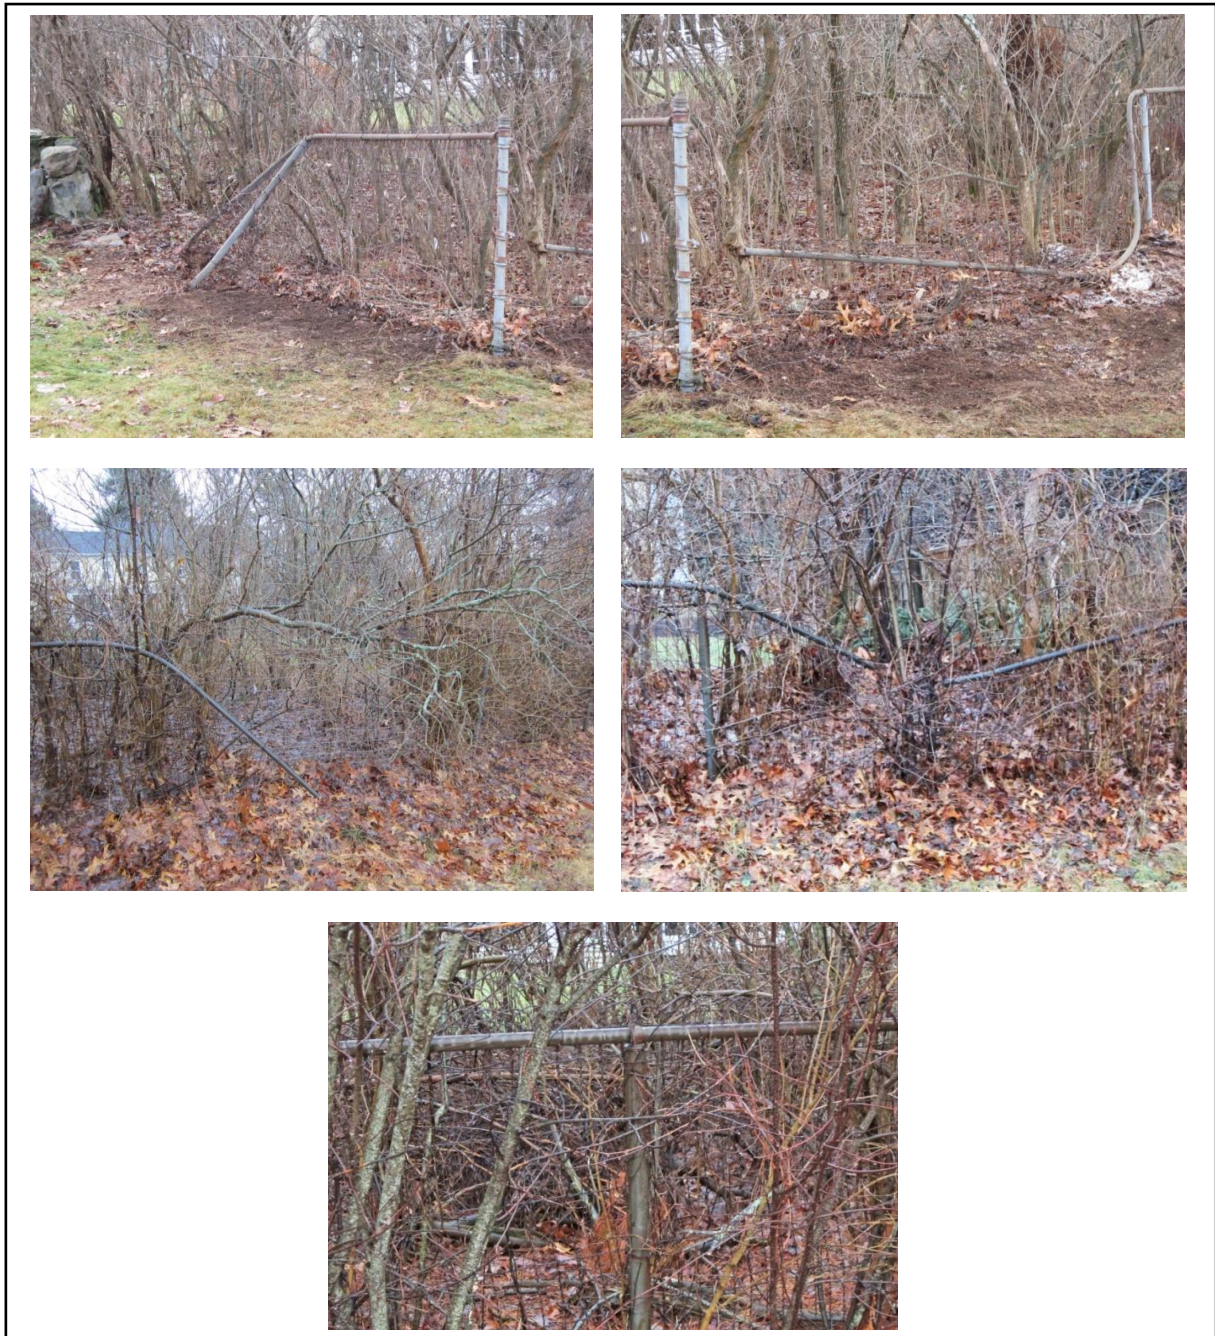
Figure 3-23. Examples of damage to the woven wire fence along the southwest side of the Old Section. Upper two rows of photos show damage to the woven wire and fence structure caused by fallen trees. These sections will require replacement. Note also the dense scrub vegetation that must be removed from around the fence. The lower photo shows a detail of intact fencing.

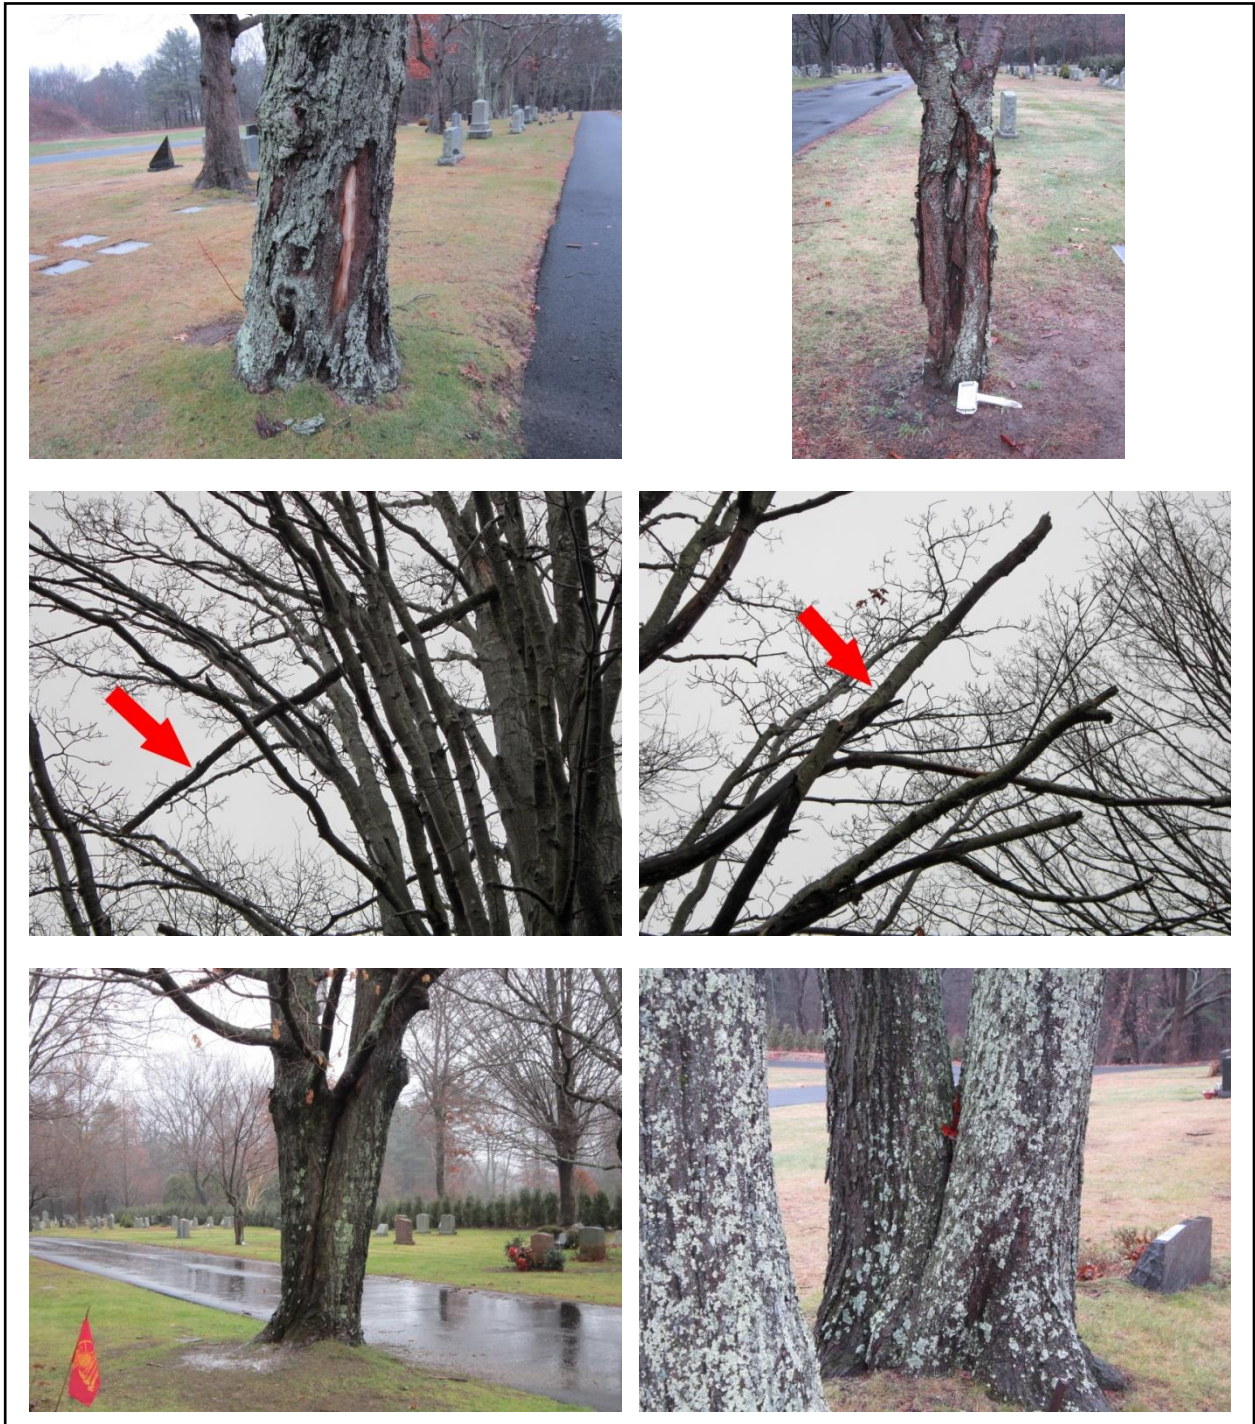
Figure 3-28. Tree Problems. Upper left photo is of a rotted tree trunk in Section A. Upper right photo shows extensive damage to a young tree in the Jewish Section. Middle left photo shows a dead limb hanging in a tree in the Lovell Section. This is an example of a “widow maker.” Middle right photo shows dead wood in a tree canopy in the Lovell Section and is another example of a “widow maker”. The lower two photos show codominant stems forming weak crotches prone to failure.

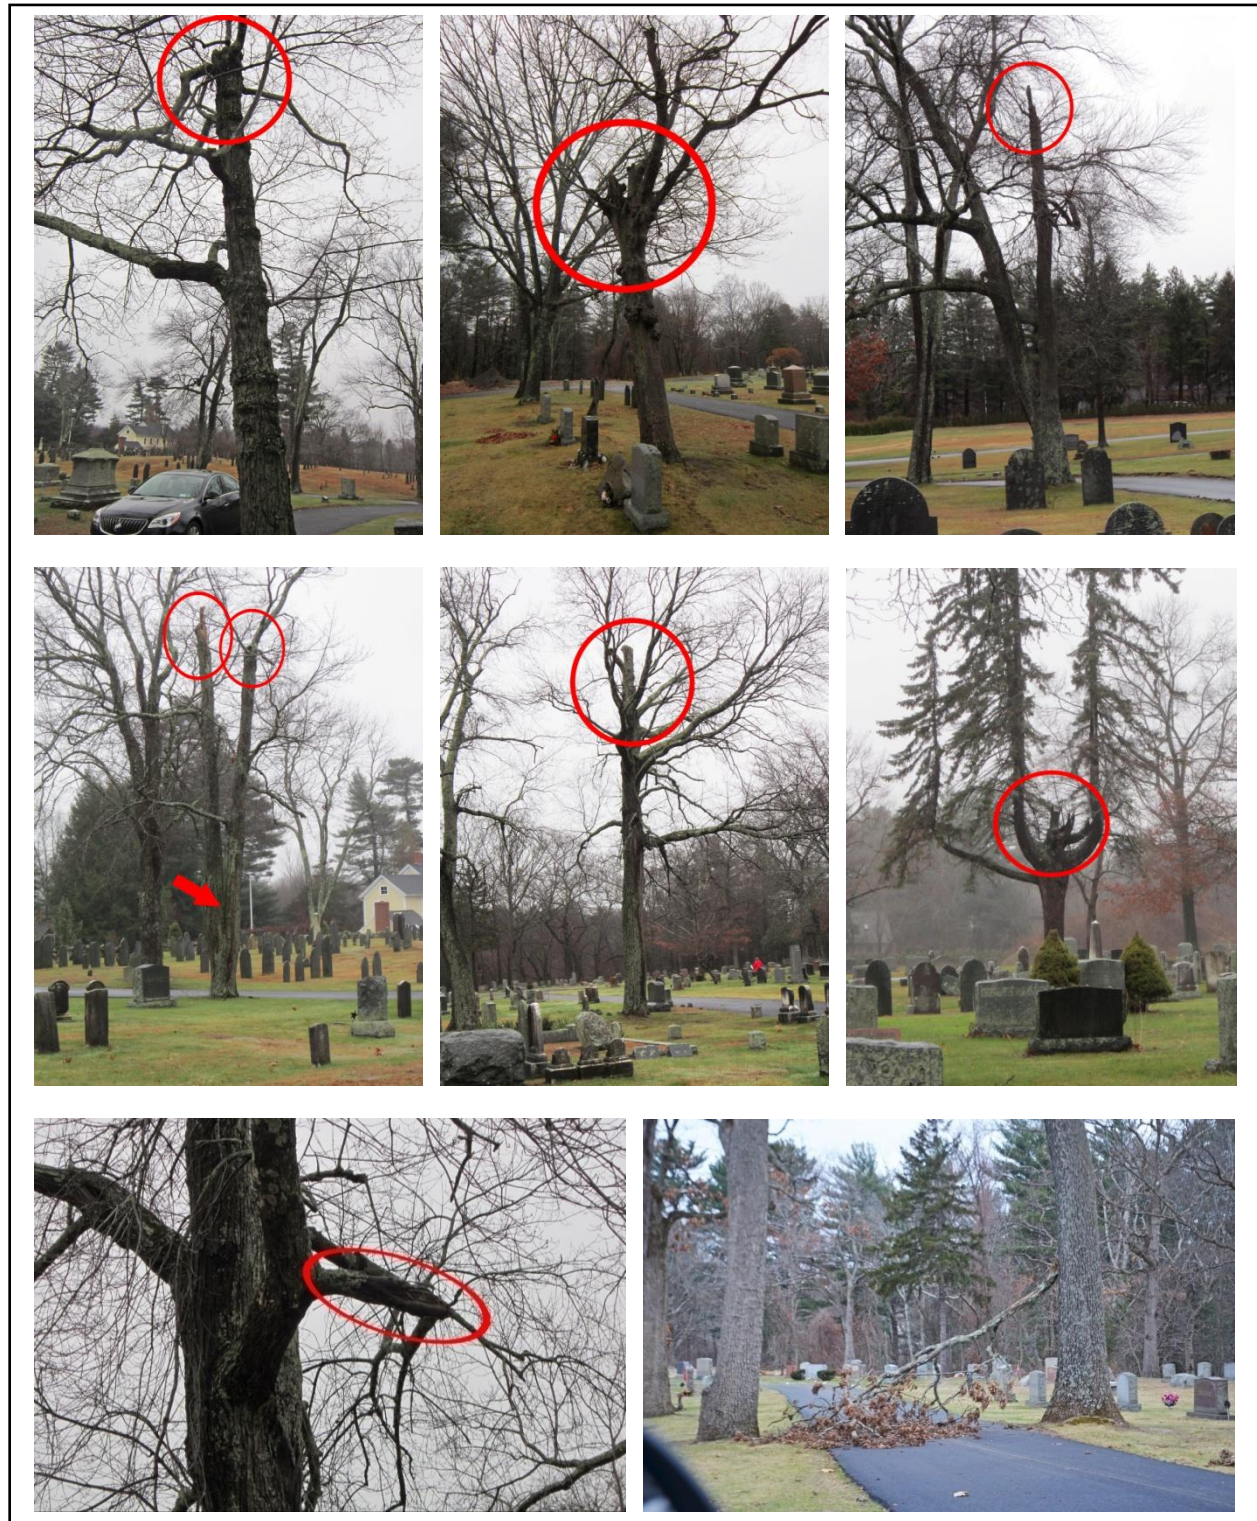
Figure 3-29. Tree Problems. Upper row shows topped trees in Section A and the Old Section. Middle row shows three topped trees in the Stoney Section. The middle left shows a tree that also has a codominant stem forming a weak crotch prone to failure. Lower left photo shows dead limb in the Stoney Section. Lower right photo shows a limb torn and fallen from a tree, blocking the road.

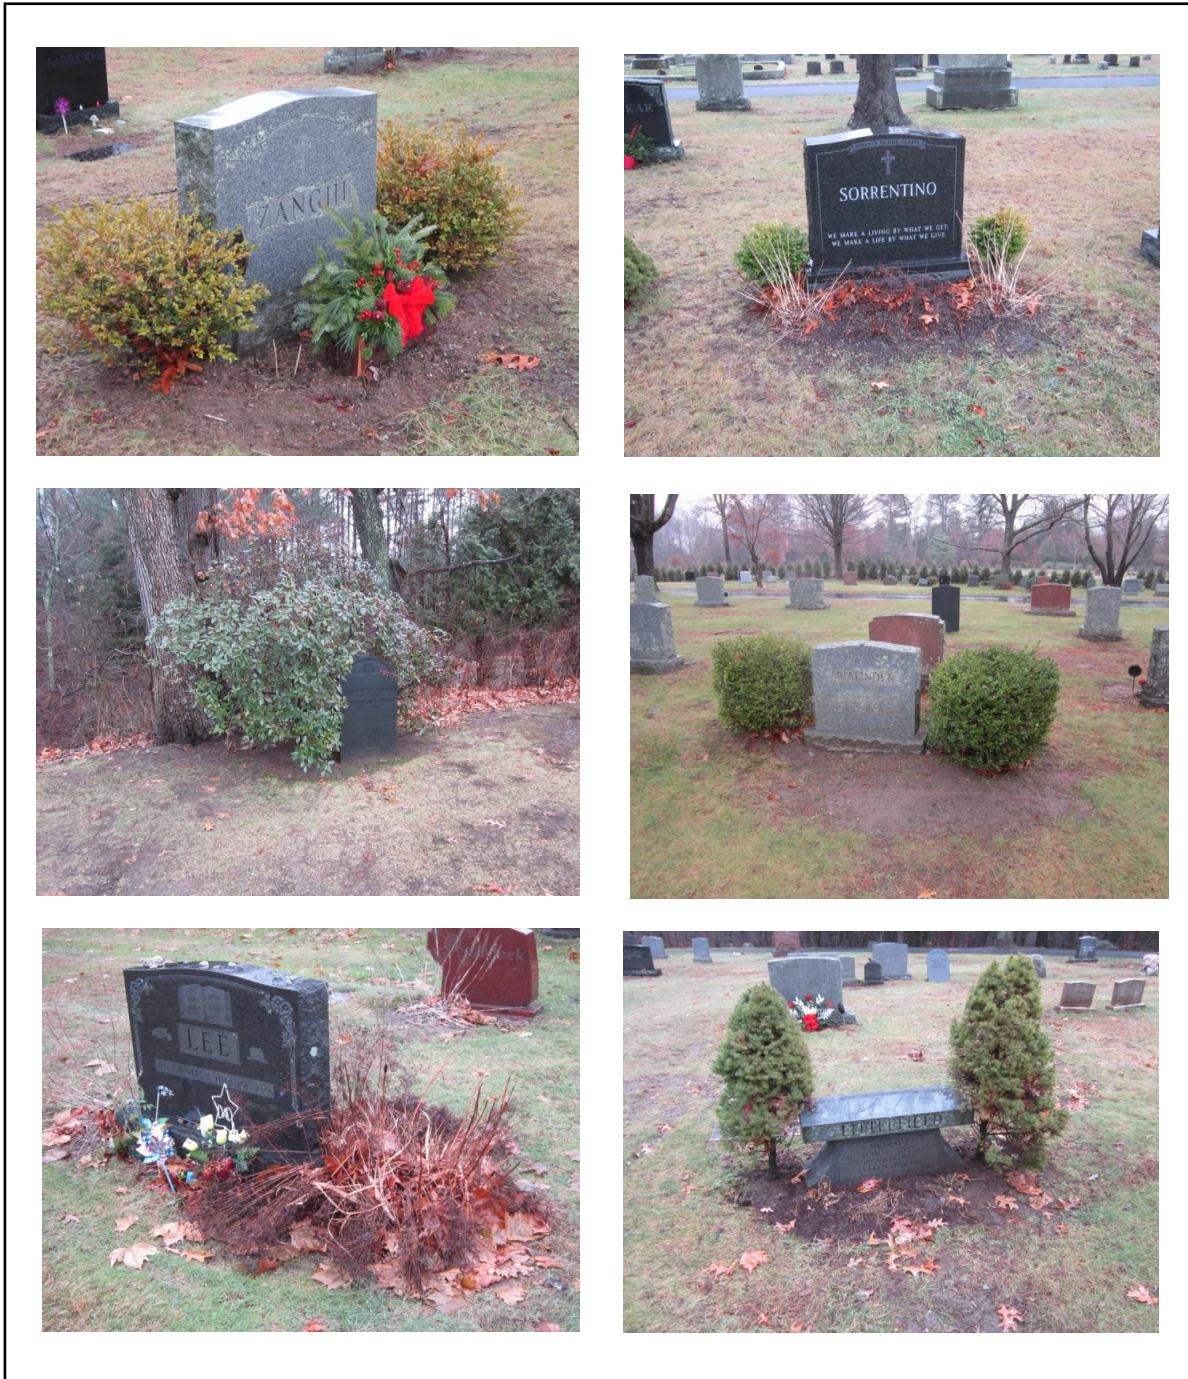
Figure 3-30. Shrubs. While the rules specify that only two “dwarf evergreen shrubs” may be planted on either side of the monument “not to exceed the height of the monument,” this is not being enforced. As a result, we see the presence of non-evergreen plantings, plantings that exceed height requirements, and plantings that are not dwarf varieties.

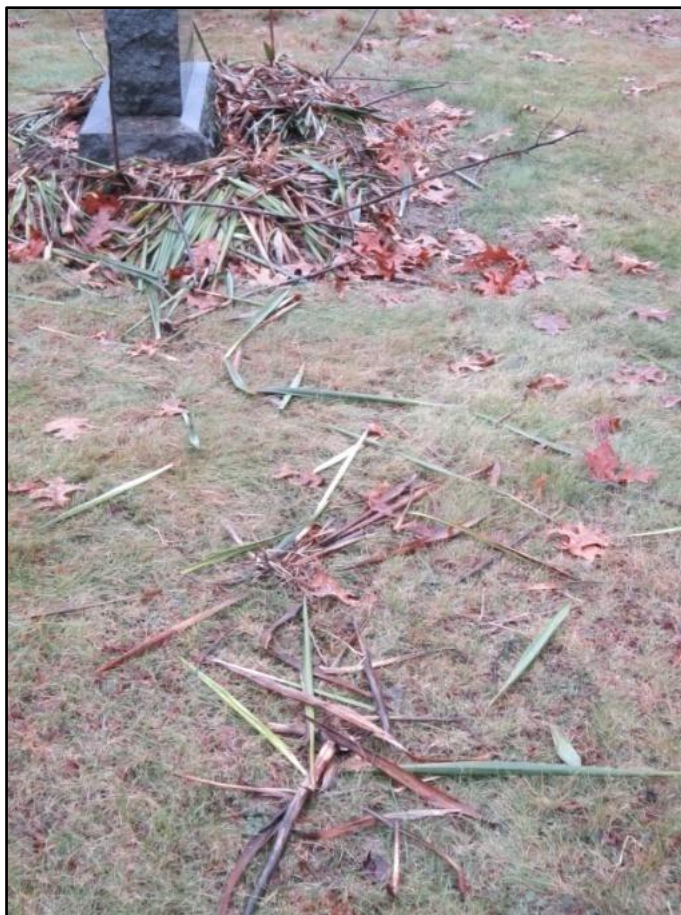
Figure 3-31. Yucca that has
been mowed.

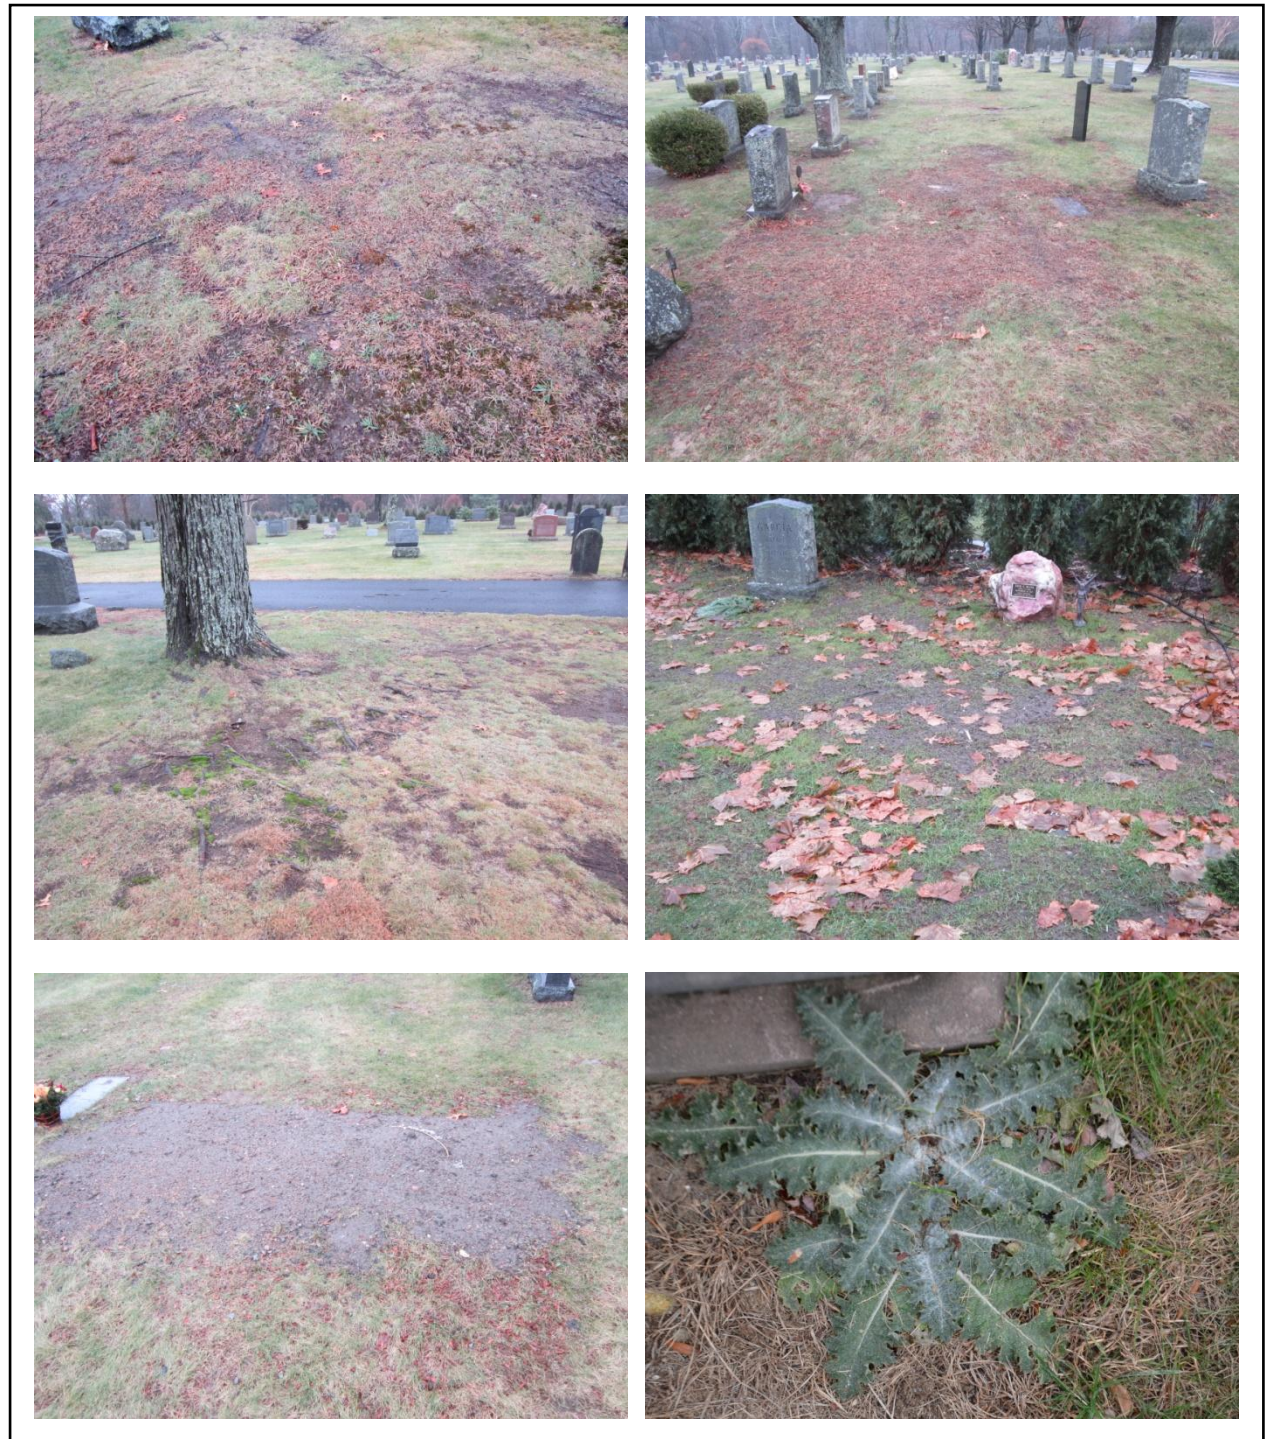
Figure 3-32. Turf problems. The upper two rows shows weedy, damaged turf in Section A, Lovell Section, and the Stoney Section. Lower left photo shows a seeded area with no cover and rotting seed.
Lower right photo shows some of the broadleaf weeds present in the cemetery.

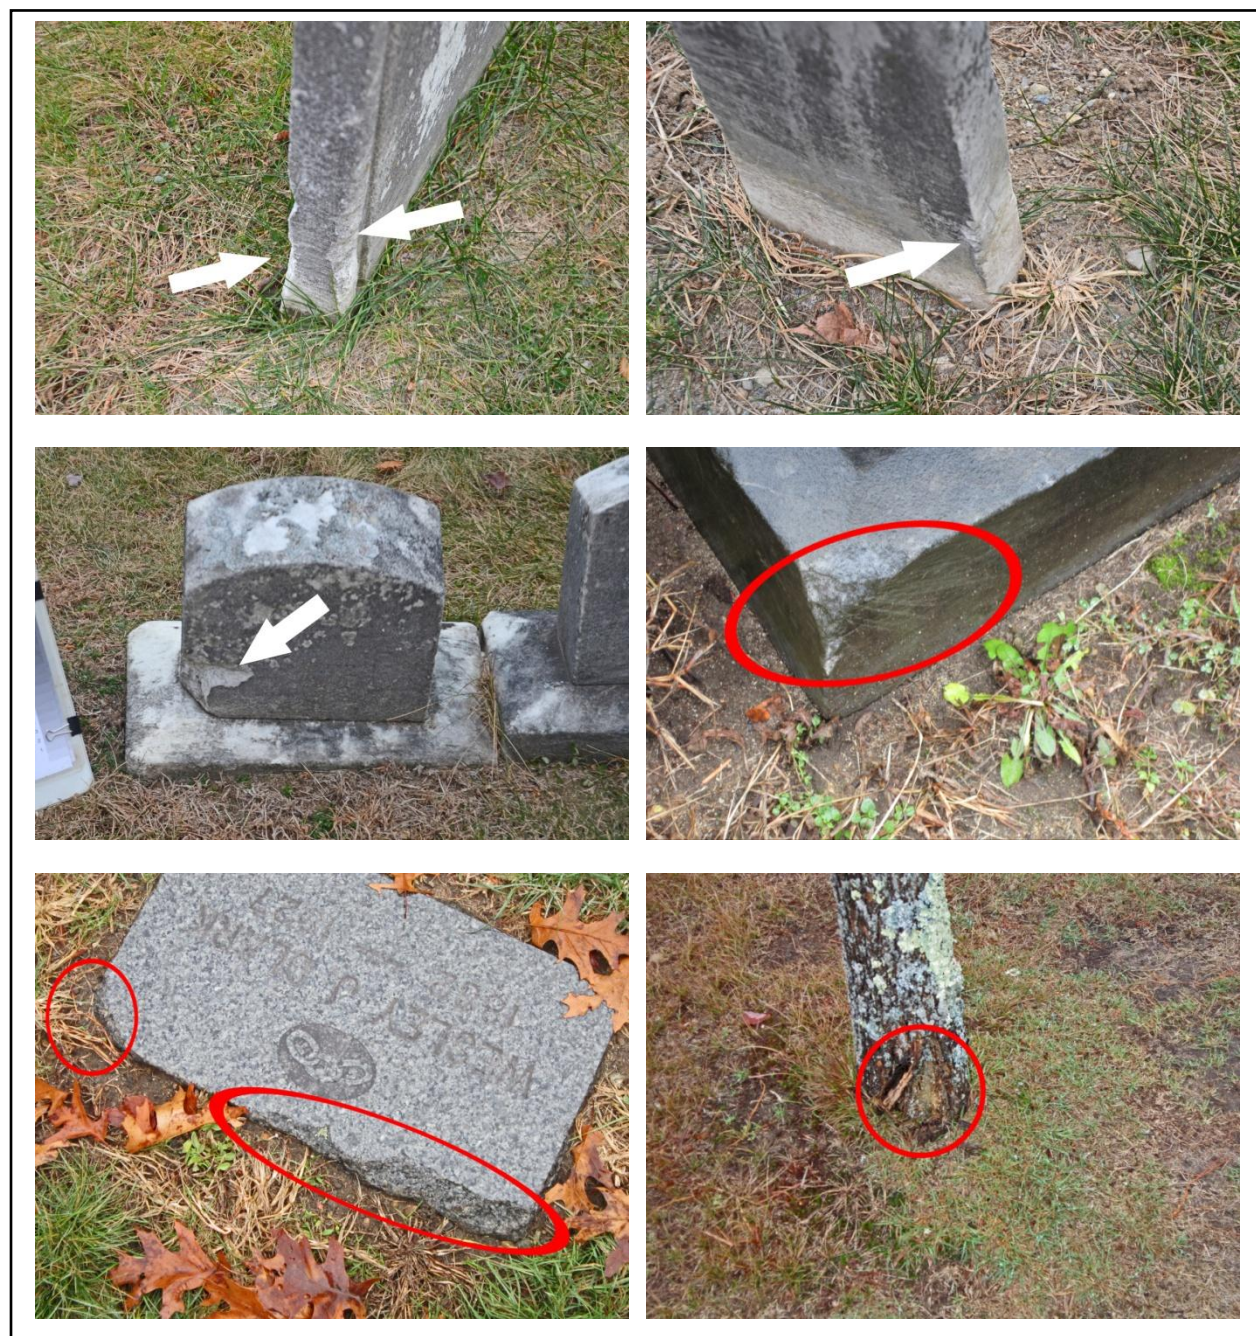
Figure 3-33. Mower damage to monuments and trees at North Cemetery.

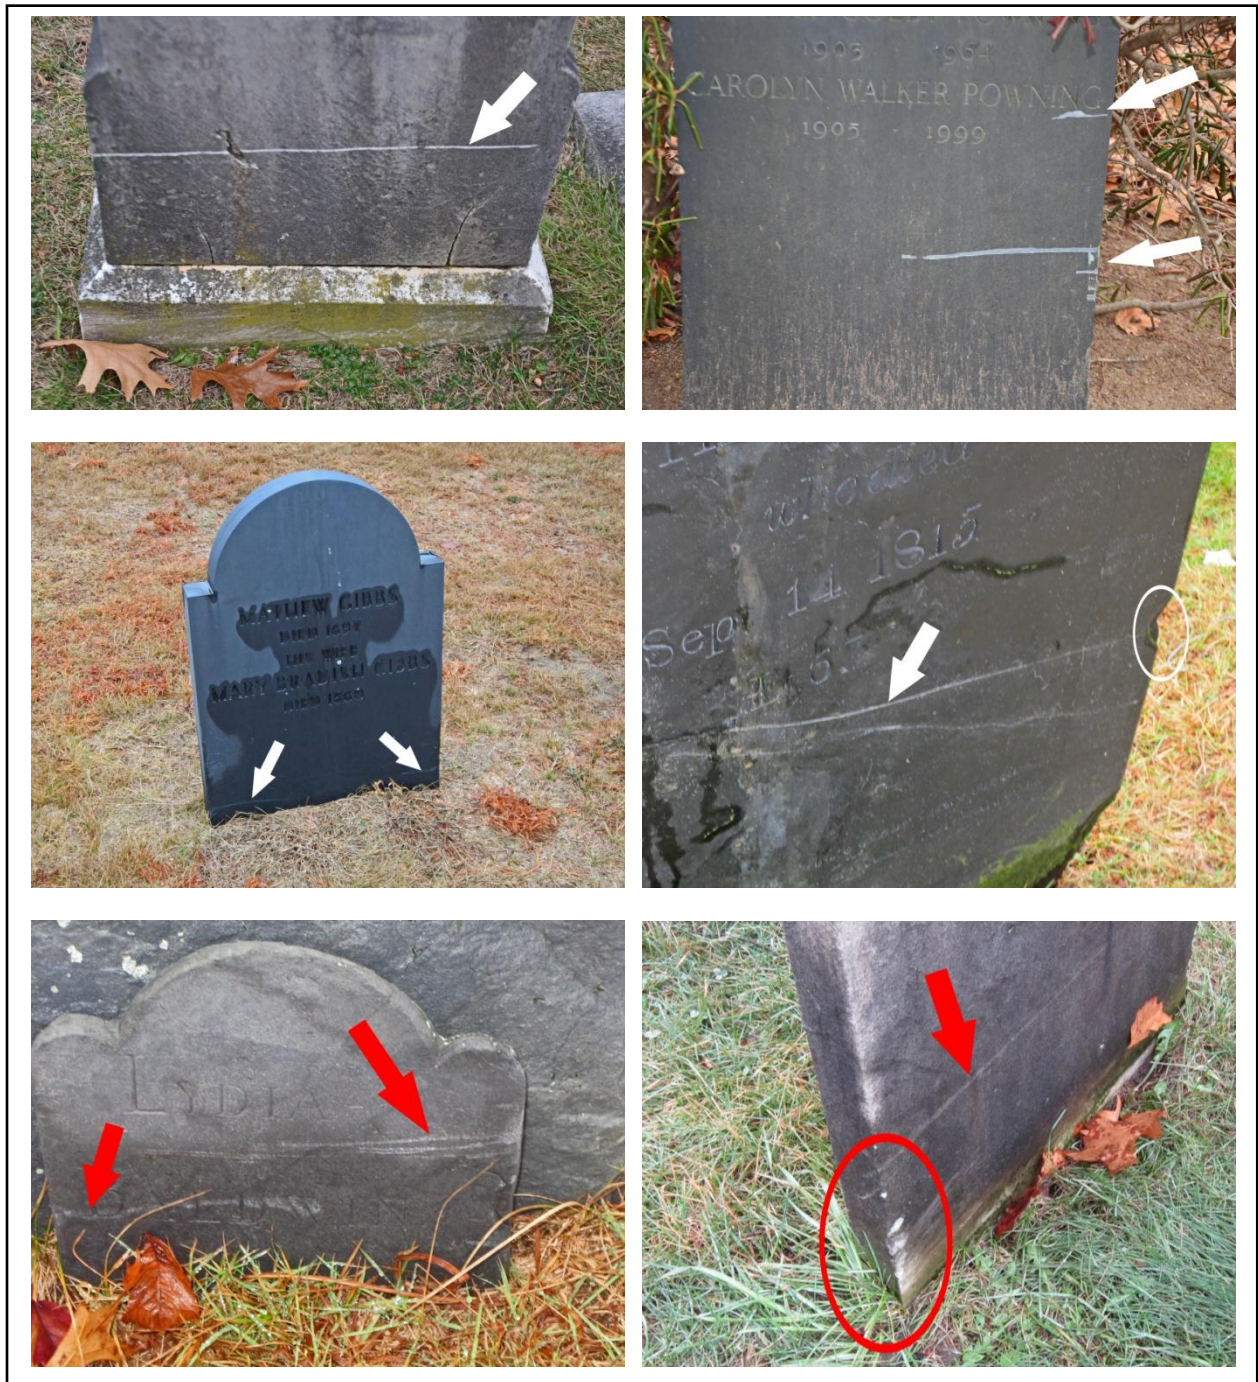
Figure 3-34. Scratches to stones caused by mowers operating too close. Both marble and slate stones are being damaged. Even modern replacement stones are being damaged by inappropriate mowing practices.

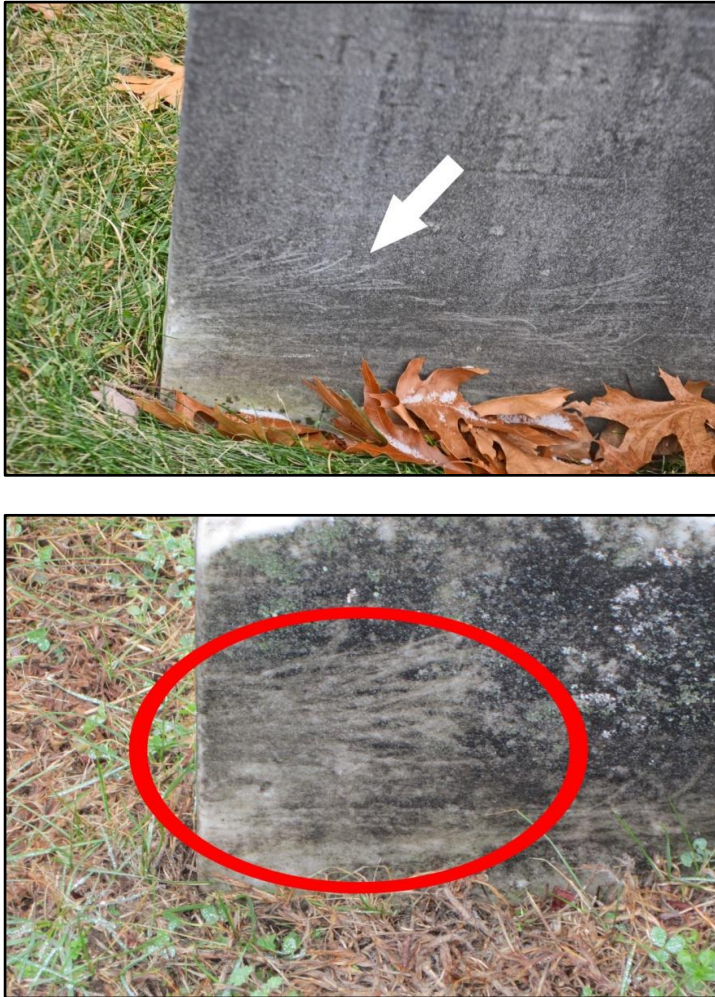
Figure 3-35. Nylon trimmer damage caused by improper operation and the use of string that is too heavy for the delicate stones.

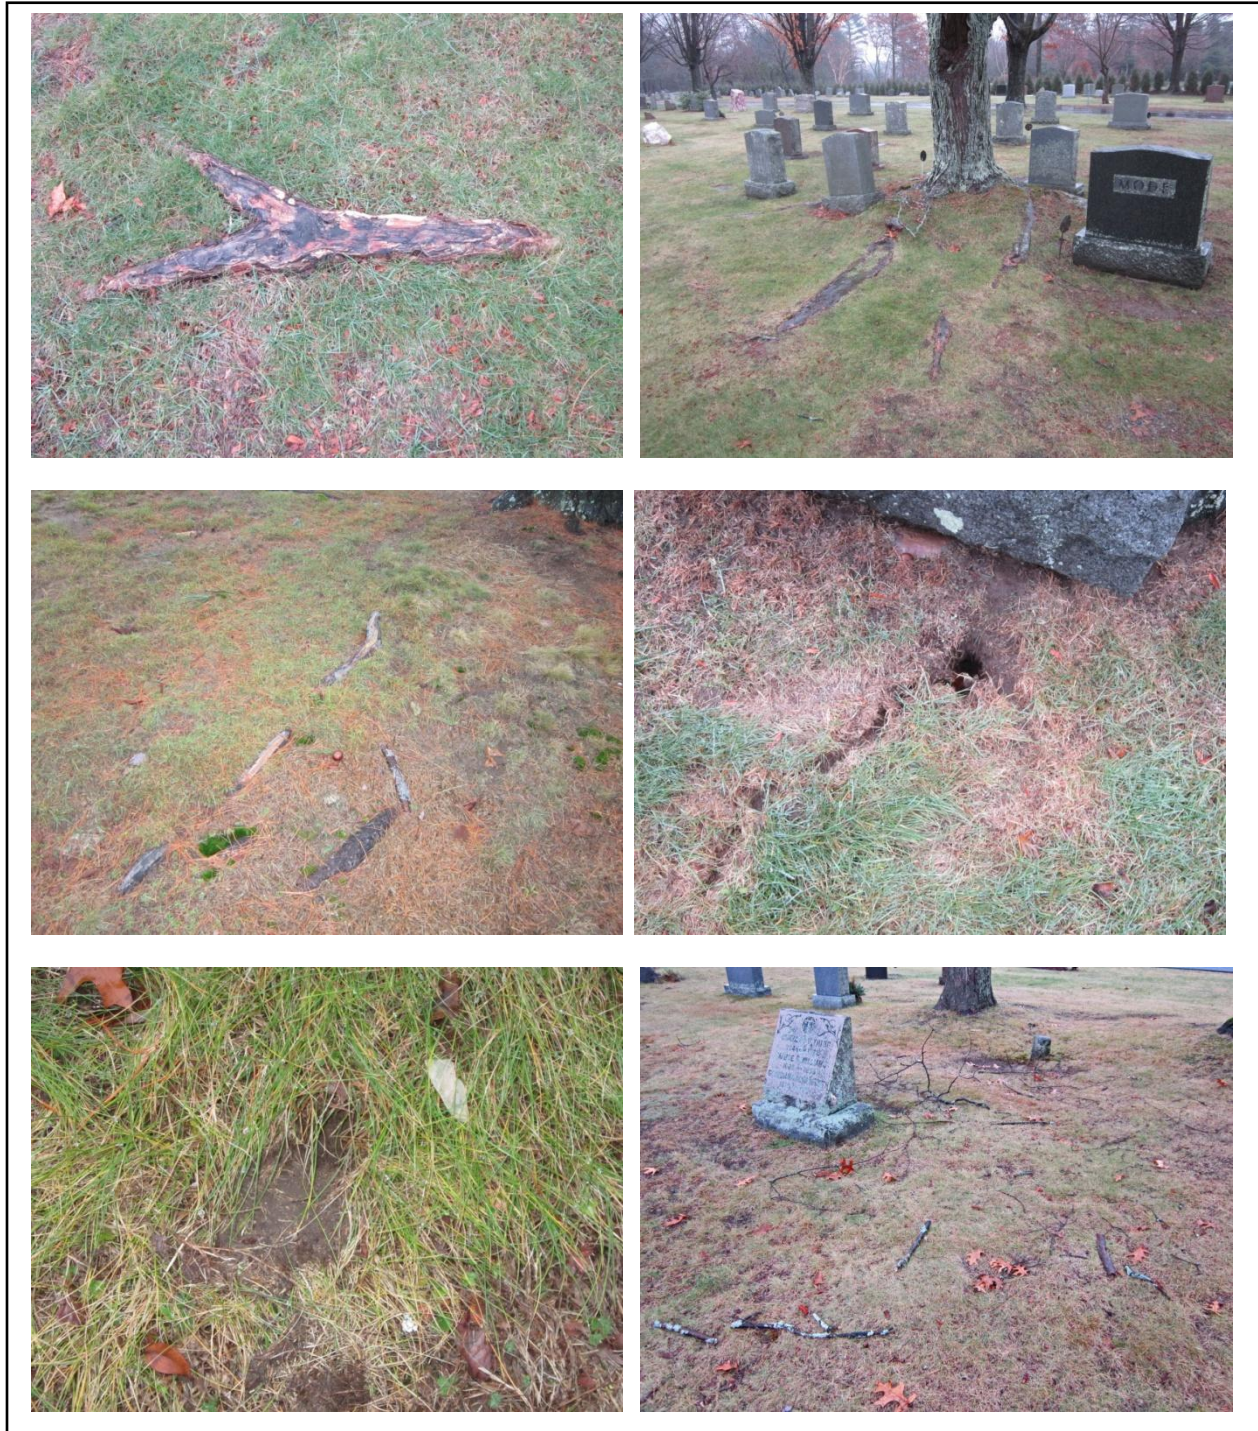
Figure 3-36. Other turf issues. The upper three photos show examples of surface roots scalped by mowing to low. The next two photos show evidence of animal burrows in the cemetery. The lower right photo shows branches that must be collected prior to mowing.

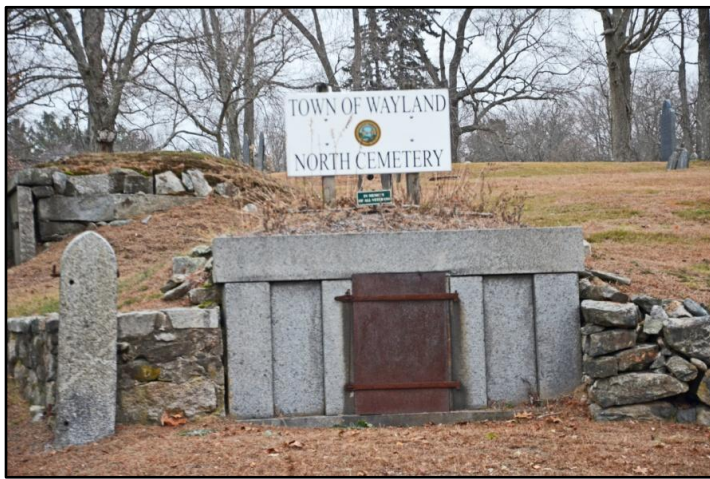
The current identification sign, while consistent with signage for South Cemetery and Lakeview Cemetery, is unimpressive and does not encourage visitation (Figure 3-37). It looks more like a temporary billboard than a sign for a cemetery.

The painted sign is mounted on two 4x4 wood posts that have been sunk into the earth covering of a vault. This is a very poor location since it dramatically detracts from the solemnity of the vault and may have compromised the stability of the vault roof (which has not been inspected recently since the door itself is welded shut).

Figure 3-37. Current identification signage at the entrance.

At the very least the location should be changed, removing the sign from the vault. We also recommend a more suitable design that encourages public interest. For example, a sign in classic black with rich gold lettering using a contemporary, but easily read typeface would be appropriate.

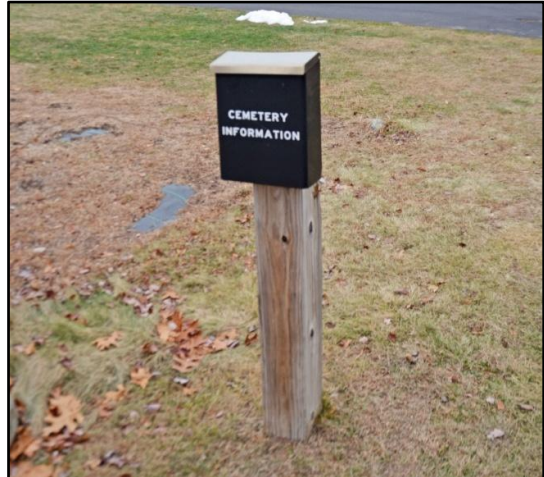
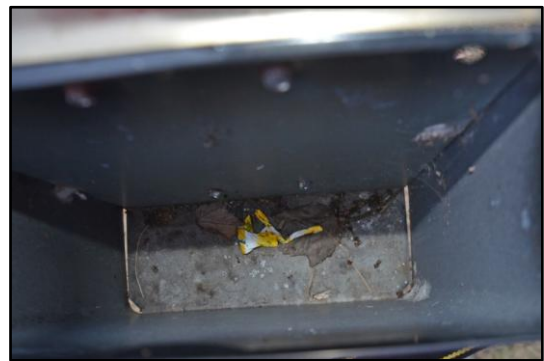
It may be that a simple tour brochure incorporating a map might be useful. Although we found a box in the cemetery identified as “Cemetery Information,” when we opened the box it was empty and appears to have been empty for quite some time (Figure 3-39). If information is being offered, the boxes must be inspected at least weekly – otherwise it appears that the Town really does not care about its cemetery.

Figure 3-39. Cemetery Information box, while present, was found to be empty, except for a candy wrapper.

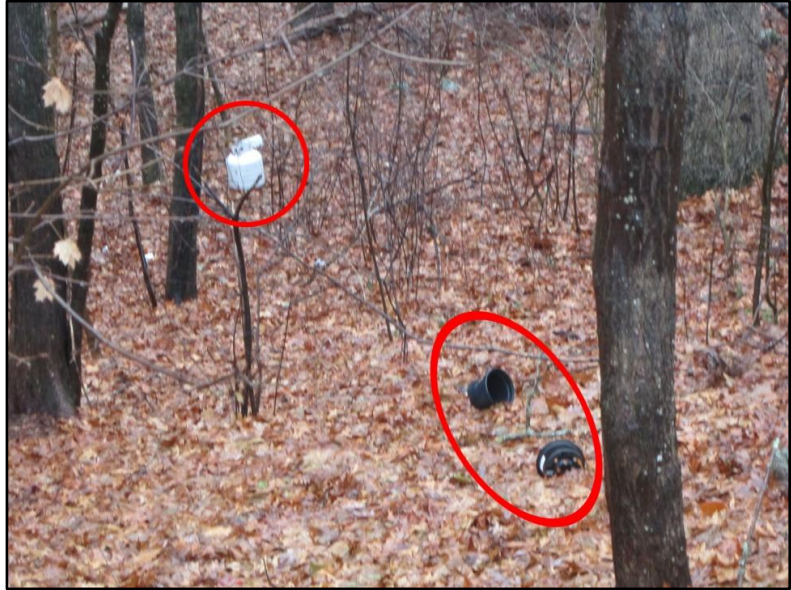
Figure 3-41. Trash thrown down the bank behind the Back Section.

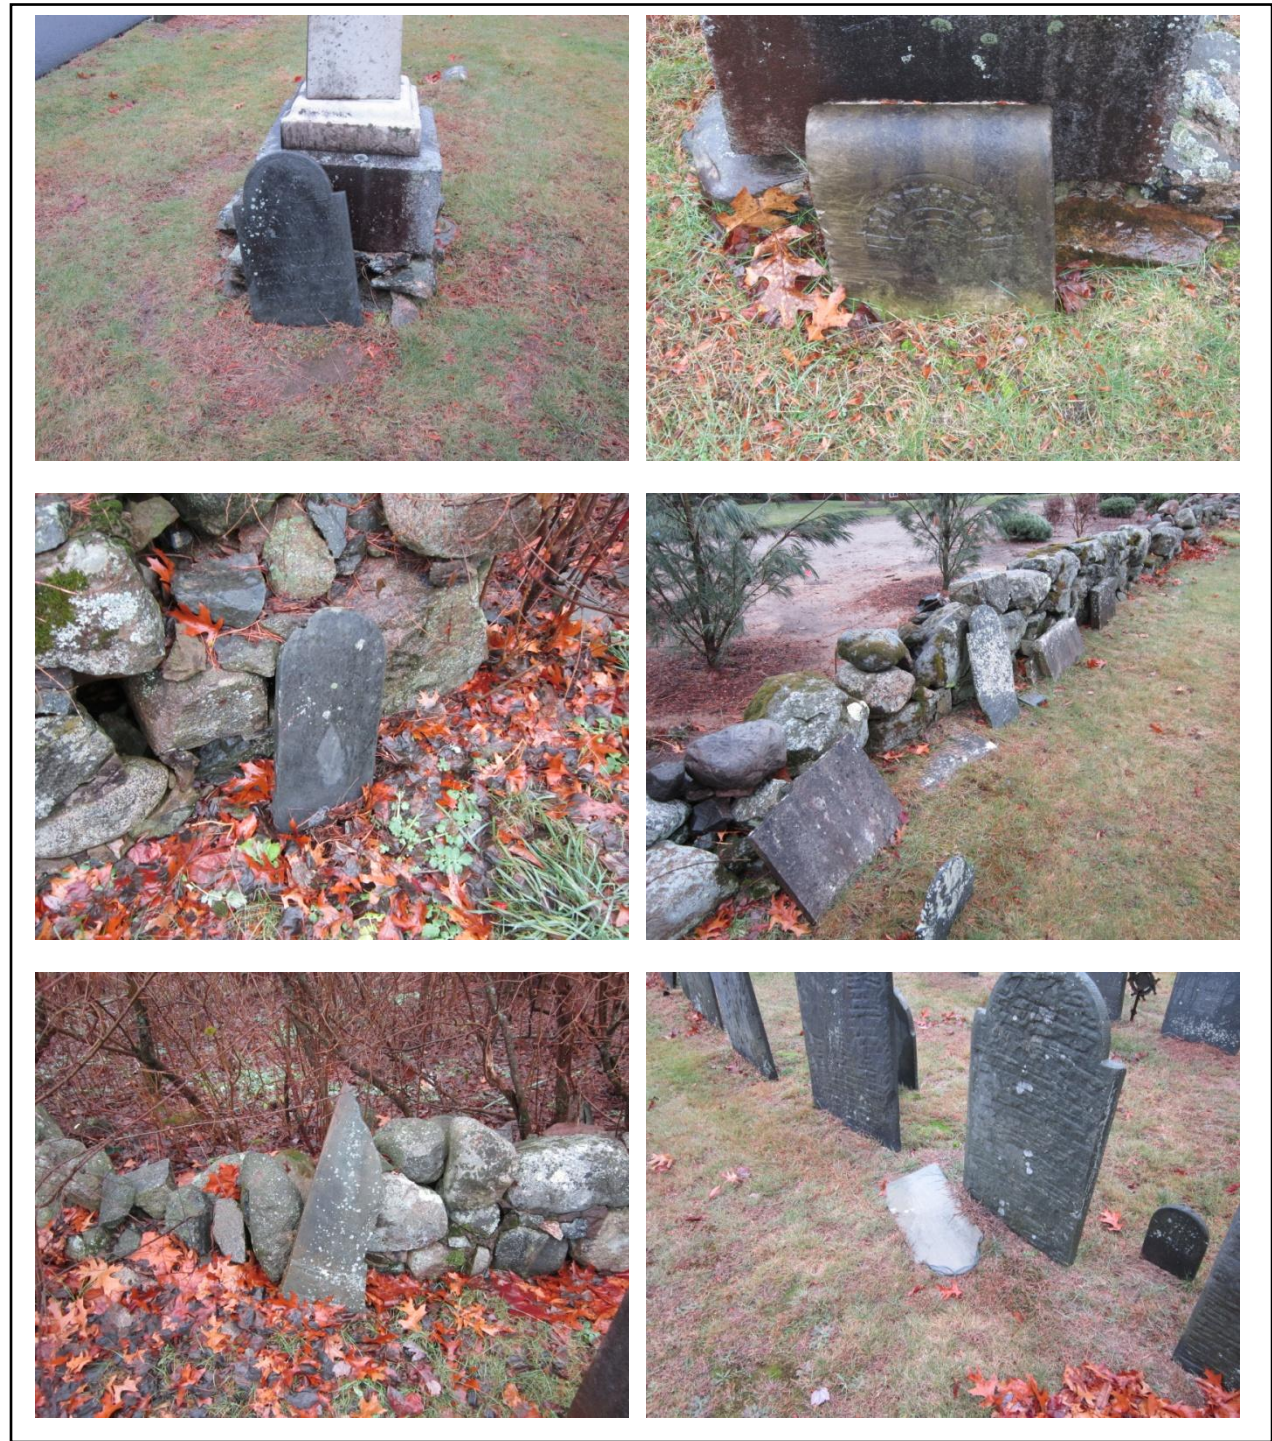
Figure 3-42. Examples of orphan stones found throughout North Cemetery. Leaving these stones unsecured subjects them to mower and trimmer damage (see, for example, upper right and lower left photos). It also risks vandalism or theft. The Town has a responsibility to document and secure these stones – as well as to return them to their proper locations.

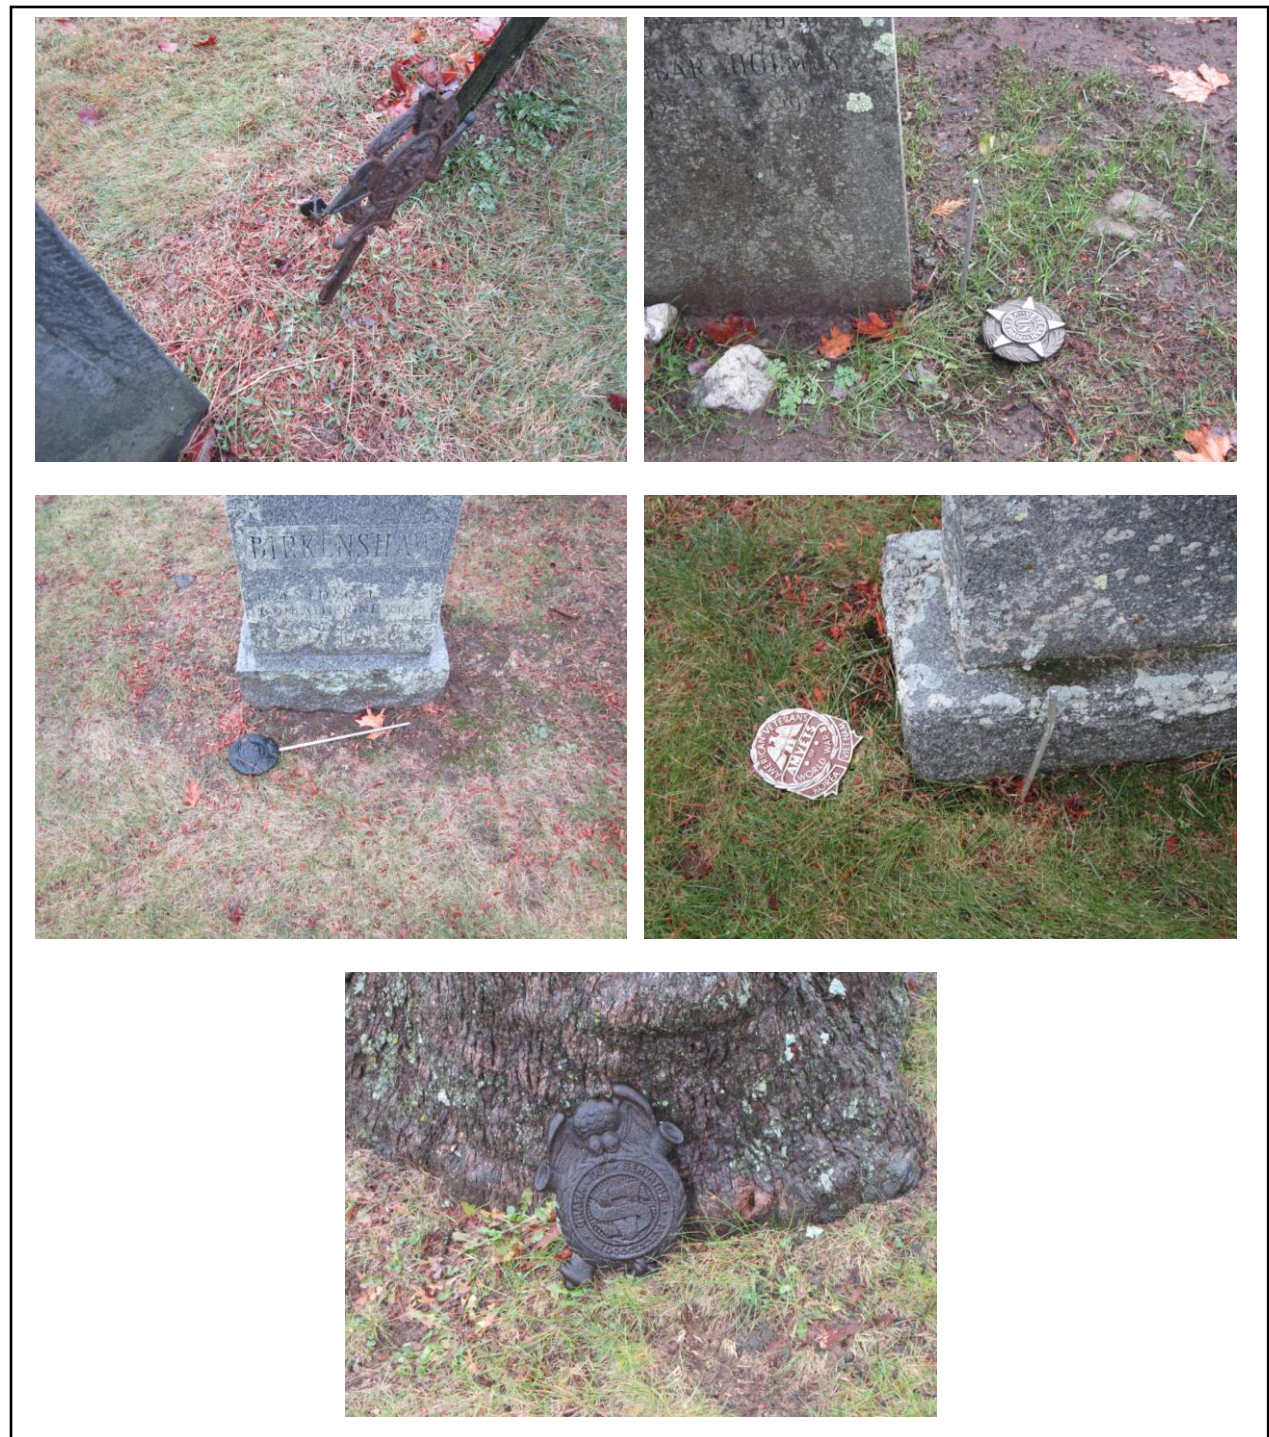
Figure 3-44. Damaged and orphaned emblems in North Cemetery. Upper left is an example of a broken shaft in the Old Section. Upper right shows a damaged emblem from the Lovell South Section. Middle left shows a fallen emblem in the Lovell Section. Middle right shows a damaged emblem from the Lovell Section. Bottom image shows an orphan emblem from Section A. Failure to repair or replace these military emblems is not only disrespectful, but will result in many being stolen.

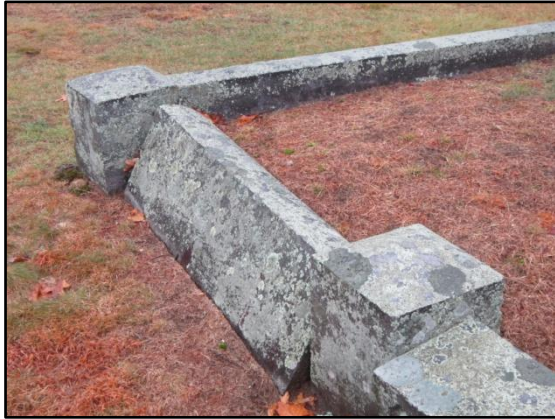
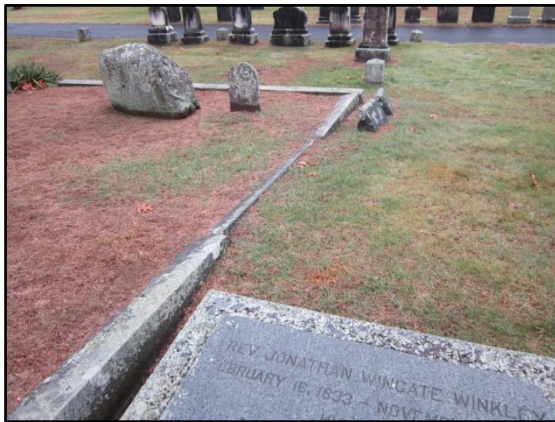
Plot curbs and coping are considered here since they are of secondary important to the condition of the monument. However, the curbs and coping are in overall poor condition with considerable displacement. Several examples are shown in Figure 3-45.

Figure 3-45. Displaced and sinking curbs are common, especially in the Stoney Section.

While initially we were told that the Parks, Trees, and Cemeteries resets these curbs, subsequent discussions revealed that the staff “has very little time to do this” and there is no formal training. Infilling of depressed areas and resetting of curbs should be a routine maintenance operation. That it is not is additional evidence that the Town is failing to provide adequate funding and staffing to maintain North Cemetery.

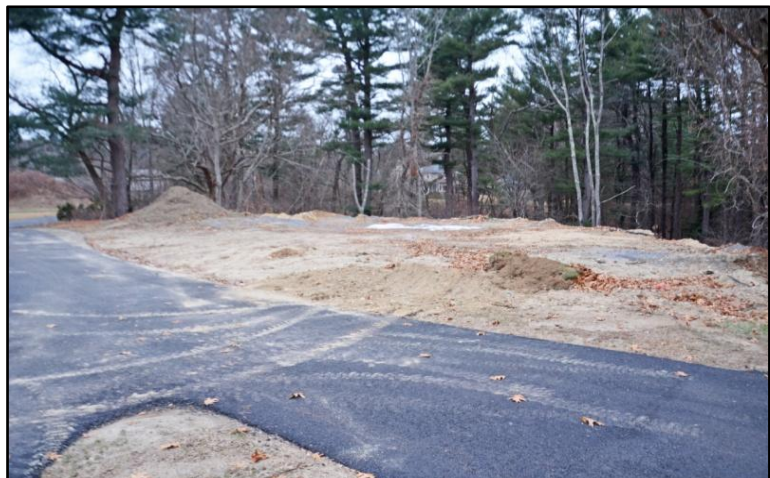
Figure 3-46. The soil area detracts from the cemetery and should be moved or screened.

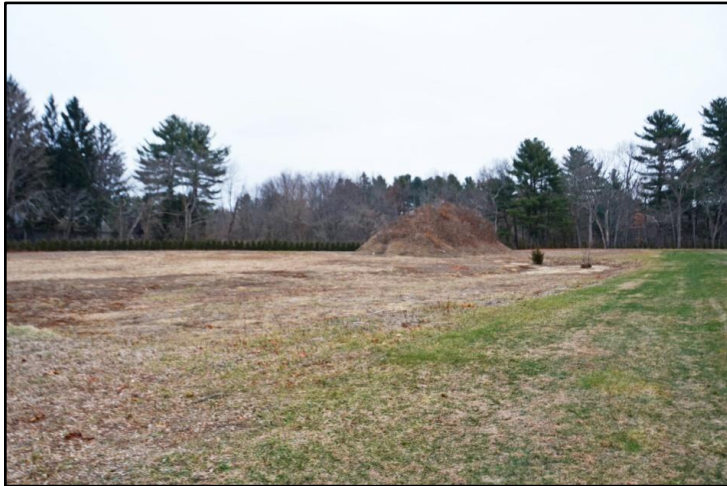
Figure 3-47. Depression and spoil pile in the section being developed.

As with the storage building, if removal is not possible, then the area must be screened using plantings so that it doesn't detract from the cemetery's ambiance.
