Preservation Management Plan for the North Cemetery Wayland, Massachusetts

**Prepared For
The Town of Wayland**

June 30, 2015

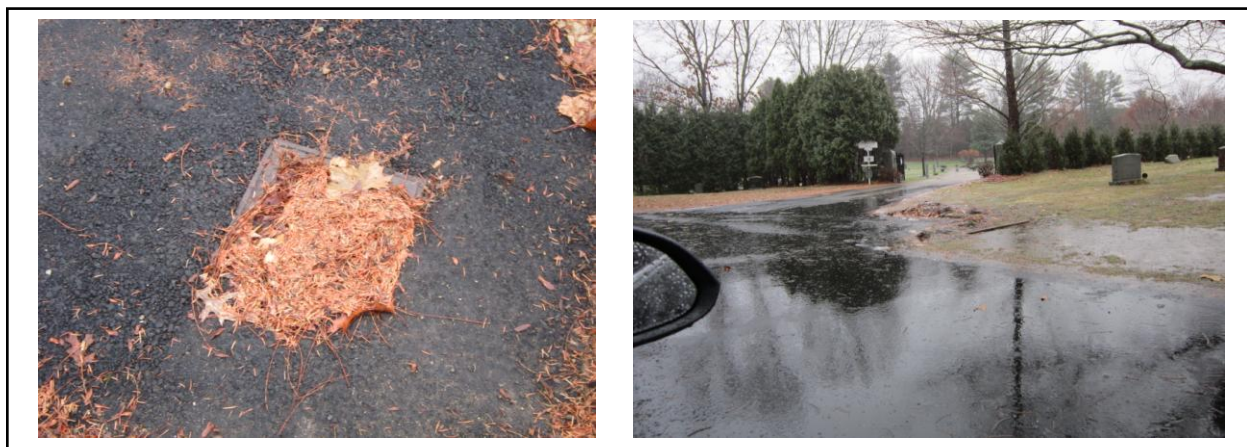
Figure 3-48. Issues with drains in the Cemetery. The photo on the left shows a drain clogged by leaves and other debris. On the right is a photo of a largely ineffectual drain with soil piled up around it, causing localized flooding or ponding of water in the cemetery.

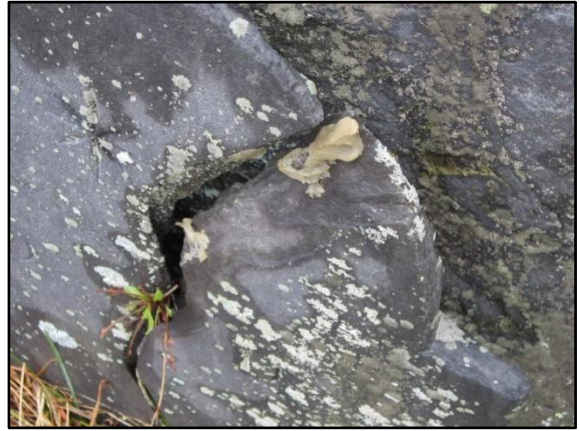
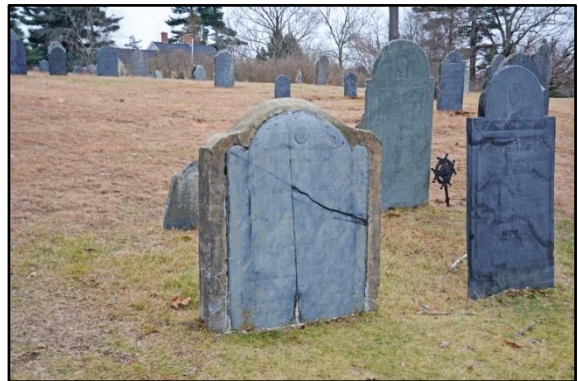
As is the case in all cemeteries, some of the previous repairs have used what are known today to be inappropriate materials. Some stones have suffered from the well meaning, but inappropriate treatments (Figure 3-49). Recently, however, the Town of Wayland has taken great efforts to ensure that appropriate conservation treatments were used.

Figure 3-49. Poor repairs. In the top photo a silicon caulk has been used in an effort to adhere a broken slate stone. In the lower photo a slate stone has been encased in a hard Portland cement.

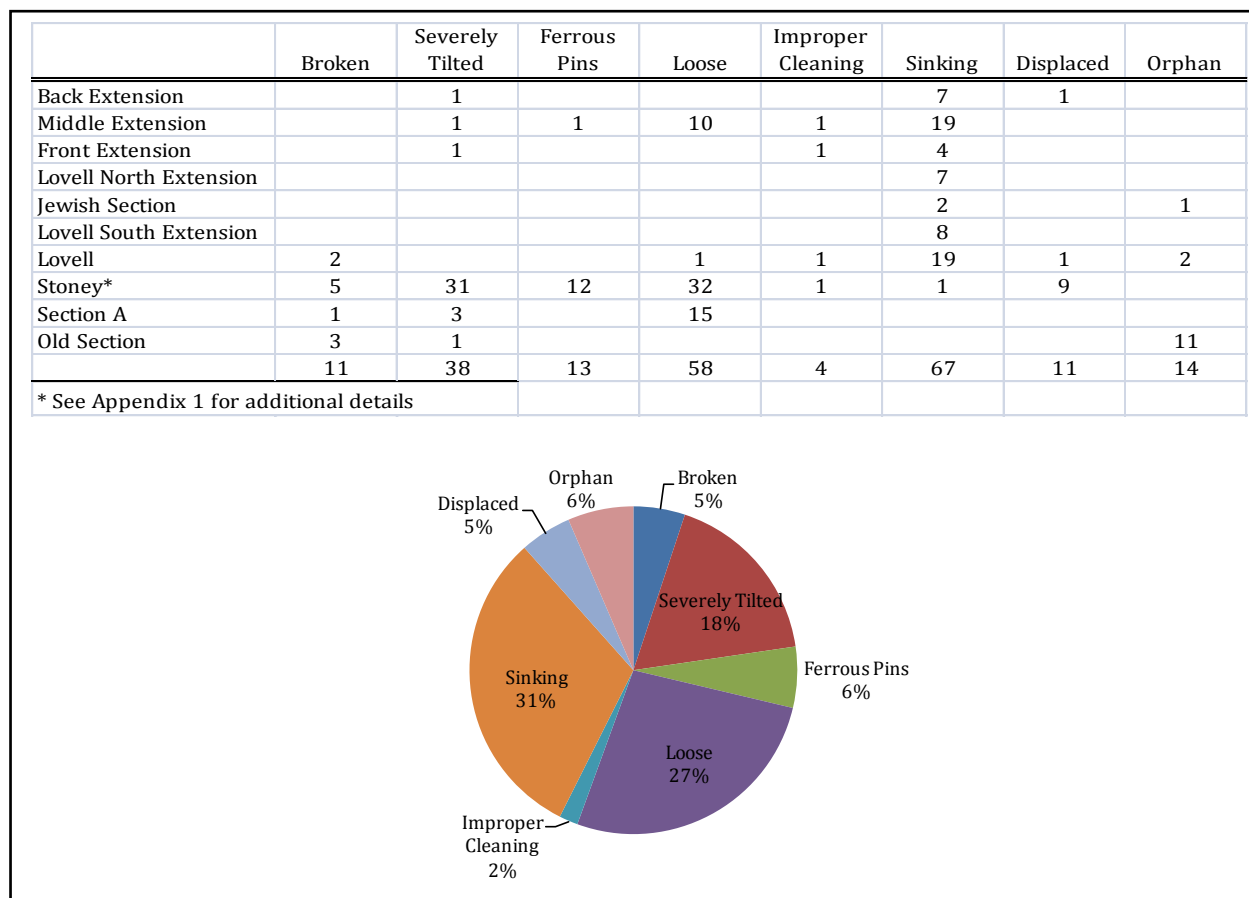
Figure 3-50. Damaged stones and conservation problems in North Cemetery.

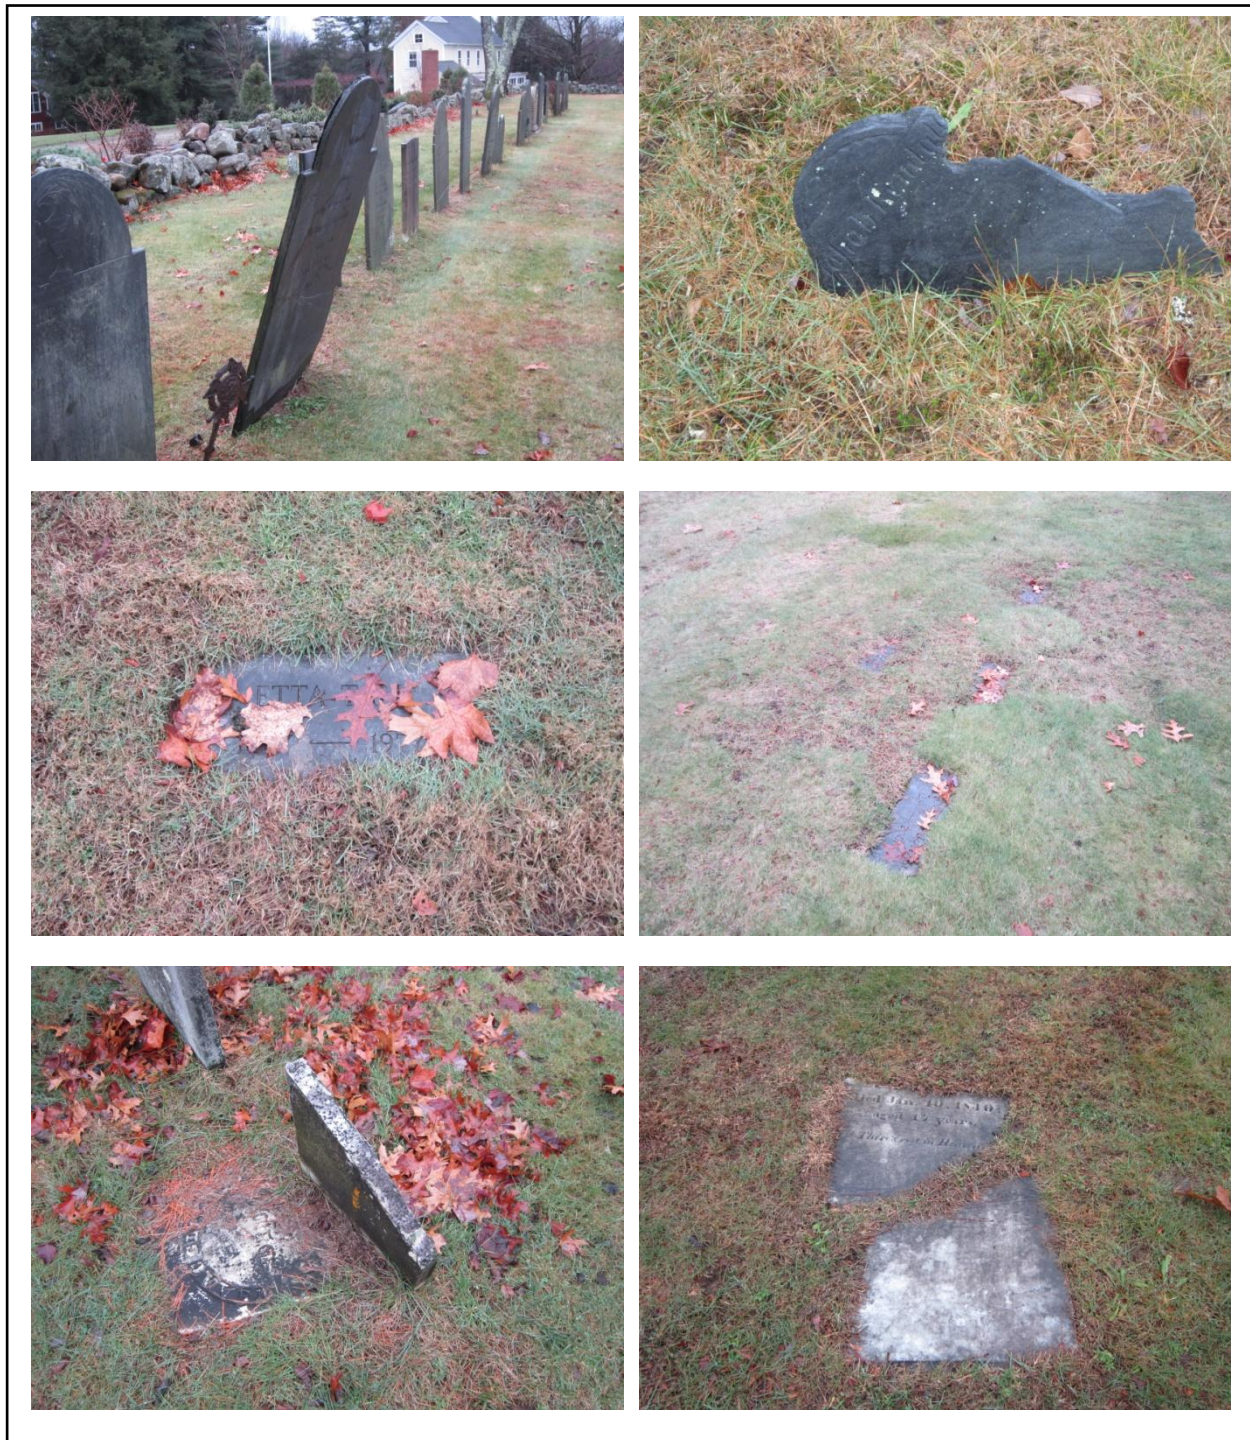
Figure 3-51. Examples of damaged stones. Upper row shows severely tilted stones, both the Old Section. Middle row shows sunken markers in the Jewish Section (left) and Lovell Section (right). Lower row shows broken stones in the Old Section (left) and Lovell Section (right).

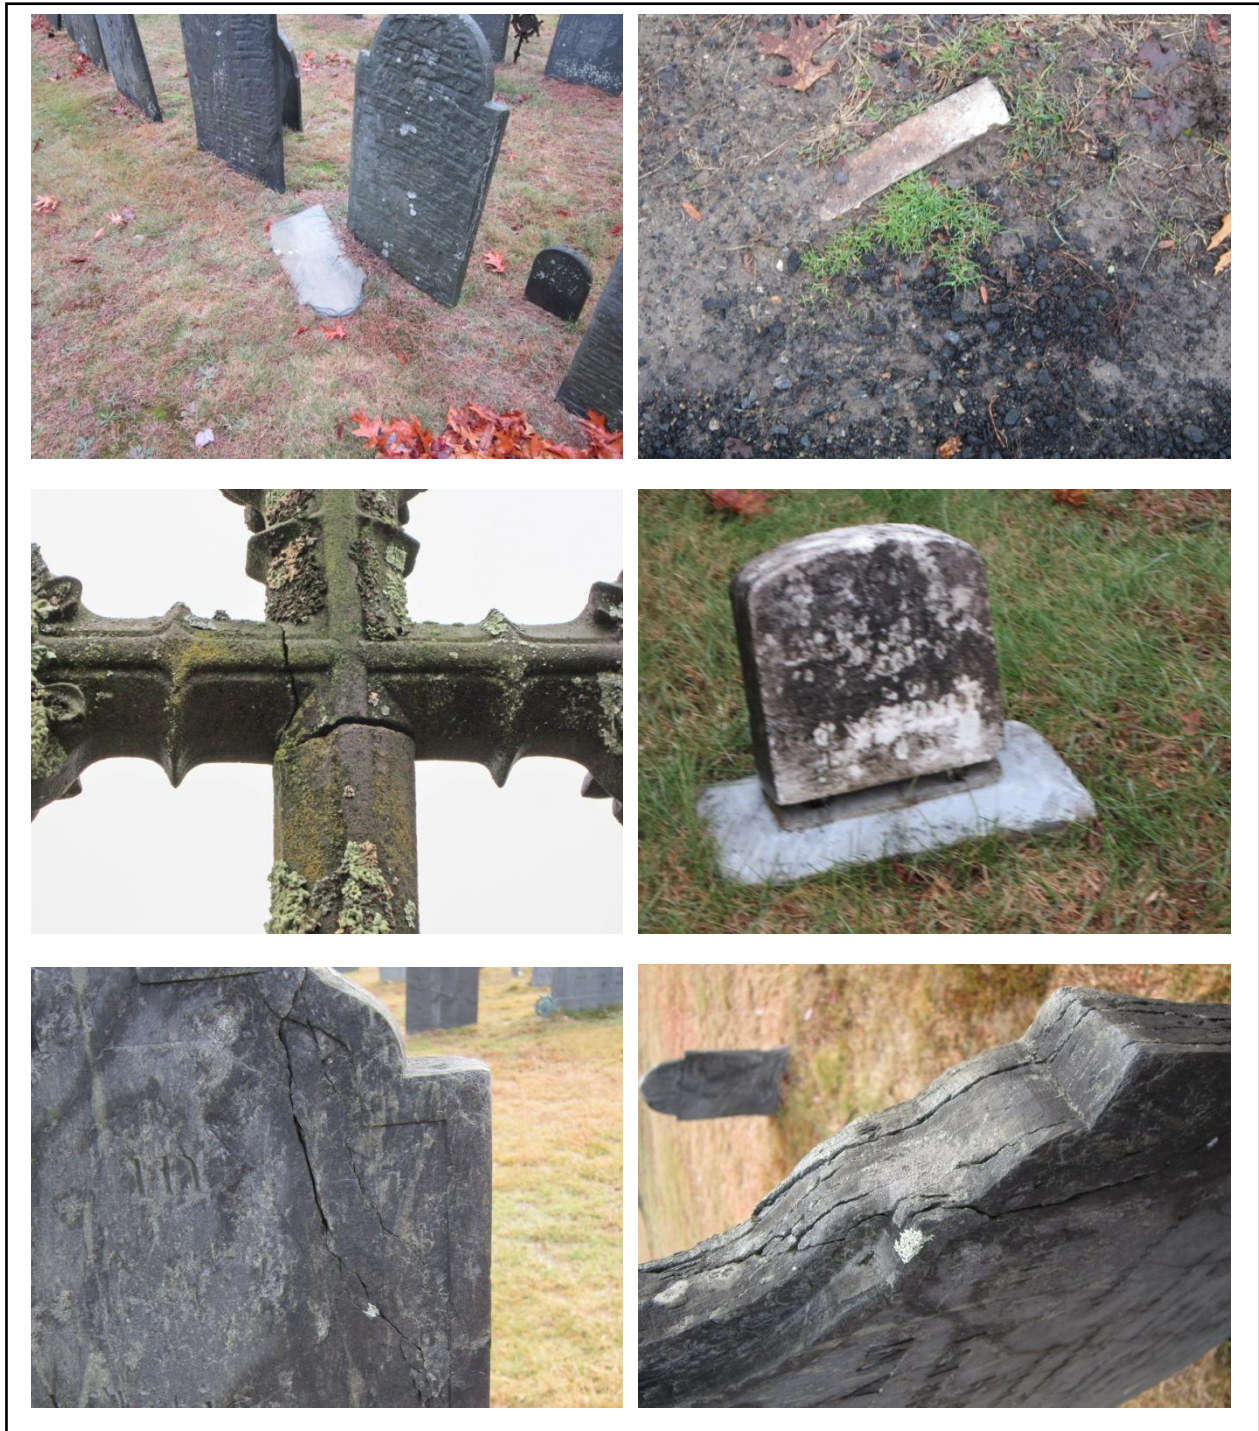
Figure 3-52. Examples of damaged stones. Upper left shows a stone out the ground (Stoney Section). Upper right shows a broken stone (Stoney Section). Middle left shows a broken sandstone cross with heavy lichen (Stoney Section). Middle right shows unattached die on base (Stoney Section). Lower left shows a cracked slate (Old Section). Lower right shows severe spalling of a slate stone (Old Section).

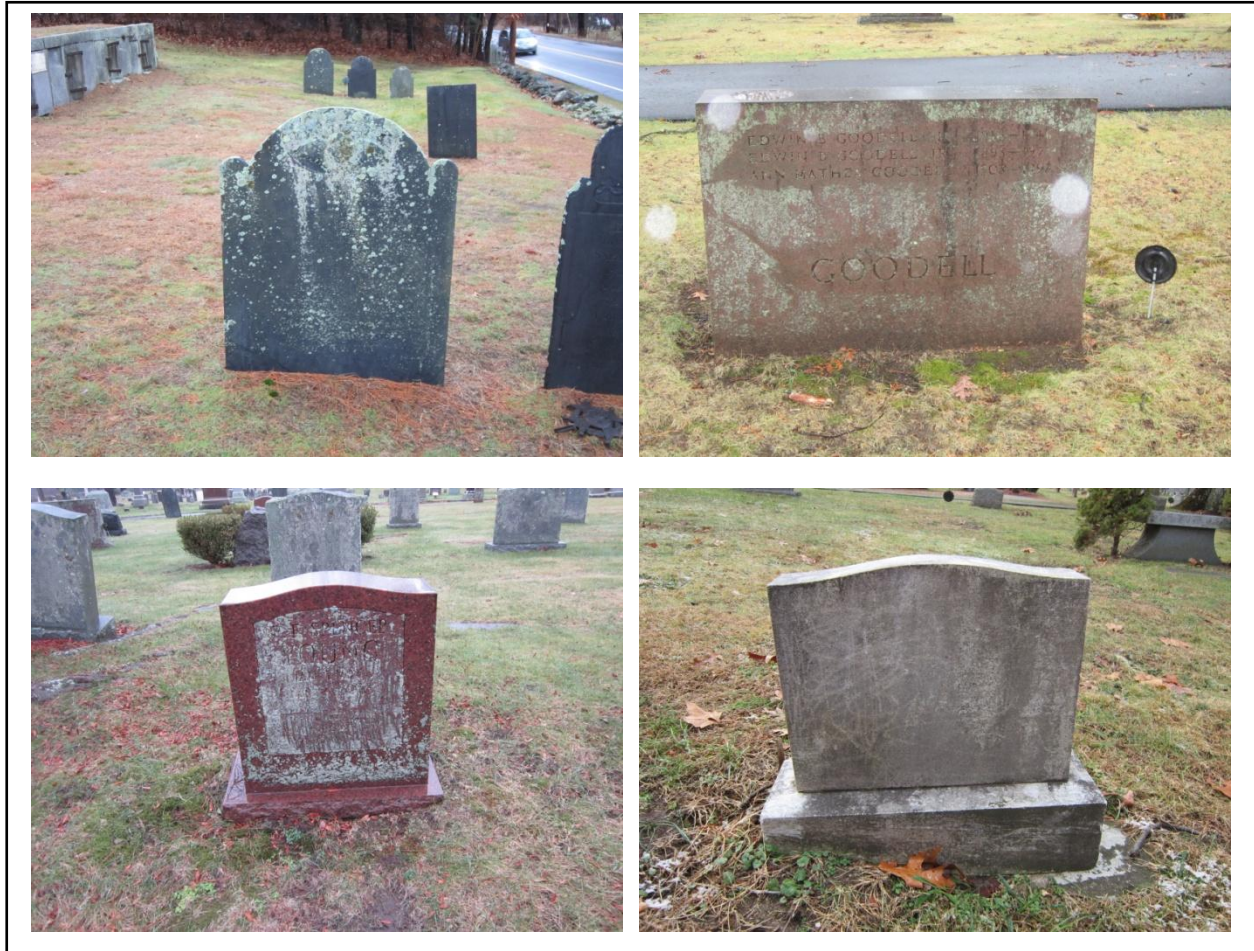
Figure 3-53. Cleaning Issues. Upper left photo shows typical extensive development of lichen on many stones at North Cemetery. Upper right and lower left both illustrate improper efforts to clean just names, probably for genealogical research. Lower right photo shows a marble stone incorrectly cleaned with a pressure washer (notice the streaks, especially on the left side of the die).

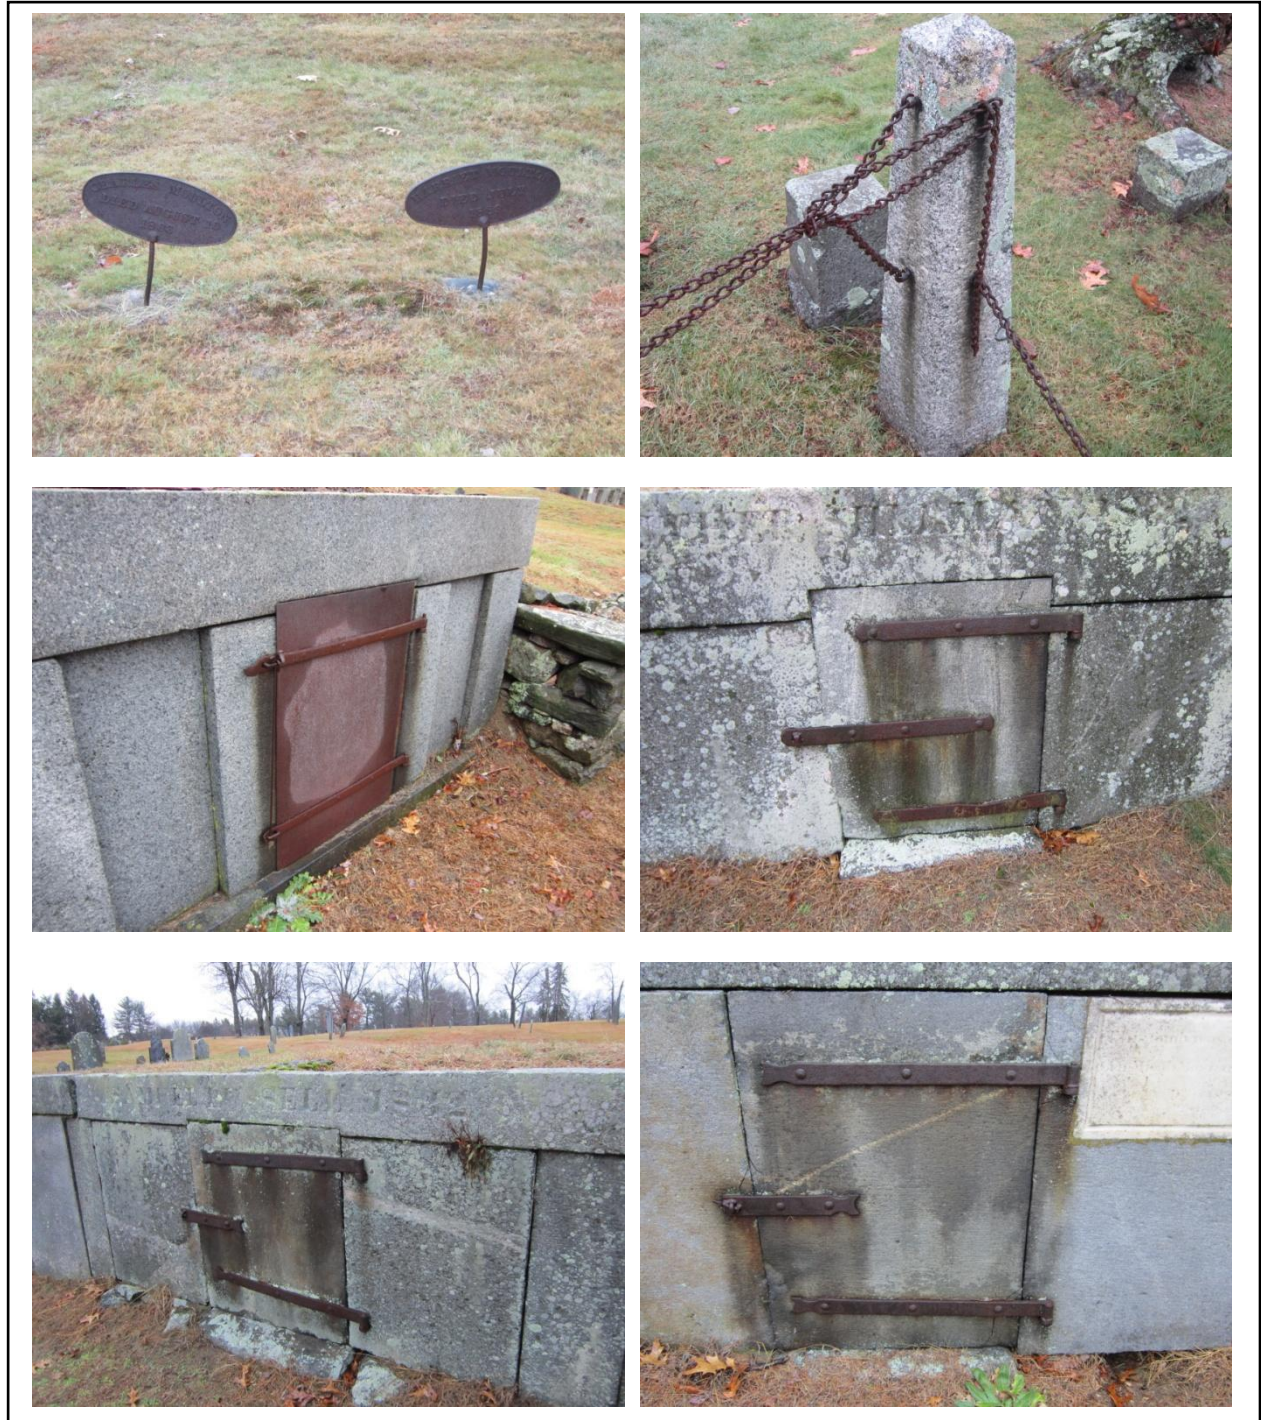
Figure 3-54. Iron objects in North Cemetery. Upper left photo shows the two cast iron markers in the Old Section. Upper right shows a portion of the chained plot in the Stoney Section. The lower two rows show four of the five iron doors on vaults in the cemetery.

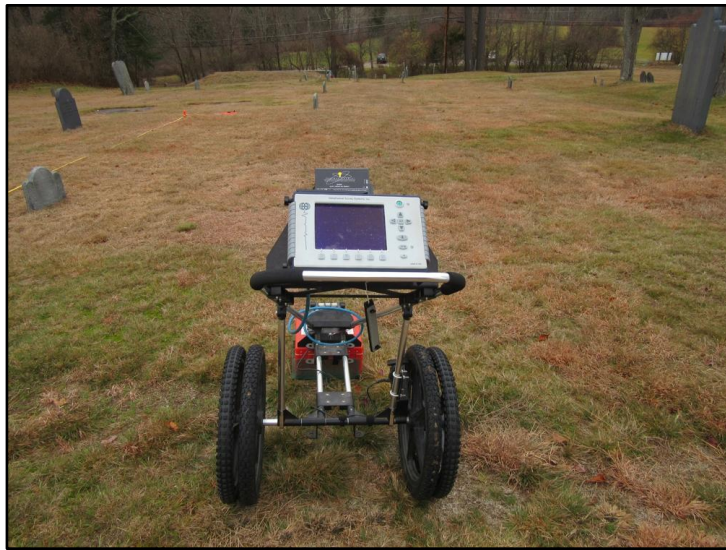
When physical features are obscured or otherwise disturbed in a cultural landscape, every effort should be made to determine what remains of the original features and design, detail how the landscape has changed, and then determine how what remains (both above and below ground) can best be preserved. A ground penetrating (GPR) survey provides a non-destructive means to permanently document potential areas of concern. Therefore a GPR survey was included in the Preservation Management Plan to answer site-specific questions that were of interest to the historical commission and the town including the location of the original meeting house in the Old Section, information about the Indian Burial Ground in the Middle Extension, and information about a former palisade in Section D. The survey was conducted during November, 2014 and April, 2015. A 400 MHz antenna, which has a typical depth range around 9 to 12 ft depending on the soil conditions, was used for the survey (Figure 4-1).

Figure 4-1. Photo of GPR equipment.

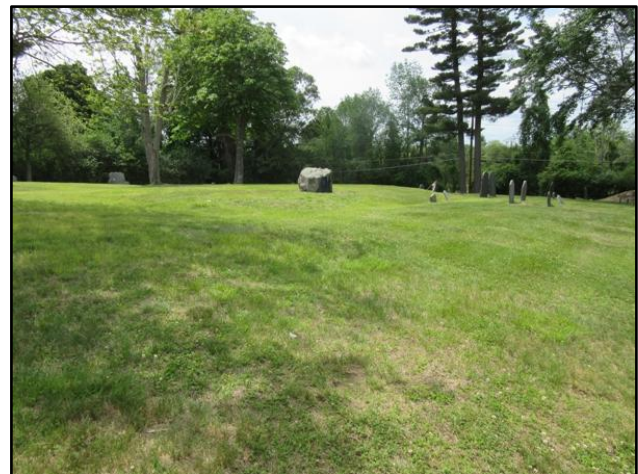
While there is a boulder with a plaque in North Cemetery noting the location of Sudbury's original meeting house, it is unclear how that information was obtained. Indeed the landscape appears as a square area that has been filled (Figure 4-2). As there were three meeting houses constructed within the Old Section in the seventeenth century and there are several large open area areas within this section of the cemetery, the GPR survey was designed to cover as much of the open area as practicable.

Figure 4-2. Photo of the boulder with plaque identifying the location of the first meeting house.

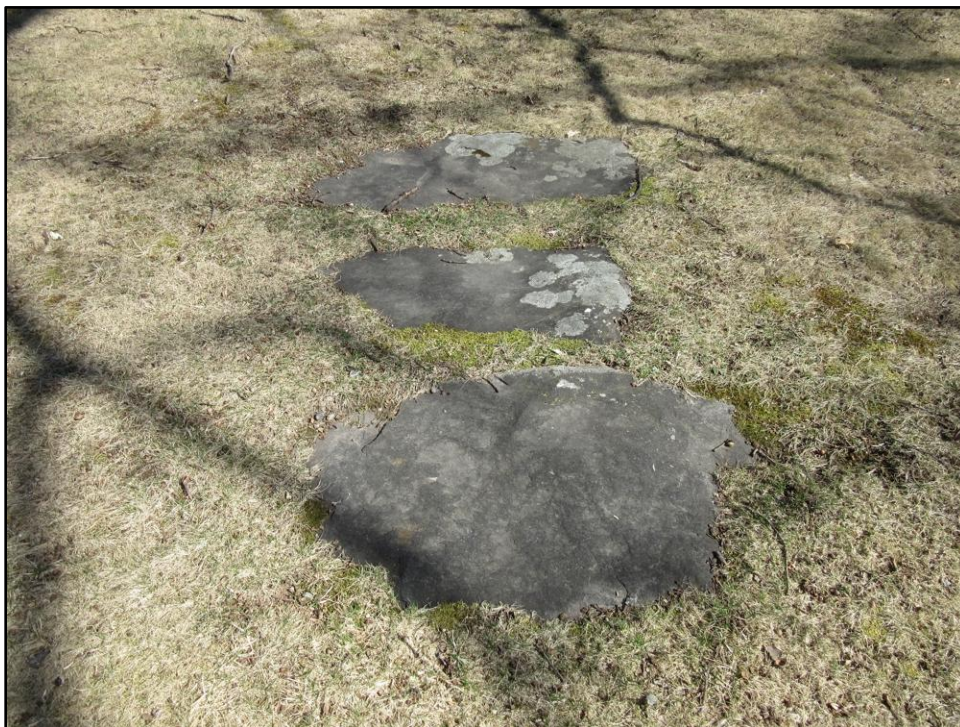
As discussed above in Section 2.0, it has been speculated that an Indian Burial Ground is located in the eastern section of the cemetery, specifically in the Middle Extension. Indian graves are believed to be marked at two locations that have flush-to-the-ground (flat) stone markers, one with three flat stones (Figure 4-18) and the other with one flat stone (Figure 4-19). A 1925 photo of the three flat stones provides them with better definition than is visible today (Fig 4-20). In 1950 shrubs were placed around the two burial lots with the flat stones, but have since been removed. Four other locations of Indian Graves are noted on a plan of the Middle Extension.

Figure 4-18. Photo of three flat stone markers.

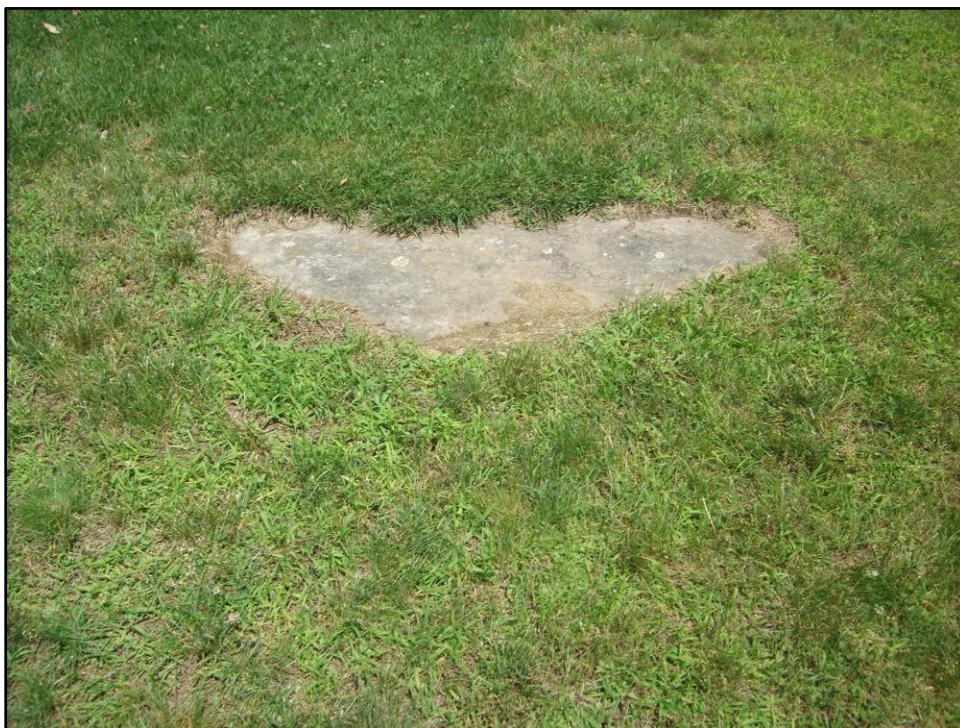
Figure 4-19. Photo of one flat stone marker.

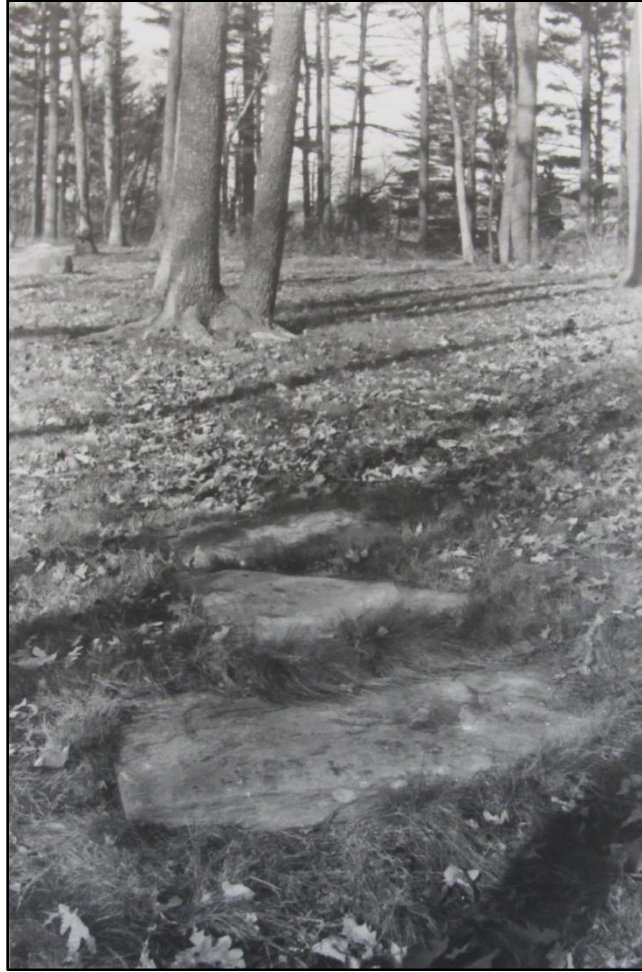
Figure 4-20. Historic photo of three flush stone makers
(Courtesy of Wayland Historical Society).

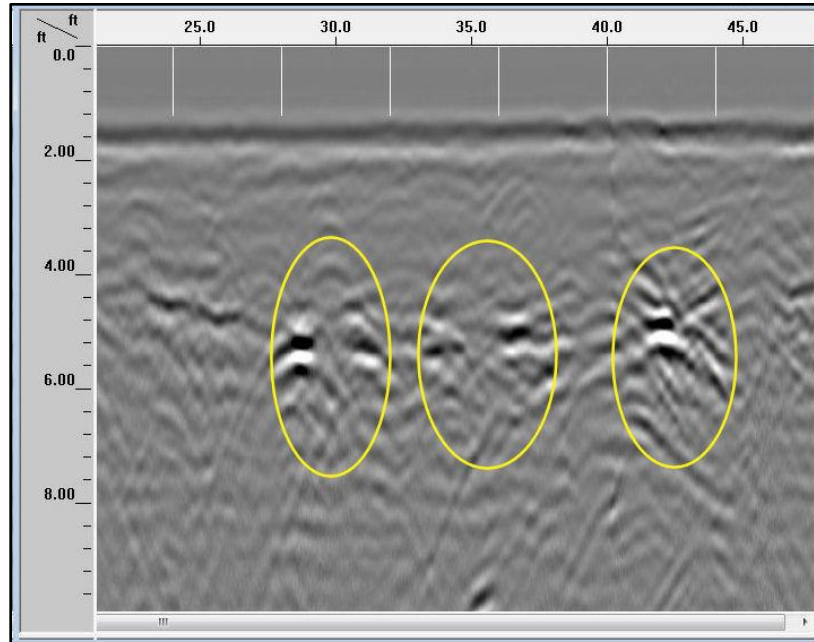
Figure 4-24. Burials in plots 34 and 36, note that they are all at the same elevation.

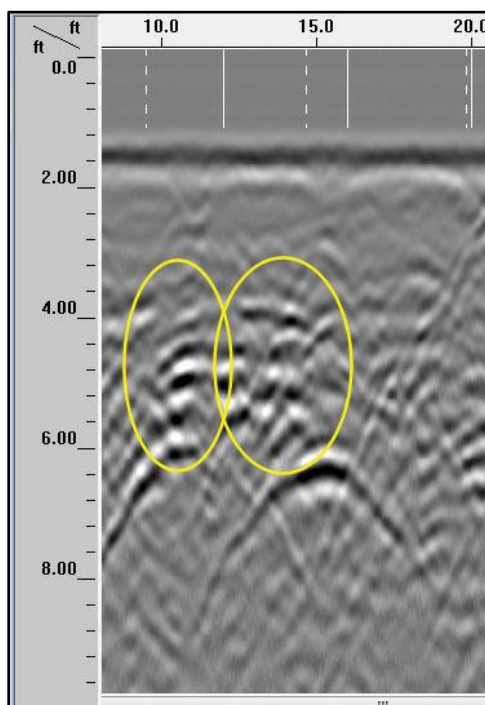
Figure 4-26. Multiple burial in plot 168.

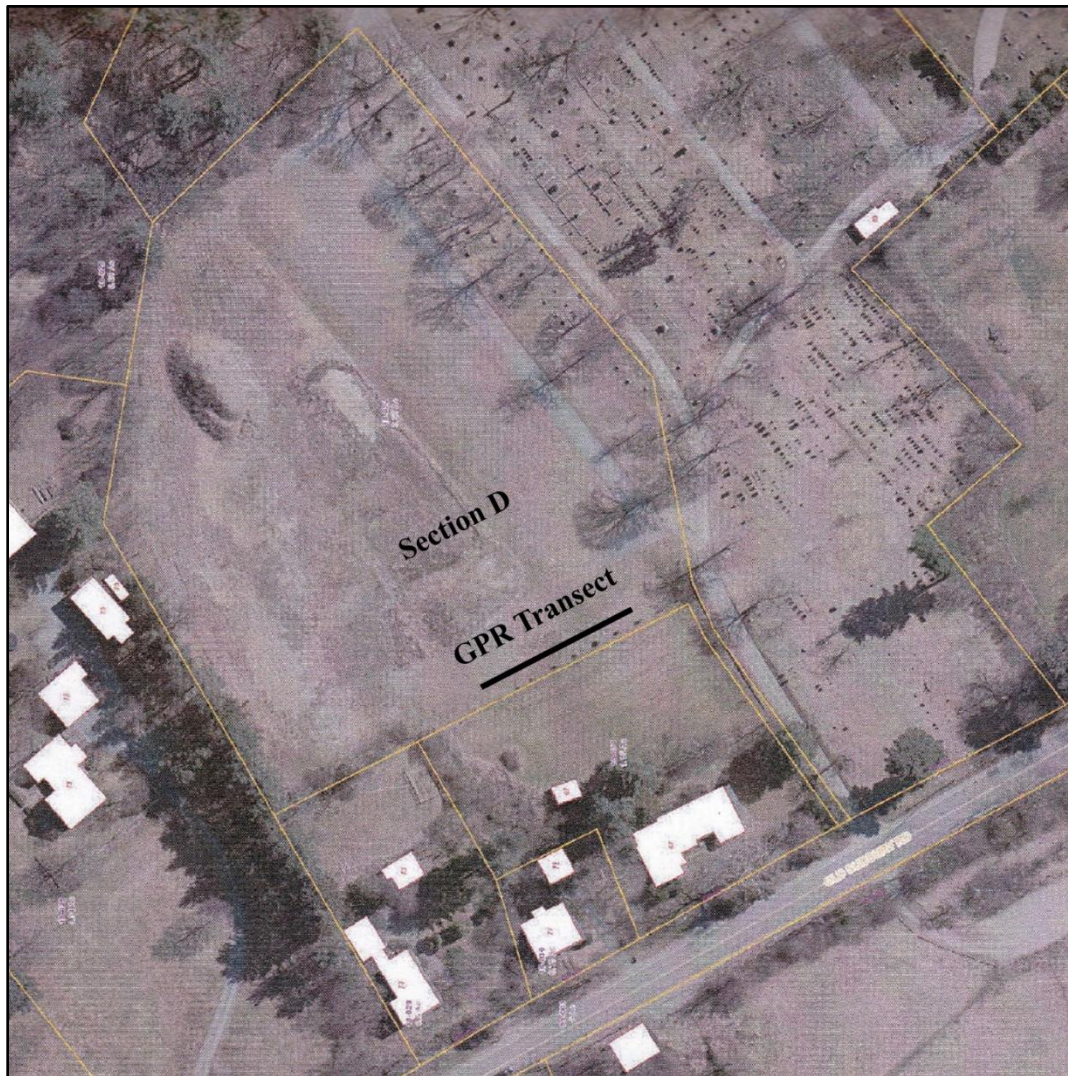
Only filled-in and added soils were seen along speculated path of the palisade. No evidence of a palisade could be determined through the use of GPR. About a year prior to the GPR survey the town planted trees along the above-described boundary likely accounting for the disturbance.

Figure 4-30. Location of the transect in Section D.
