Shoreline Stabilization and Utility Assessment

Town of Falmouth

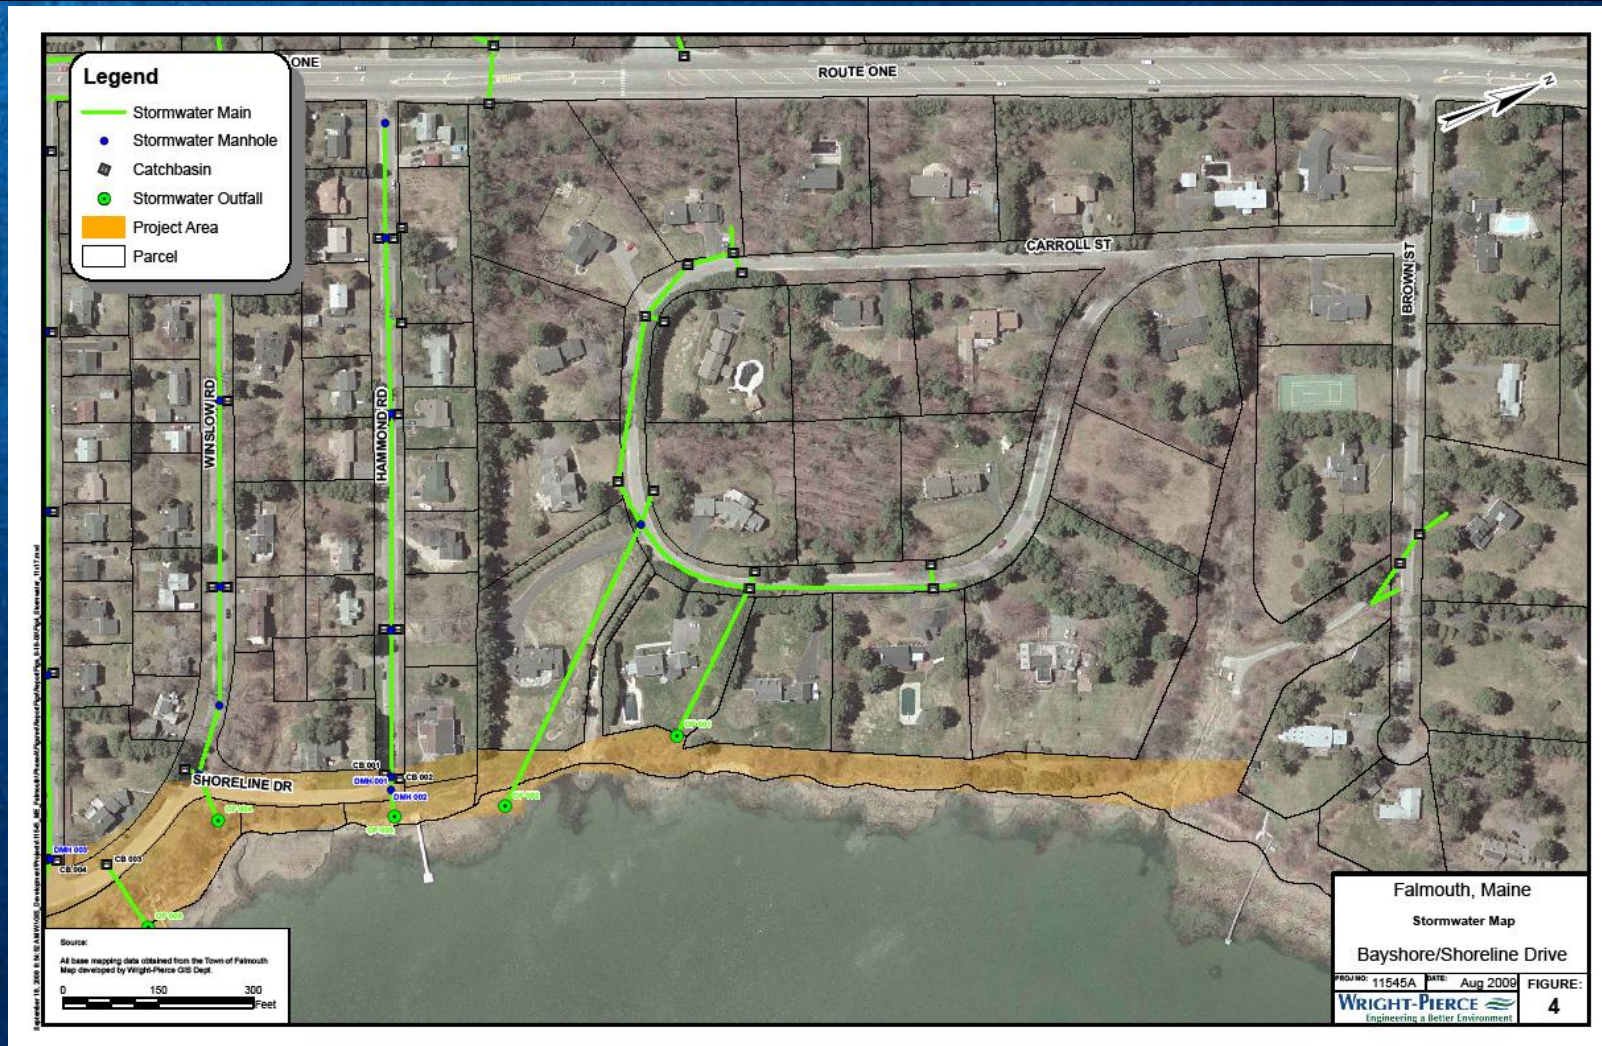
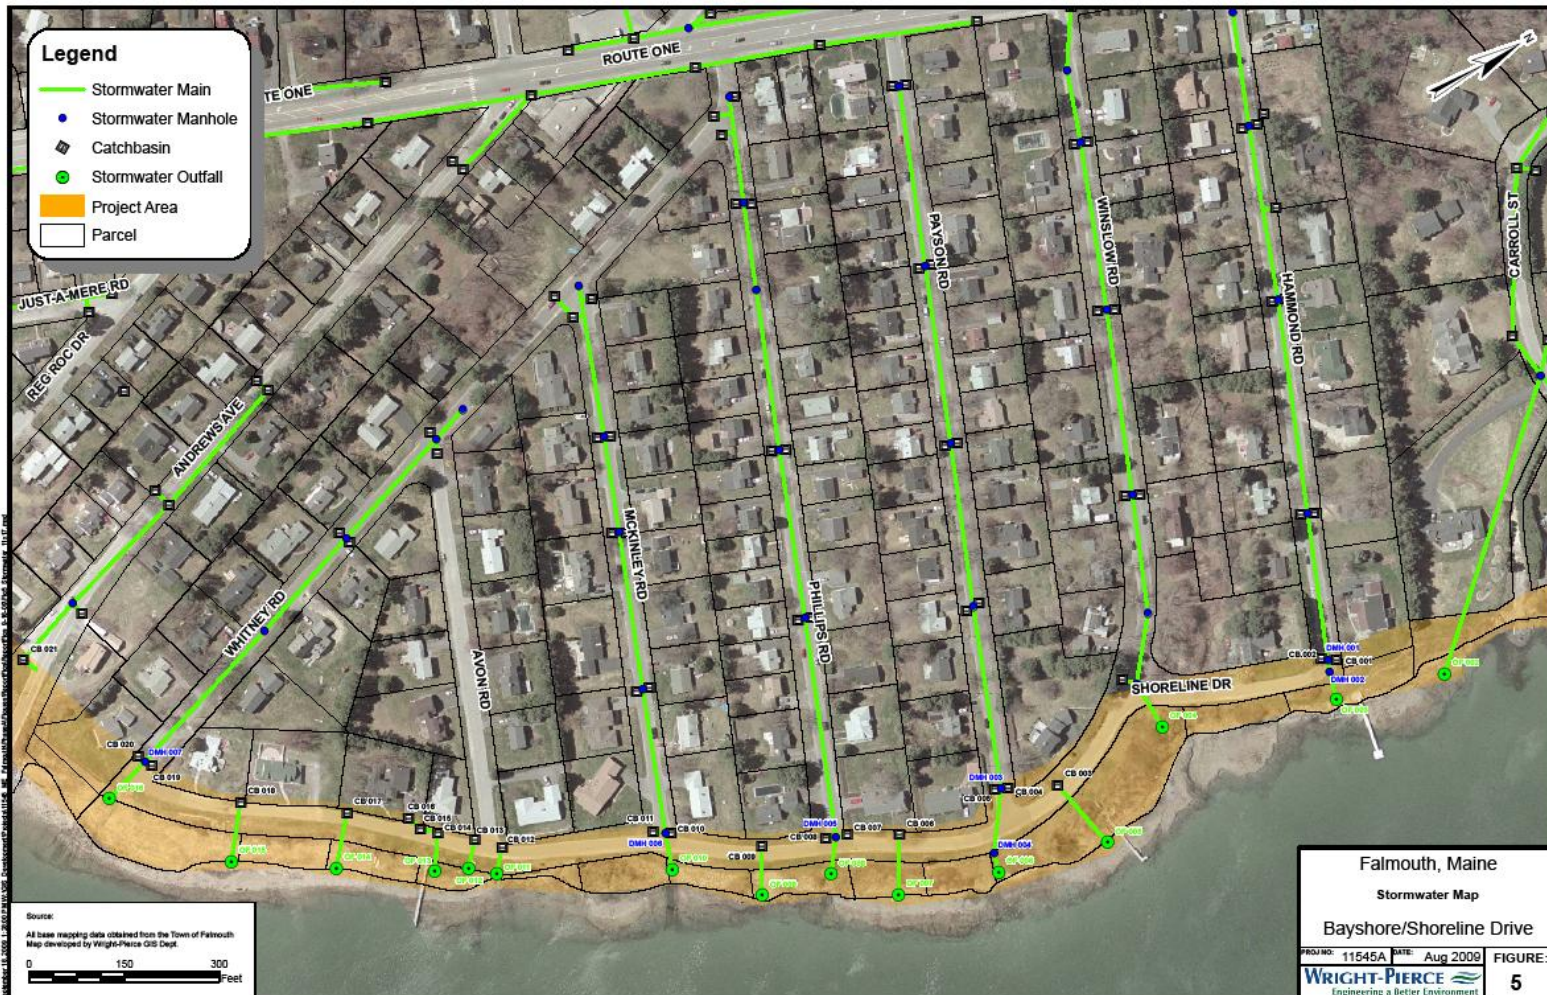
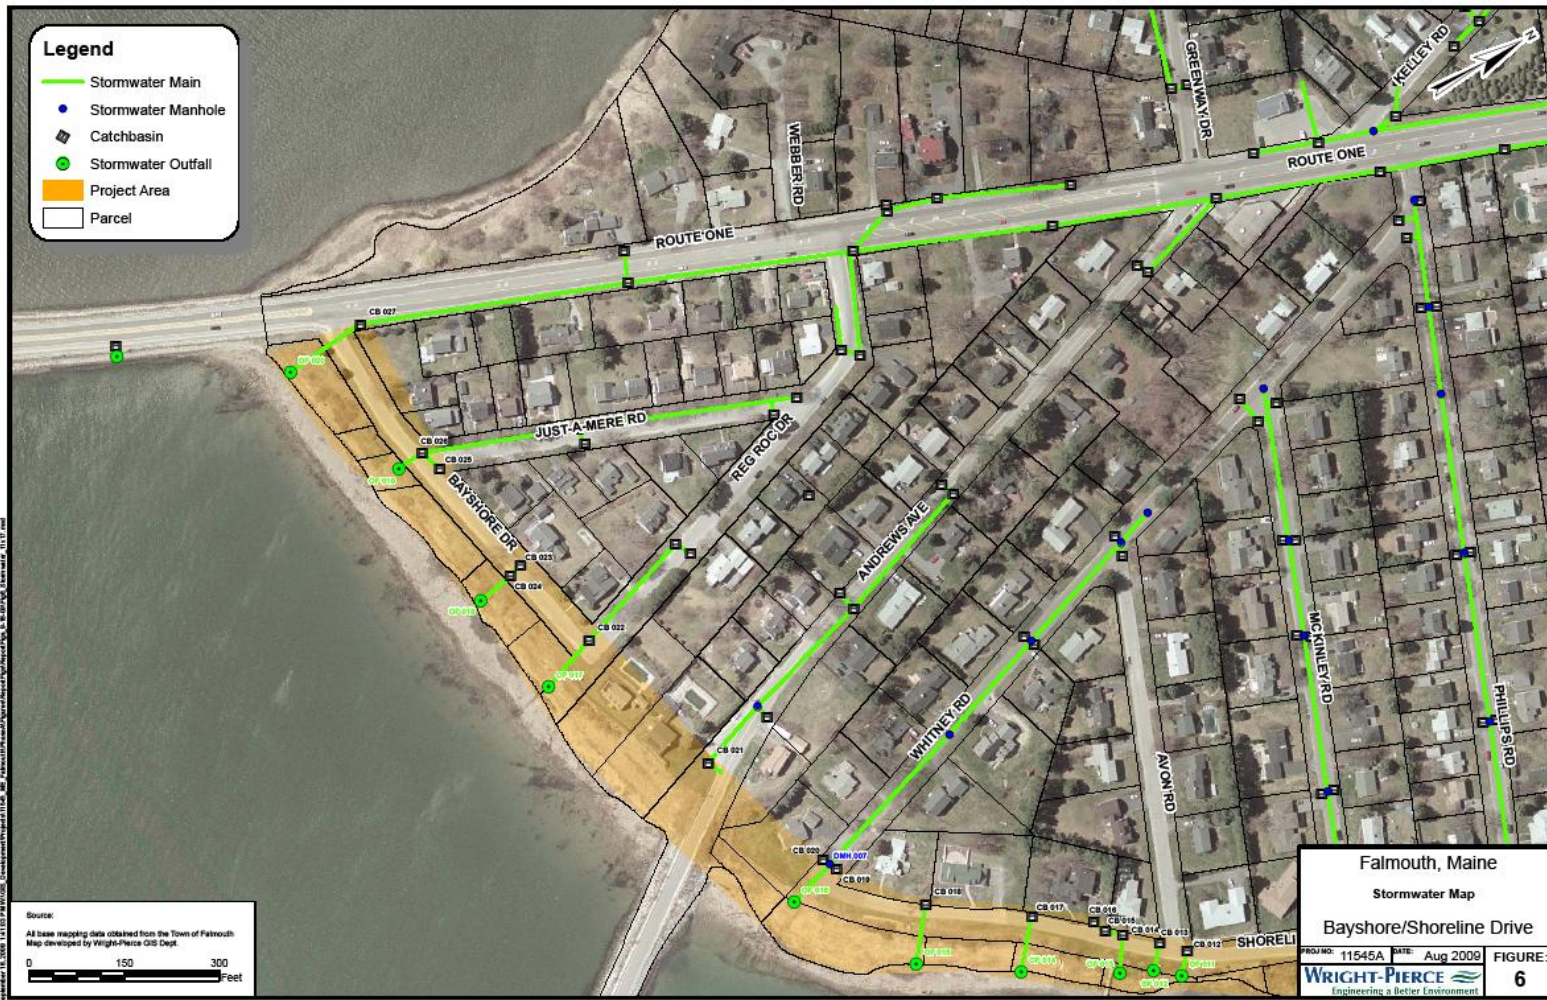
Storm Drain Outfall Map

- Generally sound, concerns focus on the outfalls
- Localized surface erosion
- Address with placement of riprap & some pipe repairs
- MEPDES Stormwater Permit compliance
- Need to address dumping of yard waste
- Maine DEP permitting required
- Access for construction
