GCG ASSOCIATES, INC.

RE: Sewage Pump Station Evaluation

STATION NAME: Water Street Wastewater Pump Station

DATE: 8/27/2012

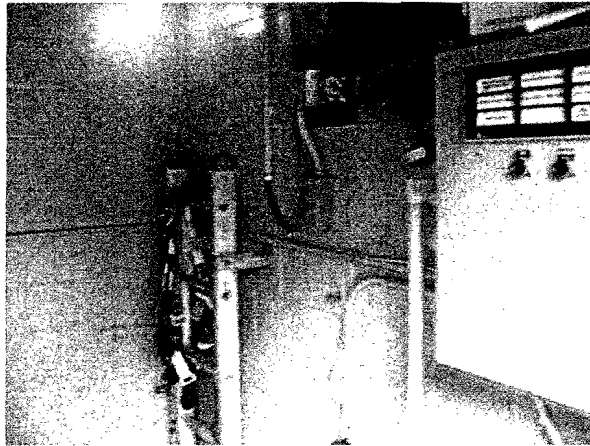
- Safety and air quality concerns within the station due to multi-level below ground access design by vertical ladder and lower level heating/ventilation system.
