**Municipal Buildings Strategic Plan  
Advisory Committee**

## Newtown Facilities Condition Assessment Report

JULY 20, 2015

# NEWTOWN FACILITIES CONDITION ASSESSMENT REPORT

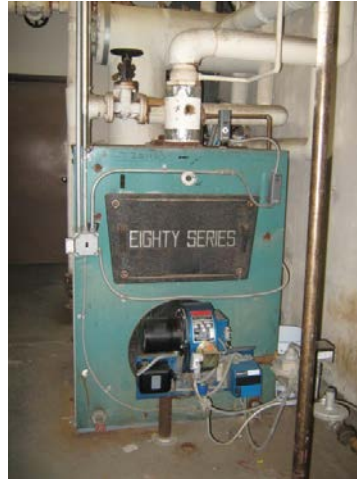
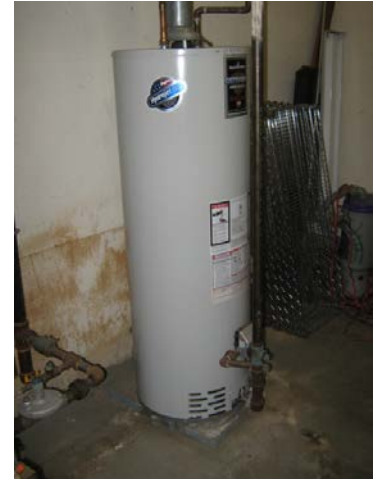
- Existing Domestic Hot Water System: The domestic hot water is generated by a Bradford White gas fired water heater with 50 gallon storage. The water heater is in good condition, but does not incorporate a mixing valve at the hot water supply. Recommend adding mixing valve to water heater.

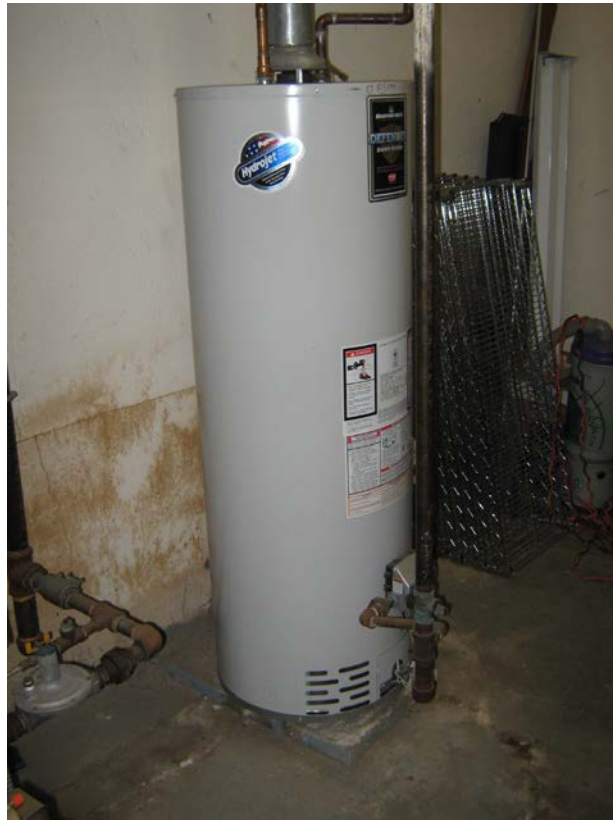
1. Existing Domestic Hot Water System: The domestic hot water is generated by a Bradford White gas fired water heater with 50 gallon storage. The water heater is in good condition, but does not incorporate a mixing valve at the hot water supply.

1. Replace all plumbing fixtures and water piping.
2. Add mixing valve to water heater.

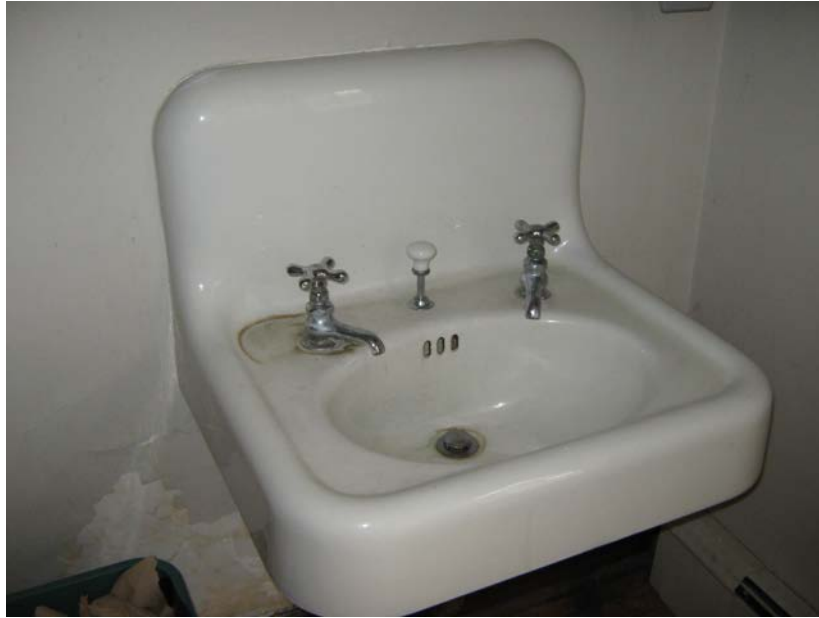
1. Existing plumbing fixtures are as follows:
  - a. In general, there are a variety of fixtures of different age and condition. Most of the fixtures are in need of replacement due to age and also to benefit from sensor mounted controls and water conserving features.
  - b. Water closets are floor mounted; tank type, vitreous china
  - c. Urinals are wall mounted with manual flush valves.

- d. Lavatories are wall hung with outdated faucets.

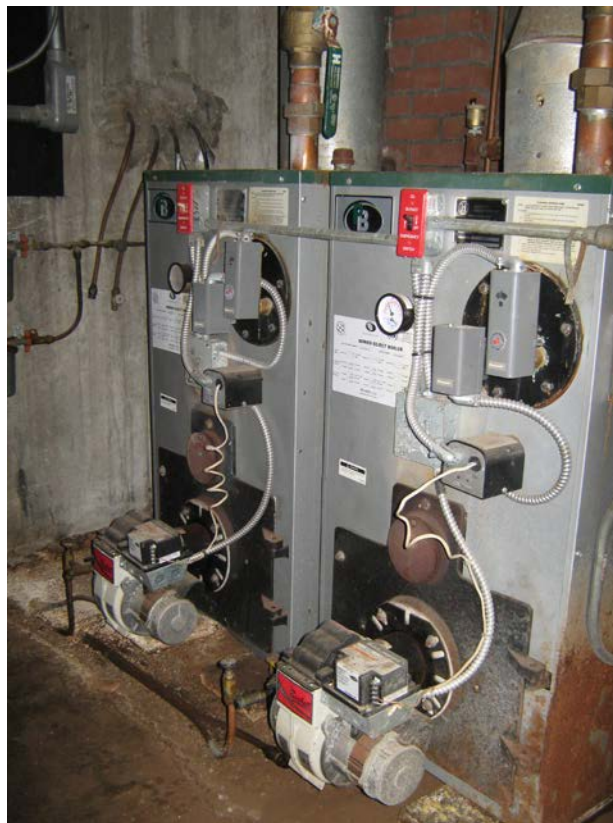
1. Boiler Plant: The building is heated by two (2) Peerless hot water boilers; each with nominal 350 MBH capacity. The boilers are fuel fired fed from a buried fuel oil tank outside the building. The buried fuel oil piping does not appear to be double wall. The boilers are in good condition.
2. There are four (4) hot water pump zones controlled by local electric thermostats.

3. The hot water system serves unit heaters and cast iron radiators. The unit heaters are in good condition, the cast iron radiators are most original to the building and nearing the end of their useful life.

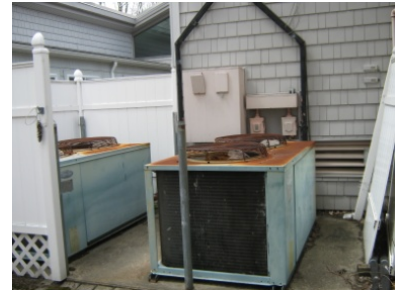
Existing Air Handling Systems: The buildings area served by indoor mounted air handling units with remote compressor / condensers located outside at grade. The two units at the original building are in fair to poor condition. The unit at the new building addition is in good conditions. The systems are fully ducted on the supply air and return air. "Local" air conditioning is also provided at specific areas with ductless split units. Temperature control is via local 7 day programmable thermostats.

Replace the air handling units and compressor / condensers serving the original building. The indoor units are located in mechanical rooms above the main floor and replacement of these units will be difficult. Also, the refrigerant piping may need to be replaced to accommodate newer types of refrigerant. Upgrade the temperature controls to provide off site monitoring through a web based program.

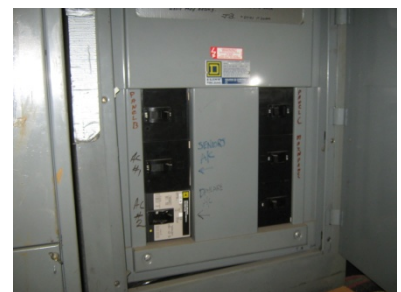
The building is served by a Square D distribution panel, rated at 400 amperes, 208Y/120 volts, 3-phase. The service equipment and main distribution panels are in good to fair condition. Recommend upgrading electrical service, local panels, receptacles and wiring at the original building.

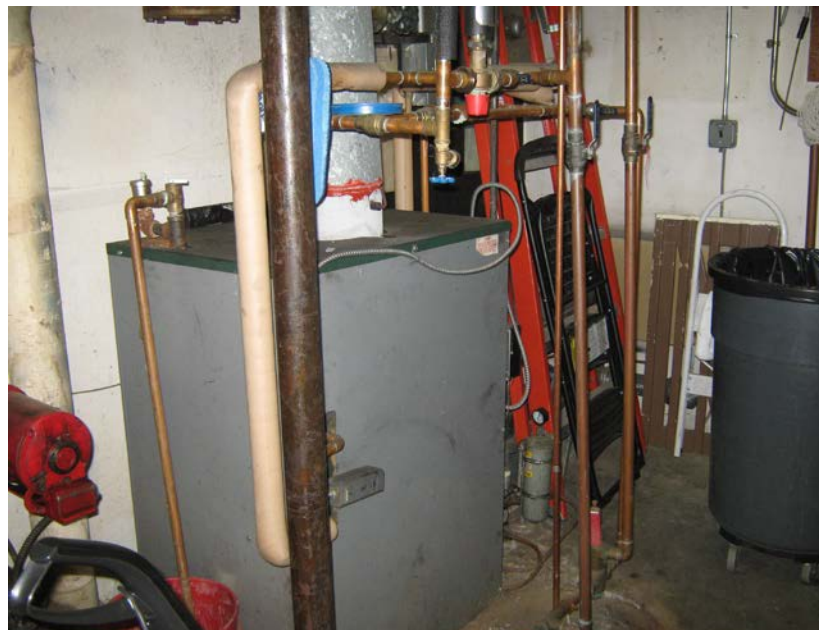
#### **HOT WATER BOILER @ ORIGINAL BUILDING**

1. Boiler Plant: Overall, the building is heated by two separate boilers which are not interconnected. Both boilers are fuel oil fired. The boiler at the original building is a Peerless Model STC-07 hot water boiler with nominal capacity of 400 MBH. This boiler, its pumps and related hydronic piping system is reaching the end of its useful life.

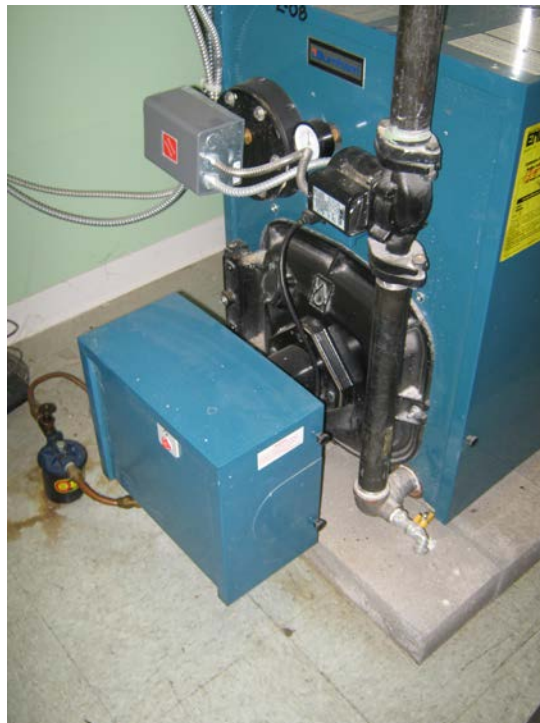
HOT WATER BOILER @ NEW BUILDING ADDITION

2. Boiler Plant: The boiler at the building addition is a Burnham Model PV85 hot water boiler with nominal capacity of 196 MBH. This boiler is in good condition

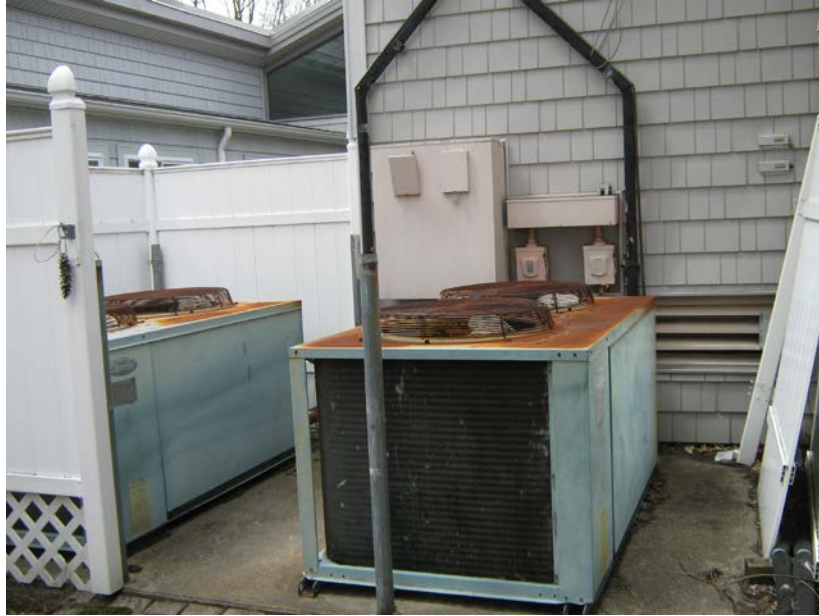
### COMPRESSOR / CONDENSER @ ORIGINAL BUILDING

1. The buildings area served by indoor mounted air handling units with remote compressor / condensers located outside at grade. The two units at the original building are in fair to poor condition. The unit at the new building addition is in good conditions.

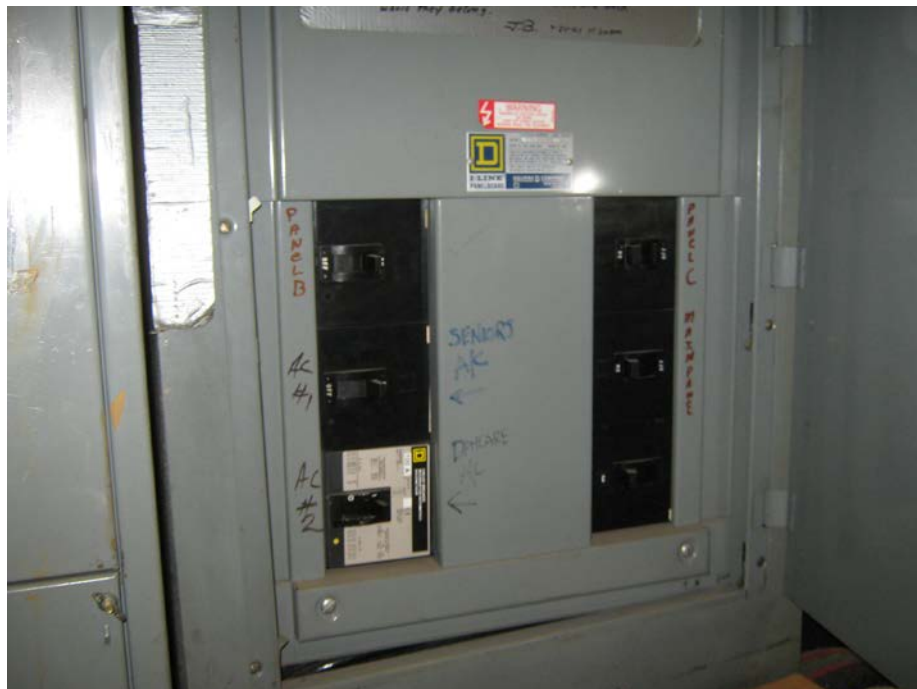
1. The building is served by a Square D distribution panel, rated at 400 amperes, 208Y/120 volts, 3-phase. The service equipment and main distribution panels are in good to fair condition.
