Inspection Date: 3/25/04 By: Fannin-Lehner

Cemetery: South Cemetery, Route 27, Wayland, MA

MONUMENT CONSERVATION COLLABORATIVE LLC

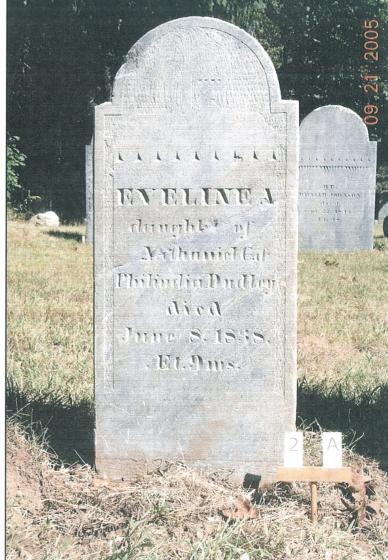
POSITION missing fragments

DETERIORATION Broken

- 1. Area around marker excavated
- 2. Lower fragment located
- 3. Fragments attached with structural adhesive (Abatron 55-22), clamped and braced until cured. Excess epoxy removed by hand chisels
- 4. Marker reset plumb and cleaned with D/2 Antimicrobial
- 5. Cracks and voids filled with RepliCal products.
- 6. Filled areas misted with water and covered for 3 days minimum
- 7. Filled surface areas treated with light acid wash rinsed thoroughly

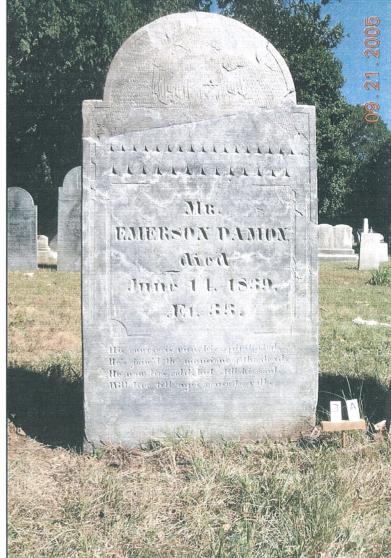
DETERIORATION Broken

- 1. Area around marker excavated
- 2. Fragments attached with structural adhesive (Abatron 55-22), clamped and braced until cured. Excess epoxy removed by hand chisels
- 3. Marker reset plumb and cleaned with D/2 Antimicrobial
- 4. Cracks and voids filled with RepliCal products.
- 5. Filled areas misted with water and covered for 3 days minimum
- 6. Filled surface areas treated with light acid wash rinsed thoroughly

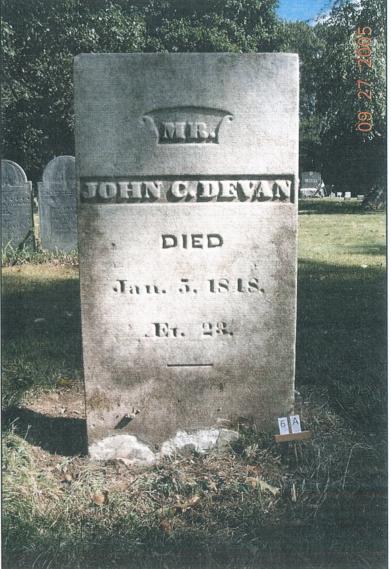
Marker# 6 Location 5

POSITION Fallen Loose or detached from base

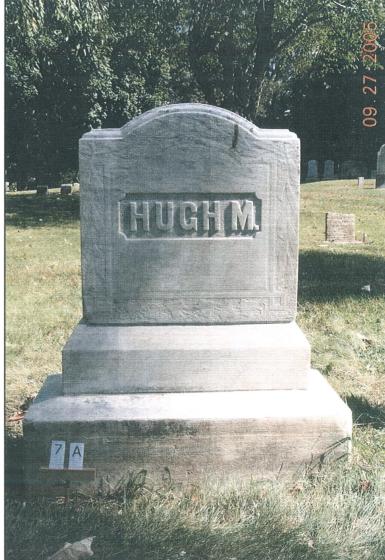
POSITION Unstable Loose or detached from base

- 1. Marker lifted clear from base with mechanical assistance
- 2. Setting areas cleared of debris and failed setting mortar removed from setting bed.
- 3. All surfaces treated with D/2 antimicrobial, rinsed with 300psi water
- 4. Setting bed area primed with Acryl 60, marker reset with 000 grout
- 5. Excess grout removed and joint area cleaned.

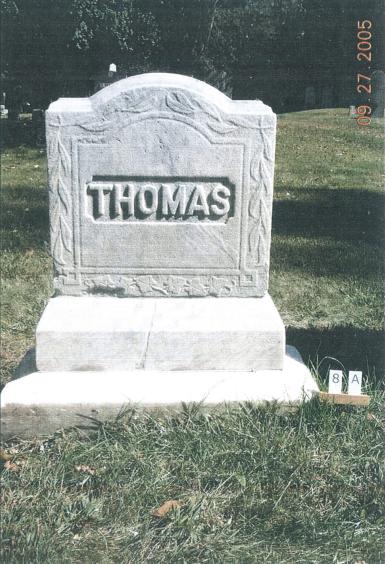
Marker# 8 Location 9

Tilted Base Loose or detached from base

- 1. Marker lifted clear from base.
- 2. Area around base excavated and base reset level
- 3. Setting areas cleared of debris and failed setting mortar removed from setting bed.
- 4. All surfaces treated with D/2 antimicrobial, rinsed with 300psi water.
- 5. Setting bed area primed with Acryl 60, marker reset with 000 grout.
- 6. Crack in base filled with grout
- 7. Excess grout removed and joint area cleaned.

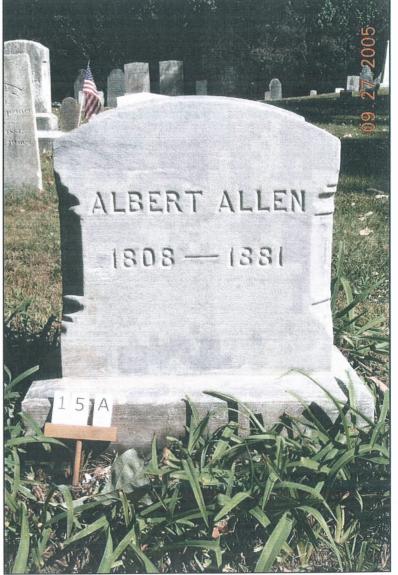
POSITION Unstable Loose or detached from base

- 1. Marker lifted clear from base.
- 2. Setting areas cleared of debris and failed setting mortar removed from setting bed.
- 3. All surfaces treated with D/2 antimicrobial, rinsed with 300psi water.
- 4. Setting bed area primed with Acryl 60, marker reset with 000 grout.
- 5. Excess grout removed and joint area cleaned.

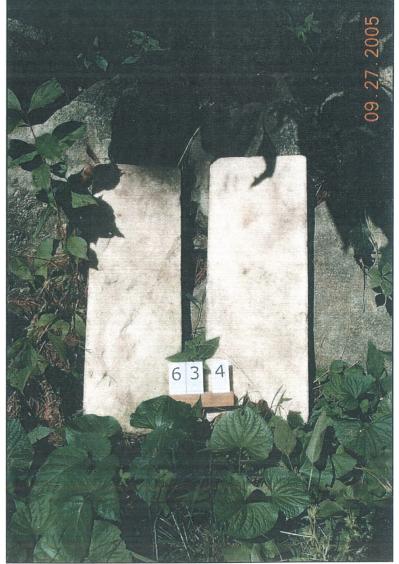
CONDITION ASSESSMENT - 63 Inspection Date: 3/25/04 By: Fannin-Lehner					
Cemetery: South Cemetery, Route 27, Wayland, MA					
NAME ON MARKER	N/A THOMPSON?				
Death Date: N/A	Material: Marbl	e Marker Type: Foots	stone		
Condition of Inscrip:					
EXISTING CONDITION CONSERVATION STRATEGY					
POSITION		Reset when locate	ed		
CONSERVATION PRIORITY 1)Hazardous immediate action 2)Unstable, -asap 3)Ongoing det. treat 2-5 yrs 4)Stable, re-inspect 5-10 yrs 5)Irreparable A)Artistic H)Historical P)Visually prominent M)Monitor					
TREATMENT					
Unable to locat	te marker				
Comments:					
Comments.

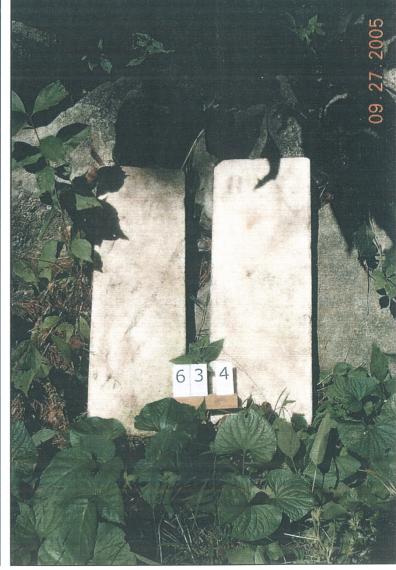
CONDITION ASSESSMENT - 64 Inspection Date: 3/25/04 By: Fannin-Lehner (8					
Cemetery: South Cemetery, Route 27, Wayland, MA					
NAME ON MARKER	N/A IHOMPSON				
Death Date: N/A	Material: Marble	Marker Type: Foots	stone		
Condition of Inscrip:					
EXISTING CONDITION CONSERVATION STRATEGY					
POSITION		Reset when locate	ed		
CONSERVATION PRIORITY 1)Hazardous immediate action 2)Unstable, -asap 3)Ongoing det. treat 2-5 yrs 4)Stable, re-inspect 5-10 yrs 5)Irreparable A)Artistic H)Historical P)Visually prominent M)Monitor					
TREATMENT					
Unable to locat	te marker				
Comments:
