Chilmark Planning;  
Menemsha Corridor Plan for Improvement

**[Analysis + Recommendations]**

Prepared for the:  
Martha's Vineyard Commission and the Town of Chilmark, MA

**October 30, 2017**

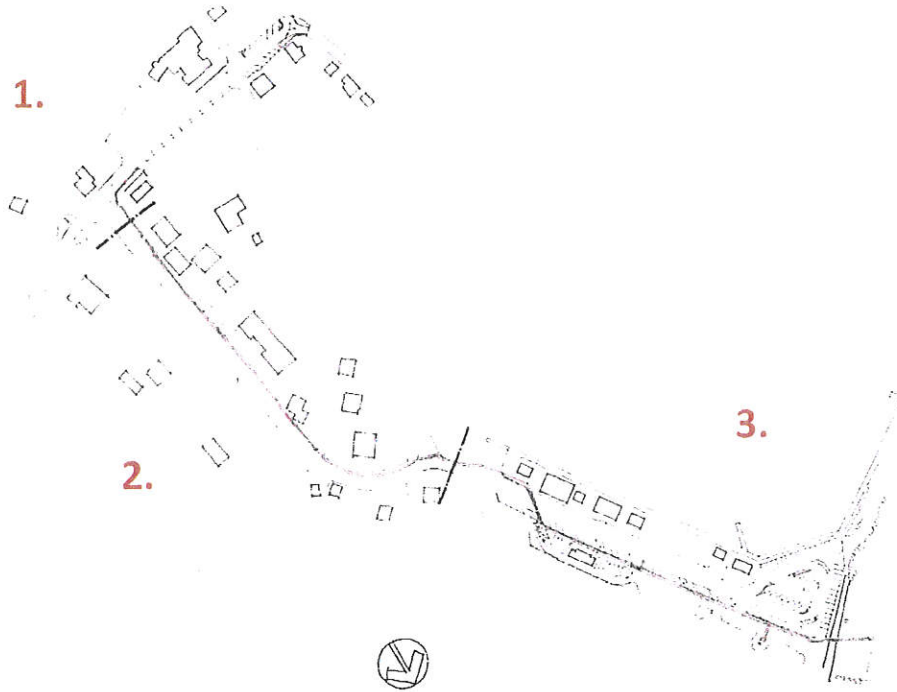
Above: Project extents.

The following represents our review of the existing conditions in the Village of Menemsha. For ease of description, the project has been divided into 3 parts:

1. North Road from the intersection of Basin Road to Boat House Road.
2. Basin Road from Dutcher Dock to the intersection of North Road.
3. Menemsha Beach to Dutcher Dock.

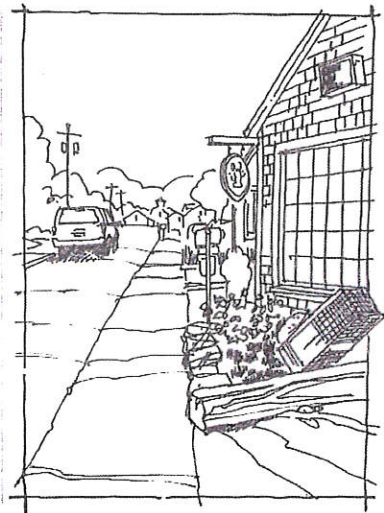
Above: Corner at Beetlebung Café looking south toward North Road.

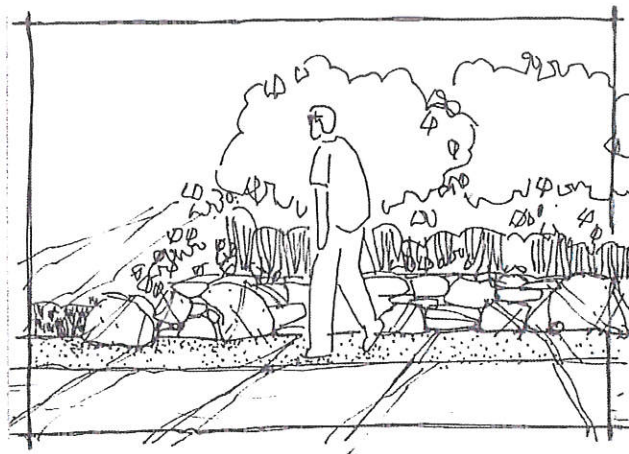
Right: Retaining wall, plantings and shell/crushed stone path.

Basin Road from the intersection of North Road offers a simple path along the business fronts on the east side of the street. A crushed stone and shell path approx. 36-48 inches wide located at the immediate edge of the road pavement is simply installed in place of gravel and turf. Where the path crosses existing paved drives and parking, a marked path can be provided. A couple of areas require the relocation of business' landscaping out of the ROW to accommodate the new path.

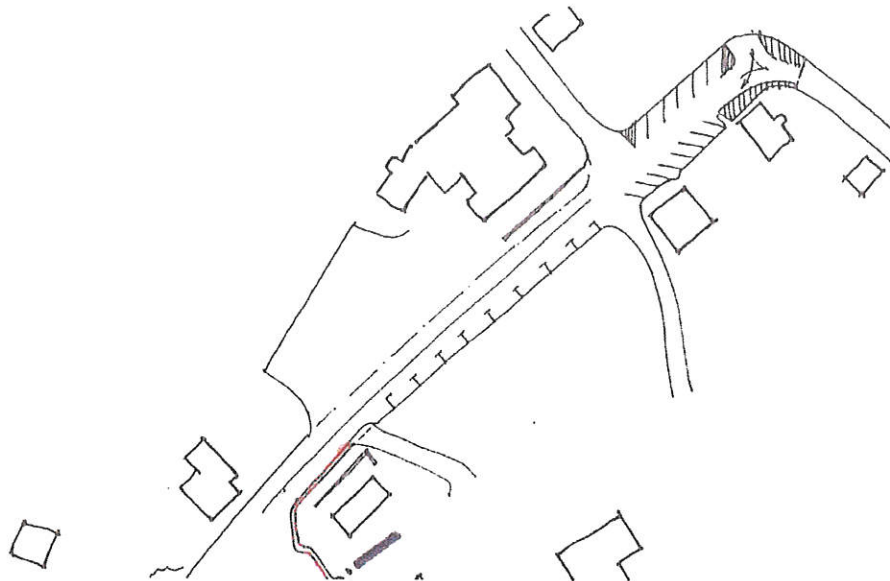
Above: Proposed parallel parking across from the Homeport and pavement markings at intersection of Boathouse Road.

Additional signage indicating 'No Outlet' should be placed near the intersection of the Coast Guard drive. Pavement markings near the intersection of Boat House Road can be used to indicate a 'T-type' turn-around, pedestrian areas in front of the Galley, possible bicycle parking, etc. Additional bollards or obstructions are recommended in front of the Galley to protect/separate customers from traffic.

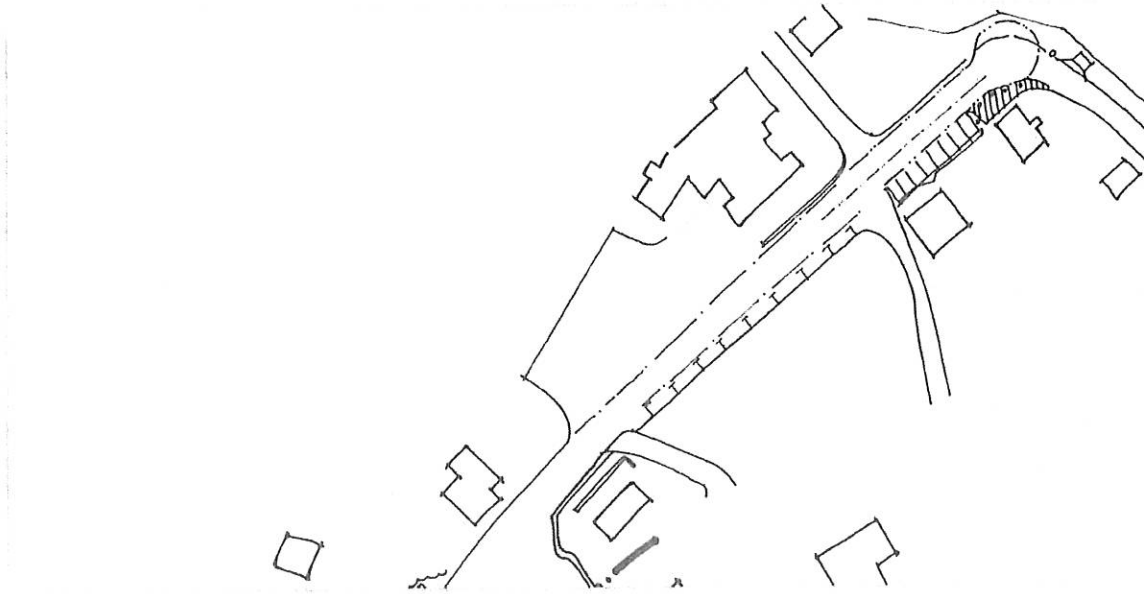
Above: Alternate proposed parallel parking across from the Homeport and cul-de-sac at intersection of Boathouse Road.<sup>2</sup>

*As a result of discussions with the Committee regarding the draft presentation of this report, a revised sketch showing the approximate turning radius for a passenger vehicle is provided. This would entail re-alignment of the road centerline beginning prior to Edy's Island Road. If maintaining the existing road edge along the south side (split-rail fence and roses) of the street and using two 10-12 foot wide travel lanes would eliminate the existing diagonal parking across from the Galley and would require the reconfiguration of the spaces in front of the Market as 90 degree spaces, resulting in approximately one-*

half the existing number at this location. Additionally, pending final layout and in order to provide a sufficient safety zone in front of the Galley, this cul-de-sac would project past the present edge of pavement and require extension of the stone retaining at the water's edge.<sup>2</sup>

3. Alternatively, re-align road centerline and provide a cul-de-sac at the intersection. This reduces existing parking, but creates a safer pedestrian zone. Determinations by Others as to possible extension town property lines to accommodate this and/or additional parking is required.<sup>2</sup>

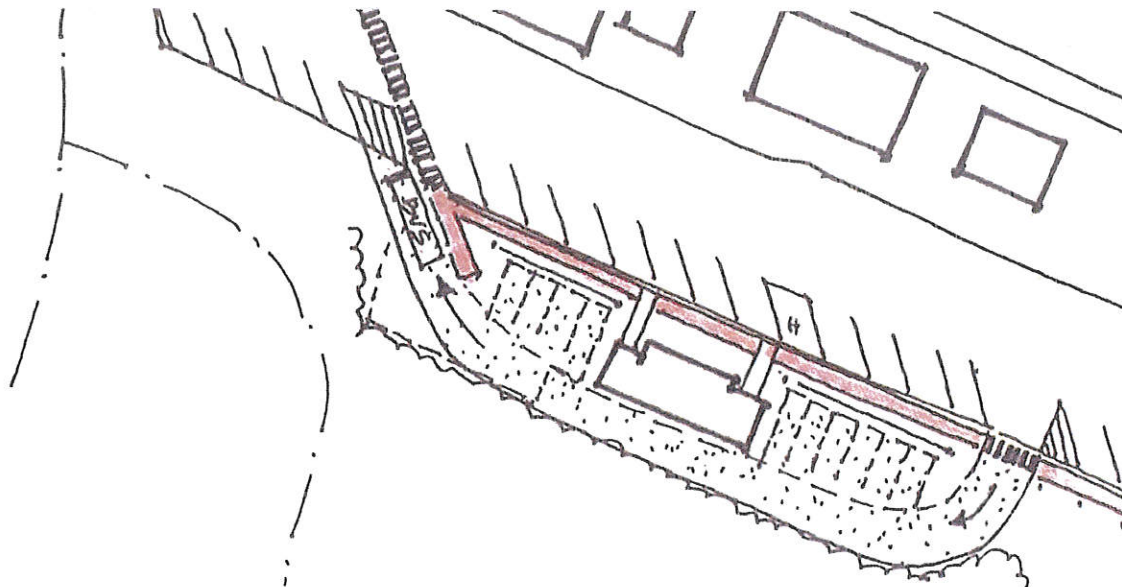
Above: Proposed Bus turn-around at Comfort Station, with additional Market Employee parking.

One proposed solution reconfigures the existing gravel lot to the south of the Comfort Station and reclaims the area to the north with a connector drive behind the building. This will certainly require permitting and may require a measure of remediation/dune replacement efforts to accomplish.

The scenario shown allows the bus to pass the Comfort Station and by coming around the back can stop against a passenger loading area at the street on the proper side of the bus. This solution reorganized the existing Market employee spaces toward the street and creates additional parking to the north as well. This concept takes advantage of the existing employee parking area, the previously disturbed/reclaimed area to the north to minimize impact on the adjacent marsh and dunes.

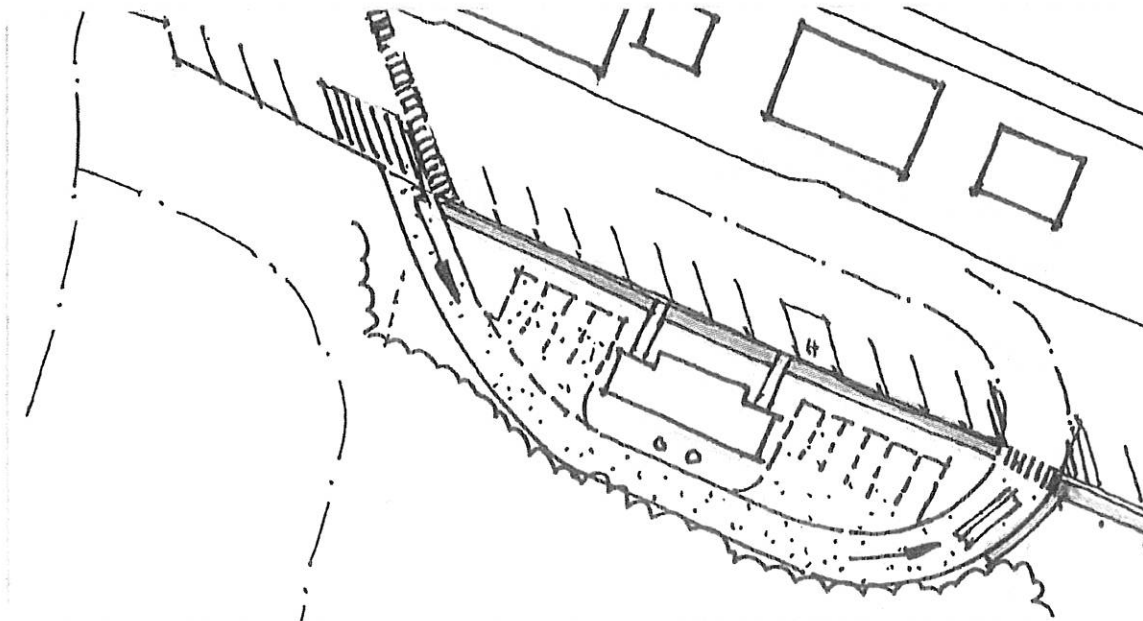
Above: Alternate proposed Bus turn-around at Comfort Station, with additional Market Employee parking.<sup>3</sup>

*As a result of discussions with the Committee regarding the draft presentation of this report, the loop was requested to be reversed such that a bus will enter before the Comfort Station and exit after. It was noted that an existing tank is buried behind the Comfort Station and will require a reinforced traffic covering, or slight relocation of the drive to avoid. Also Additional screening from the residential properties to the southeast is desirable.<sup>3</sup>*

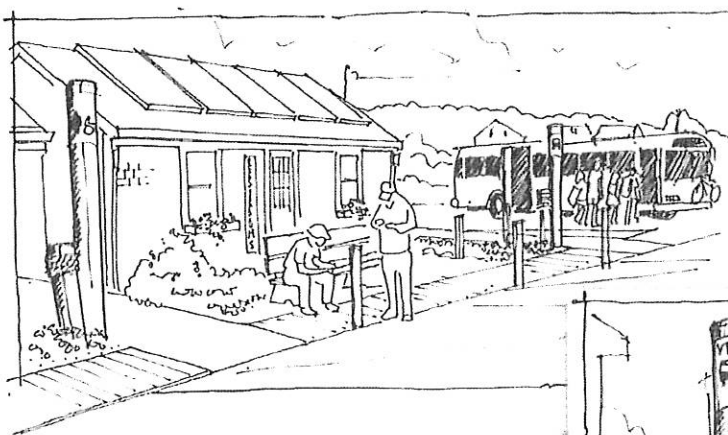
Above: Comfort Station with proposed Bus turn-around and pier-post signage.

As noted in other sections of this report, it is crucial that the proposed VTA bus turn-around concept receive the support of the both the Planning and Conservation Commissions due to the proximity to and extension of existing boundaries. The proposed drive loop behind the existing Comfort Station will encroach onto the existing dune and/or marsh areas. These areas of disturbance will require protective measures, screening, etc., as determined by the Commission. It is our understanding that the proposed employee parking area / bus entry drive shown on the northern side of the existing Comfort Station is on an area previously disturbed, but will require the same level of review and care in design and construction.

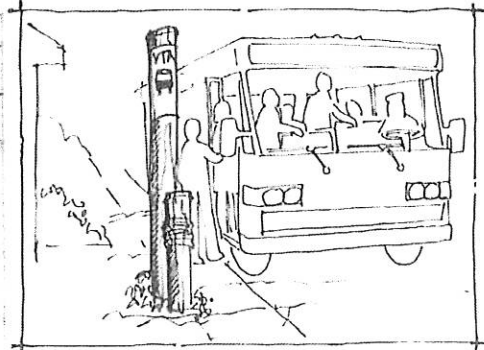
Right: Bus stop with pier-post signage.

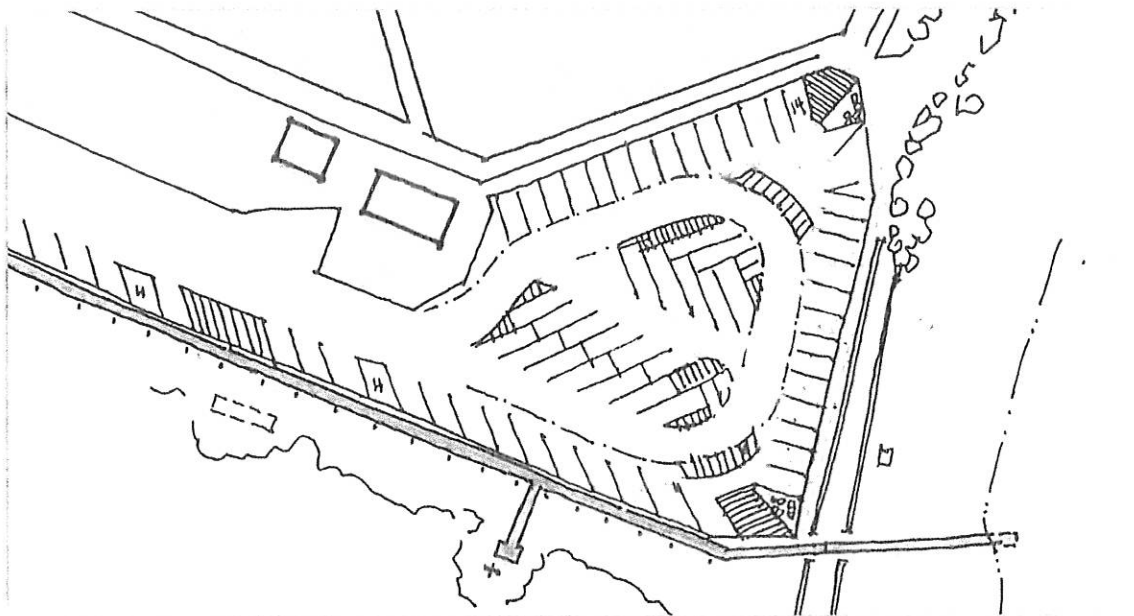
Above: Proposed beach parking with passenger drop-offs, trash and emergency access in the 'corners.'

- c. Refer to Scenario A for additional recommendations.
3. Add directional arrows on paving, with turning lane markings around the center parking spaces. Provide marked drop-off spaces in the 'corners' along beach.

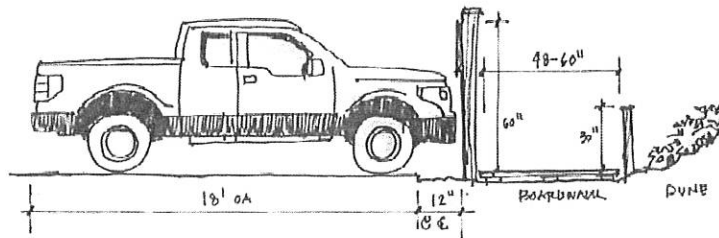
Above: Typical parking / path interface.

- i. The existing diagonal (45 degree) and 90 degree spaces are random width and do not meet the standard for standard vehicles, minimum 9 feet wide by 18 feet long. This causes the longer vehicles, such as pickup trucks to extend out into and reducing the traffic lane. Diagonal spaces require a longer space to accomplish this same standard.
- ii. The existing spaces include the front bumper overhanging past the precast concrete wheel stops. These wheel stops are not easily fixed to the ground since they sit diagonally on the edge of pavement and sand.
- iii. Along the eastern and beach edge, provide new round treated pier posts 6 inches in diameter x 72 inches above grade with chamfered tops placed at the centerline of each typical parking space in lieu of existing precast wheel stops. This would maintain the front line of parking, over the entire length.

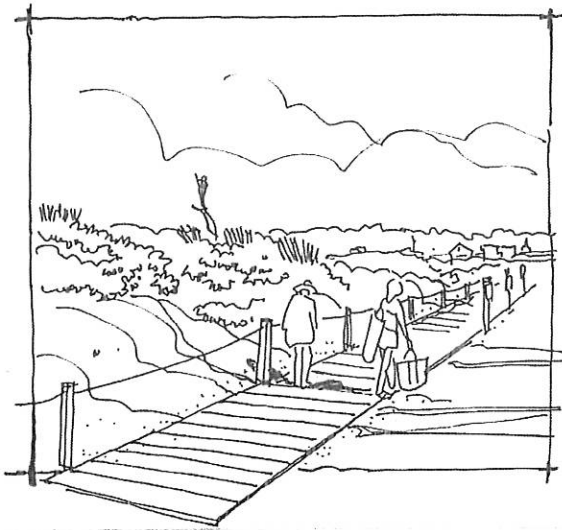
Above: Seasonal walkway, looking toward Comfort Station.

The existing slatted walkway is a modular slatted panel system comprised of hardwood slats with a cord connector with wide spaces between each board. These panels have a wide spacing between slats and are not connected to each other which allow some leading edge slats to rise up and become tripping hazards. Surface preparation is essential to the success of this particular modular panel, and requires some grooming prior to installation. Blowing sand covers portions of the walk at times; refer to other section of this report.

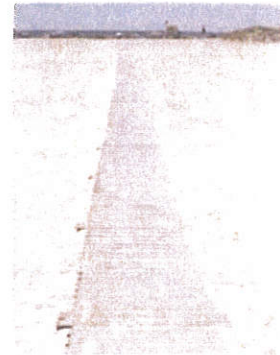
Left: Example of a 'roll-out' beach access mat.

1. Provide a 60 inch wide temporary path to the high tide water level from the public beach entrance. Beach wheelchairs are not a substitute for providing beach access routes, as they do not provide independent access. This can be accomplished with a 'roll-up' type mat in lengths as required, similar to 'Mobi-mat' which is a non-slip woven polyester mat, in choice of blue or brown color, with or without striping for the Visually Impaired.

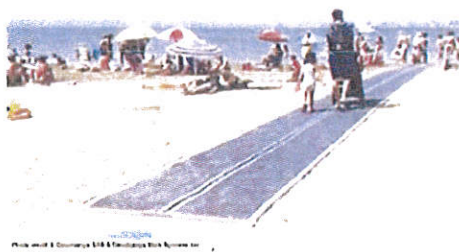
Above: example of an 'out-board connector' type walkway.

**'Quick-deck' Rigid Modular Walkway Connection.**  
Assembled with Bolts, with 'in-board' or 'out-board' connection points. 'Out-board' recommended for ease of Assembly.

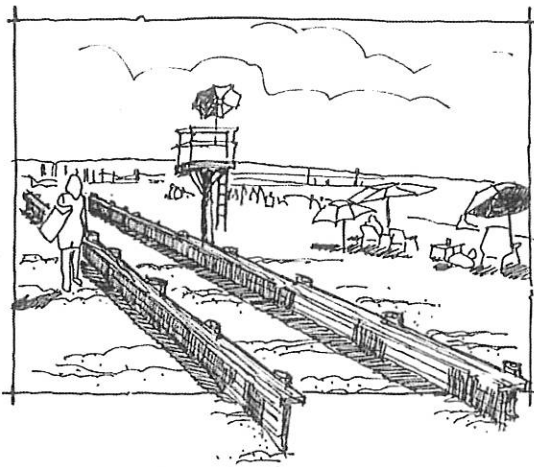
Above: Existing and proposed secondary 'bulkhead.'

Blowing sand covers portions of the parking lot and seasonal walkway at times. The existing bulkhead constructed along the beach parking lot is an ideal construction that accommodates both seating as well as a wind break. Based on wind energy diagrams, the bulkhead would be more efficient with the hollow space beneath the seat if it faced the water. This would trap the sand as opposed to creating the conditions which now redirect blow the sand over the top. The disadvantage of this mirrored construction would be the need to clean out the sand to maintain the pocket.

1. Reconstruct the existing bulkhead wind-break at the same bench height in its mirror image, with the pocket facing the water. Replace damaged components, and provide a new opening for access for mobility impaired visitors to gain access without having to go around.
2. Construct a secondary bulkhead, approx. 4 feet toward the parking lot to disrupt the wind-borne sand a second time before the parking lot edge. Use the similar materials, such as treated pier pilings (dock posts), 2x and 3x material.
  - a. Alternatively, a row of slatted 'sand-fence' can be an effective barrier to disrupt the wind energy. This is typically 48 inches high, comprised of wood slats, connector wires and wood posts.

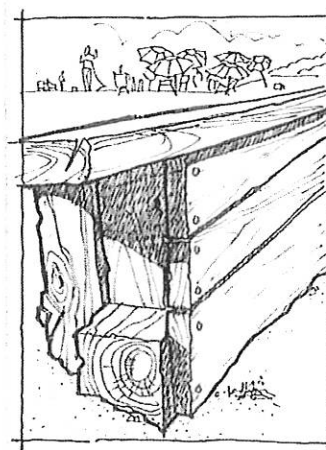
Right: Bulk-head detail with sand capture toward beach.

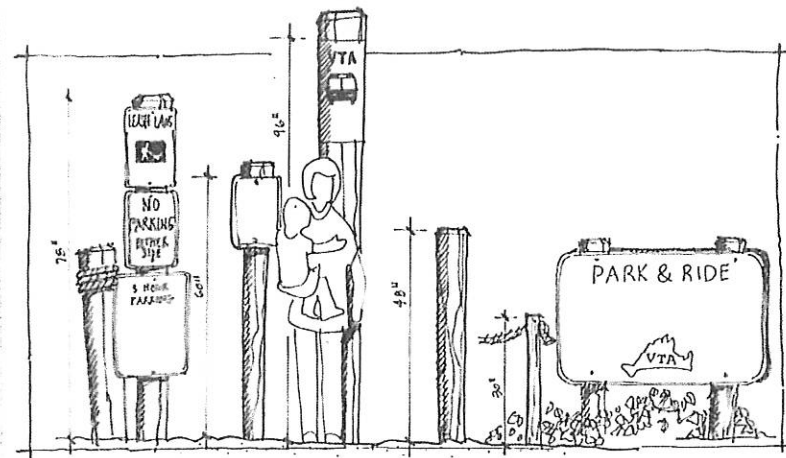
Above: Various signage types.

2. Repetition of pattern and placement is the key to the success of the signage package. Sub-consciously training a Visitor to recognize that a sign or symbol will be in the same location on a post as the previous item allows them to quickly respond to the directions on the sign.
3. Provide taller, larger diameter pier posts for hierarchically more significant items, such as the VTA pick-up points, emergency access, toilet facilities, etc. Suggest a painted graphic band at the top approx. 18 inches of these posts using a muted color scheme in keeping with the sun-bleached context of the existing area.

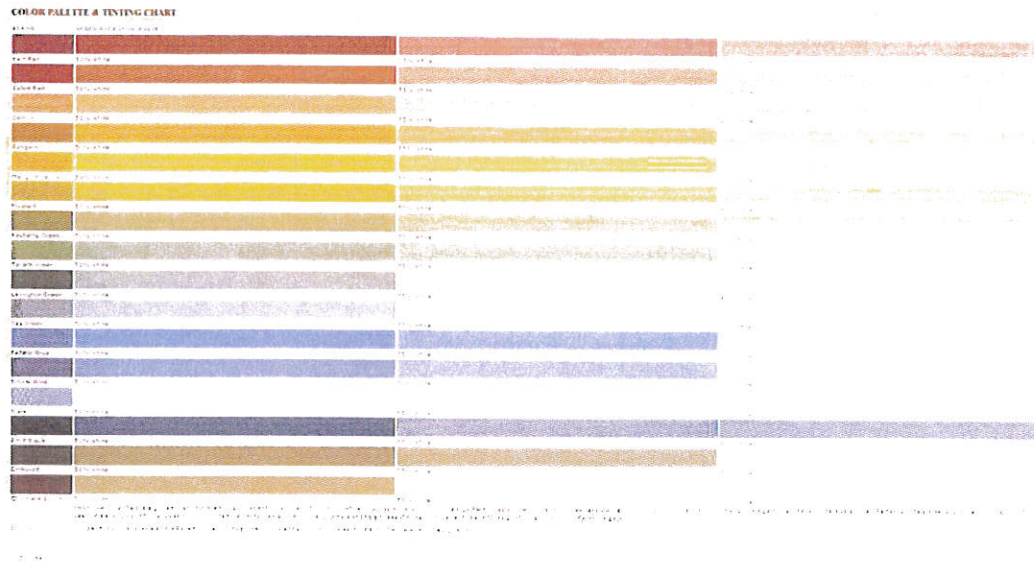
Above: Milk paint color range.

4. The sun-bleached finish of any new wood surfaces can be accelerated using 'bleaching' stains, similar to those produced by Cabot Stain Company.
5. The sun-bleached finish of any new paint can be accomplished using 'Milk Paint.' This paint is made in MA, and typically used in historic applications such as Williamsburg and Sturbridge. It is comprised of a base and pure minerals, offering the flexibility of thinning to stain or thickening to paint consistency. The color variations can be made to be subtle hints of color, recreating the faded appearance.

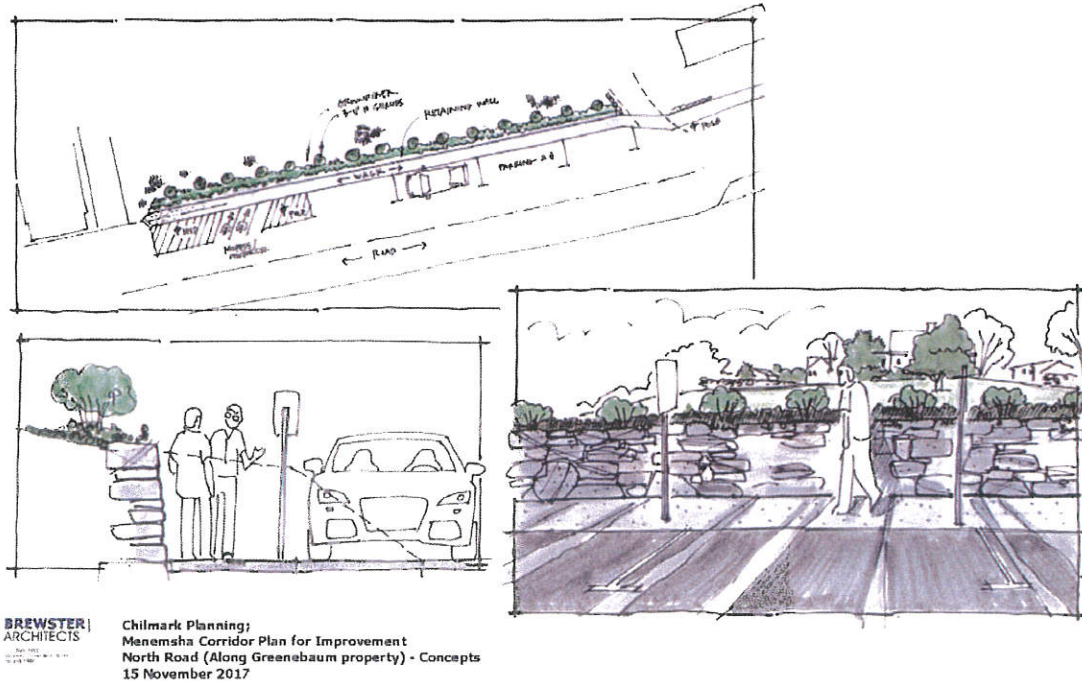
Above: Updated North Road parking along Greenebaum property.

- B.0 Develop drawings showing an overview, an elevation and a section of the North Road/Greenebaum lot area developed for an additional walkway.  
*Response: Additional views of the Greenebaum property have been provided.*

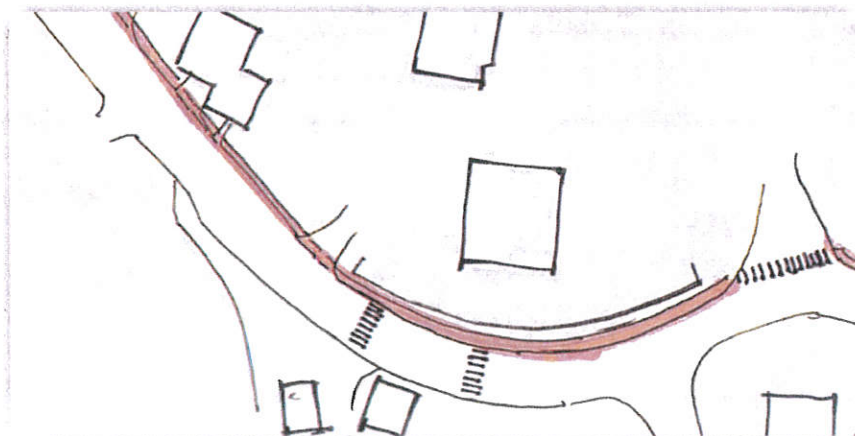
Above: Updated Basin Road (North Road to Dutcher Dock) Concepts drawing showing additional cross-walks at 'The Bite.'

- B1.0 Provide on page 10, more clarification on exactly what is recommended for the Basin Road walkway/path.

*Response: This is shown as much as possible on the 'Overall Key plan – Concepts' as well as the enlarged plan views. Further definition of exactly where there is shell/gravel vs. existing pavement will require a much larger scale engineering drawing/survey to identify and finalize.*

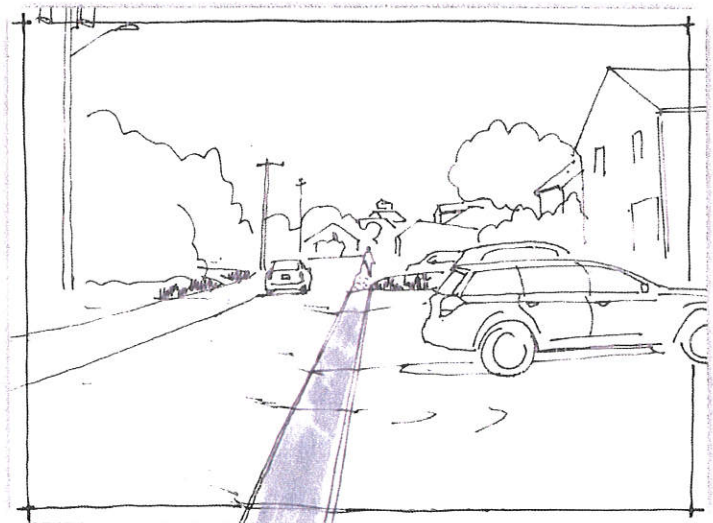
Above: Typical walkway with pavement marking.

B1.1 Illustrate exactly where the shell/rock path is and where the painted areas and crosswalks are located and can you provide a very clear recommendation for the entire walkway/path in this area so that the person implementing the plan is clear on what is to be done.

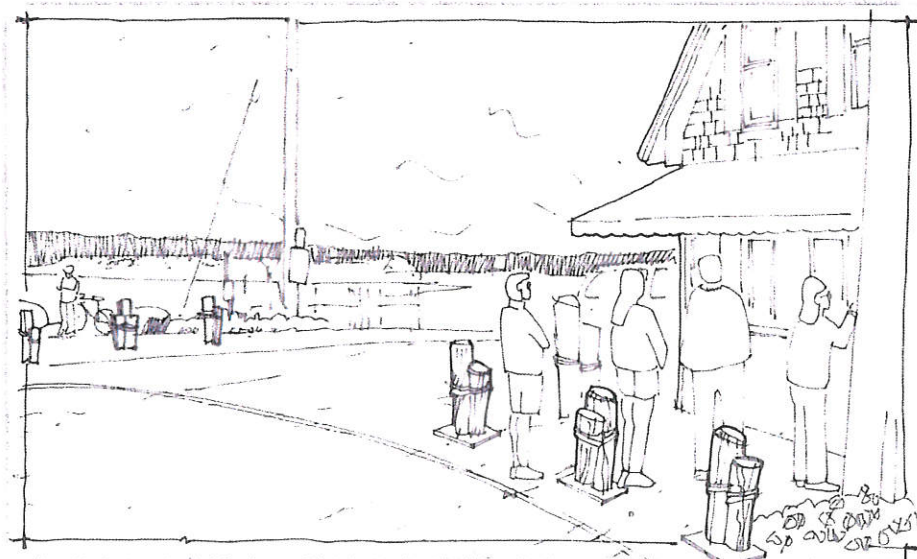
Above: Looking west toward The Galley.

- a. Provide an additional sketch description and of the waiting area in front of the Galley.

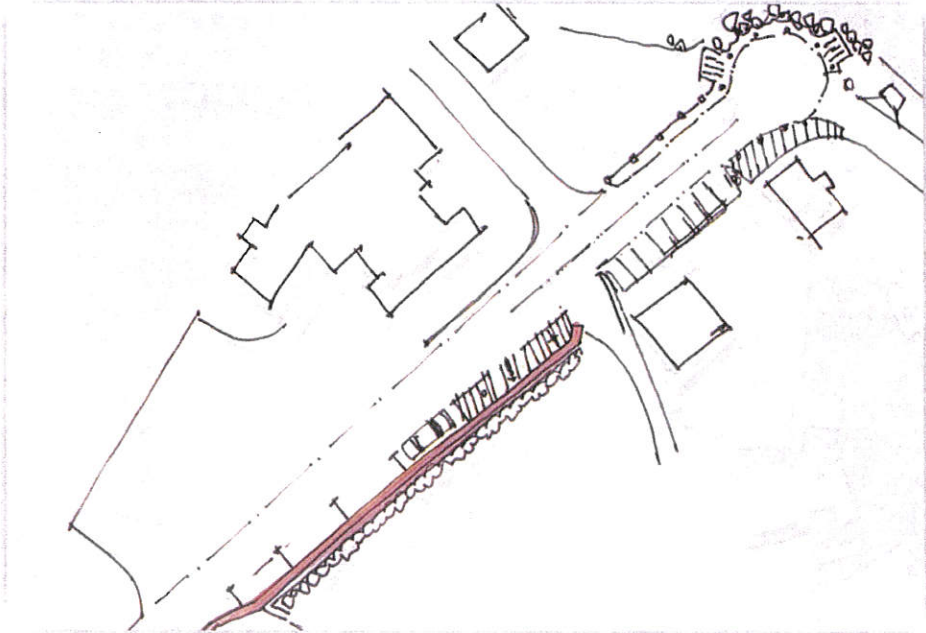
Above: Updated vehicle and moped parking near Greenebaum parcel and bicycle racks at the Galley cul-de-sac.

- b. Recommendations #4 & #5 do not appear to be shown on the accompanying sketch.  
*Response: Refer to Greenebaum parcel update, above.*

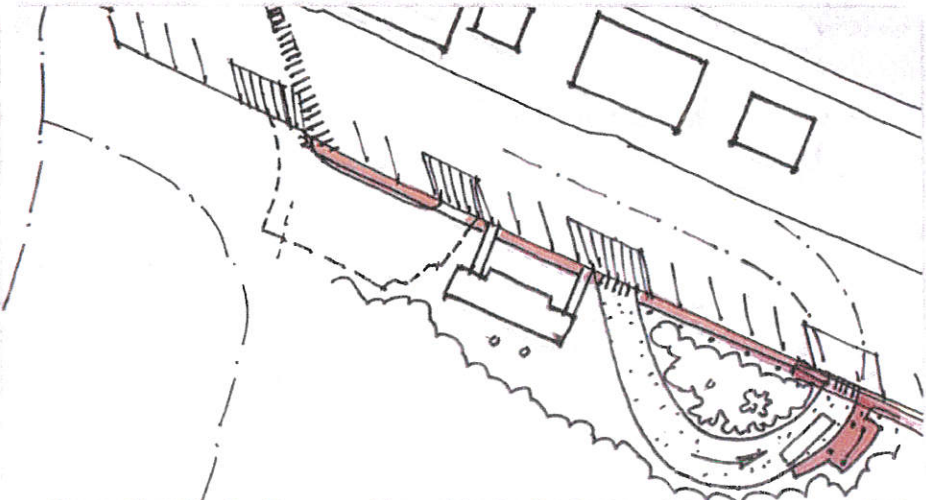
Above: Alternative Bus Turn-around beyond the Comfort Station, with Bus Shelter on north side.

- B3.1 Provide sketch at turnaround after the comfort station, on pages 13-15, that the first south side "shell lot" remains and an additional "shell lot" is to be added on the north side of the Comfort Station with a passenger drop-off and embarkation site on that north side.

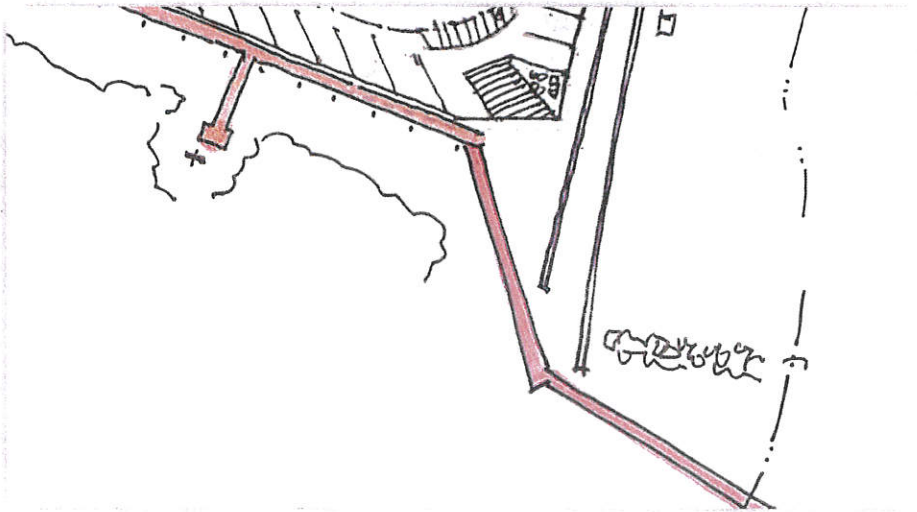
Above: Alternative beach access on north side of headwall and break-water.

- B4.1 Provide an illustration of how a person using a wheelchair or walker or other type of access vehicles would access the beach from the parking lot.  
*Response: Drawing (p. 8) Dutcher Dock to Menemsha Beach Parking shows the proposed beach access through the new and existing headwall for a fairly direct route to the waterline. Alternatively, the path can be flipped such that the bulkhead can remain as it presently is, and the path configured to the north of the breakwater to the highwater line.*
