WETLAND RESOURCE AREA DELINEATION

PREPARED FOR:
TOWN OF BOXFORD DEPARTMENT OF PUBLIC WORKS

CULVERT REPLACEMENT
CROOKED POND STREAM CROSSING
 MIDDLETON ROAD
 BOXFORD, MASSACHUSETTS

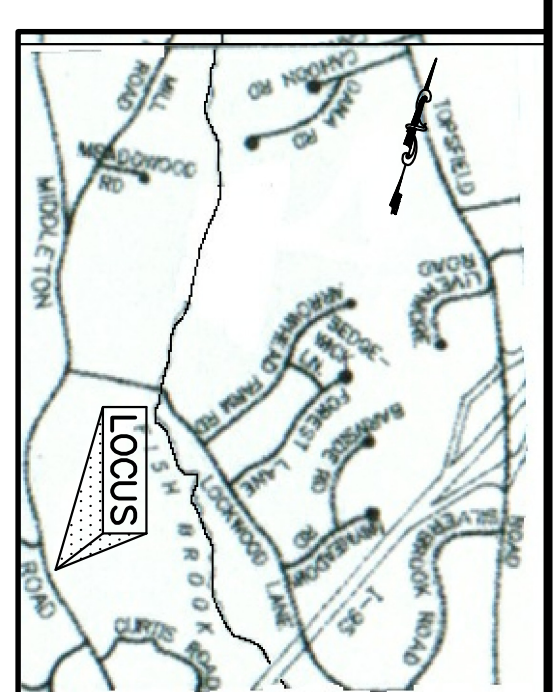
- WESTERNLY OF MIDDLETON ROAD:**
 BANK BANK 10 TO BANK 18
 RW WF B1 TO B12
- EASTERLY OF MIDDLETON ROAD:**
 BANK BANK 1 TO BANK 10
 RW WF A1 TO A14
