RE: Soil Tests – 4 North Ridge Road, Chilmark Assessor Parcel 18-32

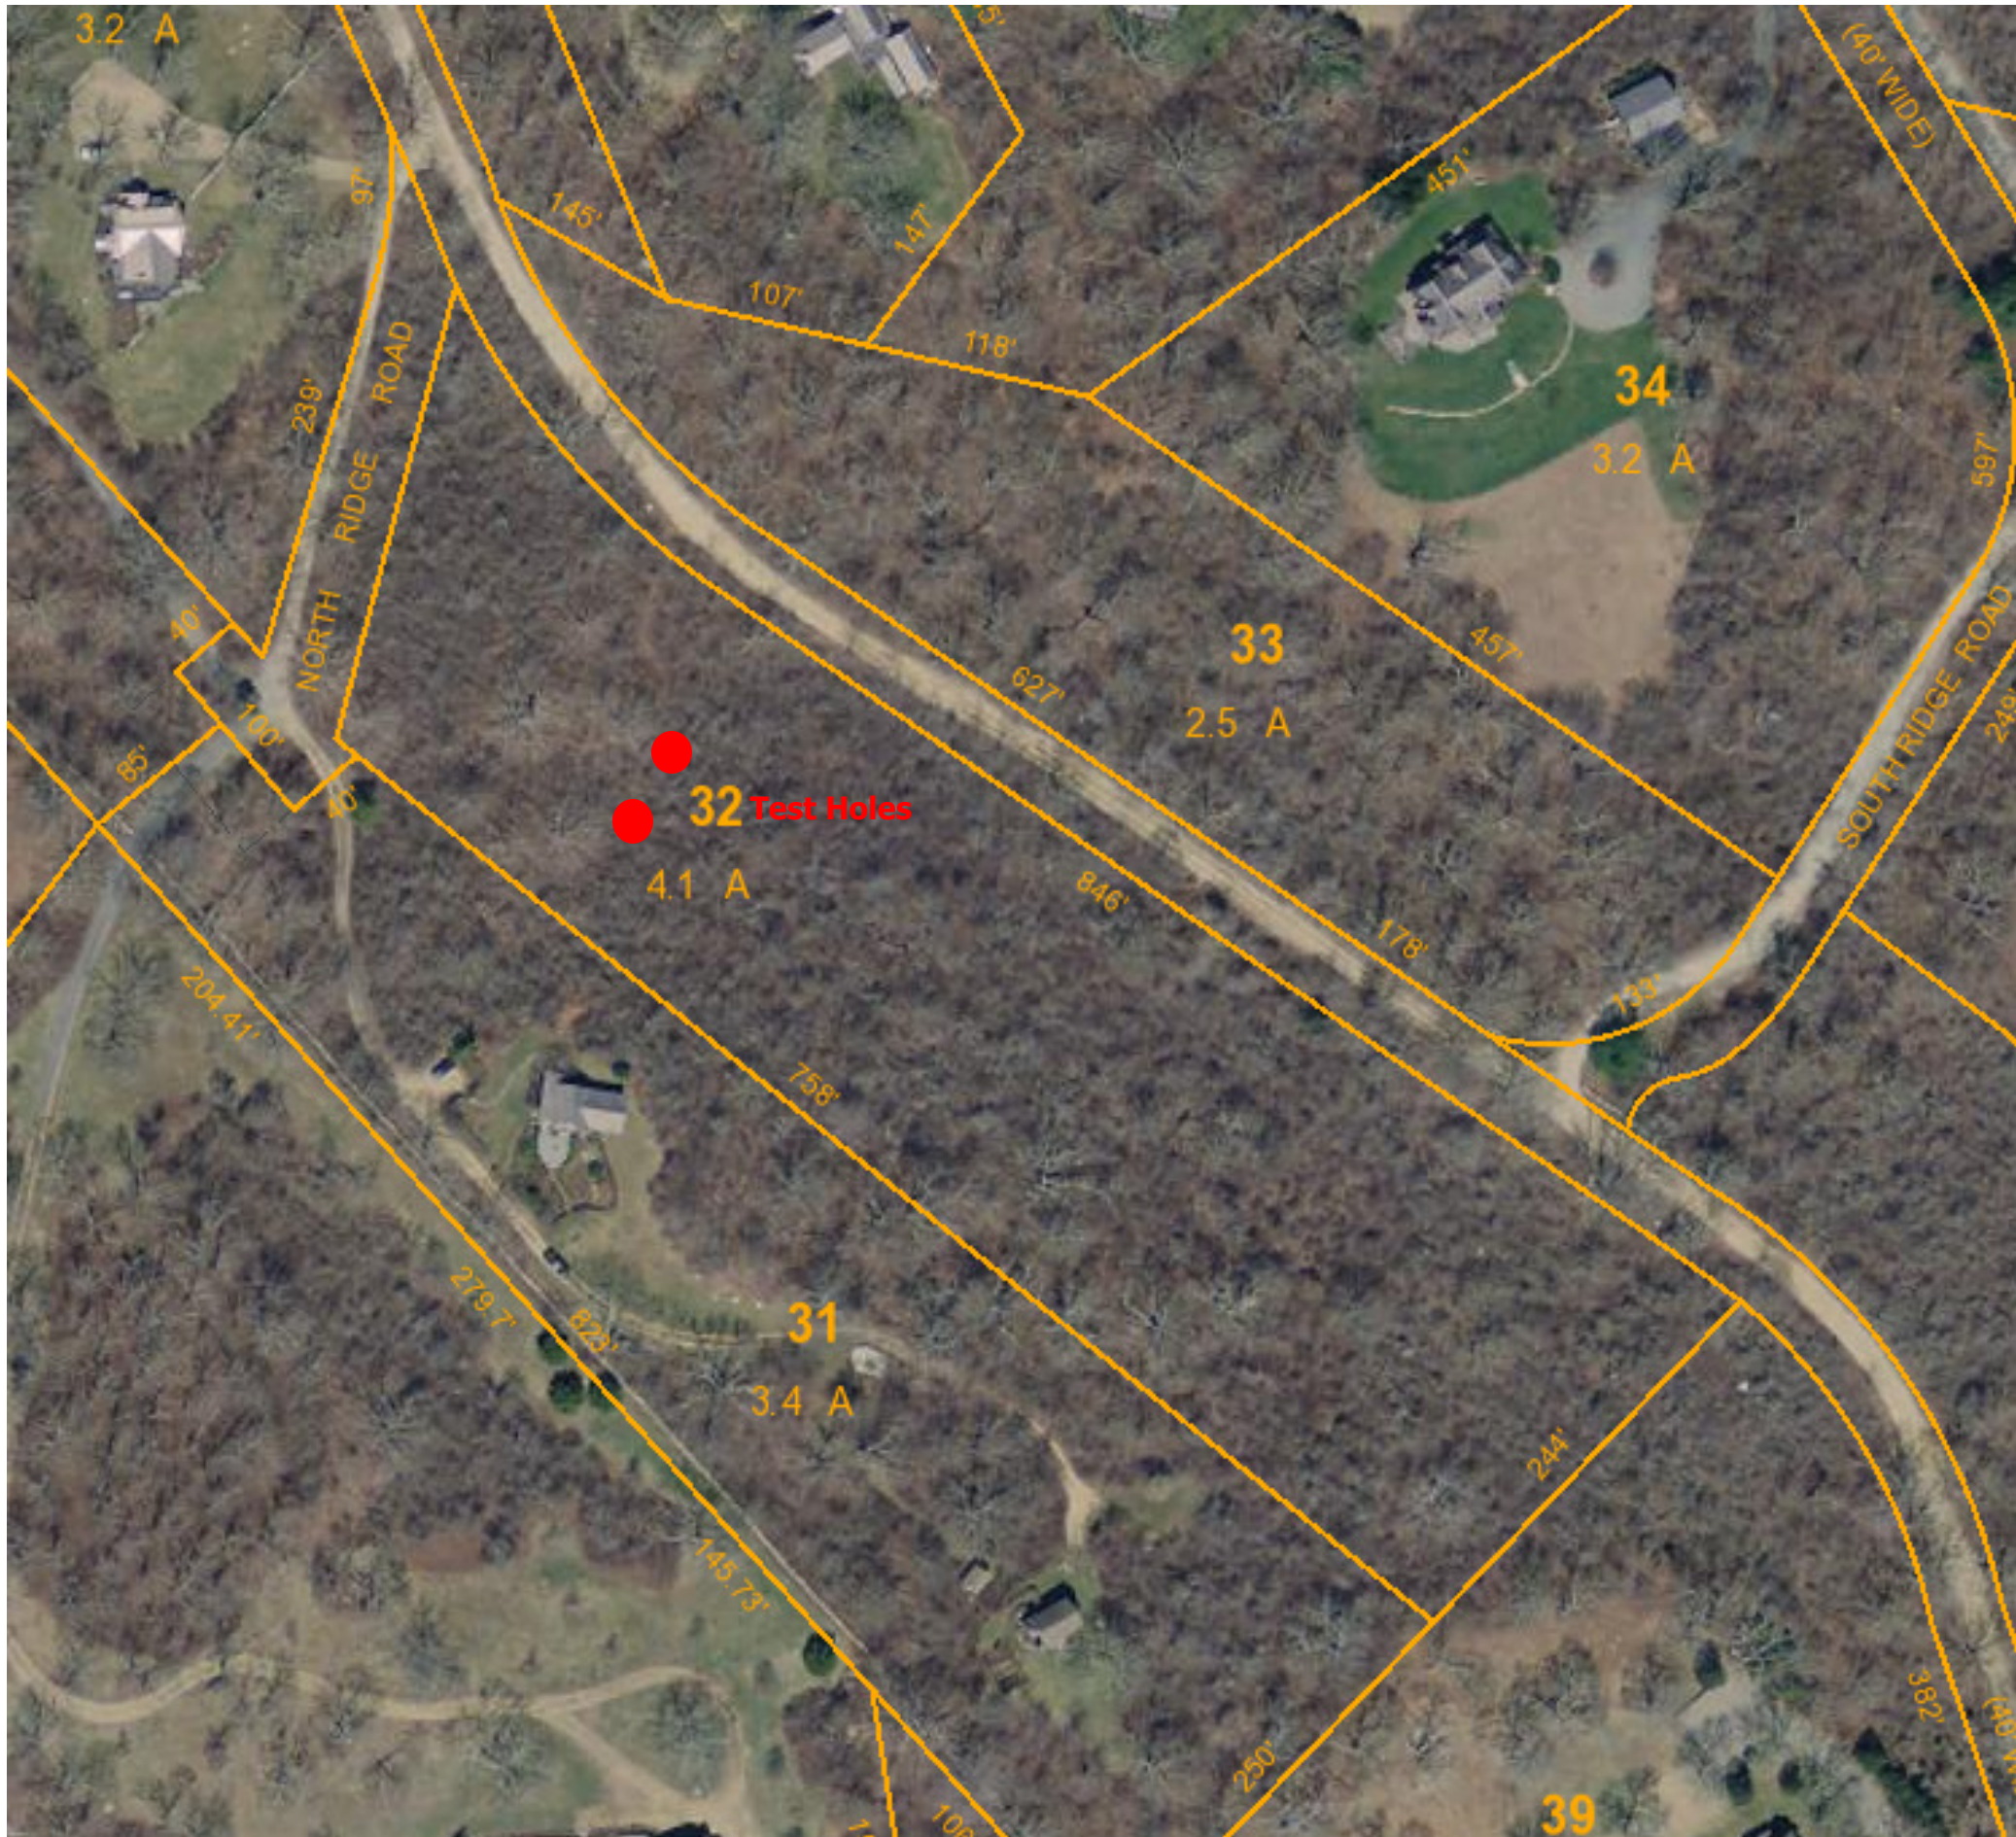
It is my opinion that the existing soil conditions are suitable for the development of an onsite septic system on this lot that could support a house of 6 bedrooms. Attached is a sketch identifying the approximate location of the tests, if you have any questions regarding this matter, please feel free to give me a call.
