TOWN COUNCIL AGENDA

August 14, 2017

Dendrochronology Study

c.1722, 24 Griffin Rd

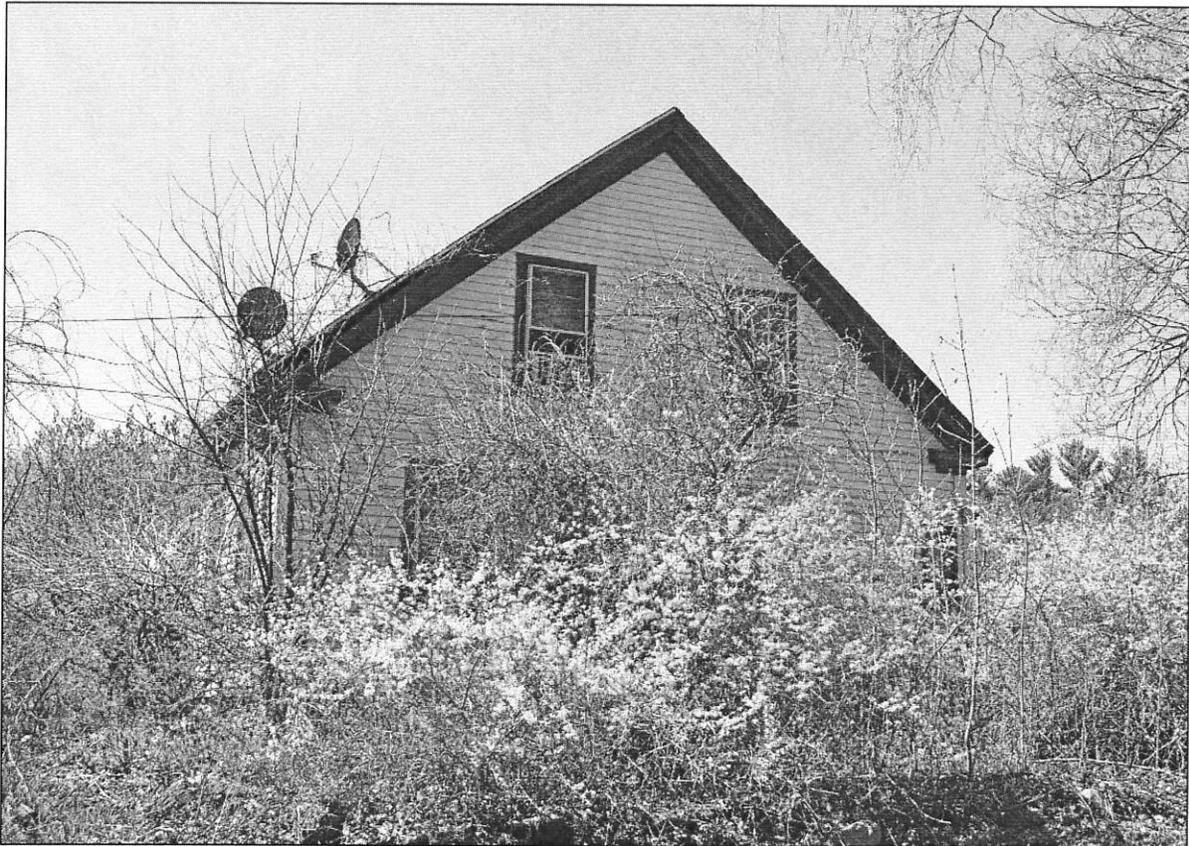
Holmes House, North and East (Front) Elevations

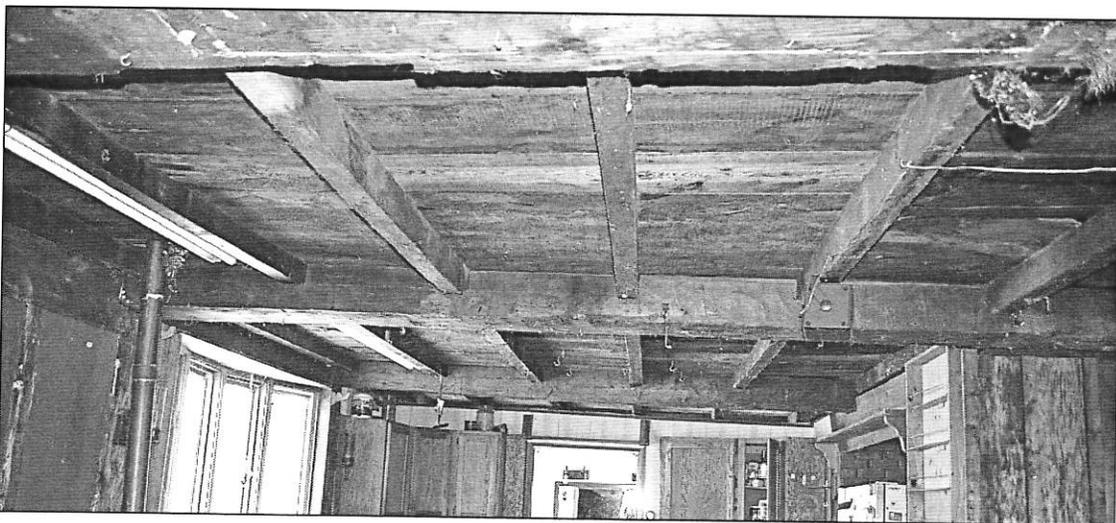
Above: Rear area of Holmes House, looking north, showing bridging joists and common joists.

This exposure disclosed the fact that the framing system is unusual in incorporating a series of four internal bridging joists, often called "summer beams," and two gable-end girts that extend across the house from front to rear and are tenoned into structural posts within the walls. More unusual for an eighteenth-century dwelling, these posts extend above the floor of the second story, where they are capped by front and rear wall plates that support the roof system of the building. This framing configuration creates a knee-wall dwelling.

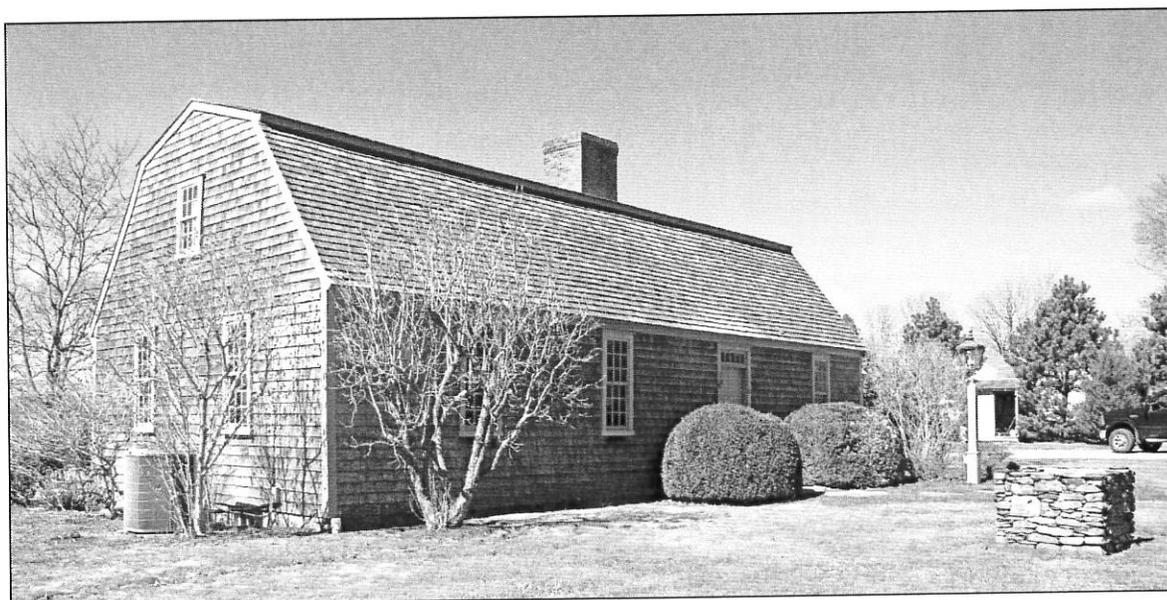
As seen below, the Seaborn Mary House differs from the Holmes house in several respects. It is a one-room-deep dwelling with a gambrel roof instead of a gable roof. Its wall plates, which define the eaves of the roof, lie just above the windows rather than being elevated by a knee wall, as in the Holmes House.

“Seaborn Mary” House, c. 1730, South of Commons Road, Little Compton, Rhode Island, moved from Londonderry, New Hampshire, to Rhode Island in 1937.

Summary of the Evolution of the Holmes House: As shown above, the frame of the Holmes House shares structural characteristics with the Seaborn Mary House and appears to be an eighteenth-century structure. Further examination of evidence may confirm this general date, but a more accurate date for the house and a fuller history of ownership may eventually be revealed through deed research and other documentary investigation. As noted below, the frame of the Holmes House is the element of the building that holds the highest research value; the interior finishes of the building almost all date from the mid-1800s or the late twentieth century.

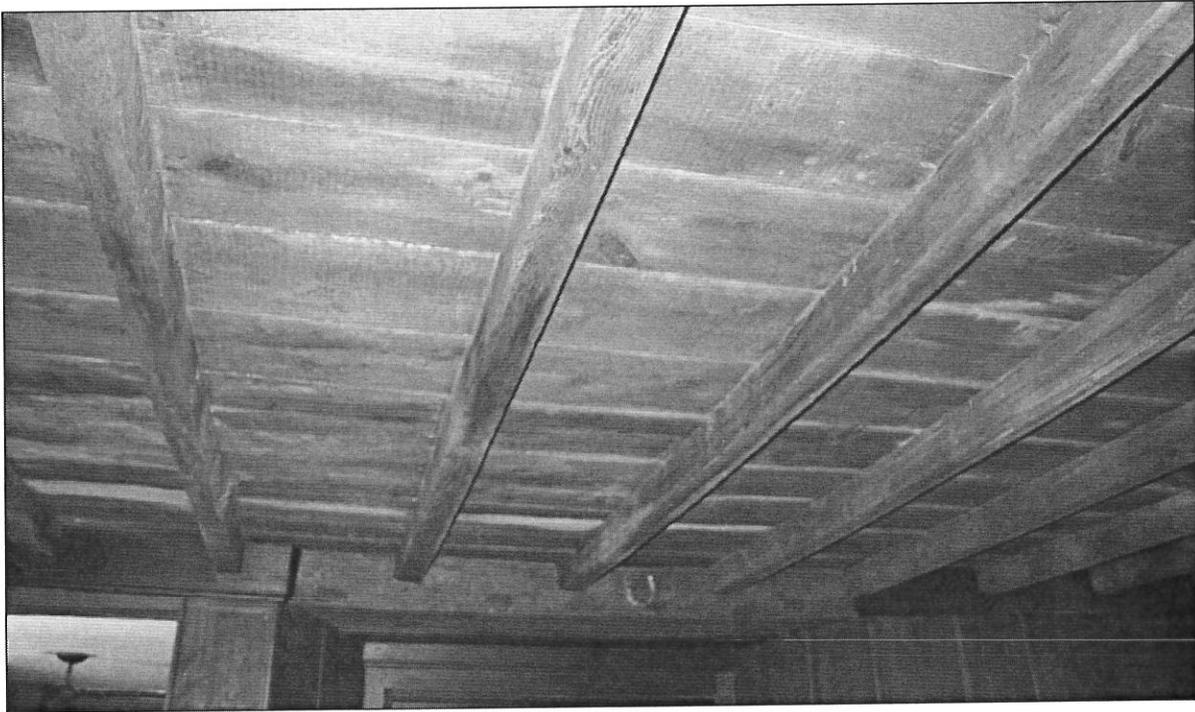
however, the Seaborn Mary House shares one principal characteristic with the Holmes House. As seen in the photograph below, the house utilizes a second-floor (attic floor) framing system that is highly similar to that of the Holmes House. Both houses utilize a series of hewn summer beams or bridging joists that extend laterally through the building, linking front and rear wall posts and providing support for ranges of sawn common joists that hold the floor boards above.

Parlor ceiling, looking north, "Seaborn Mary" House, c. 1730, Little Compton, Rhode Island.

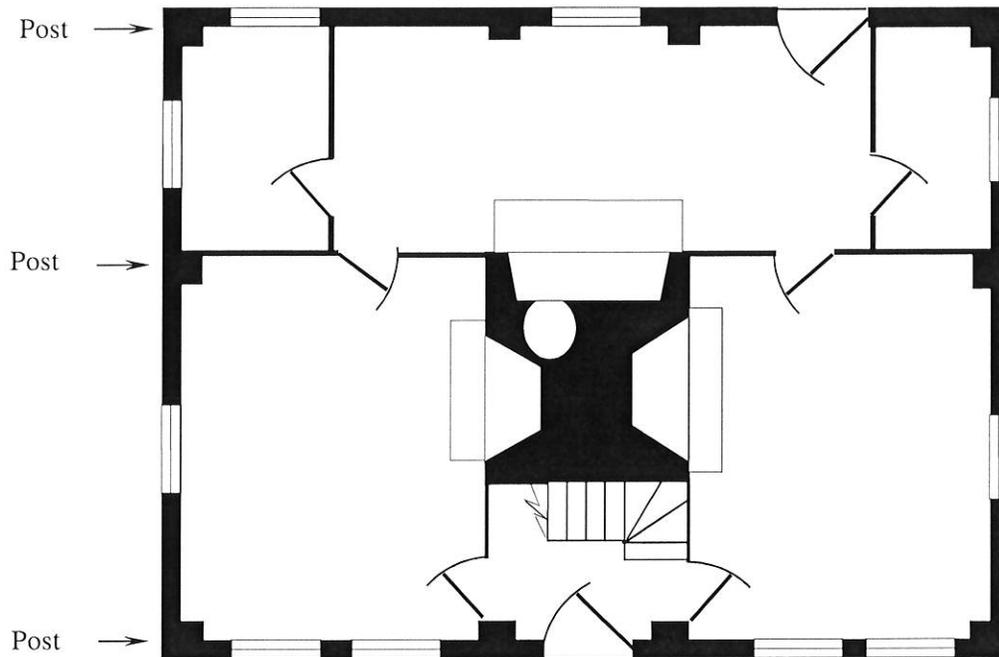
Typically, an "English" house has four frames that compose its skeleton: two in the end or gable walls, and two that embrace the chimney in the center of the building. Each frame has three

posts, one at the front wall of the building, one at the rear wall, and one just behind the chimney, as shown below.

Floor plan of a typical "English" house, showing the three posts that compose parts of the framing units and define the division between front and rear rooms in the dwelling.

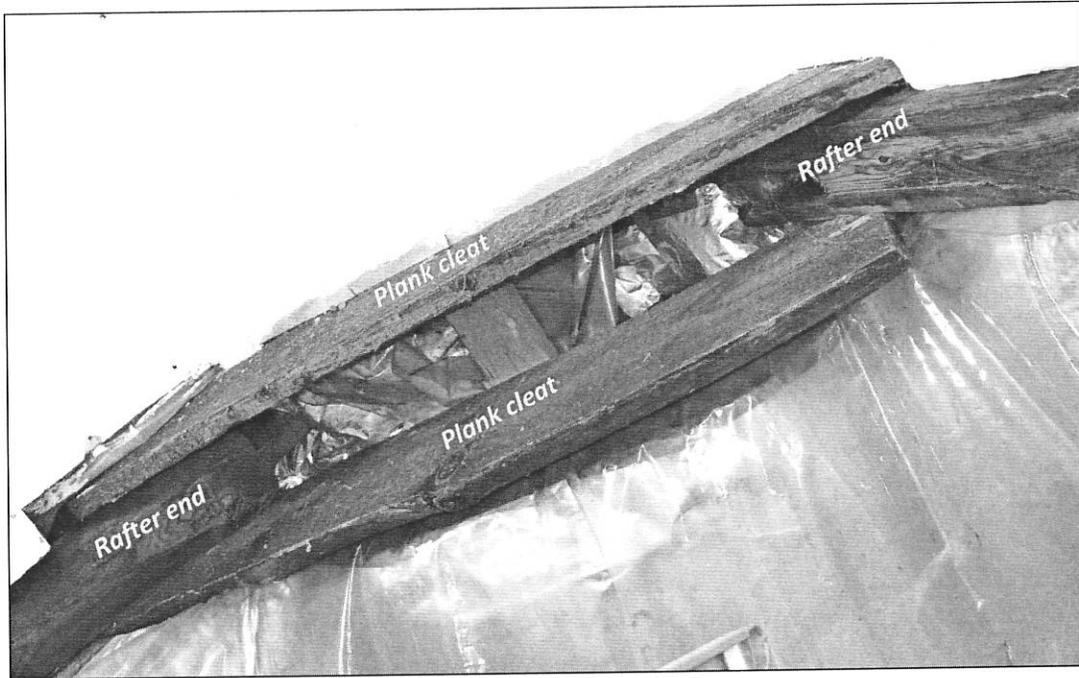
Physical evidence shows that the Holmes House was transformed during the mid-1800s. Whatever its original appearance may have been, the house was remodeled into an example of the then-fashionable Greek Revival farmhouse. To accomplish this, the original roof frame of

the house was separated at the ridge, the upper ends of the rafters were lifted and held apart by plank cleats nailed to their sides, and new materials were added to extend the ridge to its present elevation.

Attic rafters, showing separation at the original ridge and insertion of plank cleats to hold the rafters in lifted position. Additional framing was added above to support the raised ridge.

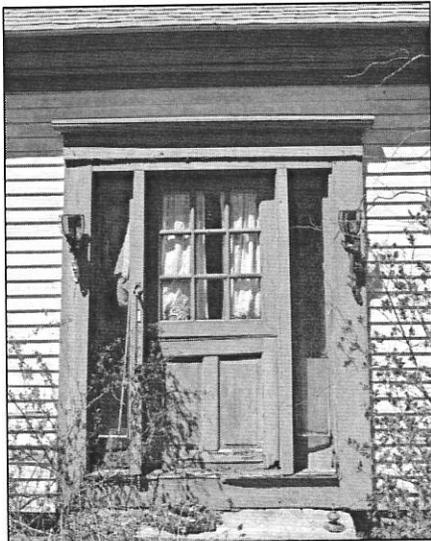
With the geometry of the house altered, stylistic details were added on the exterior and interior. The most characteristic exterior feature was a new front doorway in the robust but fashionable Greek Revival style. The original window placement of the house is unclear, but the house was given a balanced façade with two windows on each side of the front doorway if it did not already have such symmetry. The window sashes were updated to display a muntin profile that was fashionable at the time.

Left: Front doorway, circa 1850.

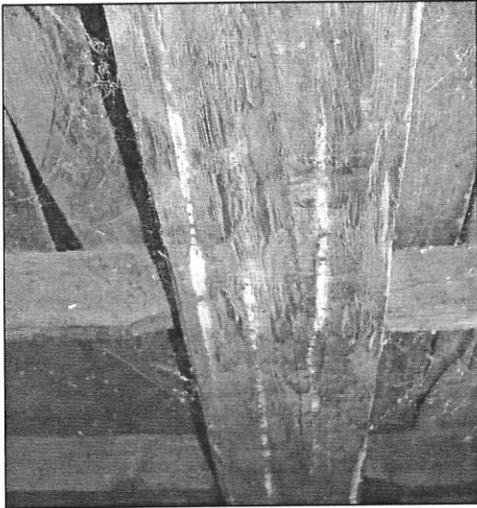
regarding its character. As seen at the left, lime stains on the bottoms of the heavy beams of the second floor frame show that the first story was provided with plastered ceilings. There is relatively little evidence of ceiling plaster prior to this date, so it appears that the ancient character of the interior was retained until the transformation of the mid-1800s. The new ceilings were dropped to the elevation of the bottoms of the heavy beam, undoubtedly by the common practice of nailing boards to the sides of the smaller joists and nailing the new lath to the bottom edges of these boards.

Left: Lime stains from former ceiling lath and plaster on the bottom of a bridging joist or summer beam, northeast room.

As noted previously, there is slight evidence of a remodeling of the house in the early 1800s, almost completely erased by the extensive remodeling of c. 1850. The house retains two four-panel doors with raised panels and elaborated stile and rail moldings, one of which is seen in the photograph on page 8. These doors are typical of the early Federal style. Many of the hewn framing members of the house were expertly hewn with a broad-axe, a technique that leaves a somewhat rough and uneven surface when not followed by smoothing with an adze. Such a surface is seen in the photograph of a bridging joist (summer beam) on page 8.

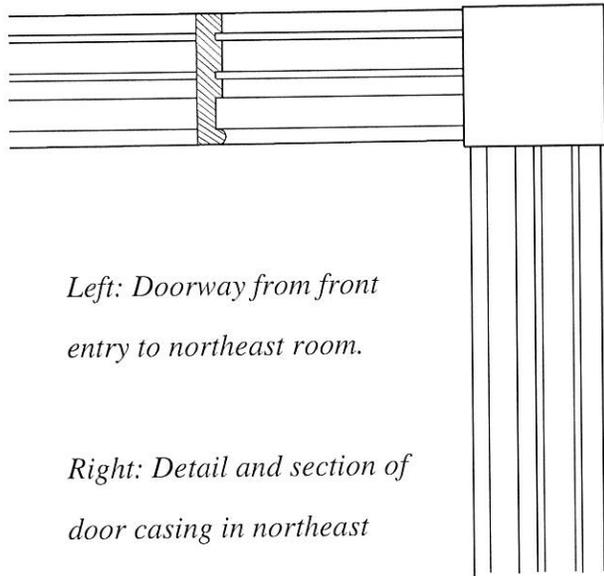
Right: Detail and section of door casing in northeast room.

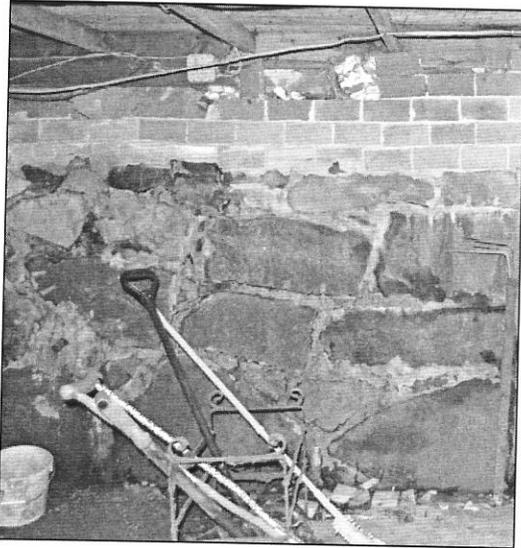
The fashion for full basements increased during the nineteenth century. In the case of the Holmes House, physical evidence shows that the entire house was lifted and supported, a full basement was excavated if it did not exist, and new cellar walls of split granite boulders was constructed up to the elevation of the exterior grade. Above grade, the house was underpinned with slabs of granite backed by a veneer of brickwork.

This granite foundation may be dated at 1830 or later through evidence of the splitting technique that was employed on the cellar walls and underpinning slabs, as explained in the Appendix to this report.

Left: North wall of the basement, showing the walls of split fieldstones and the brick backing for the granite underpinning that is visible above grade on the exterior of the house.

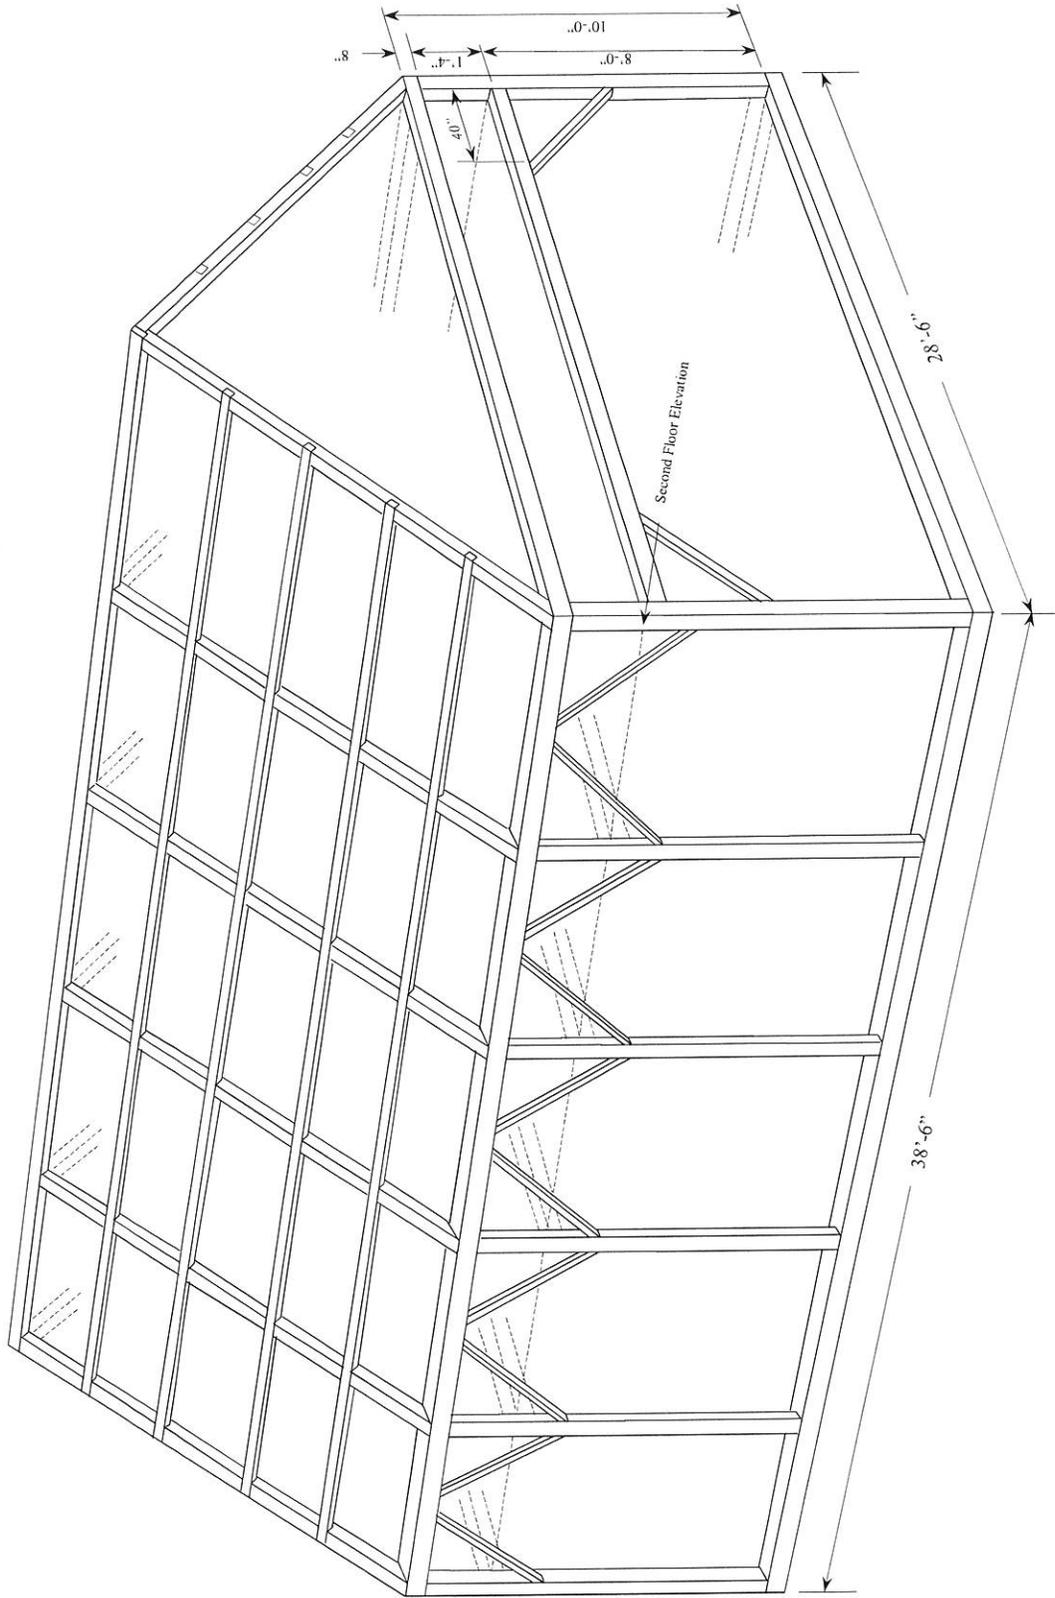
HOLMES HOUSE FRAME—AXONOMETRIC VIEW

The frame measures 28'6" in depth (front to back) and 38'-6" in length. It is composed of front and rear broadsides, each having sills, corner posts, and four intermediate posts, capped by a wall plate that appears to be continuous along the length of the house. The knee-wall design of the frame suggests that the front and rear walls were probably raised as preassembled units that were linked together across the depth of the building by the insertion of the bridging joists or summer beams. As shown in the drawing on the following page, the total height of the frame from the top of the sills (first floor elevation) to the top of the front and rear wall plates is about 10'-0." The height of the individual wall posts (cited in eighteenth-century terminology as the distance "between joints") is about 9'-4.

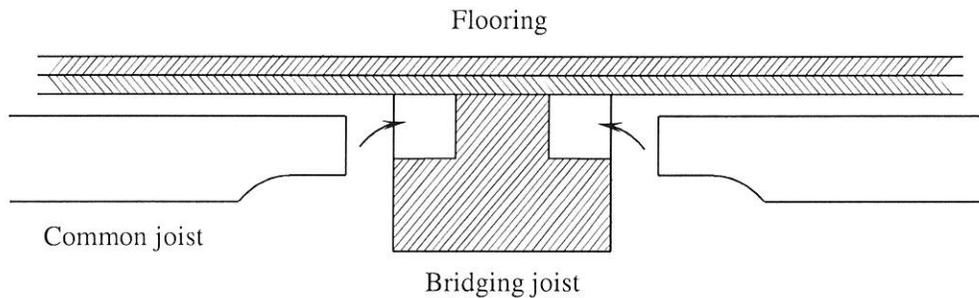
The common joists of the second floor frame were sawn in a reciprocating or “upright” sawmill. Where their grain is visible (many are painted), these joists are seen to be oak, apparently white oak (*Quercus alba*). Their dimensions vary somewhat, but they average 3 inches in width and 4 to 4¾ inches in height. Except in the presumed location of the former chimney, their spacing is quite uniform throughout the house, as shown on the second floor framing plan on page 2. As seen in the photograph on page 8, and below, the common joists are diminished slightly at their ends, forming simple cogs that rest in notches in the bridging joists that support them.

The front and rear wall plates of the frame appear to be white pine (*Pinus strobus*). They are hewn, and measure approximately 7 inches in height and 6 inches in depth (thickness). The posts that support the plates are also 6 inches in depth above the second floor (below, right).

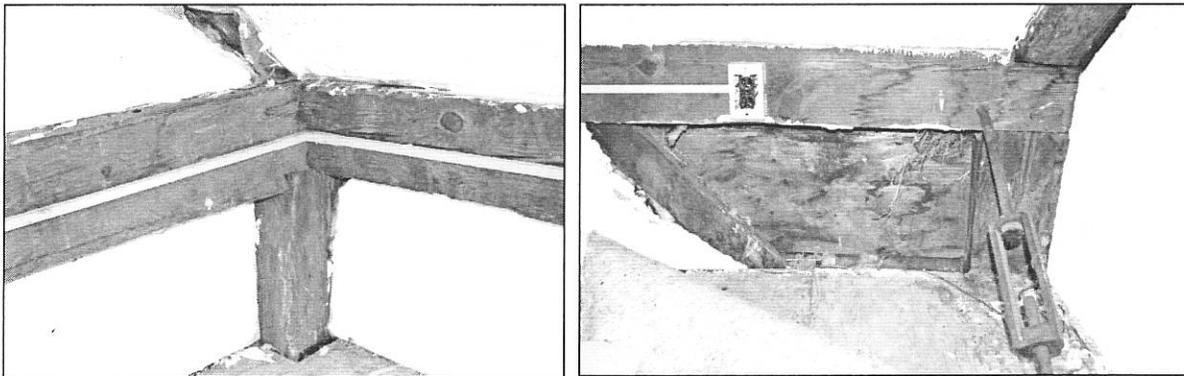
The knee-wall construction of the house employs relatively simple carpentry joints. In general, the joining of wall and roof structural members does not make use of the complex joints that characterized “English” houses from the 1600s until after 1800.⁸

Left: Corner joint of knee-wall frame, showing juncture of corner post, wall plate, tie beam (left), and rafter.

Right: Middle joint of knee-wall frame, showing juncture of wall post, wall plate, and rafter, with added iron turnbuckle to resist spreading of the wall. A brace is visible at the left.

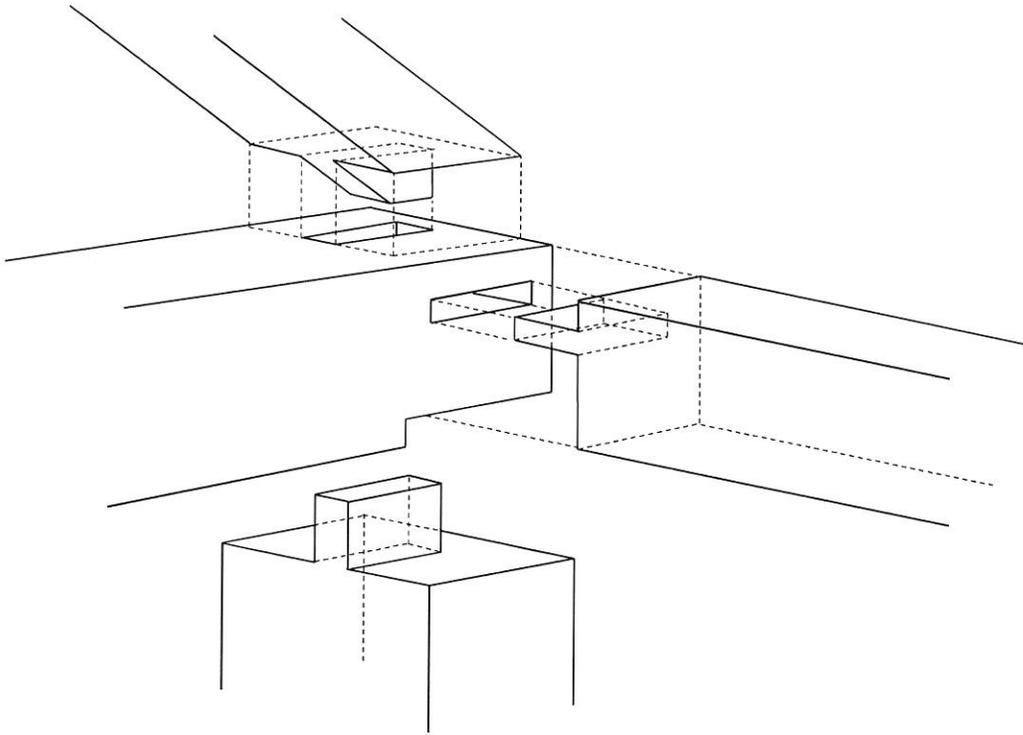
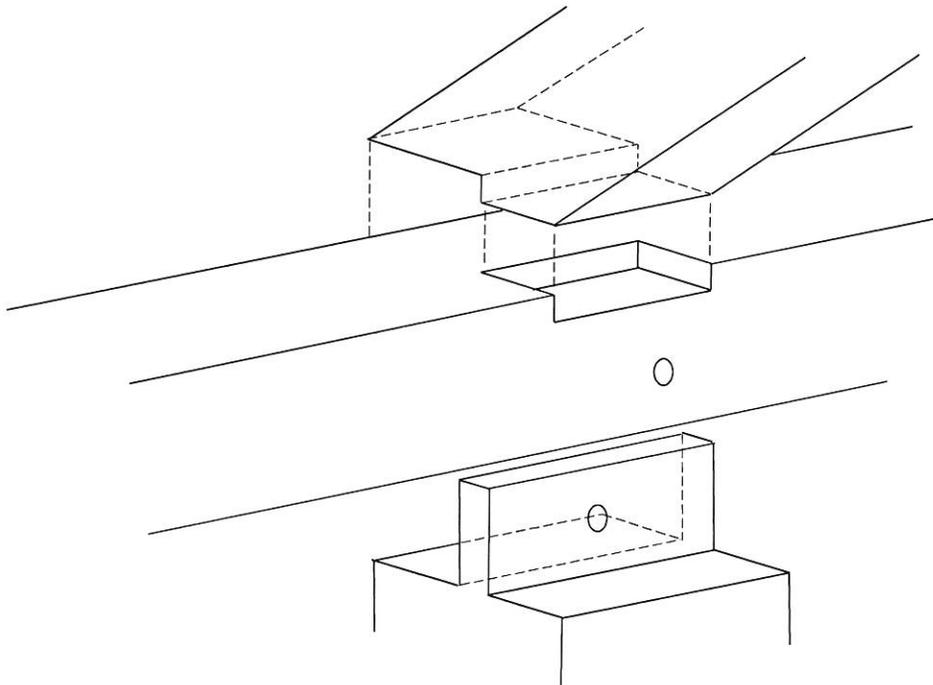
Above: exploded diagram of framing joints at a corner of the building based on visual details seen in the photograph on the previous page, left. Below: exploded view of rafter seat and wall post tenon.

The drawing at the bottom of the previous page shows an unusual seat for the rafters that rest on the wall plates at the four inner posts of the front and rear walls. This insubstantial notched seat provides insecure anchorage for the feet of the rafters. There may be a hidden detail that adds some strength to the rafter seats, such as a pin (treenail) driven diagonally through the feet of the rafters into the wall plates, but it cannot be detected in places where the rafter feet were rotated upward by the lifting of the roof planes when the ridge was raised. As nearly as can be determined, the rafters were laid out as shown below. The rafters are hewn, and measure approximately 6 inches deep by 5½ inches wide.

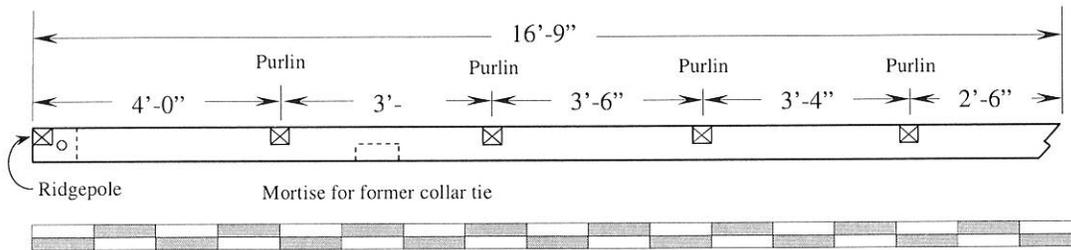
Rafter layout, Holmes House

The anchorage of the rafter feet at the top of the front and rear wall plates, without a tenon anchored more deeply within the plates, exerted a twisting or overturning force on the plates. The tendency for the plates to twist outward, or for the walls to spread at the top, may have been seen as increasingly troublesome when the roof planes were raised and the expanse of the roof was enlarged by the addition of new construction above the old ridge elevation, as shown on page 7. Probably at the time of the wholesale remodeling of the house circa 1850, wrought iron turnbuckles were inserted in the two central structural units of the house. These were intended to link the tops of the front and rear wall plates and the bridging joists below by means of devices that could be tightened by turning the hand-forged turnbuckle. Although hand fabricated, these pieces of hardware do not appear to be ancient; the threads appear to be machine-made rather than cut by the blacksmith.

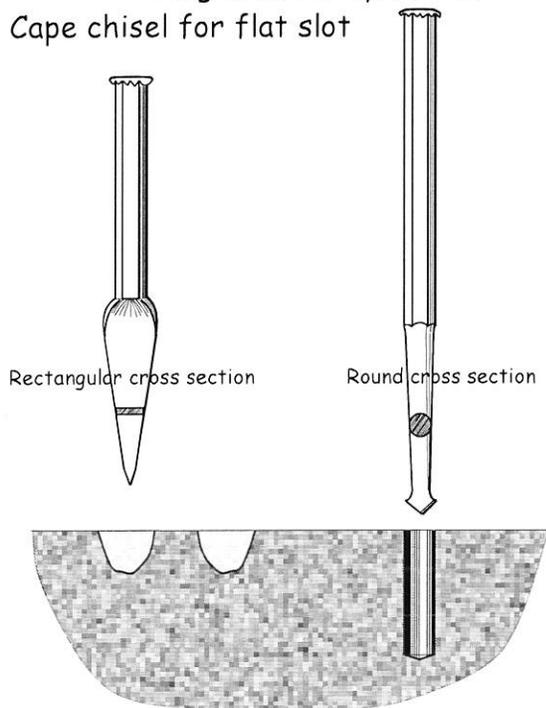
Plug drill for cylindrical hole
 Cape chisel for flat slot

Into this hole were placed a pair of half-round steel shims or “feathers,” and between these was driven a wedge or “plug” which exerted outward pressure and split the stone. The advantage of the “plug-and-feathers” method of splitting was the greater depth within the stone at which the wedges exerted their pressure, thus allowing larger pieces to be split more accurately.

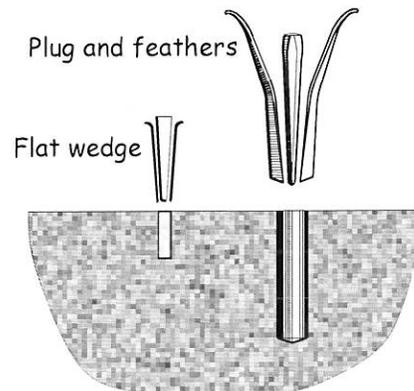
The new splitting technology seems to have spread rather rapidly through the granite quarrying centers of New England, although one is likely to find evidence of both old and new methods being used concurrently in stonework of the 1830s, especially in rural areas. The technique employed on a given stone can usually be seen on the split face, and provides some aid in dating granite masonry. The old, flat-wedge method is marked by a series of slot-like depressions which extend inward an inch or so from the edges of the split stone. The plug-and-feathers method leaves a row of rounded holes, two or three inches deep and usually about six inches apart.

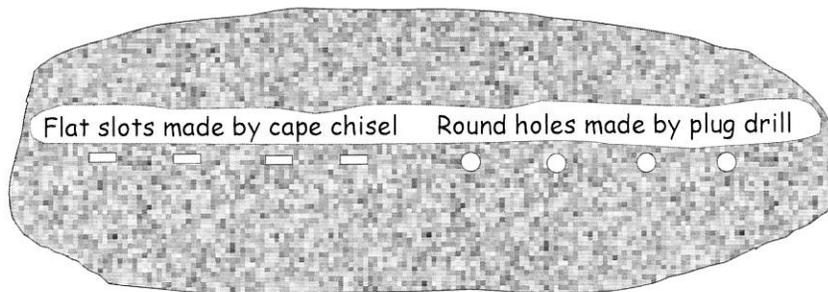
When seen on the surface of a stone that was prepared for splitting but never split, these slots or holes appear as shown below:

The use of the plug drill in combination with the plug-and-feathers provided greater force and control in splitting granite. Until the introduction of the new technique, most granite for buildings and posts was split from surface boulders that had been strewn across the New England landscape at the retreat of the glaciers. Such stone had been transported by the ice from many points of origin, and each boulder challenged the stonecutter with different grain and behavior when split.
