Appendix D

Manhole Inspection Logs  
May 2008

**Falmouth on the Green  
Manhole Numbering Reference Table**

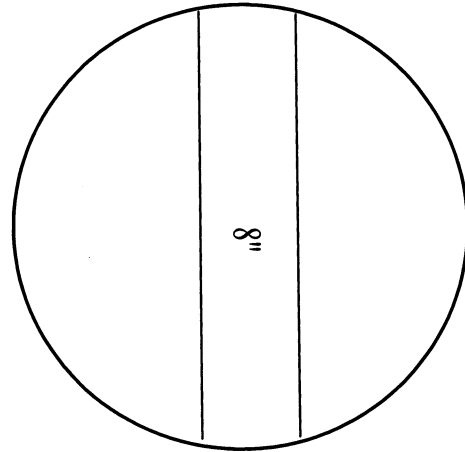
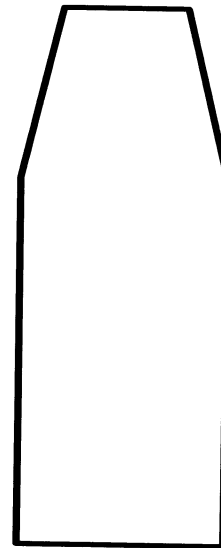
CONDITION OF TABLE: EX GD  $\leftrightarrow$  PR Dirty

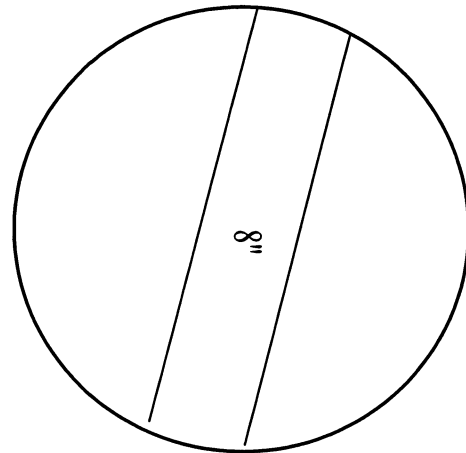
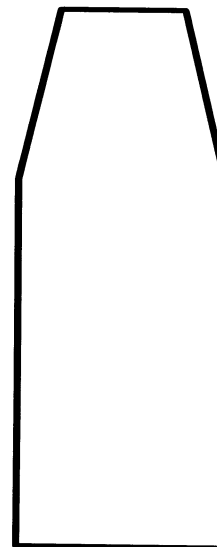
CONDITION OF TABLE: EX GD PR Dirty!

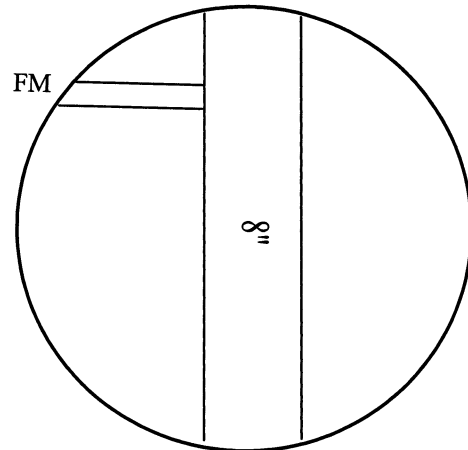
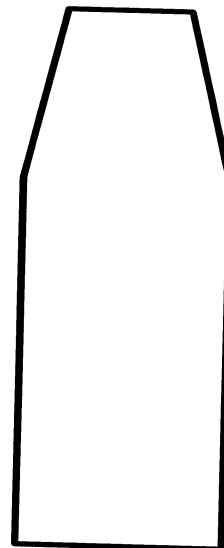
CONDITION OF TABLE: EX GD PR Dirty

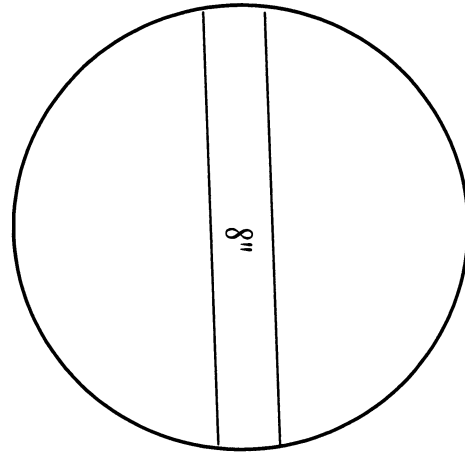
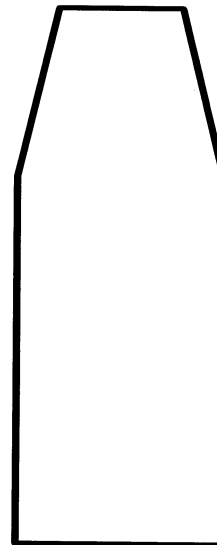
CONDITION OF INVERTS: EX GD PR - Rock

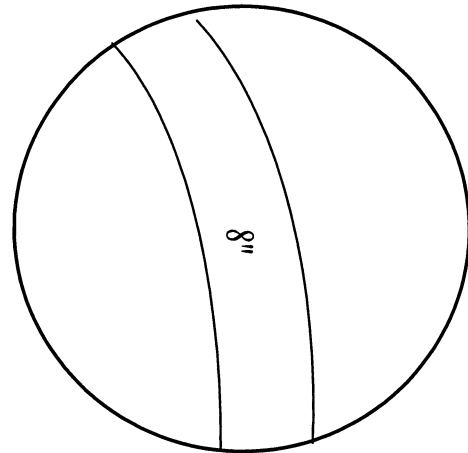
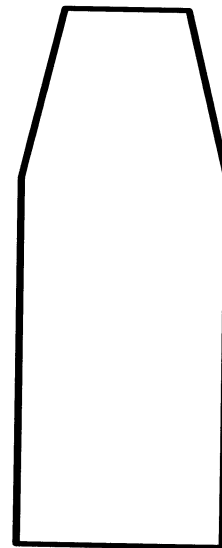
CONDITION OF TABLE: EX GD PR Dirty

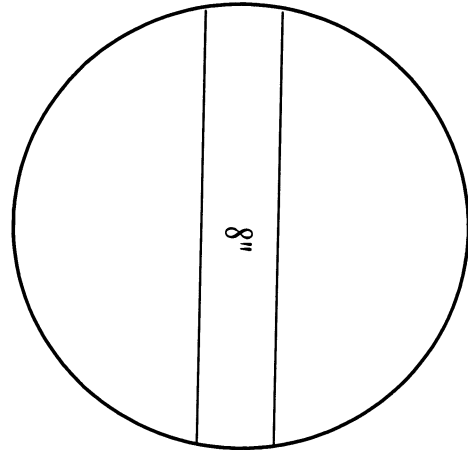
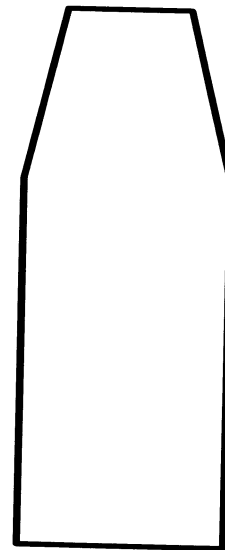
CONDITION OF TABLE: EX GD PR Dirty

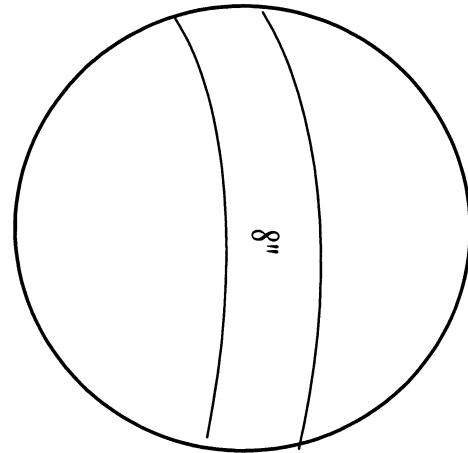
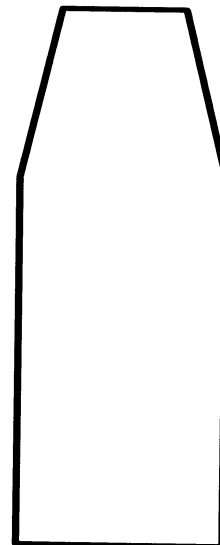
| NUMBER OF SECTIONS: | 2 | 3 | <u>4</u> 1 Missing |

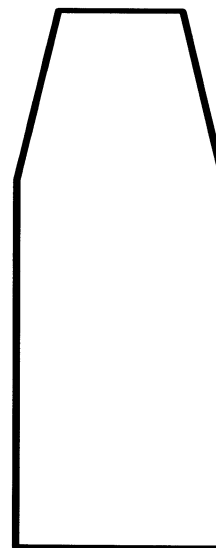
**WRIGHT-PIERCE**  
**MANHOLE INSPECTION REPORT**MH No. FCC-24PROJECT LOCATION: Falmouth on the Green Falmouth, Maine PROJECT NO.: 10876BDATE: 5/19/08 WEATHER: Cloudy TIME: 1:17 INSPECTOR: Tim ParksLOCATION DATA:STREET: BirkdaleBURIED: Yes/No PAVED AREA: Yes/NoMANHOLE DATA:COVER CONDITION: EX GD PRCOVER DIAMETER: 18" 24" 26" 30"NO. OF COVER HOLES: 0SIZE OF COVER HOLES: -CONDITION OF RIM: EX GD PRCONDITION OF FRAME: EX GD PRRISER CONDITION: EX GD PRRISERS ARE: BRICK BLOCK PRECASTMANHOLE DIAMETER 2FT 3FT 4FT OTHER:                     MANHOLE IS: BRICK BLOCK PRECAST OTHER:                     DEPTH OF MANHOLE: 10.5 FTCONDITION OF WALLS: EX GD ⇔ PR Exp. RebarCONDITION OF STEPS: EX GD PRNUMBER OF SECTIONS: 1 2 3 4 6CONDITION OF INVERTS: EX GD PRCONDITION OF TABLE: EX GD PRLEAKAGE POINTS:COVER: Y/N JOINTS: Y/NFRAME: Y/N INVERTS: Y/NWALLS: Y/N TABLES: Y/NESTIMATED I/I (GPM):                     CORROSION PROBLEMS? Y/NCOMMENTS: Experienced rebar on wall.

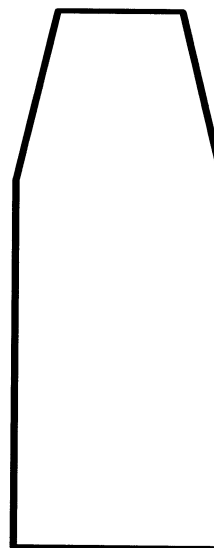
ESTIMATED I/I (GPM):                     CORROSION PROBLEMS? Y/NCOMMENTS: Number of Sections: 1 missing. SECTION

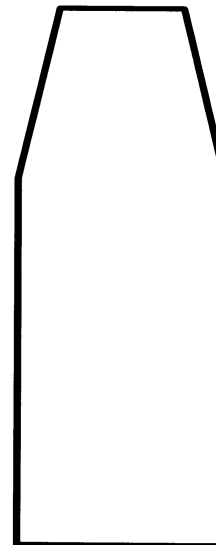
CONDITION OF INVERTS: EX GD PRCONDITION OF TABLE: EX GD PRLEAKAGE POINTS:COVER: Y/N JOINTS: Y/NFRAME: Y/N INVERTS: Y/NWALLS: Y/N TABLES: Y/NESTIMATED I/I (GPM):                     CORROSION PROBLEMS? Y/NCOMMENTS: Number of Sections: 7 - need rotation as noted. SECTION

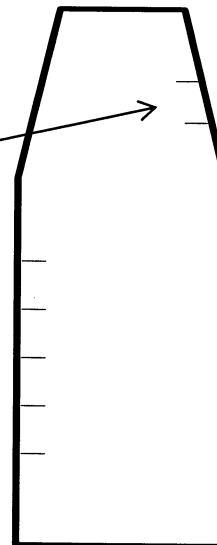
**WRIGHT-PIERCE**  
**MANHOLE INSPECTION REPORT**MH No. FCC-27PROJECT LOCATION: Falmouth on the Green Falmouth, Maine PROJECT NO.: 10876BDATE: 5/19/08 WEATHER: Cloudy TIME: 4:03 INSPECTOR: Tim ParksLOCATION DATA:STREET: BirkdaleBURIED: Yes/No PAVED AREA: Yes/NoMANHOLE DATA:COVER CONDITION: EX GD PRCOVER DIAMETER: 18" 24" 26" 30"NO. OF COVER HOLES: 0SIZE OF COVER HOLES: -CONDITION OF RIM: EX GD PRCONDITION OF FRAME: EX GD PRRISER CONDITION: EX GD PRRISERS ARE: BRICK BLOCK PRECASTMANHOLE DIAMETER 2FT 3FT 4FT OTHER:                     MANHOLE IS: BRICK BLOCK PRECAST OTHER:                     DEPTH OF MANHOLE: 9.42 FTCONDITION OF WALLS: EX GD ↔ PRCONDITION OF STEPS: EX GD PRNUMBER OF SECTIONS: 1 2 3 4 5CONDITION OF INVERTS: EX GD PRCONDITION OF TABLE: EX GD PRLEAKAGE POINTS:COVER: Y/N JOINTS: Y/N smallFRAME: Y/N INVERTS: Y/NWALLS: Y/N small TABLES: Y/NESTIMATED I/I (GPM):                     CORROSION PROBLEMS? Y/NCOMMENTS: Small leakage points in joints and walls.SECTION

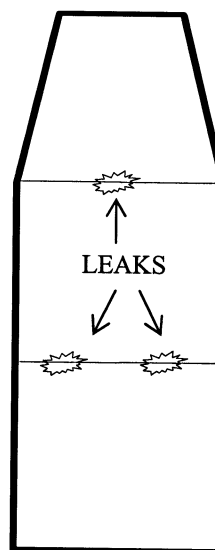
**WRIGHT-PIERCE**  
**MANHOLE INSPECTION REPORT**MH No. FCC-28PROJECT LOCATION: Falmouth on the Green Falmouth, Maine PROJECT NO.: 10876BDATE: 5/19/08 WEATHER: Cloudy TIME: 4:03 INSPECTOR: Tim ParksLOCATION DATA:STREET: BirkdaleBURIED: Yes/No PAVED AREA: Yes/NoMANHOLE DATA:COVER CONDITION: EX GD PRCOVER DIAMETER: 18" 24" 26" 30" P.S. ←NO. OF COVER HOLES: 0SIZE OF COVER HOLES: -CONDITION OF RIM: EX GD PRCONDITION OF FRAME: EX GD PRRISER CONDITION: EX GD PRRISERS ARE: BRICK BLOCK PRECASTMANHOLE DIAMETER 2FT 3FT 4FT OTHER:                     MANHOLE IS: BRICK BLOCK PRECAST OTHER:                     DEPTH OF MANHOLE: 11.42 FTCONDITION OF WALLS: EX GD PRCONDITION OF STEPS: EX GD PRNUMBER OF SECTIONS: 1 2 3 4 8CONDITION OF INVERTS: EX GD PRCONDITION OF TABLE: EX GD PR DIRTYLEAKAGE POINTS:COVER: Y/N JOINTS: Y/N smallFRAME: Y/N INVERTS: Y/NWALLS: Y/N small TABLES: Y/NESTIMATED I/I (GPM):                     CORROSION PROBLEMS? Y/NCOMMENTS: Table was dirty.SECTION

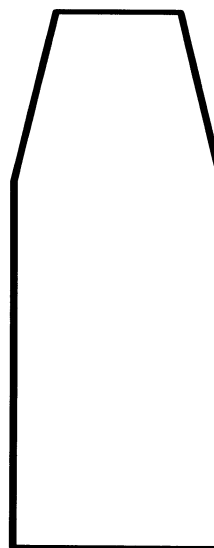
**WRIGHT-PIERCE**  
**MANHOLE INSPECTION REPORT**MH No. FCC-37PROJECT LOCATION: Falmouth on the Green Falmouth, Maine PROJECT NO.: 10876BDATE: 5/20/08 WEATHER: Sunny TIME: 7:53 INSPECTOR: Tim ParksLOCATION DATA:STREET: BirkdaleBURIED: Yes/No PAVED AREA: Yes/NoMANHOLE DATA:COVER CONDITION: EX GD PRCOVER DIAMETER: 18" 24" 26" 30"NO. OF COVER HOLES: 0SIZE OF COVER HOLES: -CONDITION OF RIM: EX GD PRCONDITION OF FRAME: EX GD PRRISER CONDITION: EX GD PRRISERS ARE: BRICK BLOCK PRECASTMANHOLE DIAMETER 2FT 3FT 4FT OTHER:                     MANHOLE IS: BRICK BLOCK PRECAST OTHER:                     DEPTH OF MANHOLE: 8 FTCONDITION OF WALLS: EX GD PRCONDITION OF STEPS: EX GD PRNUMBER OF SECTIONS: 2 3 4 5CONDITION OF INVERTS: EX GD PR **DIRTY**CONDITION OF TABLE: EX GD PRLEAKAGE POINTS:COVER: Y/N JOINTS: Y/NFRAME: Y/N INVERTS: Y/NWALLS: Y/N TABLES: Y/NESTIMATED I/I (GPM):                     CORROSION PROBLEMS? Y/NCOMMENTS: Inverts are dirty.SECTION

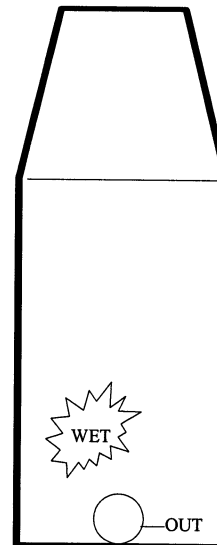
CORROSION PROBLEMS? Y/NCOMMENTS: Table was dirty.SECTION

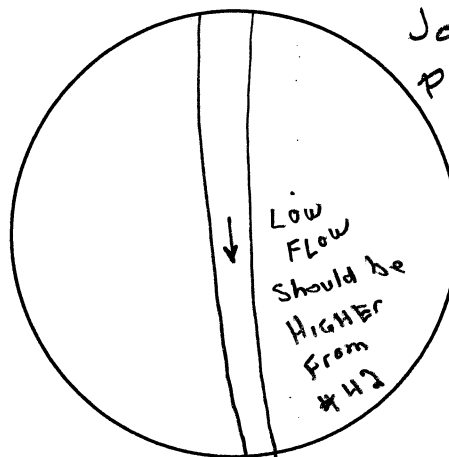
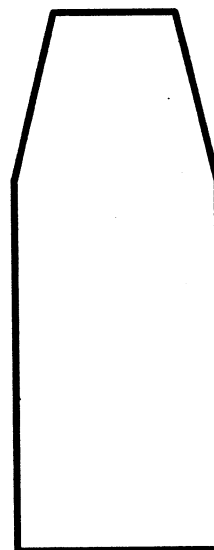
TV'D PIPE  
JOINTS OK  
PIPE OK  
FLOW FROM  
HOUSE

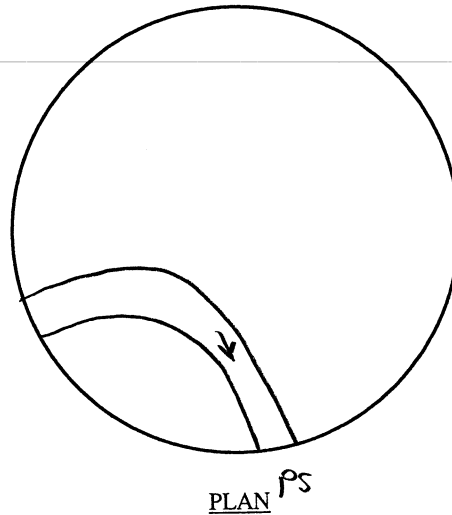
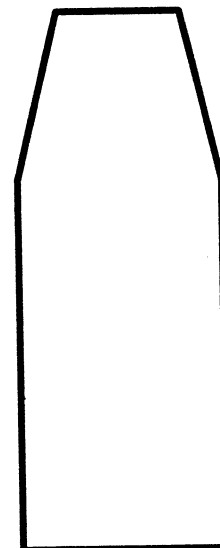
PR LOOSE

RISER CONDITION: EX GD **PR**

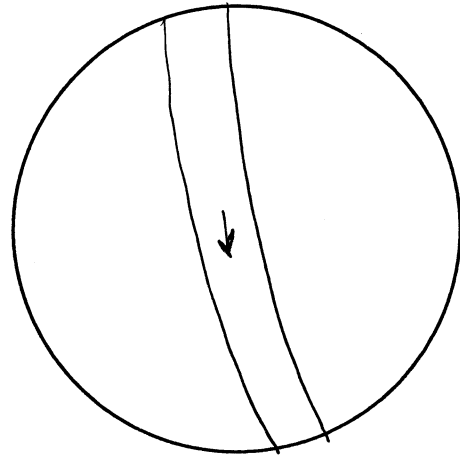
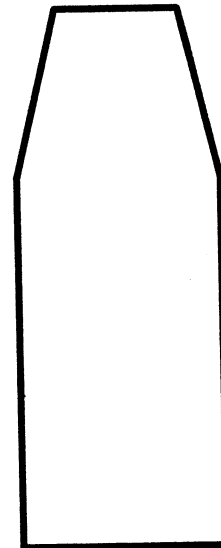
LOCATION DATA:STREET: HBURIED: Yes ☒ No ☐ PAVED AREA: Yes ☒ No ☐MANHOLE DATA:COVER CONDITION: EX ☒ GD ☐ PR ☐COVER DIAMETER: 18" 24" 26 30"NO. OF COVER HOLES: 0SIZE OF COVER HOLES: -CONDITION OF RIM: EX ☒ GD ☐ PR LooseCONDITION OF FRAME: EX ☒ GD ☐ PRRISER CONDITION: EX ☒ GD ☐ PRRISERS ARE: BRICK BLOCK ☒ PRECASTMANHOLE DIAMETER 2FT 3FT ☒ 4FT OTHER: \_\_\_\_\_MANHOLE IS: BRICK BLOCK ☒ PRECAST OTHER: \_\_\_\_\_DEPTH OF MANHOLE: 84 FTCONDITION OF WALLS: EX ☒ GD ☐ PRCONDITION OF STEPS: EX ☒ GD ☐ PRNUMBER OF SECTIONS: ☒ 2 3 4CONDITION OF INVERTS: EX ☒ GD ☐ PRCONDITION OF TABLE: EX ☒ GD ☐ PRLEAKAGE POINTS:COVER: Y/N JOINTS: Y/NFRAME: Y/N INVERTS: Y/NWALLS: Y/N TABLES: Y/N

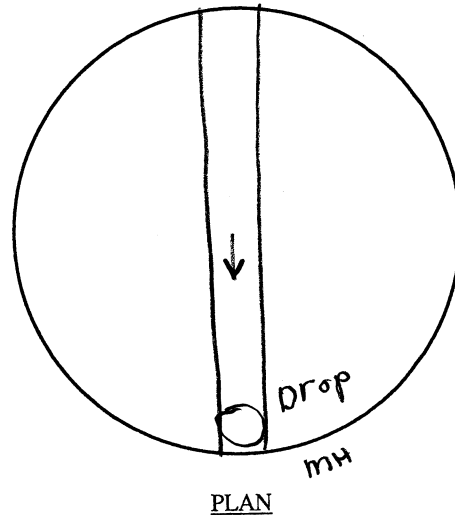
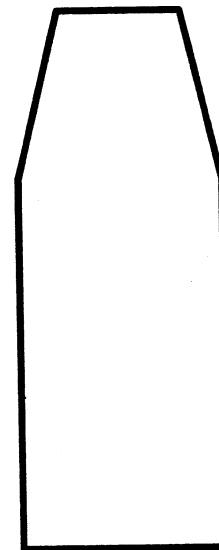
PR LOOSE

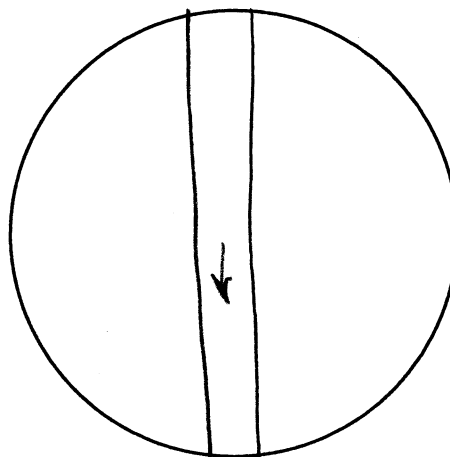
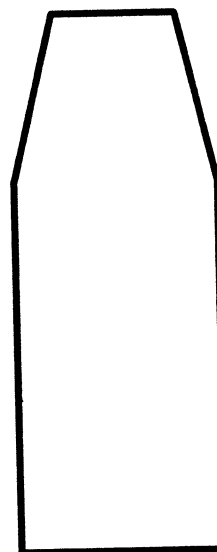
CONDITION OF TABLE: EX GD PR DIRTY

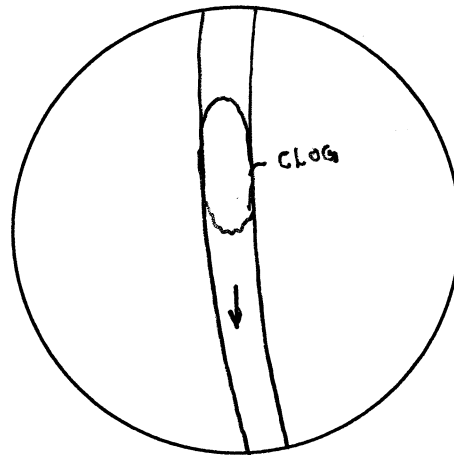
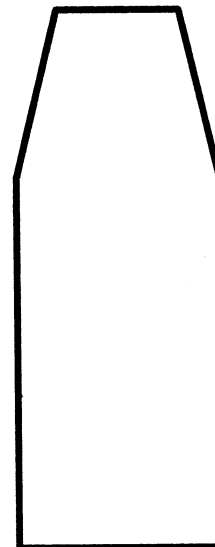
CONDITION OF INVERTS: EX GD  $\leftrightarrow$  PR *clog*

CONDITION OF TABLE: EX  PR *DIRTY*
