CONDITION ASSESSMENT - 223 Inspection Date: 3/25/04 By:

MONUMENT CONSERVATION COLLABORATIVE LLC

Cemetery: North Cemetery, Route 27, Wayland, MA

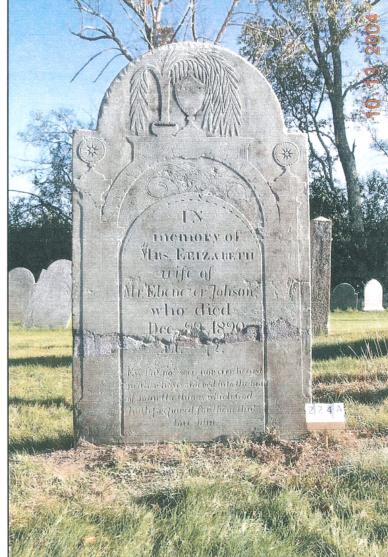
Marker# 223

Material: Slate

Marker Type: Footstone

POSITION Fallen

- 1. Footstone excavated, soil removed from setting area to appropriate depth.
- 2. Footstone re-set plumb at appropriate height and level onto gravel bed, aligned with adjacent markers
- 3. Area around footstone backfilled with tamped sand and gravel
- 4. Disturbed areas re-graded with topsoil and seeded
- 5. All surfaces treated with antimicrobial D/2 and scrubbed with nylon brushes.
- 6. Full rinse with water at no greater than 300psi

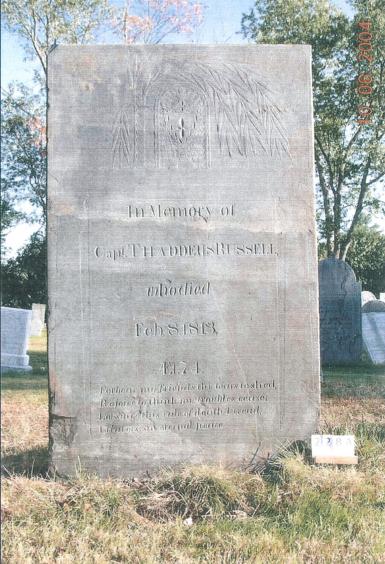
Marker# 228 Location D-139

**DETERIORATION Delamination/Detachment**

- 7. Interior voids flushed with water and any loose debris removed.
- 8. "Dams" created along sides of delamination using a Replical pigmented crack filler. Backer rod used to fill larger delaminations. Stone is misted with water and wrapped in plastic for min 3 days during curing.

- 9. All interior voids caused by splitting or delaminations filled with a pigmented pourable grout.
- 10. After partial cure, any remaining open areas filled with Replical pigmented crack filler and stone is misted with water and wrapped again for min 3 days.

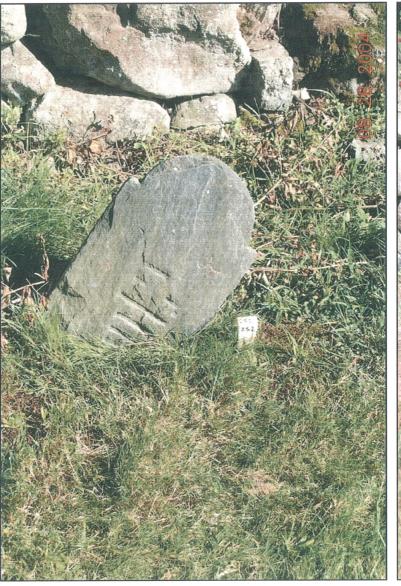
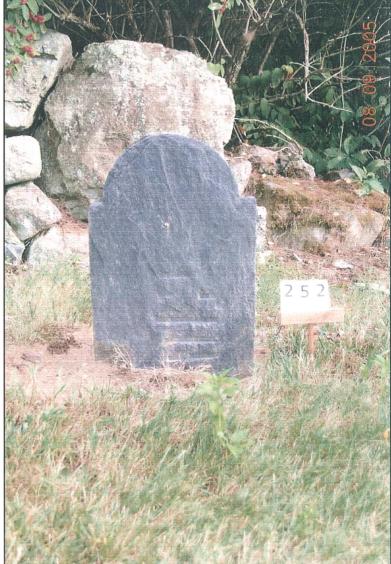
CONDITION ASSESSMENT - 252 Inspection Date: 3/25/04 By: Fannin-Lehner

Condition of Inscrip: Clear but worn

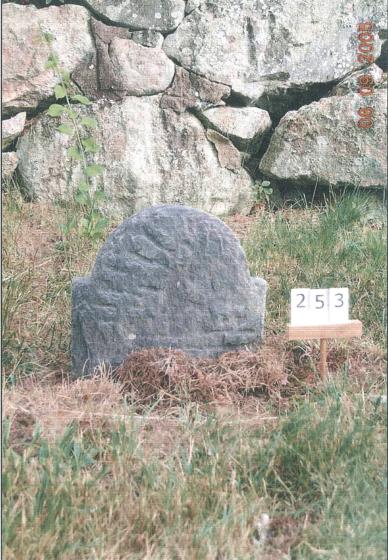
CONDITION ASSESSMENT - 253 Inspection Date: 3/25/04 By: Familia-Lehner

Condition of Inscrip: Clear but worn

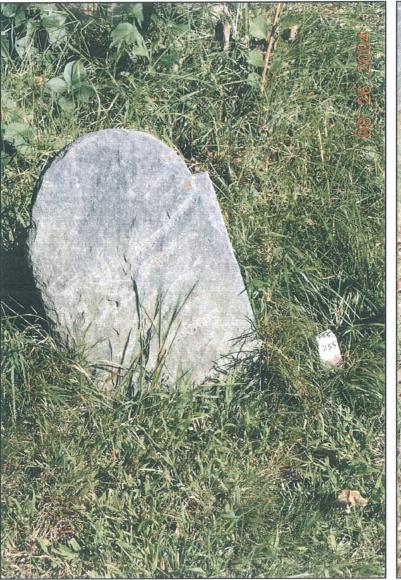
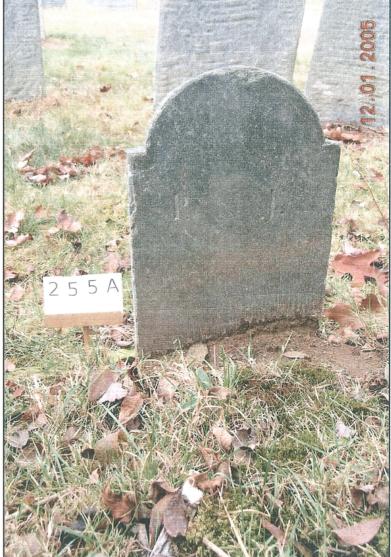
CONDITION ASSESSMENT - 255 Inspection Date: 3/25/04 By

Condition of Inscrip: Clear but worn

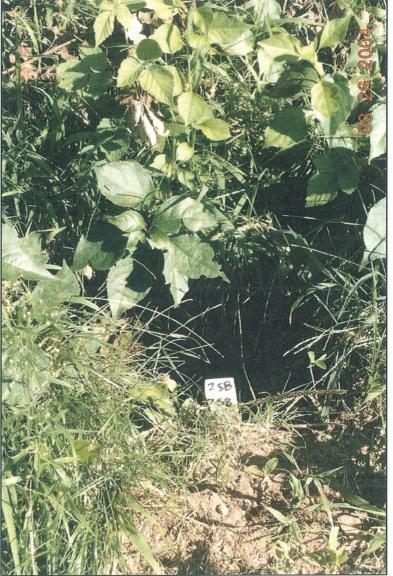
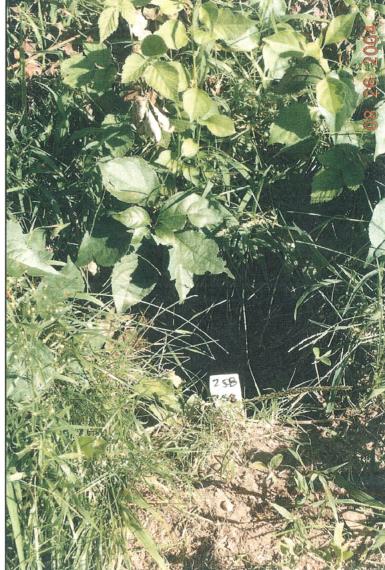
Location E-19F Marker# 258

CONDITION	ASSESSMENT - 258 Inspection Date: 3/25/04 By:	annin- ehner <sub>(</sub>			
Cemetery: North	Cemetery, Route 27, Wayland, MA				
NAME ON MARKER	EDWIN A. JOHNSON				
Death Date: <b>OCT. 12, 1823</b>	Material: Slate Marker Type: Footstone				
Condition of Inscrip	IG CONDITION CONSERVATION STRATE	-CV			
POSITION Over	grown				
CONSERV		)Irreparable			
Not oble to less	TREATMENT	0			
Not able to loca	ate marker.				
		5			
		A C			
Comments:		w			
Joinnents:		L

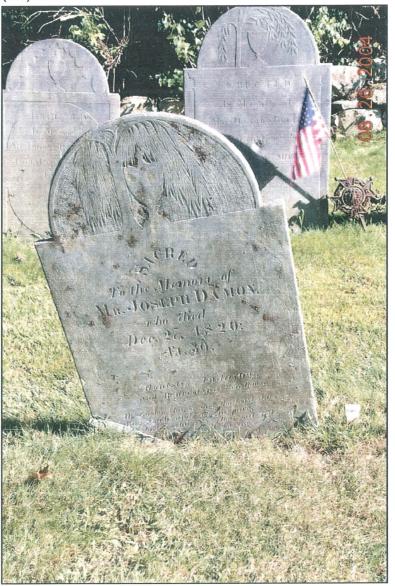
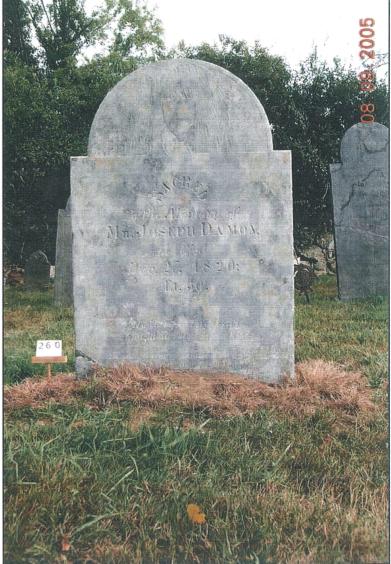
Marker# 260 Location E-21

Condition of Inscrip: Clear but worn

**DETERIORATION Broken**

- 7. Cracks and losses filled with RepliCal products.
- 8. Filled areas misted with water and covered for 3 days minimum
- 9. Filled surface areas treated with light acid wash rinsed thoroughly

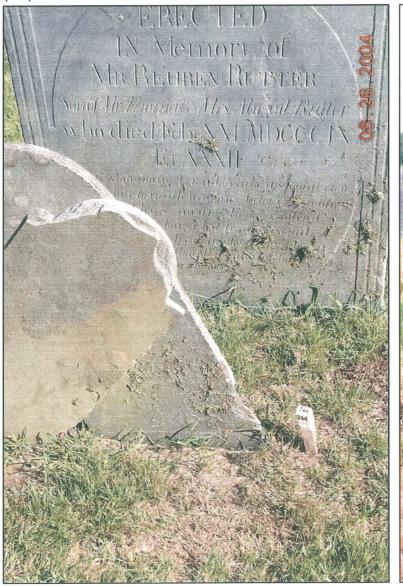
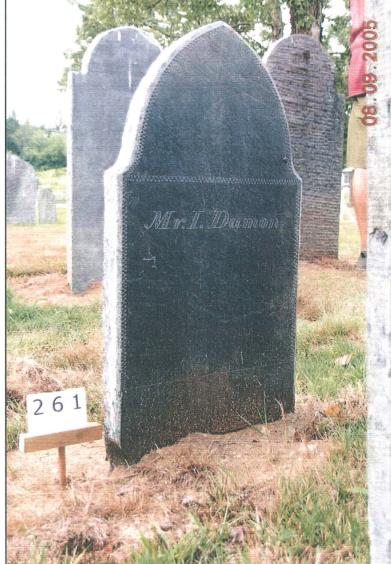
CONDITION ASSESSMENT - 261 Inspection Date: 3/25/04 By:

Condition of Inscrip: Clear but worn

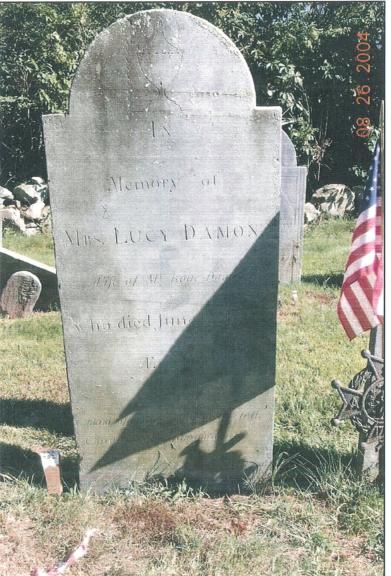
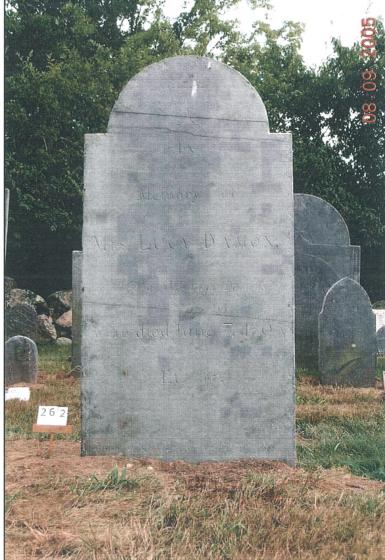
CONDITION ASSESSMENT - 262 Inspection Date: 3/25/04 By:

Condition of Inscrip: Clear but worn

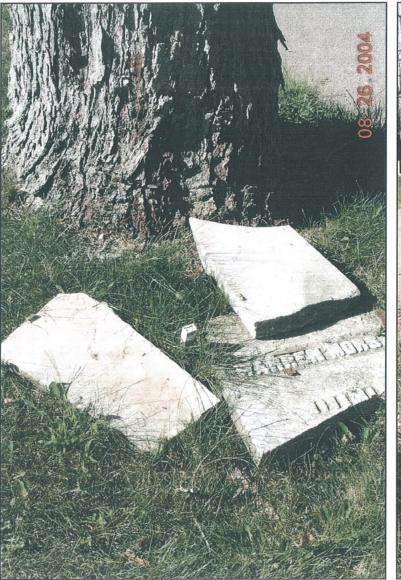
# CONDITION ASSESSMENT - 277 Inspection Date: 3/25/04 By

Condition of Inscrip: Mostly decipherable

EXISTING CONDITION	CONSERVATION STRATEGY					
POSITION Fallen	EXTENT 3)Extensive >50% 2)Partial 25% - 50% 1)Minimal <25%	Re-set in existing base Re-square bottom edge				
DETERIORATION Broken Cracked Losses	2 1 2	Structual adhesion Repair mortars Crack fillers				
SOILING Biological	1	Chemical Pressure wash

- 1. Area around existing base excavated and base unit leveled
- 2. Lower fragment re-set into base slot with cement/lime grout (3/2/5) with 000 sand
- 3. Lower fragment is set plumb and level, braced until 5 days minimum
- 4. Mating edges of marker treated with D/2 antimicrobial and rinsed thoroughly with water
- 5. Fragments attached with structural adhesive ( Abatron 55-22), clamped and braced until cured. Excess epoxy removed by hand chisels.
- 6. Cracks and losses filled with RepliCal Marble products.
- 7. Filled areas misted with water and covered for 3 days minimum
- 8. Filled surface areas treated with light acid wash rinsed thoroughly
